**AGRICULTURAL LAND ASSESSMENT**

**LIDSEY ROAD, WOODGATE**

**CHICHESTER, WEST SUSSEX**

| Reference: | GE19231-ALA-JAN21 |

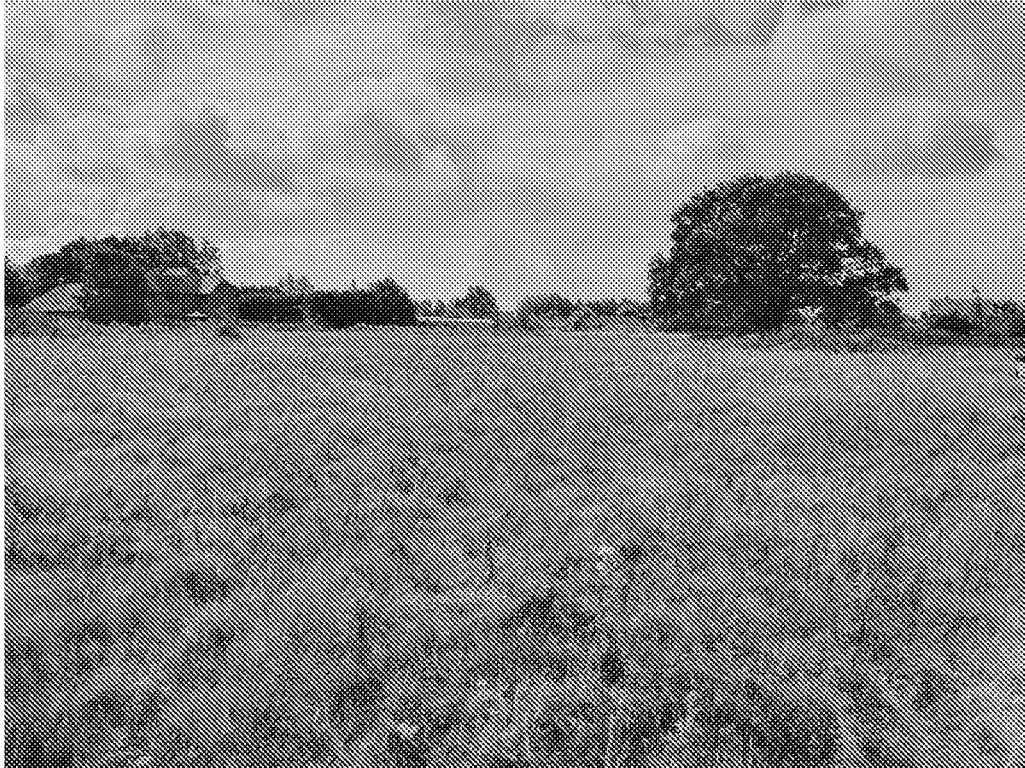
Figure 3 – View of the site facing southwest

The topography of the site is demonstrated as lying at approximately 9.51m to 8.19m AOD, generally falling from west to east.
