## Bat Emergence Report

24 Meadow Way, Westergate

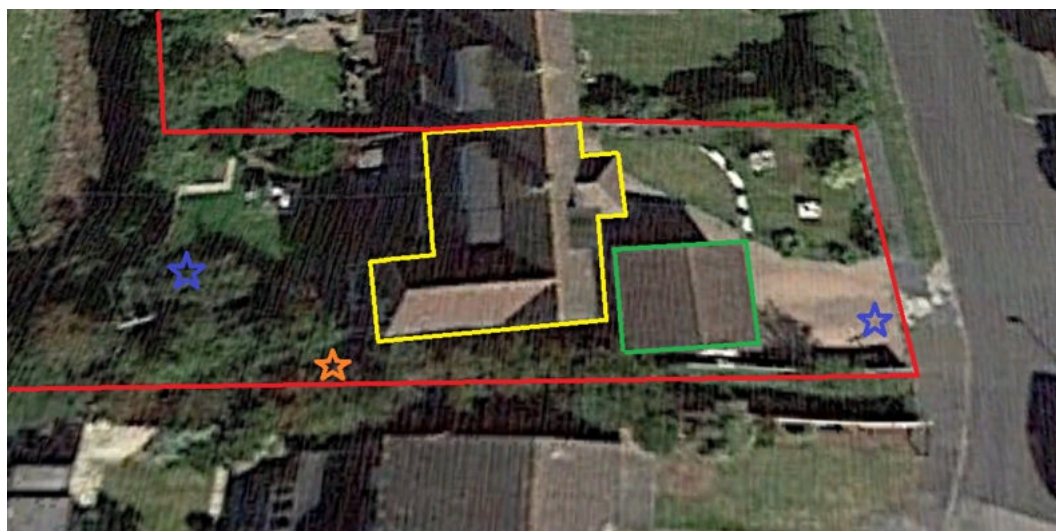
- 2.1 Following the 2021 PEA conducted by The Ecology Partnership, the property at 24 Meadow Way was assessed to have 'low' bat potential owing to a small number of lifted tiles on the western aspect of the building. The detached garage was considered to have 'negligible' potential. A single dusk emergence survey was conducted on the house on the 4<sup>th</sup> May 2023; this was conducted 15 minutes before sunset until 1.5 hours after sunset. The locations of the surveyors and infrared camera are displayed in Figure 2. The survey did not identify any bats emerging from the building.

*Figure 2: Approximate location of the surveyors (blue stars) and IR camera (orange star) around the target building – The Ecology Partnership, 2023*

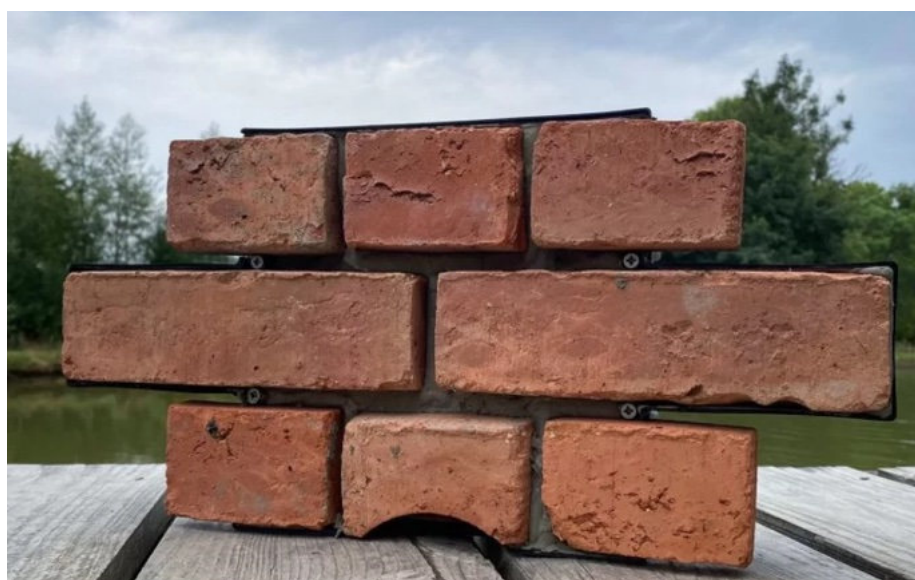
*Figure 4: An example of a Bird Brick Houses bat box (Bird Brick Houses, 2024)*

- 5.2 Ecological enhancements are outlined within the Biodiversity Enhancement Strategy (The Ecology Partnership, 2026). This includes 20 integrated bat boxes within buildings and 2 bat boxes on trees (Appendix 2). Integral bat boxes should be built high up on the external wall of new buildings, a minimum of 4m from the ground. The boxes can be built to match brick types or can be rendered over in keeping with the rest of the building. Models by Bird Brick Houses are recommended although alternative long-lasting models may be used to best match the design of the new dwellings (Figure 4).

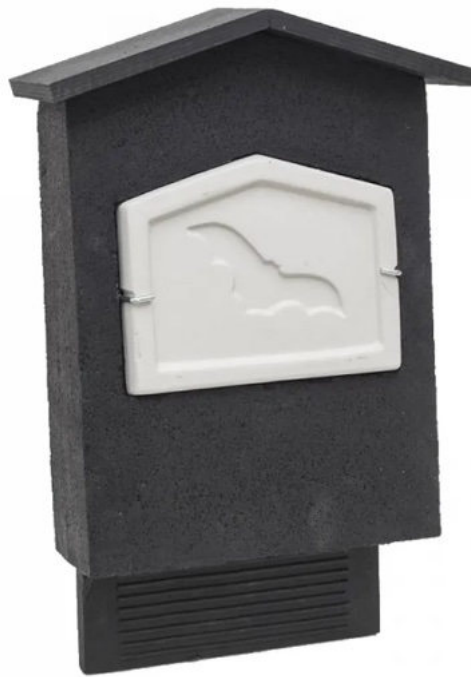
*Figure 5: Vivara Pro Low Profile WoodStone Bat Box*

- 5.3 In addition two bat boxes will be installed on mature trees to the north and southwest of the site. It is recommended that a woodcrete box is used such as the Vivara Pro Low Profile WoodStone Bat Box (Figure 5), for a long-lasting maintenance free bat box. These will be cited a minimum of 4m from ground level with an orientation of southwest, south or southeast and should be exposed to the sun for at least a part of the day.

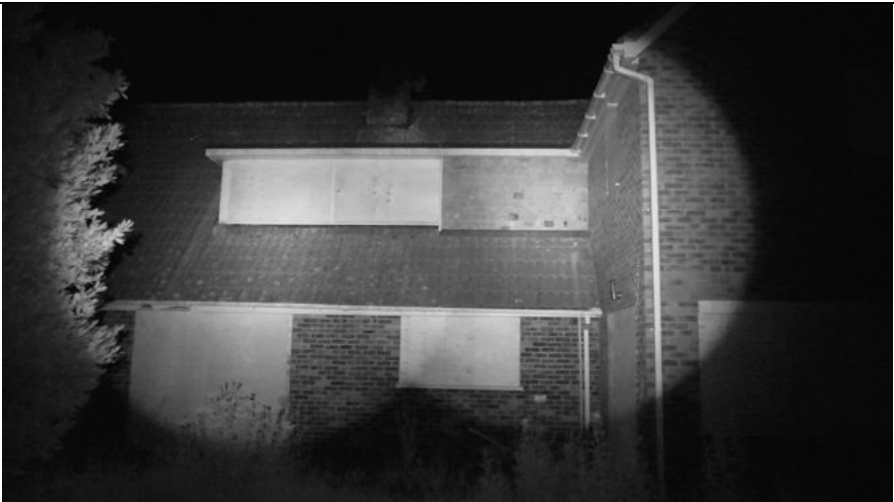
| <p><b>Photograph 1:</b><br/>Screenshot of IR<br/>footage from the<br/>western<br/>surveyor<br/>position on 25<sup>th</sup><br/>June 2026</p> | |

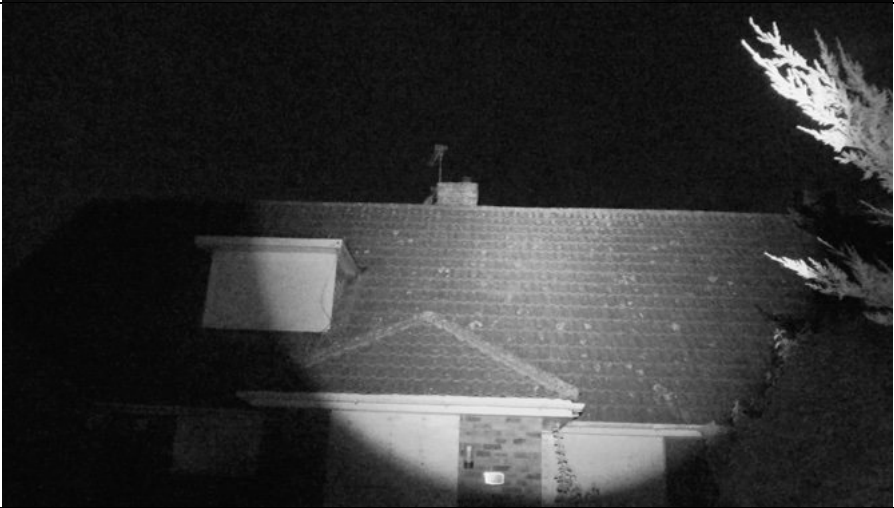
| <p><b>Photograph 2:</b><br/>Screenshot of IR<br/>footage from the<br/>eastern surveyor<br/>position on 25<sup>th</sup><br/>June 2026</p> | |

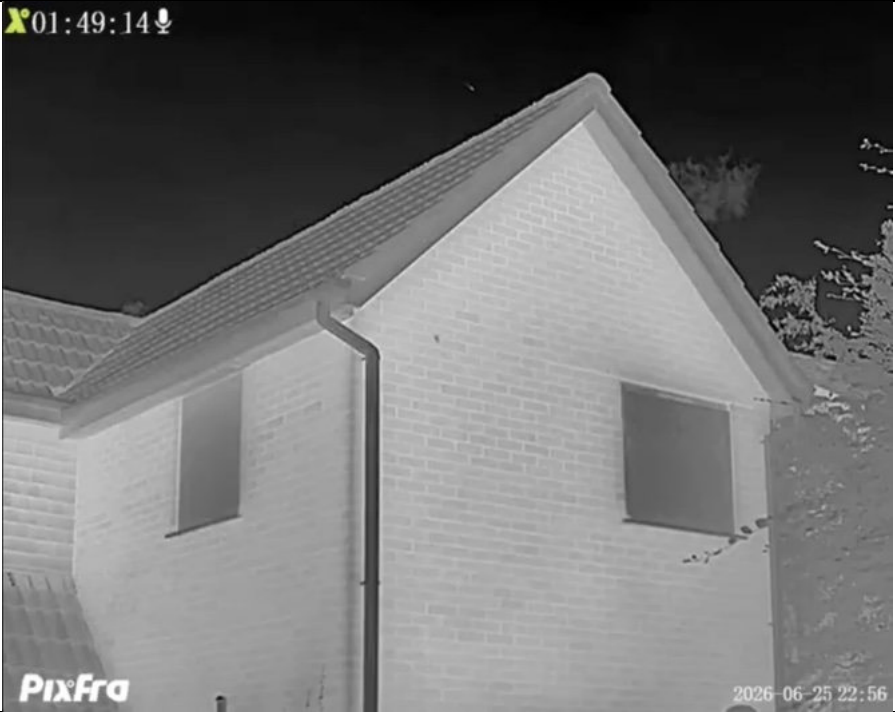
| <p><b>Photograph 3:</b><br/>Screenshot of thermal camera footage in the north-west on 25<sup>th</sup> June 2026</p> | <p>This is a thermal camera screenshot showing a two-story house with a gabled roof. The house is rendered in shades of white and grey, indicating different temperatures. A dark vertical pipe runs down the side of the house. The roofline is visible against a dark background. In the top left corner, there is a timestamp '01:49:14' with a small icon. In the bottom left corner, the 'PixFra' logo is visible. In the bottom right corner, the date and time '2026-06-25 22:56' are displayed.</p> |

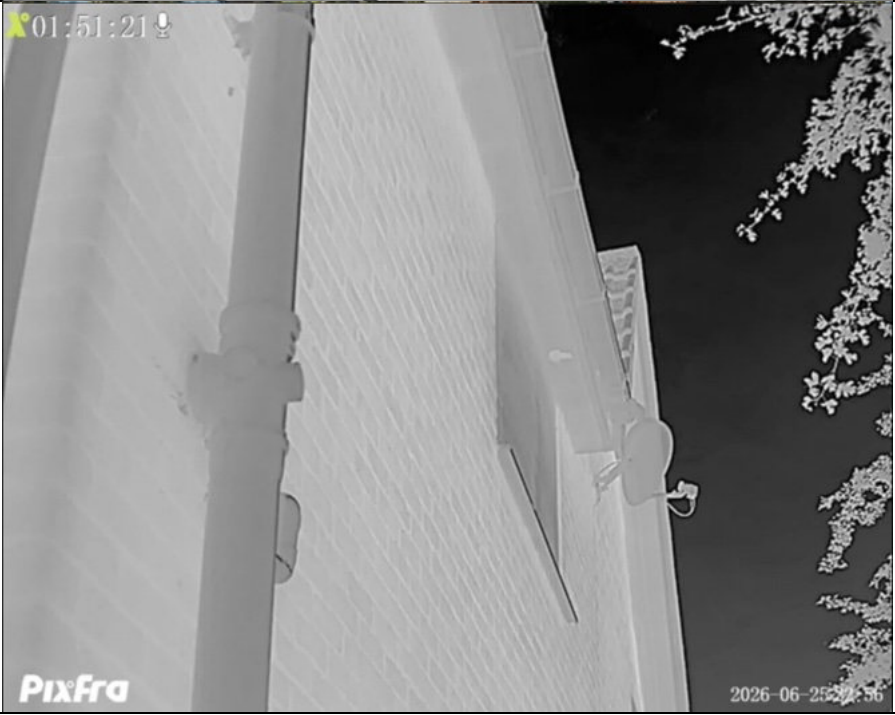
| <p><b>Photograph 4:</b><br/>Screenshot of thermal camera footage in the south-west on 25<sup>th</sup> June 2026</p> | <p>This is a thermal camera screenshot showing a different angle of a house. The house is rendered in shades of white and grey. A dark vertical pipe runs down the side of the house. The roofline is visible against a dark background. In the top left corner, there is a timestamp '01:51:21' with a small icon. In the bottom left corner, the 'PixFra' logo is visible. In the bottom right corner, the date and time '2026-06-25 22:56' are displayed.</p> |
