**Report  
of  
Preliminary Ecological Bat Survey**

**The Barn Fronting Lidsey Road  
Lidsey Farm  
Lidsey**

**20<sup>th</sup> December 2016**

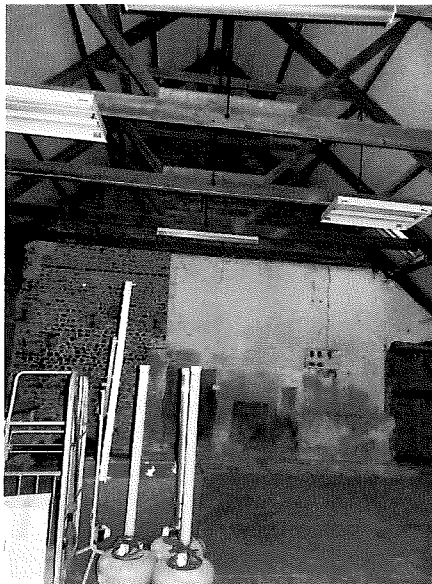
North end

There were no crevices identified in the building for bats to roost which appeared to be well sealed internally. There were no crevices or cracks in the walls or timbers.

The corrugated roof was lined with a breathable roofing membrane which was tightly fitted and the eaves sealed.

No bat droppings or bats were seen or evidence of bats feeding.

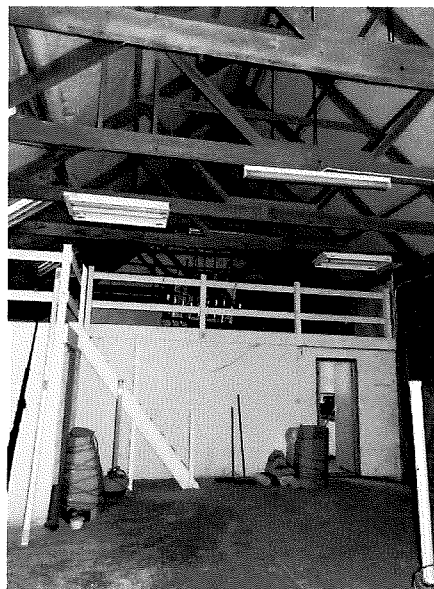
South end with stairs to floor  
over enclosed section

A small area of the ground floor was enclosed and not accessible to bats. The remainder of the building was open to the roof with stairs onto a floor over the enclosed section. Light entered roof lights.

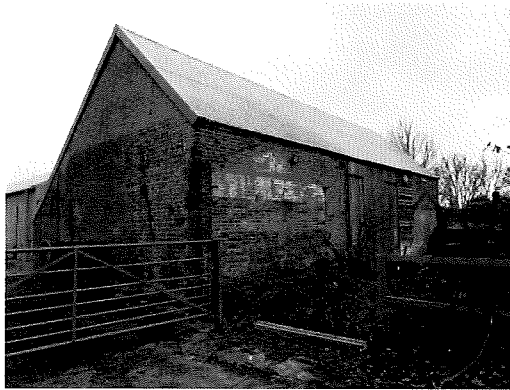
West facing frontage and northern end

The roof was covered with corrugated panels with roof lights fitted into the eastern side all of which was well sealed.

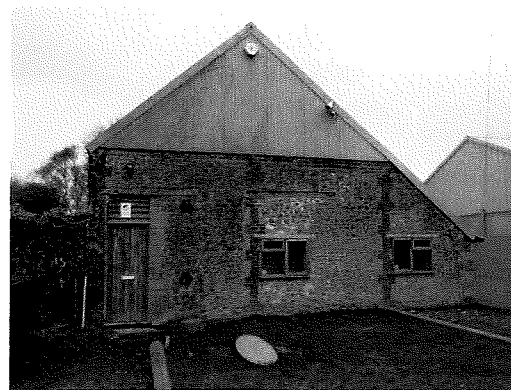
Southern end

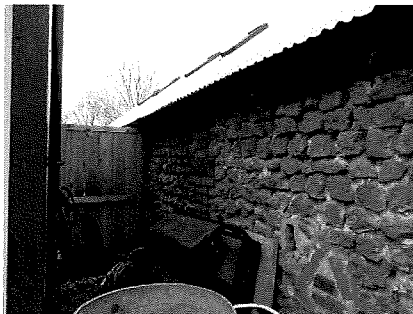
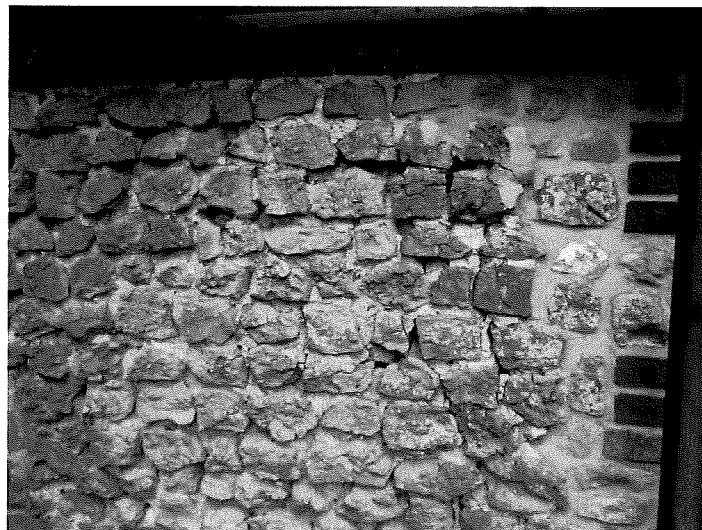
There were crevices in the low stone walls on the eastern rear where mortar had been lost which were deep enough for bats to access and roost. There was no evidence of bats roosting in these crevices, no bat droppings or bats were seen during the survey.

Low rear wall facing west showing crevices where mortar had been lost

There were crevices within a low stone wall externally on the rear of the building but no bat droppings, bats or other evidence of bats accessing these crevices were seen.

There were crevices within a low stone wall on the rear of the building. The wall is very close to a porta- cabin and has a low probability for bats to access it but it will be important to check the crevices immediately before the wall is repaired and to cease work and seek advice if a bat is seen.
