SRC RECYCLING LTD - EASTERGATE

PHASE 1 DESK STUDY

## NON-TECHNICAL SUMMARY

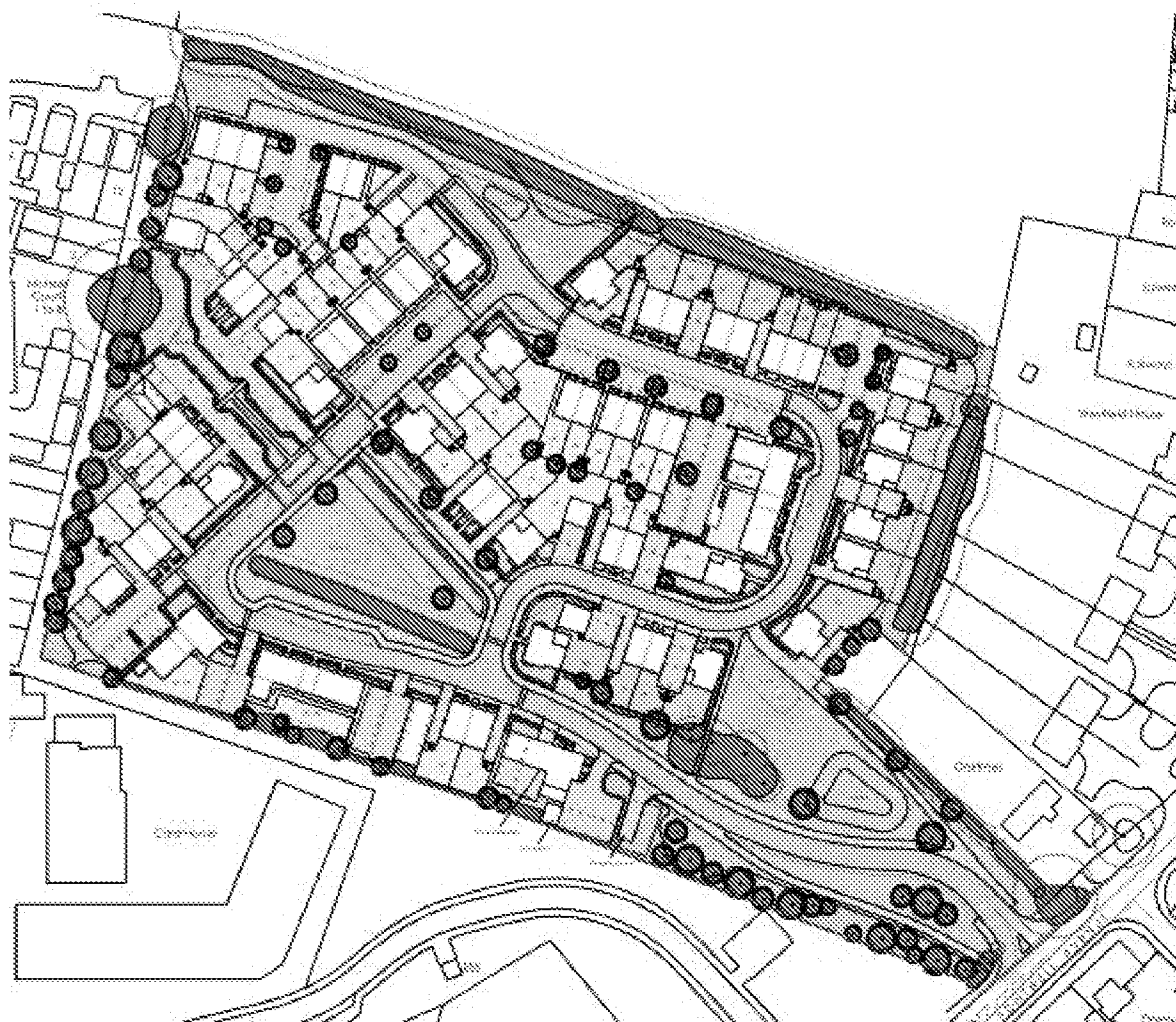
Figure 2: Proposed Site Layout

- 1.2 The site, irregular in plan, is centered at National Grid Reference 494377, 105802, and occupies an approximate area of 3.28ha as shown in Figure 1. The site currently comprises a car salvage centre and area of open land and is located within a primarily residential land use area. The Client requires this Phase 1 Desk Study to support re-development works at the site. It is understood that proposals involve the clearance of the site and construction of a residential development. The proposed development will comprise 80 residential dwellings and Co-working hub on the site of SRC recycling. Figure 2 illustrates the proposed development scheme.

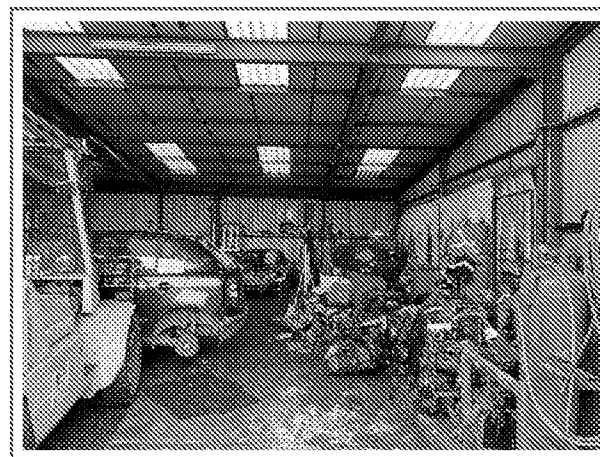
*Engine removal workshop*

- 2.12 The engine removal workshop was also of steel frame construction, with metal cladding and concrete surfacing, which was noted to be in fair condition, with some evidence of staining. Gas canisters, for powering machinery and tools, were stored within the engine removal workshop, as were several 205 litre waste fluid drums and waste drums for oily rags.

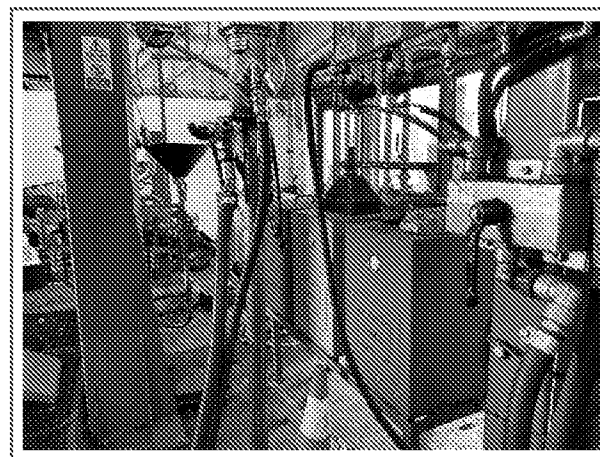
*Waste fluid extraction system within the depollution building*

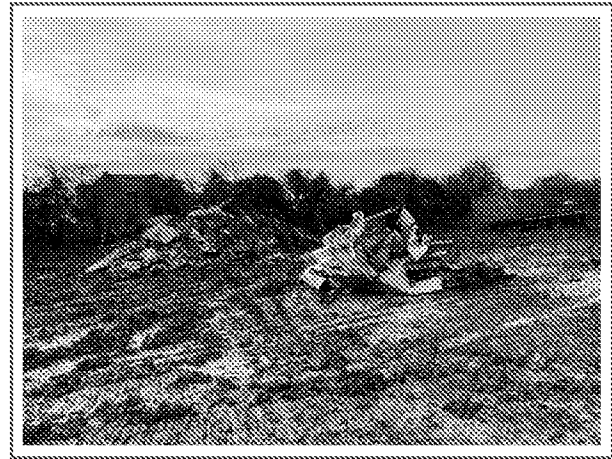
- 2.5 Various stockpiles of waste materials were noted across the western section of the site, located within the eastern and central sections of this area, including a stockpile of concrete blocks, a stockpile of cleared vegetation, a stockpile of scrap metal and a stockpile of wooden fencing and pallets.

*Waste material stockpiles within the western area*
