**SOAKAGE TESTING AND GROUNDWATER MONITORING**

**FIELD PLACE, NYTON ROAD, ALDINGBOURNE**

**G6443**

Report No./ Issue: G6443-01/1

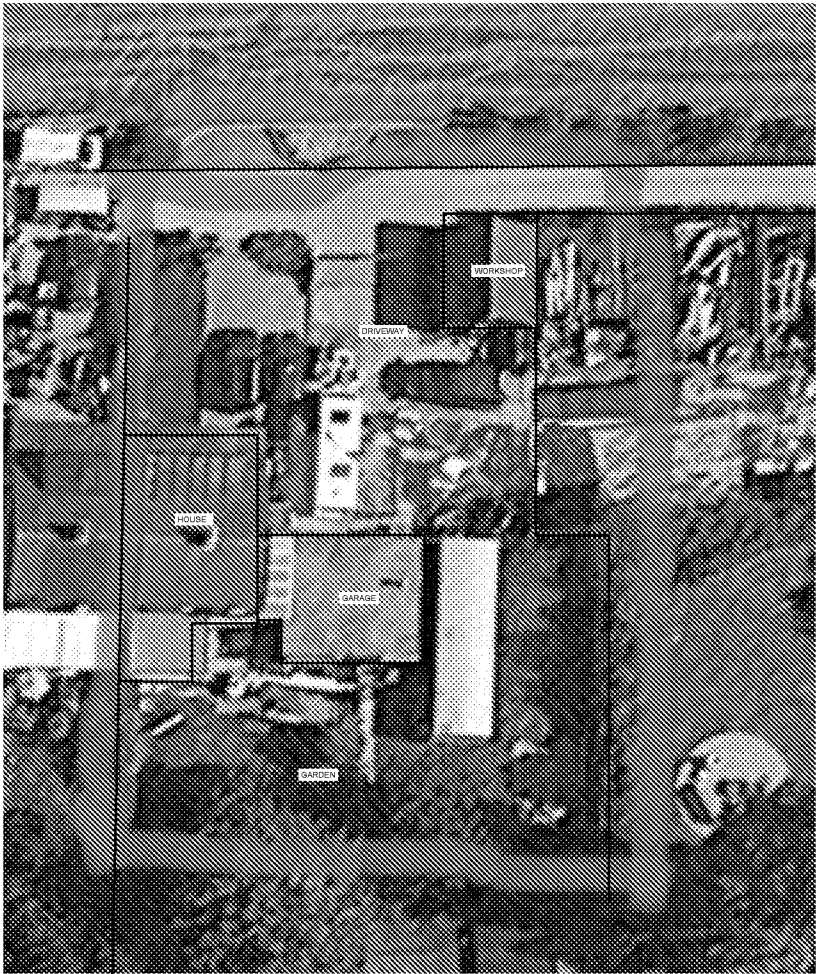
| | | FIGURE REF: Figure 2 |

| TITLE: | Existing Site Layout | DATE: March 2021 |

- 3.2 The site comprises a semi detached house, together with double garage, garden and driveway areas as indicated on the attached Figure 2.
- 3.3 The existing driveway comprises a mix of concrete, block paving, and gravel surfacing. There are no available details for the existing surface water drainage but it is believed that some areas run to soakaways while others run off to adjacent soft landscape areas.

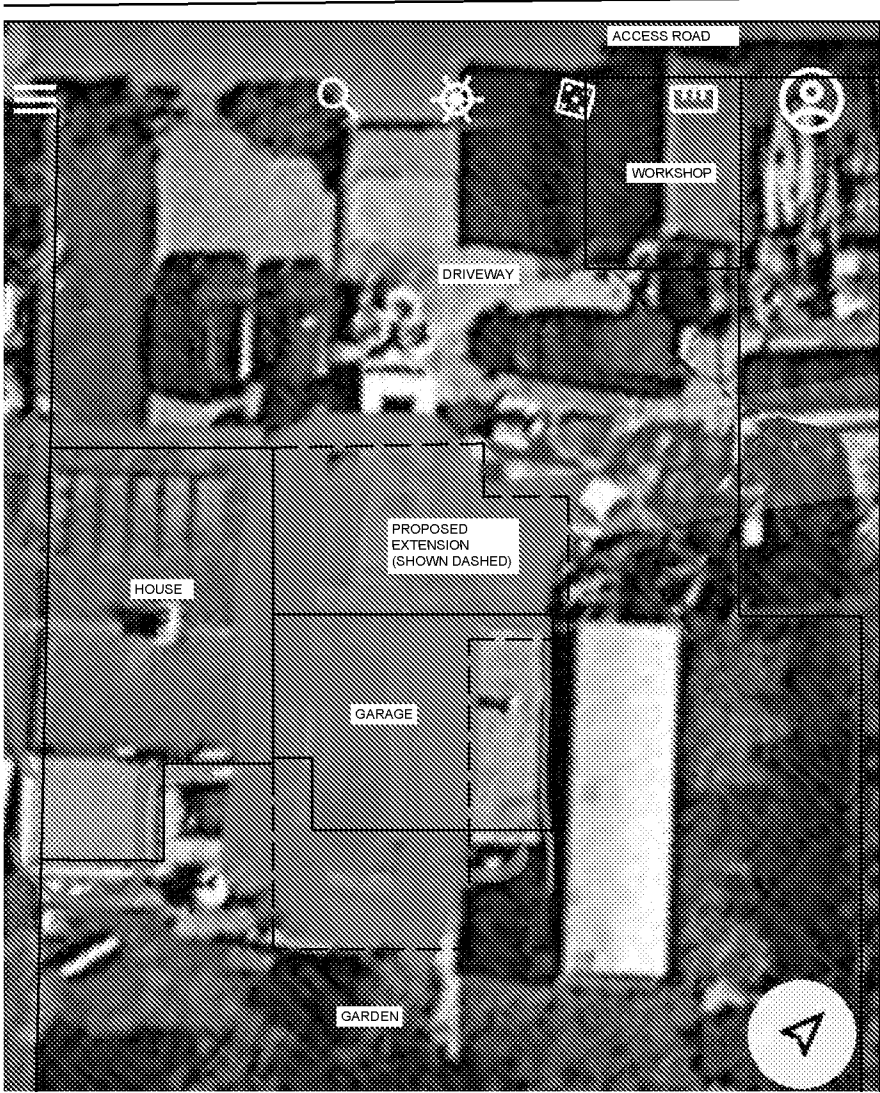
| | | FIGURE REF: Figure 3 |

| TITLE: Proposed Development | DATE: March 2021 | |

- 2.1 The proposed development is currently being designed and is expected to comprise an extension on the southwest side of the existing house as indicated on an aerial photograph annotated by the Client, which is presented on the attached Figure 3.
- 2.2 The work will include removal of an existing garage.
