PROJECT REFERENCE: 18.9862

# PHASE 2: SITE INVESTIGATION REPORT Revision 1

Sack Lane Dairy

RJCA Chartered Architects

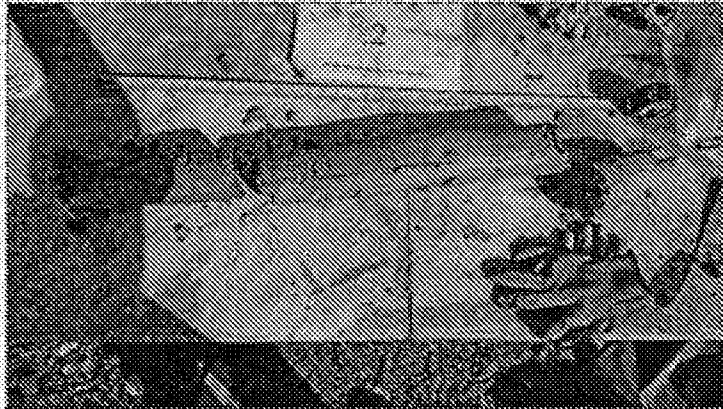
9.

9) WS02 1-2mbgl.

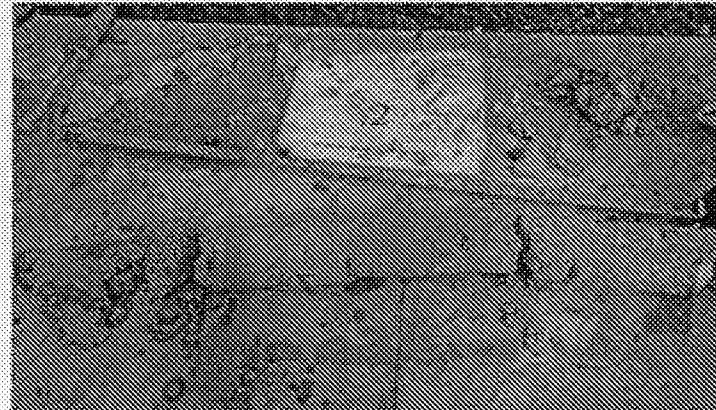
10.

10) WS02 2-3mbgl.

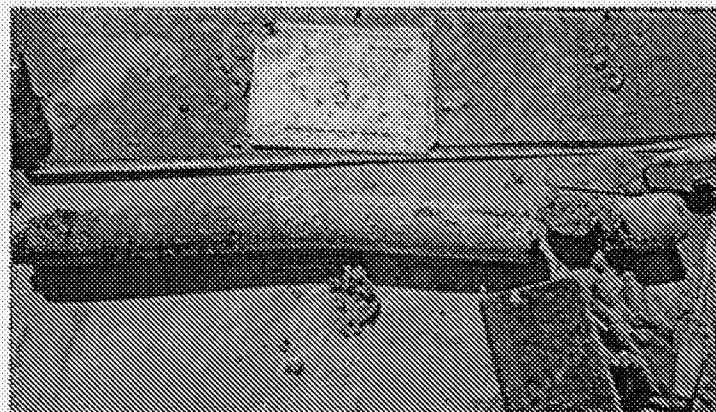
12.

12) WS03 1-2mbgl.
