Report  
of  
Preliminary Ecological Bat Survey  
22<sup>nd</sup> August 2014

The Barn  
Park Lane  
Aldingbourne

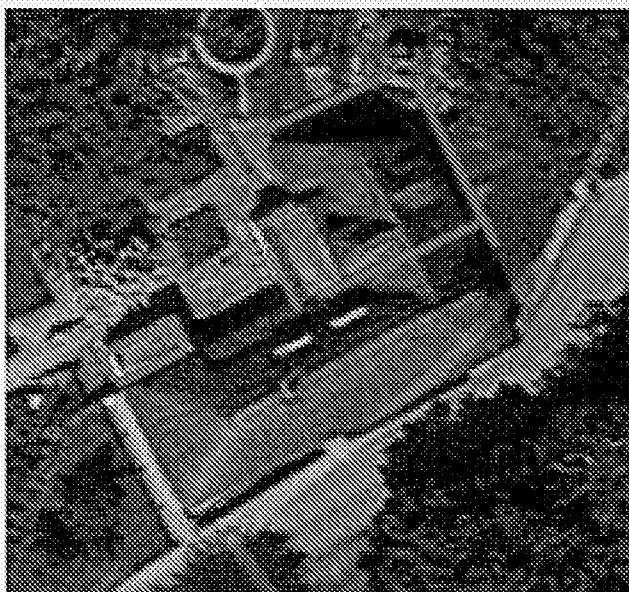
Approximate areas to be removed

It is proposed to remove an existing extension on the north western end of the property and provide a glass link to a new extension. It is also proposed to remove two flat roofed extensions. Clay tiles on the lower roofing on the north western elevation of the existing house would be replaced with thatch.

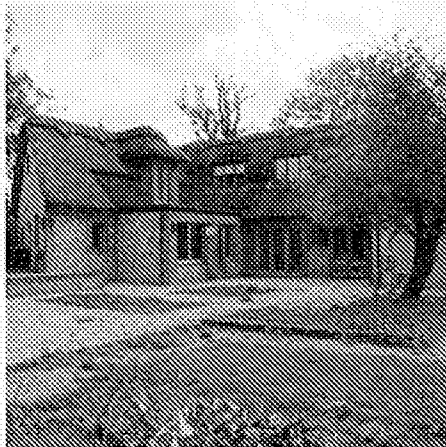
North western and south western elevations

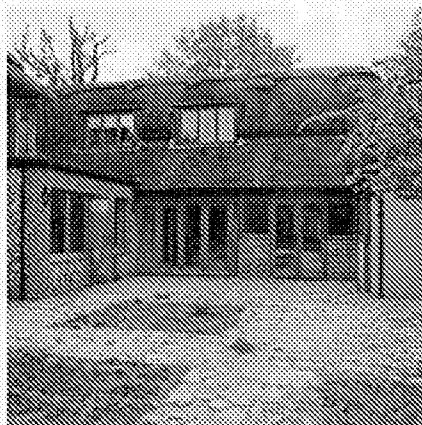
North western elevation

The roof was largely of thatch but there was an area of tiles above the eaves on the north western and south western elevations shown in the following photos.

There was good access to bats in places under the tiling.

It is proposed to demolish an existing pitched roofed extension which has roosting potential for bats under an area of clay tiles fitted on the lower roof below thatch which links to a further area of tiles on another elevation. The extension includes two dormer windows with hanging tiles. There were a small number of small, relatively fresh bat droppings on and under one face of hanging tiles. The droppings were suggestive of the small crevice dwelling Pipistrelle bat. Further investigations will be required in the form of roost surveys ( dusk emergence and /or pre- dawn re-entry surveys) to further consider the building – see 17.4 for further information.

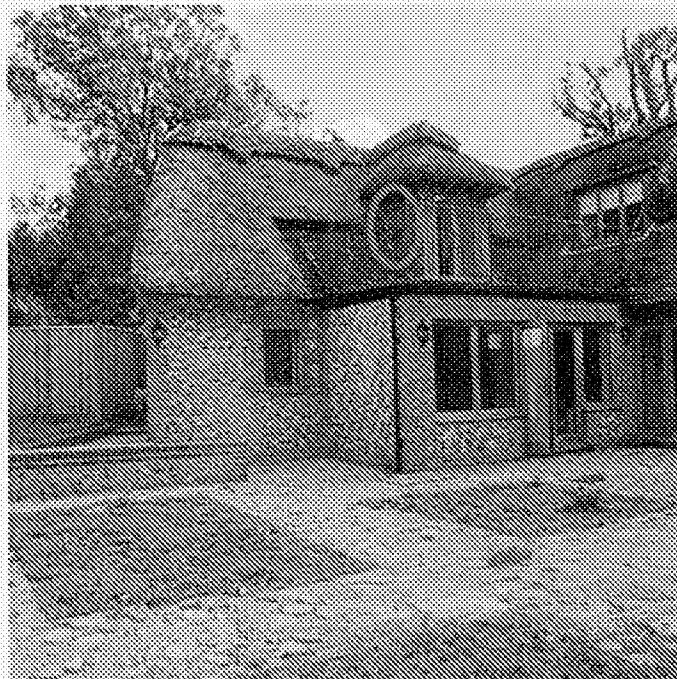
The tiles around the dormer on the south west elevation could be examined closely from a balcony. Most of the tiles were well tightly fitted but there was access under the edge of the tiles and under a small number of tiles. There were small numbers of small bat droppings under and on the hanging tiles on the north side as marked in the following photo. The droppings were relatively fresh.

South west elevation – bat droppings on north side marked

To ensure that no bat is endangered or harmed if roosting under roof or hanging tiles during building work the roof or hanging tiles must be removed by hand and each checked underneath to ensure that there are no bats on the underside of the tile. Ridge tiles should be lifted carefully and checked for bats. A licenced bat ecologist with appropriate experience will be required to supervise the removal of the tiles after providing details to workman of the care to be taken and the signs to look for before work begins. This would need to be detailed in the licence application.

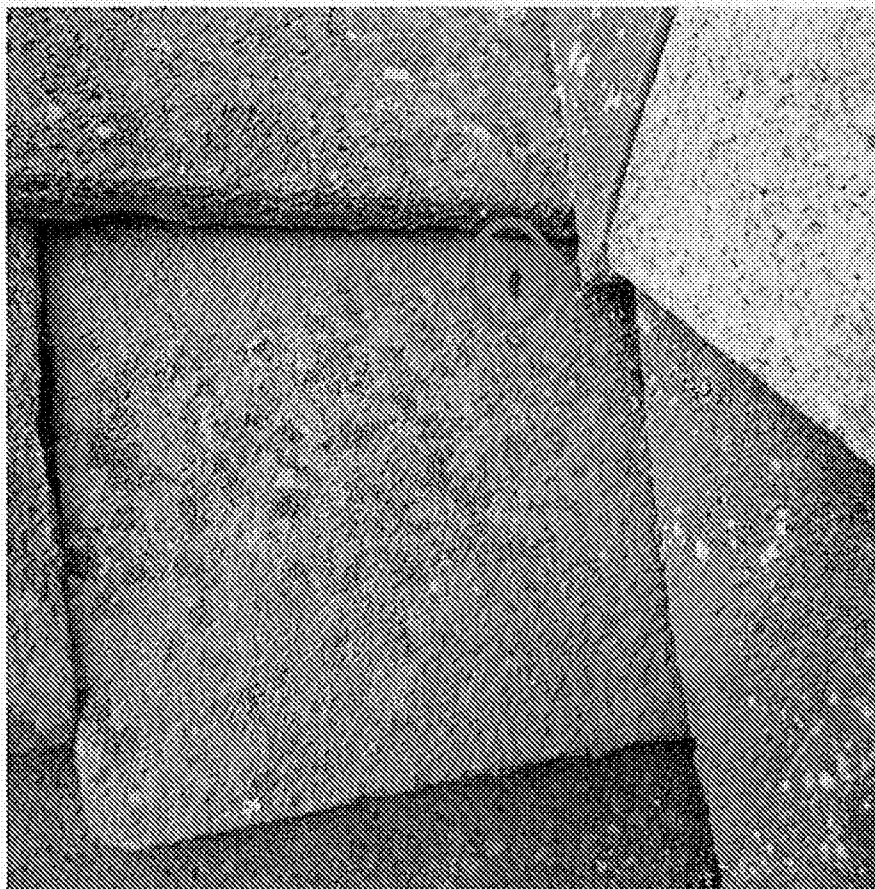
Example of small dropping found on a roof tile beside hanging tiles
