## Phase 1 Desk Study

Land to the south of Sundown, Littleheath Road, Fontwell, West Sussex BN18 0SR

| Report Reference: GWPR4206/DS/July 2021 | | | Status: Final |

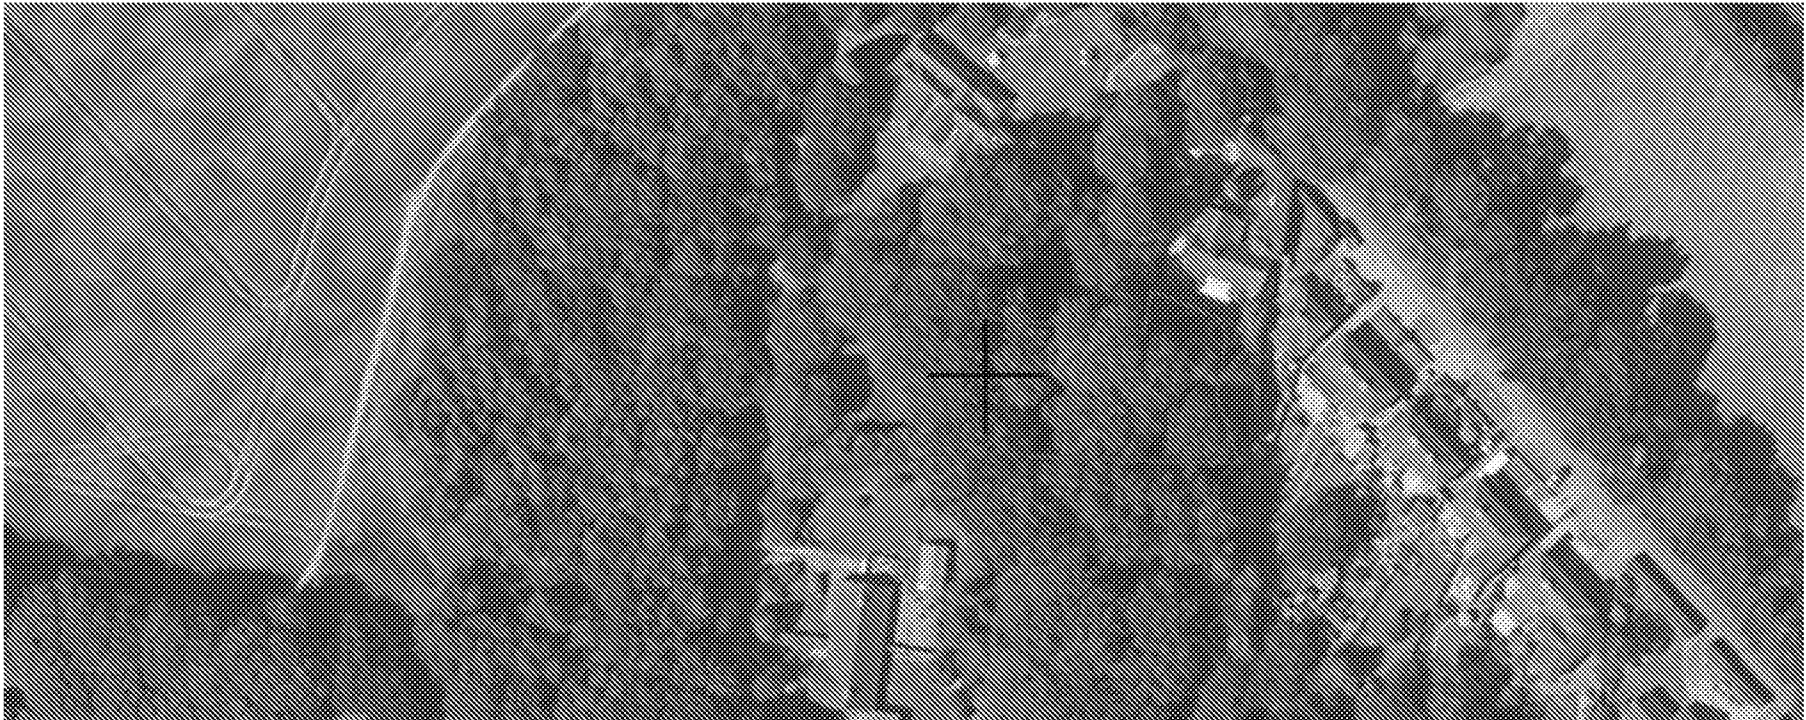
Figure 3

----- Approximate Site Boundary

A Site Walkover was undertaken on the 13<sup>th</sup> April 2021. A description of the site, as noted during the Site Walkover, is tabulated below. An aerial view of the site, showing an approximate site boundary, is given within Figure 3. Photographs taken from the site walkover can be viewed within Appendix B.

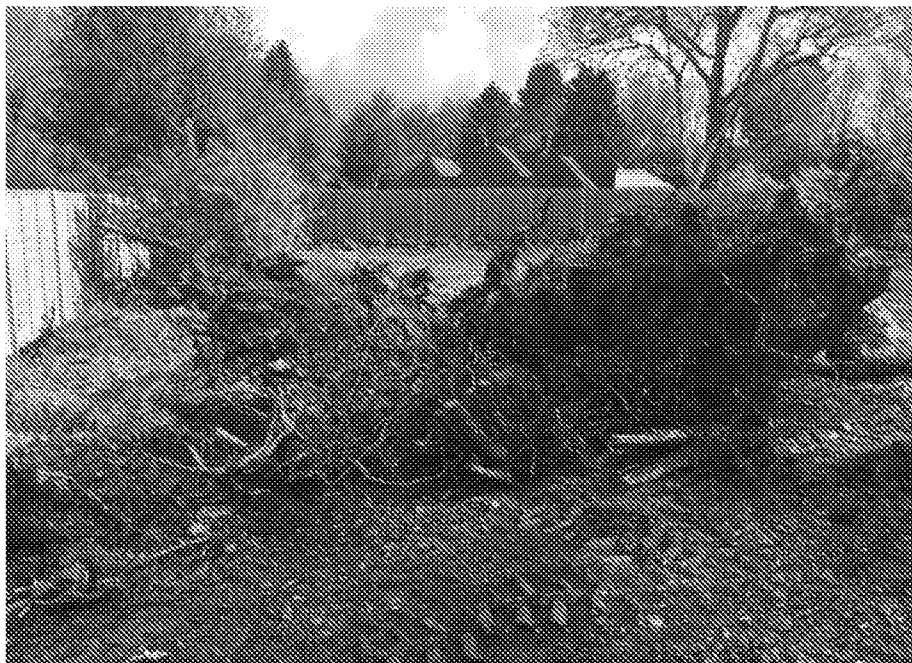
**Photograph 6:** View looking north along the western boundary of the site showing tree root balls that have been removed.

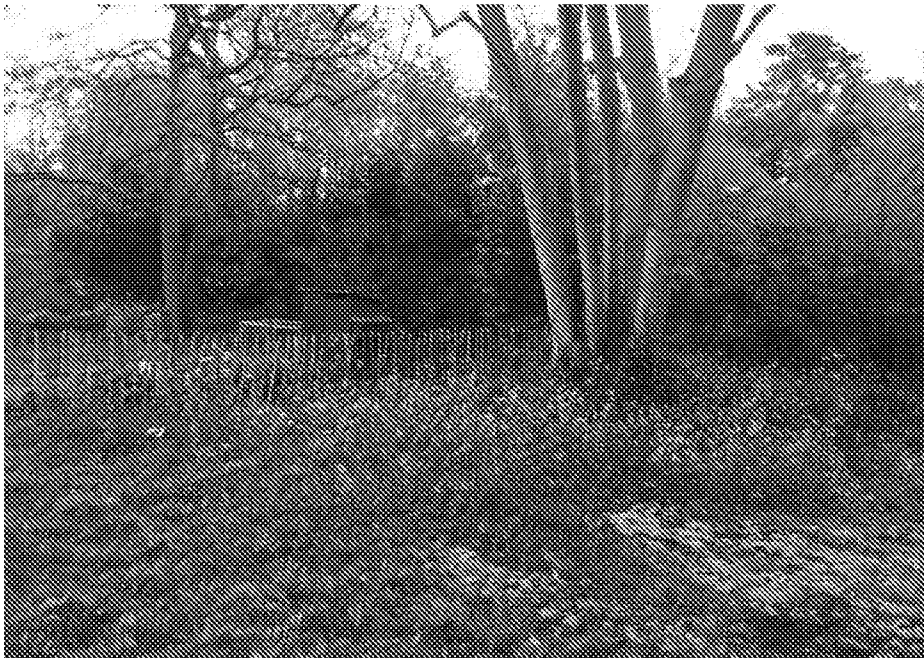
**Photograph 7:** View looking north-east towards the northern boundary in the bottom of the depression in the eastern portion of the site.

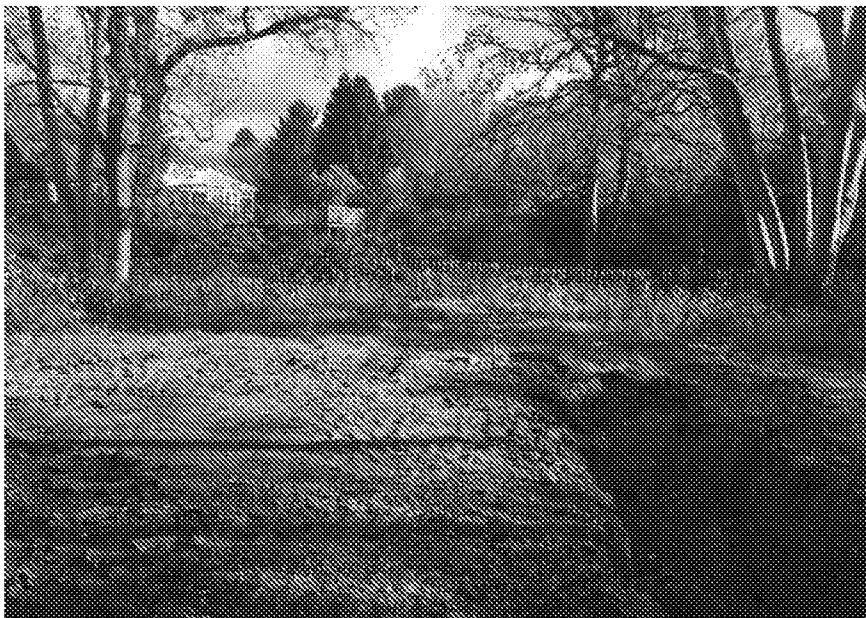
**Photograph 8:** View across the eastern portion of the site looking north showing the depression extending beyond the northern boundary.

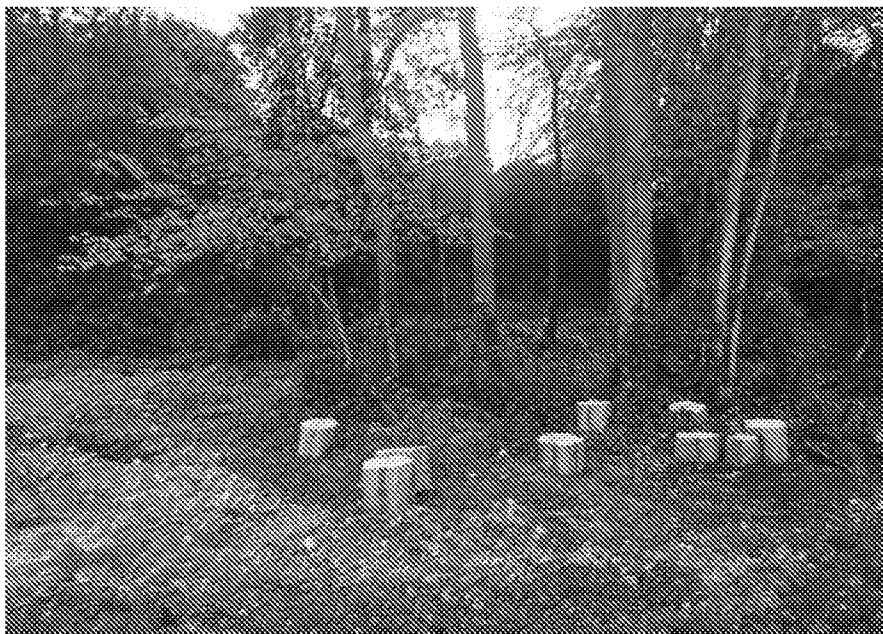
**Photograph 9:** View looking south-east towards the southern boundary in the bottom of the depression in the eastern portion of the site

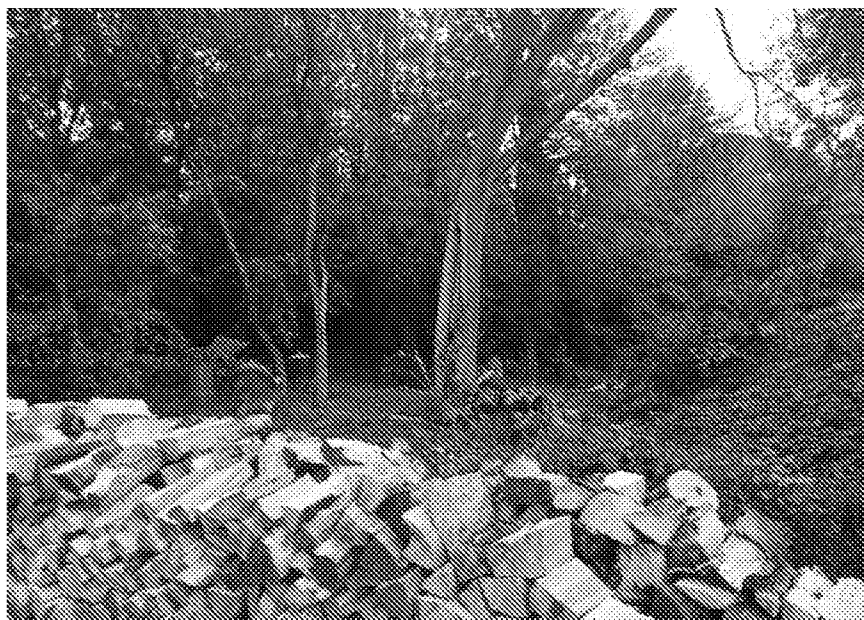
**Photograph 10:** View from the southern boundary looking south along the bottom of the depression that extends to the south.

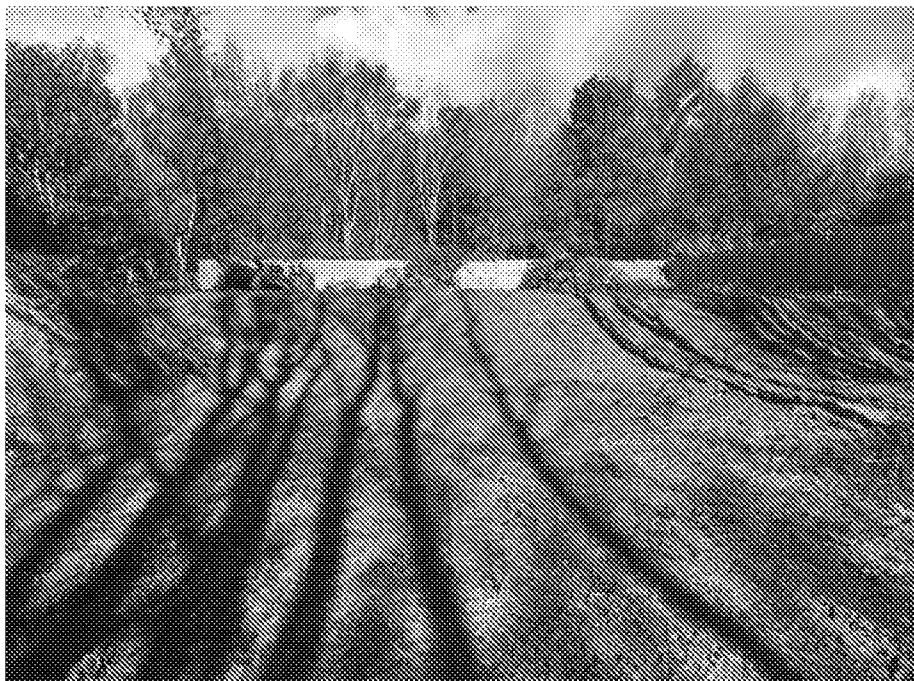
**Photograph 11:** View of the western side of the depression crossing the centre of the site looking west.

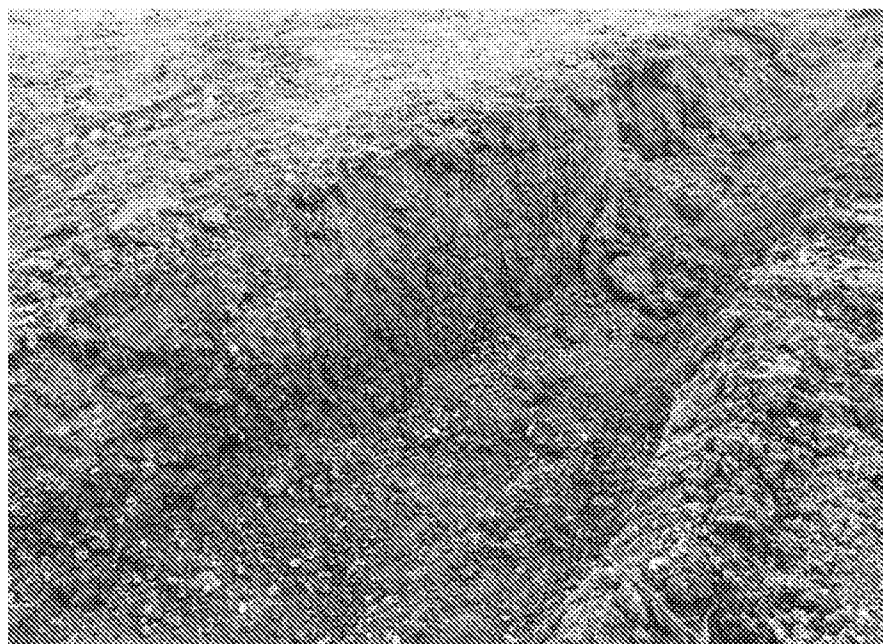
**Photograph 12:** View of soils exposed in a trench in the base of the depression showing no Made Ground or infilling has taken place

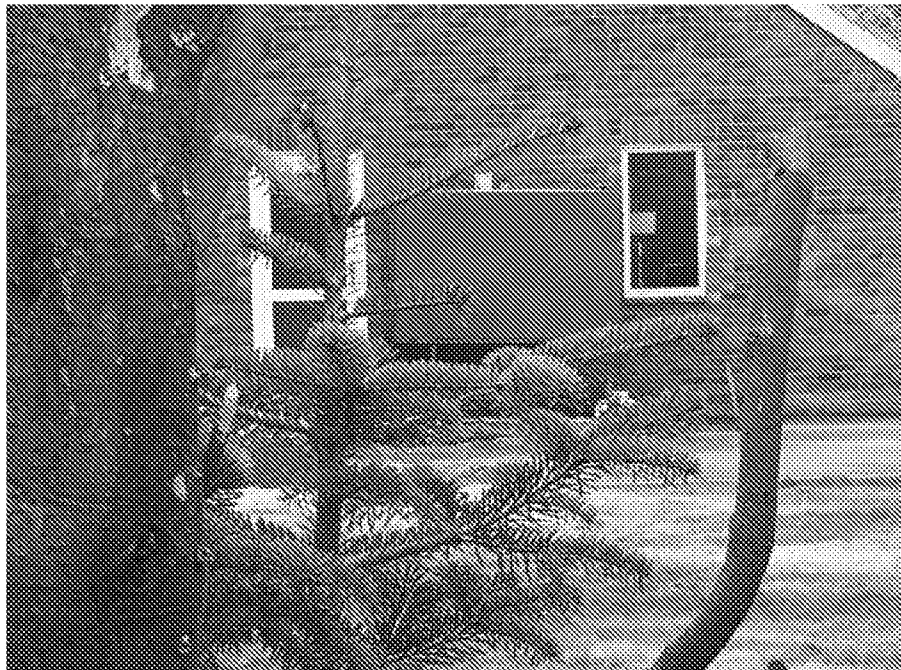
**Photograph 13:** View of the heating oil tank adjacent to the property to the south of the site

- Above ground unbunded heating oil tanks associated with the residential properties ~50m to the north and south were noted during the Site Walkover. No visual or olfactory evidence for leaks/stains of heating oil were associated with the tanks. Fuel oils are generally lighter end (C10 – C15) and therefore volatilise to atmosphere and quickly bio-degrade meaning migration over the distance the tanks are from the site is considered a negligible risk and these potential sources of contamination can be dismissed.
