## Arboricultural Report – additional supporting evidence

- 1.1 land to the south of Sundown, Littleheath Road, Fontwell, Arundel BN18 0SR.

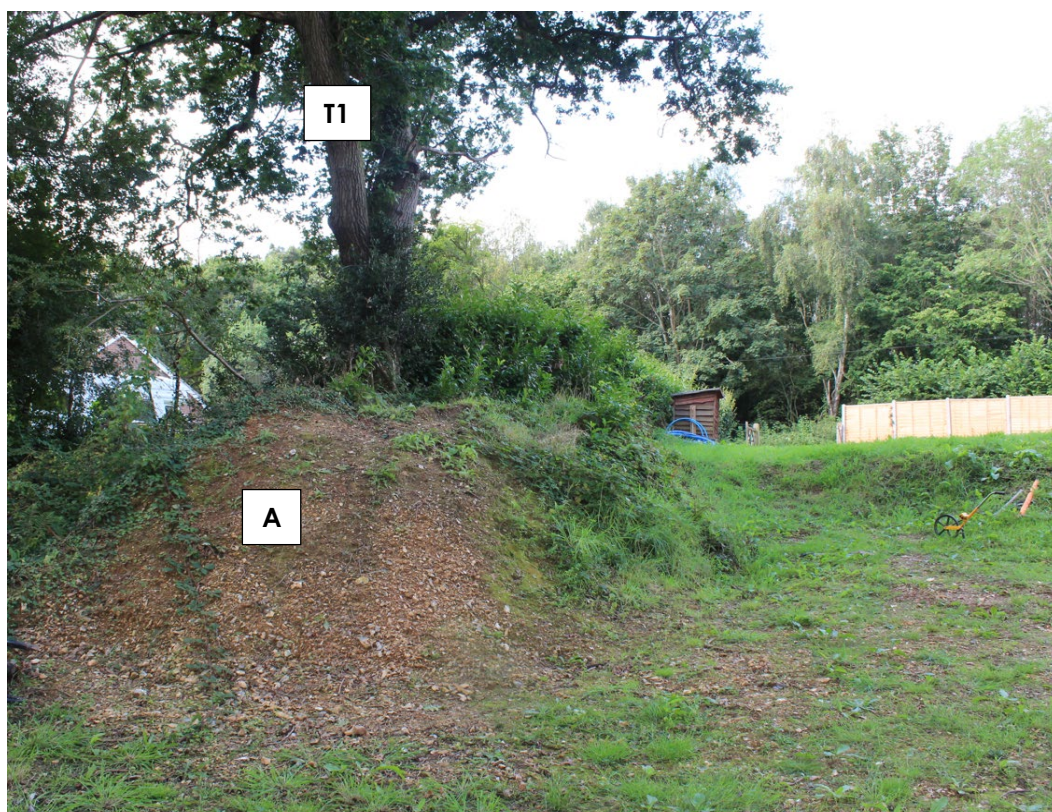
Fig. 1 - English oak (T1)

- 3.2 The English oak (**Fig.1**) is a mature Category B tree that sits at the top of a bank on the southern boundary of the plot at the point before the ground falls away into the old quarry. The stem base is 1.8m to 2m above the surface of the quarry floor. The exposed profile at the eastern end of the bank (**A**) shows the clay, gravel and flint subsoil that forms the main soil structure within the site.
- 3.3 Vegetation at the base of the oak and extending part way down the bank included small-diameter laurel, holly, elder, ash regeneration, hazel seedlings, brambles, foxgloves, ivy and grasses.

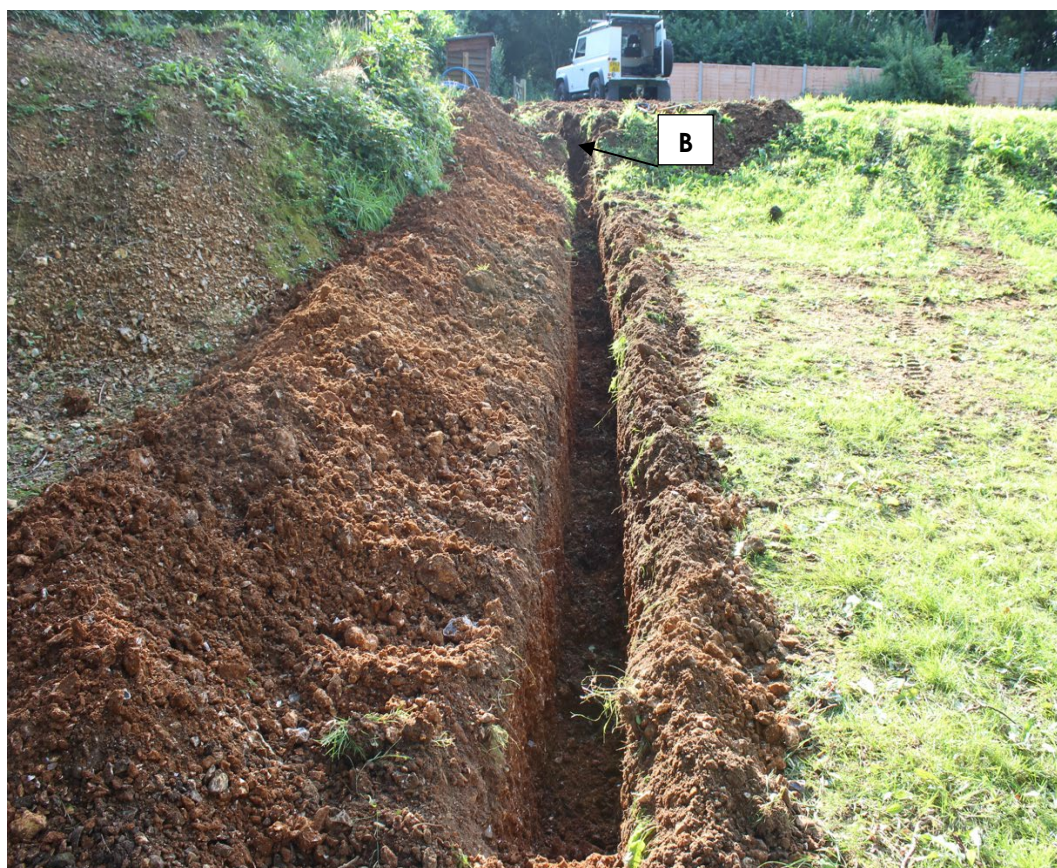
- 4.1 Following an initial site visit to determine the soil type and rooting pattern within the plot, and subsequent to discussions with the Council Tree Officer, a narrow trench was dug within the RPA of T1 and details recorded.
- 4.2 The main trench (**Fig. 2**) extended from a point at 11.5m to the east of **T1** for 13.8m to a point at the centre of the track, 5m from **T1**, where the ground rises up to the level of the proposed building.

**Fig. 2 – main trench**

- 4.3 A shorter 5m trench (**B at Fig.2**) was excavated within the section of track now filled in to the level of the higher ground.

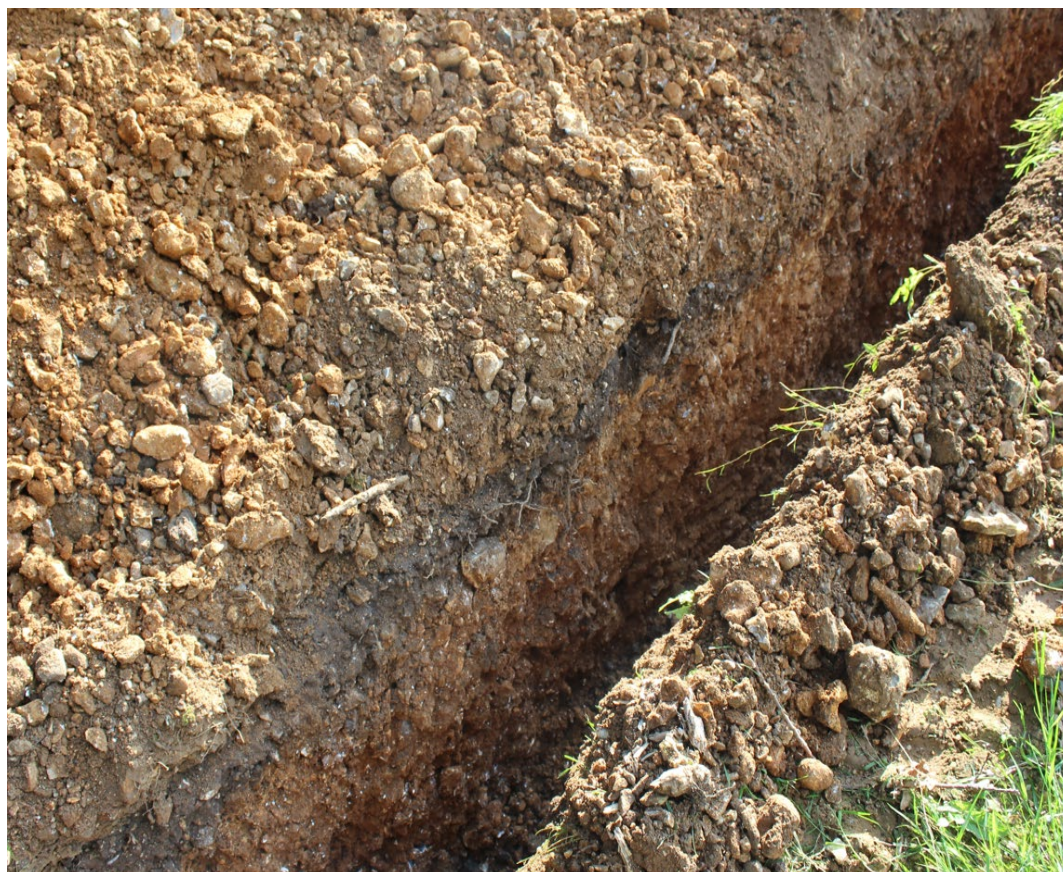
- 4.3 Excavation was initially by hand within the shallow topsoil, 50mm to 100mm, before continuing – under close supervision – with a mini digger to a depth ranging between 700mm and 800mm.
- 4.4 The soil profile exposed (**Fig. 3**) within the main trench showed a thin topsoil, between 50mm to 100mm deep, over a heavy subsoil of clay, flint and gravel.

**Fig. 3 – soil profile**

- 4.5 No roots were present in the heavily compacted subsoil.
- 4.6 The location of any roots encountered within the top soil are noted below.

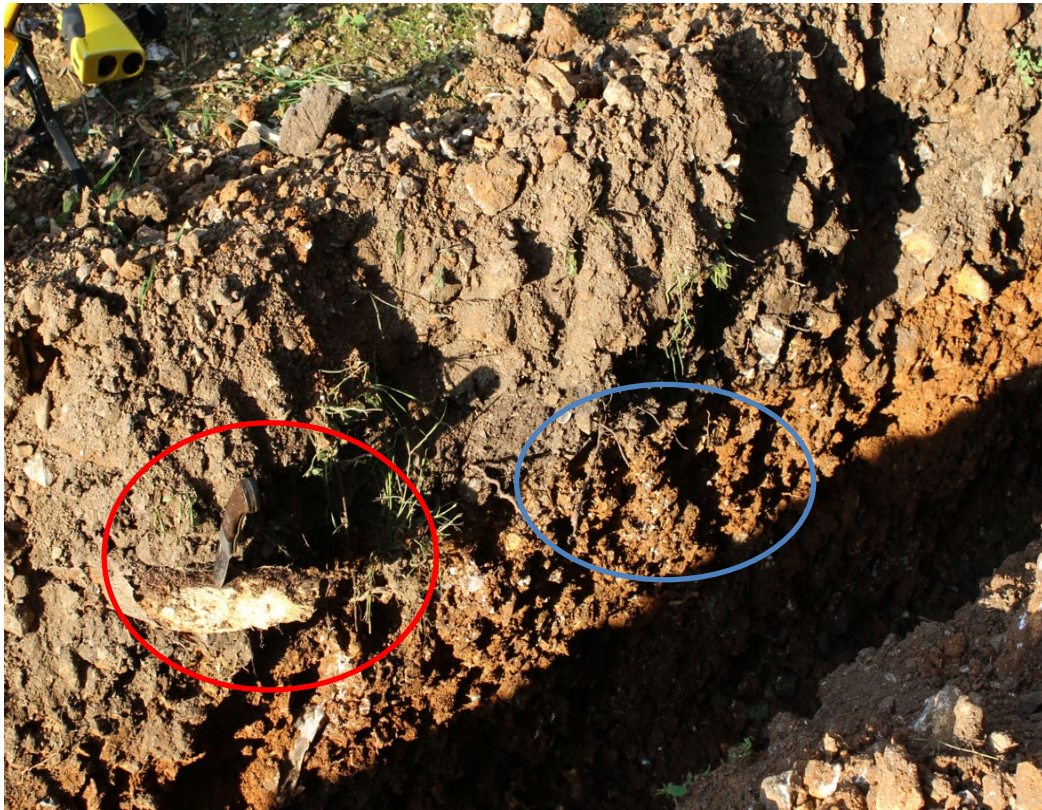
- 4.7 The 30mm diameter dead root at 7.3 m from the end of the trench (**circled in red at Fig.4**) is likely to be part of the root system of an old

dead ash that was located on the bank at the edge of the higher ground within the centre of the plot (**note <5mm roots at 6.8m circled in blue**).

**Fig. 4 – dead ash root.**

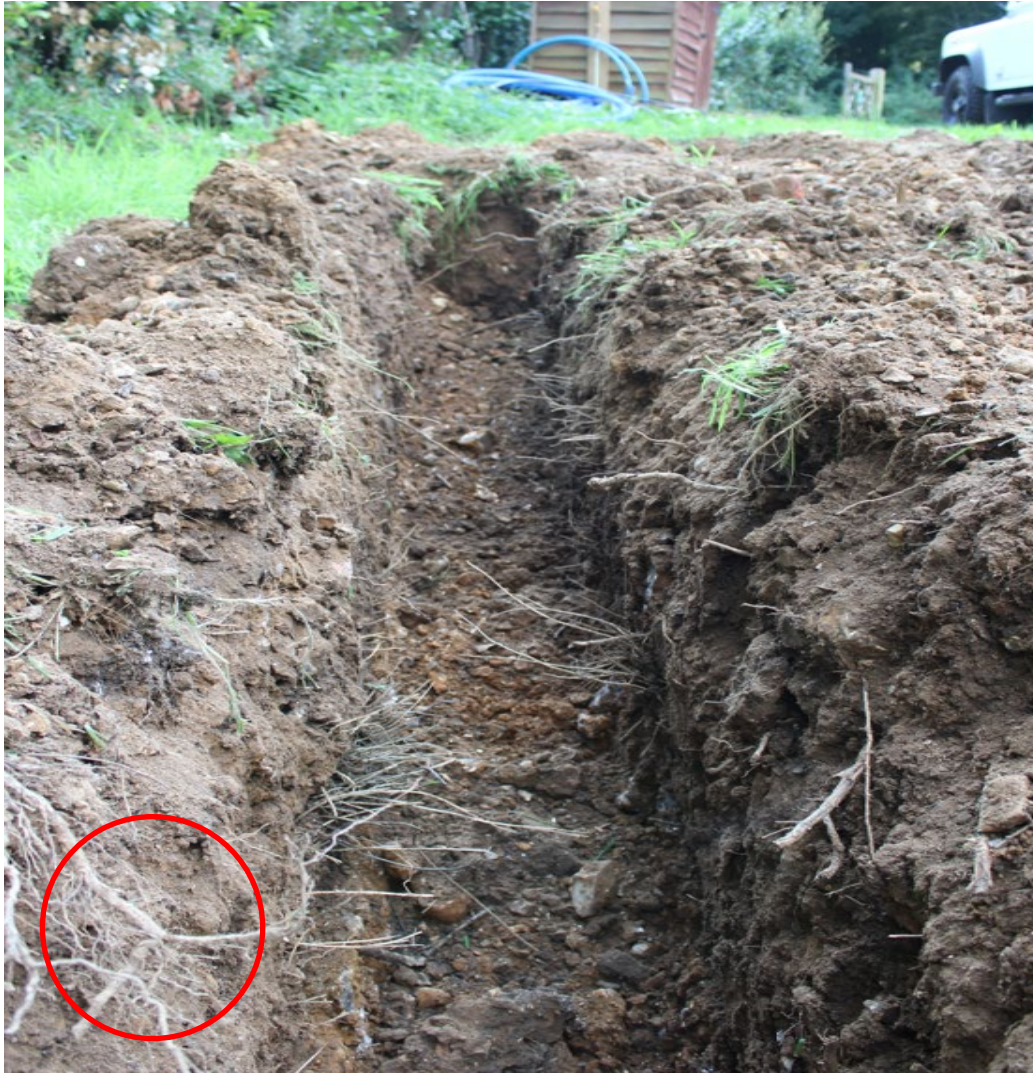
- 4.8 Excavation within the short section of track, filled in to the level of the higher ground, showed a profile that was not representative of the rest of the site (**Fig. 5**). Roots present at all depths of the trench were grass roots that had been covered when the ground was raised with one <10mm root at 1m from the east end of the trench likely to be laurel. The thin topsoil, typical of the rest of the site, can be seen below the grass roots at the bottom of the trench.

Fig. 5 – excavation within raised ground; note grass roots at all levels and <10mm Ø laurel root circled.
