**Report  
of  
Preliminary Ecological Bat Survey**

**Sack Lane Barn  
Lidsey**

**18<sup>th</sup> June 2013**

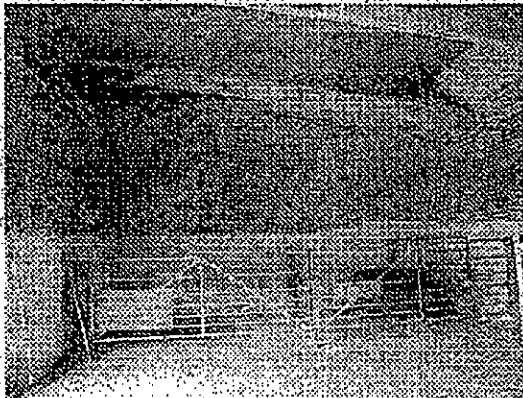
Barn internally

The barn was divided into two areas, the western end was a much smaller area. There were three large open doorways allowing access to animals.

The walls were largely absent of any roosting opportunities but there were a small number of crevices in the end walls of the larger area. These were around old timbers in the wall and in cracks in the flint. There was no evidence to suggest that bats were roosting in these crevices and most were cobwebbed suggesting animals were not accessing them.
