### The Old Cottage & Bridge Cottage, Lidsey

- Preliminary Ecological Appraisal Survey
- Preliminary Bat Roost Assessment
- HSI Assessment

| Document Reference | LLD1349-ECO-PEA |

LAND AT THE OLD COTTAGE & BRIDGE COTTAGE, LIDSEY  
PRELIMINARY ECOLOGICAL APPRAISAL SURVEY

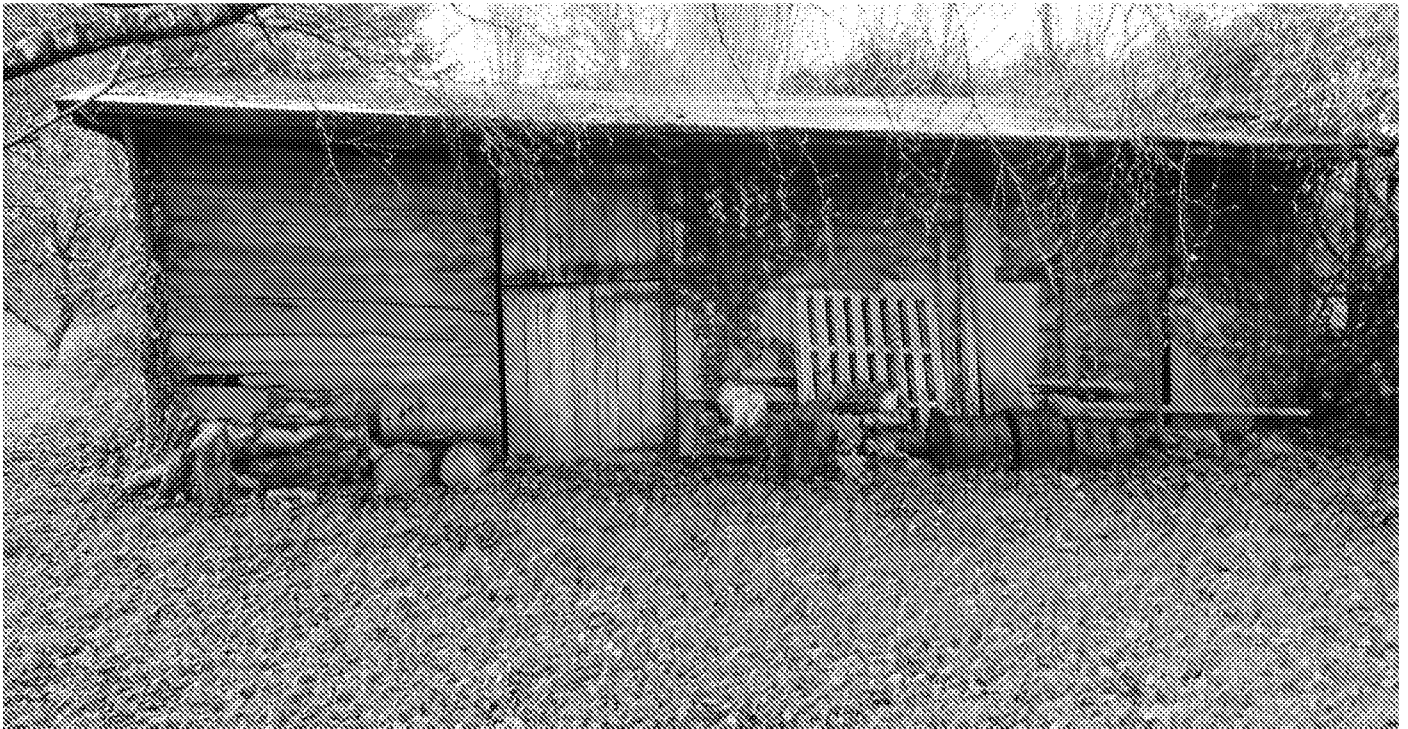
- 4.3.7 **Building B4** is a disused stable block of typical wooden construction with felt roof. The building is in poor condition and is considered to be too wet and thermally instable to support a bat roost.

Photograph No. 7 - Building B4, assessed as providing 'negligible' bat roost suitability.

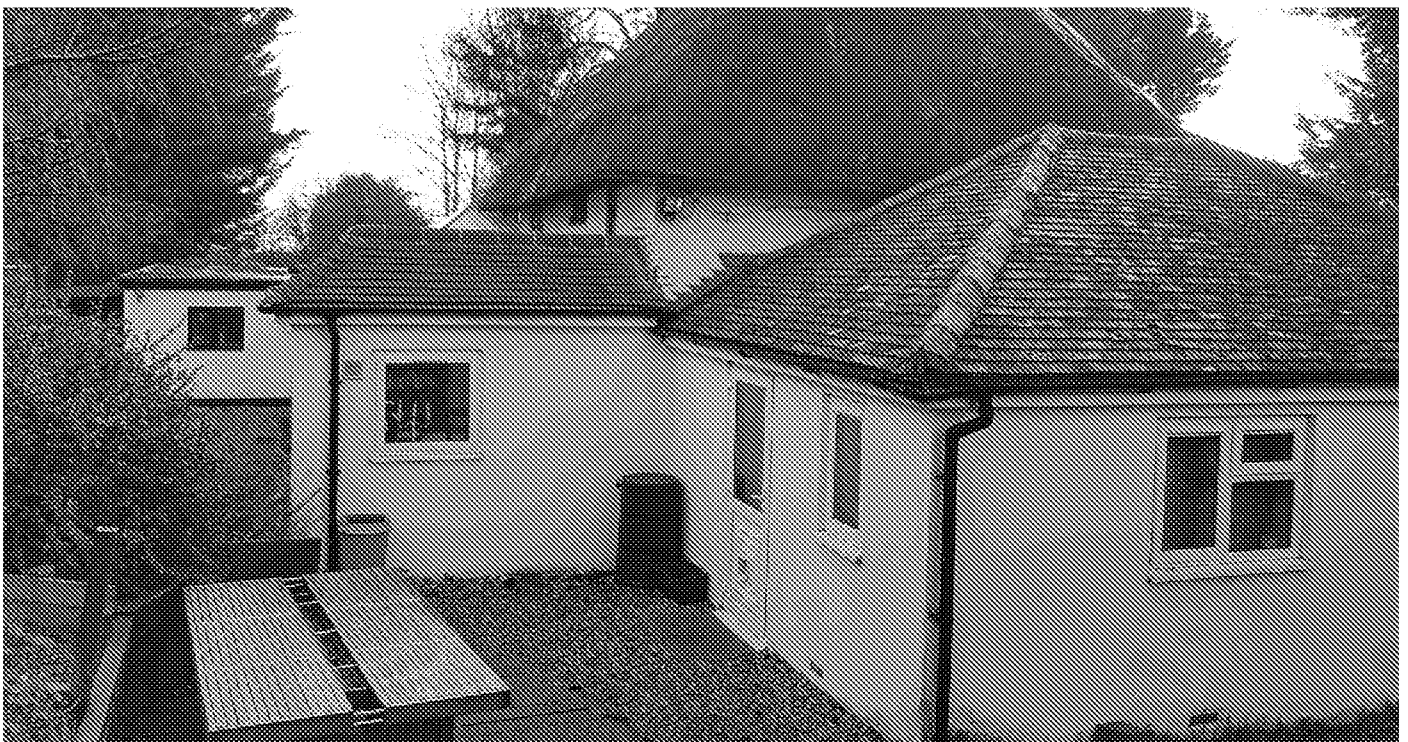
- 4.3.9 Bridge Cottage (**Building B6**) is a two-storey painted brick building with thatched roof. Windows and brick work appeared to be in good condition. 2 no. recent extensions exist to the northern and north-western sections of the site, these are of brick construction with tile roof in good condition. Small gaps were recorded between wooden panels at the eaves of the main house. No evidence of bats was recorded with the roof voids of the building.
- 4.3.10 **Building B7** is a detached double garage with small lean-to constructed to the north-east. The building is of block construction with flat felt roof.

Photograph No. 8 - Building B6, assessed as providing 'low' bat roost suitability.

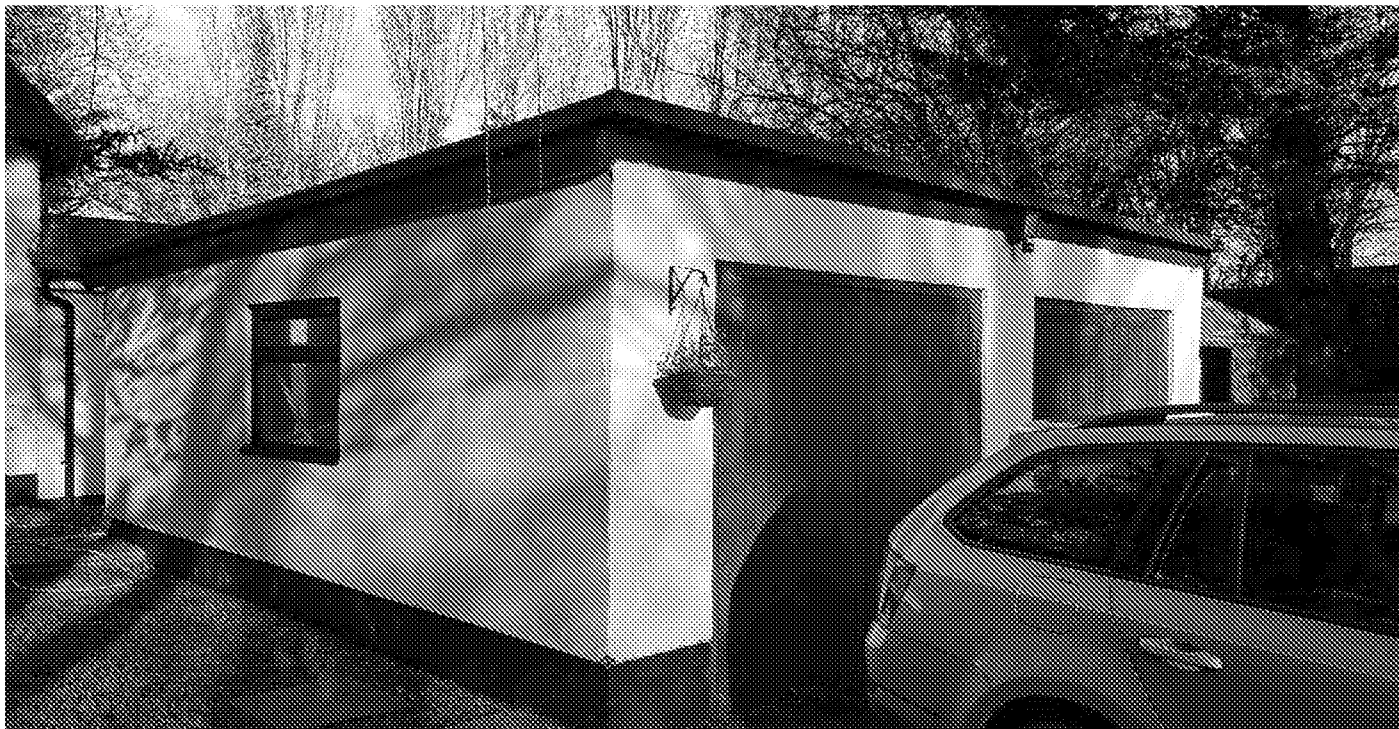
Photograph No. 9 - Building B7, assessed as providing 'negligible' bat roost suitability. - Bridge Cottage.

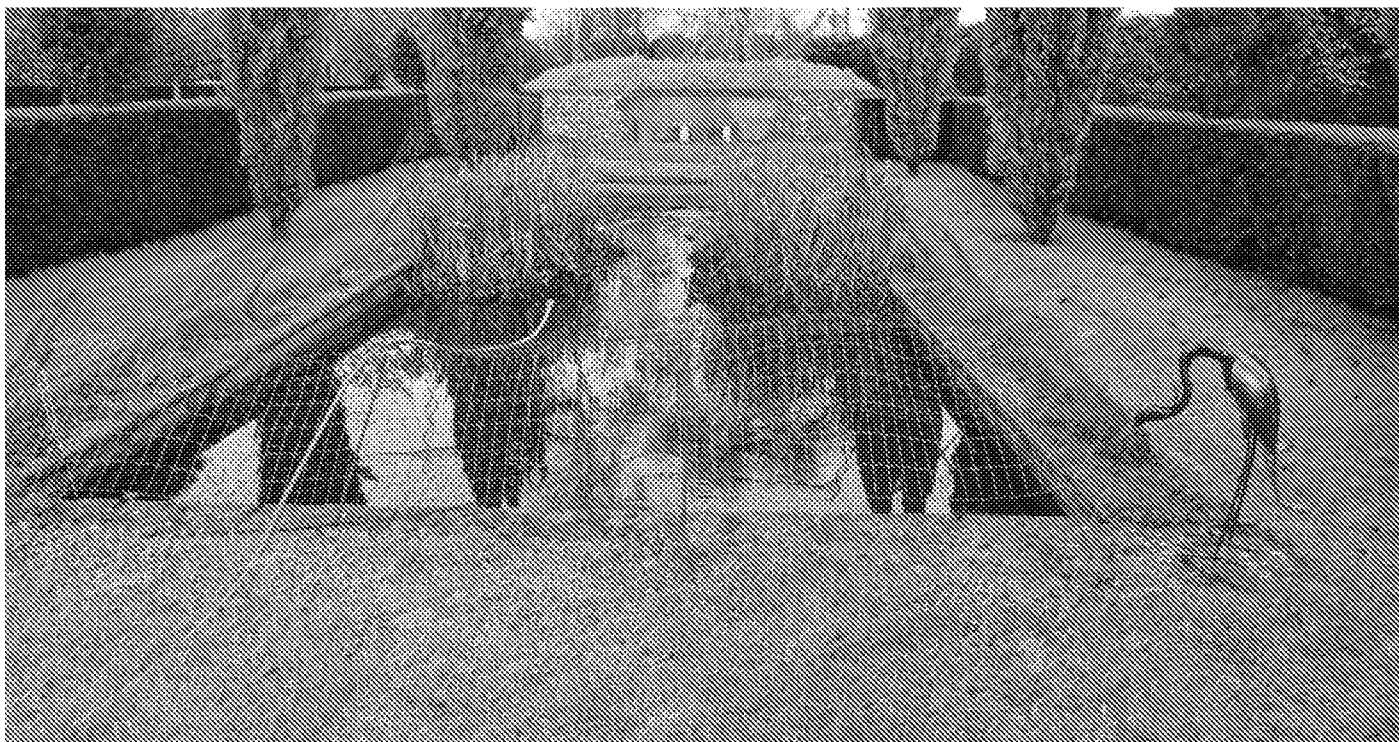
Photograph No. 10 - Pond P1, assessed as providing '*below average*' habitat suitability for Great Crested Newts. - Bridge Cottage.

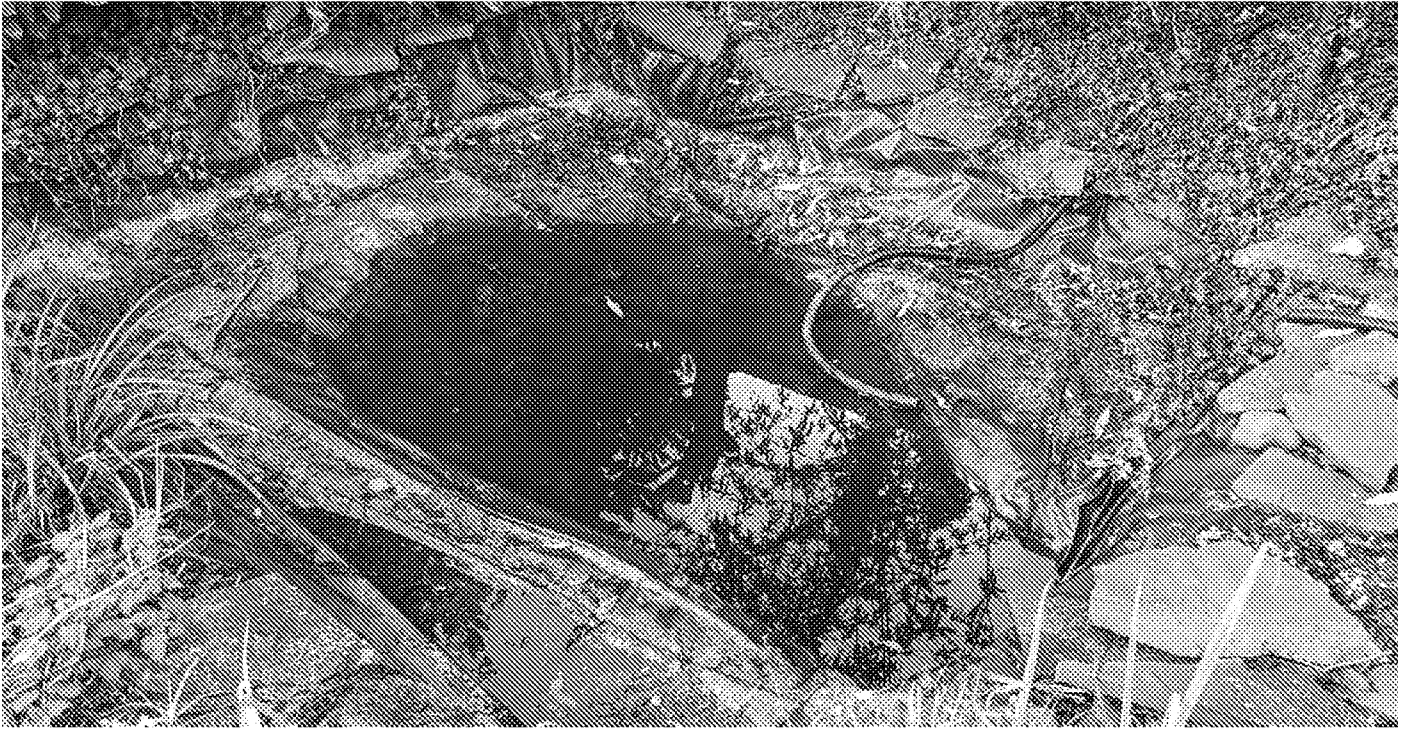
4.4.3 **Pond P2** is a small defunct pond c. 3.0 x 5.0 m located to the western section of the site. The pond was holding approximately 10cm of water at the time of the survey. The pond usually contains fish, however, these were recently removed when the pond began leaking. No macrophytes or emergence vegetation was noted.

Photograph No. 11 - Pond P2, assessed as providing 'poor' habitat suitability for Great Crested Newts.

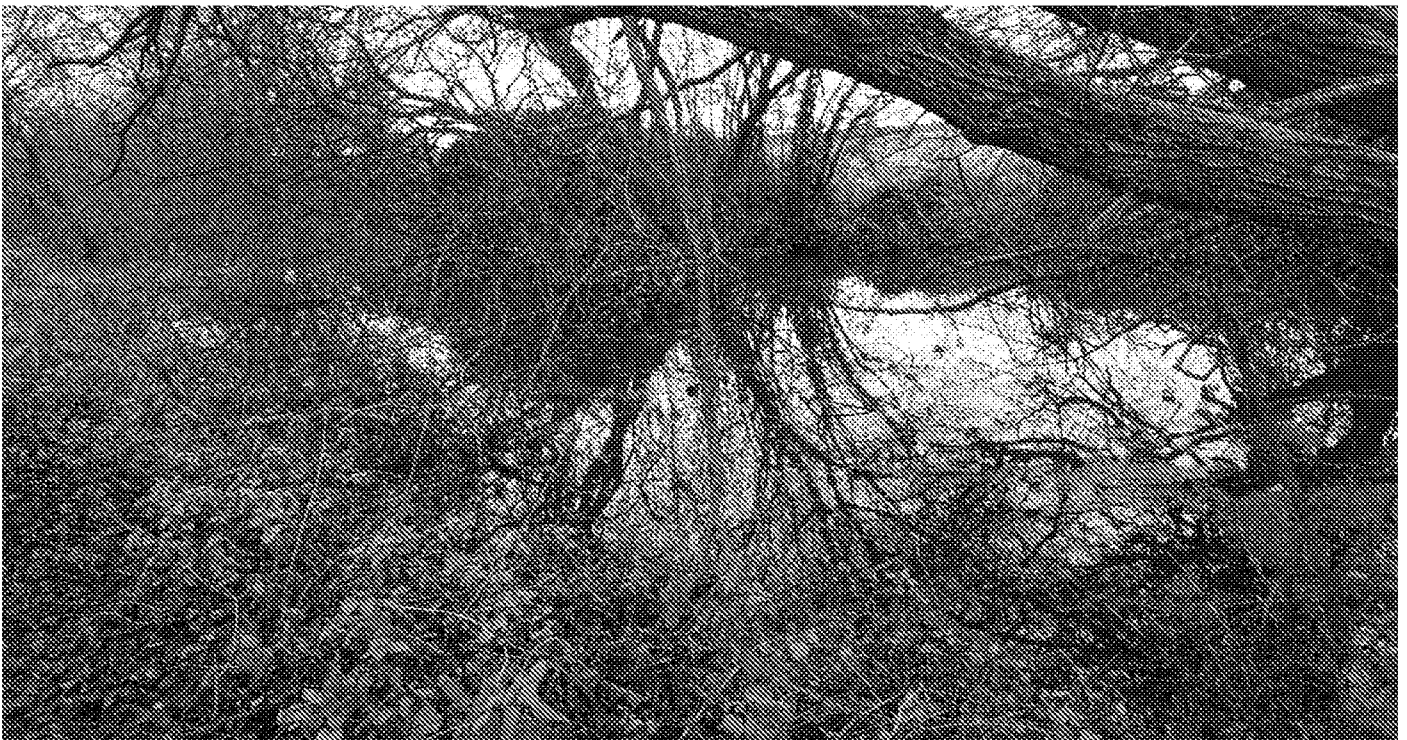
Photograph No. 12 - Pond P3, assessed as providing '*below average*' habitat suitability for Great Crested Newts.
