**Ryefield Farm House  
Woodgate**

***Borehole Logs, Infiltration Test Information  
and  
Winter Groundwater Monitoring Results***

# Insitu Testing Report

## Land to the West of Ryefield Farmhouse, Chichester - Soakage Testing

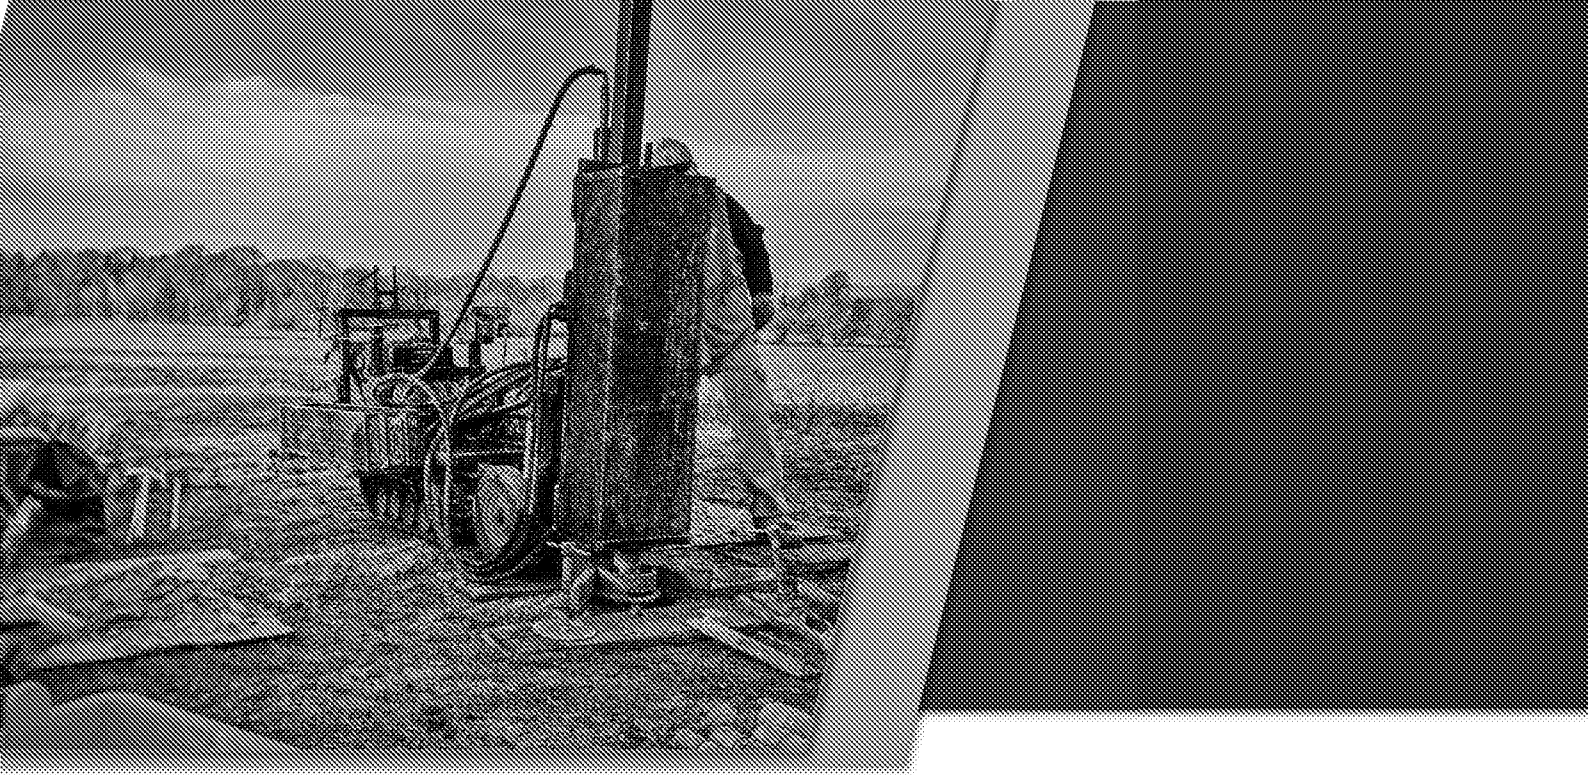
**Ground Water Monitoring-Ryefields Farmhouse**

| Date | 05/01/2021 | 05/02/2021 | 17/02/2021 | 05/03/2021 | 15/03/2021 |
|---|---|---|---|---|---|
| WS1 | 0.09 | 0.74 | 0.98 | 1.4 | 1.5 |
| WS2 | 0.31 | 1 | 1.3 | 1.4 | 1.5 |
| WS3 | 0.37 | 0.9 | 1.2 | 1.4 | 1.55 |

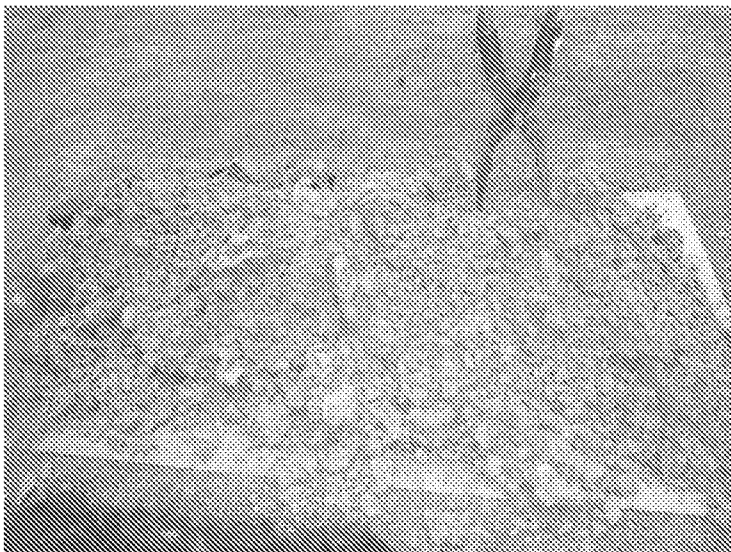
- 5. SA1 Spoil
- 6. WS1 1.00-4.00bgl
- 7. WS 1.00-4.001mbgl
- 8. WS3 1.00-4.00mbgl
