# ARCHAEOLOGICAL DESK BASED ASSESSMENT

Land at Oldlands Farm, Bognor Regis

JAC27136  
Land at Oldlands Farm,  
Bognor Regis  
Version 1 Draft for Comment  
May 2021

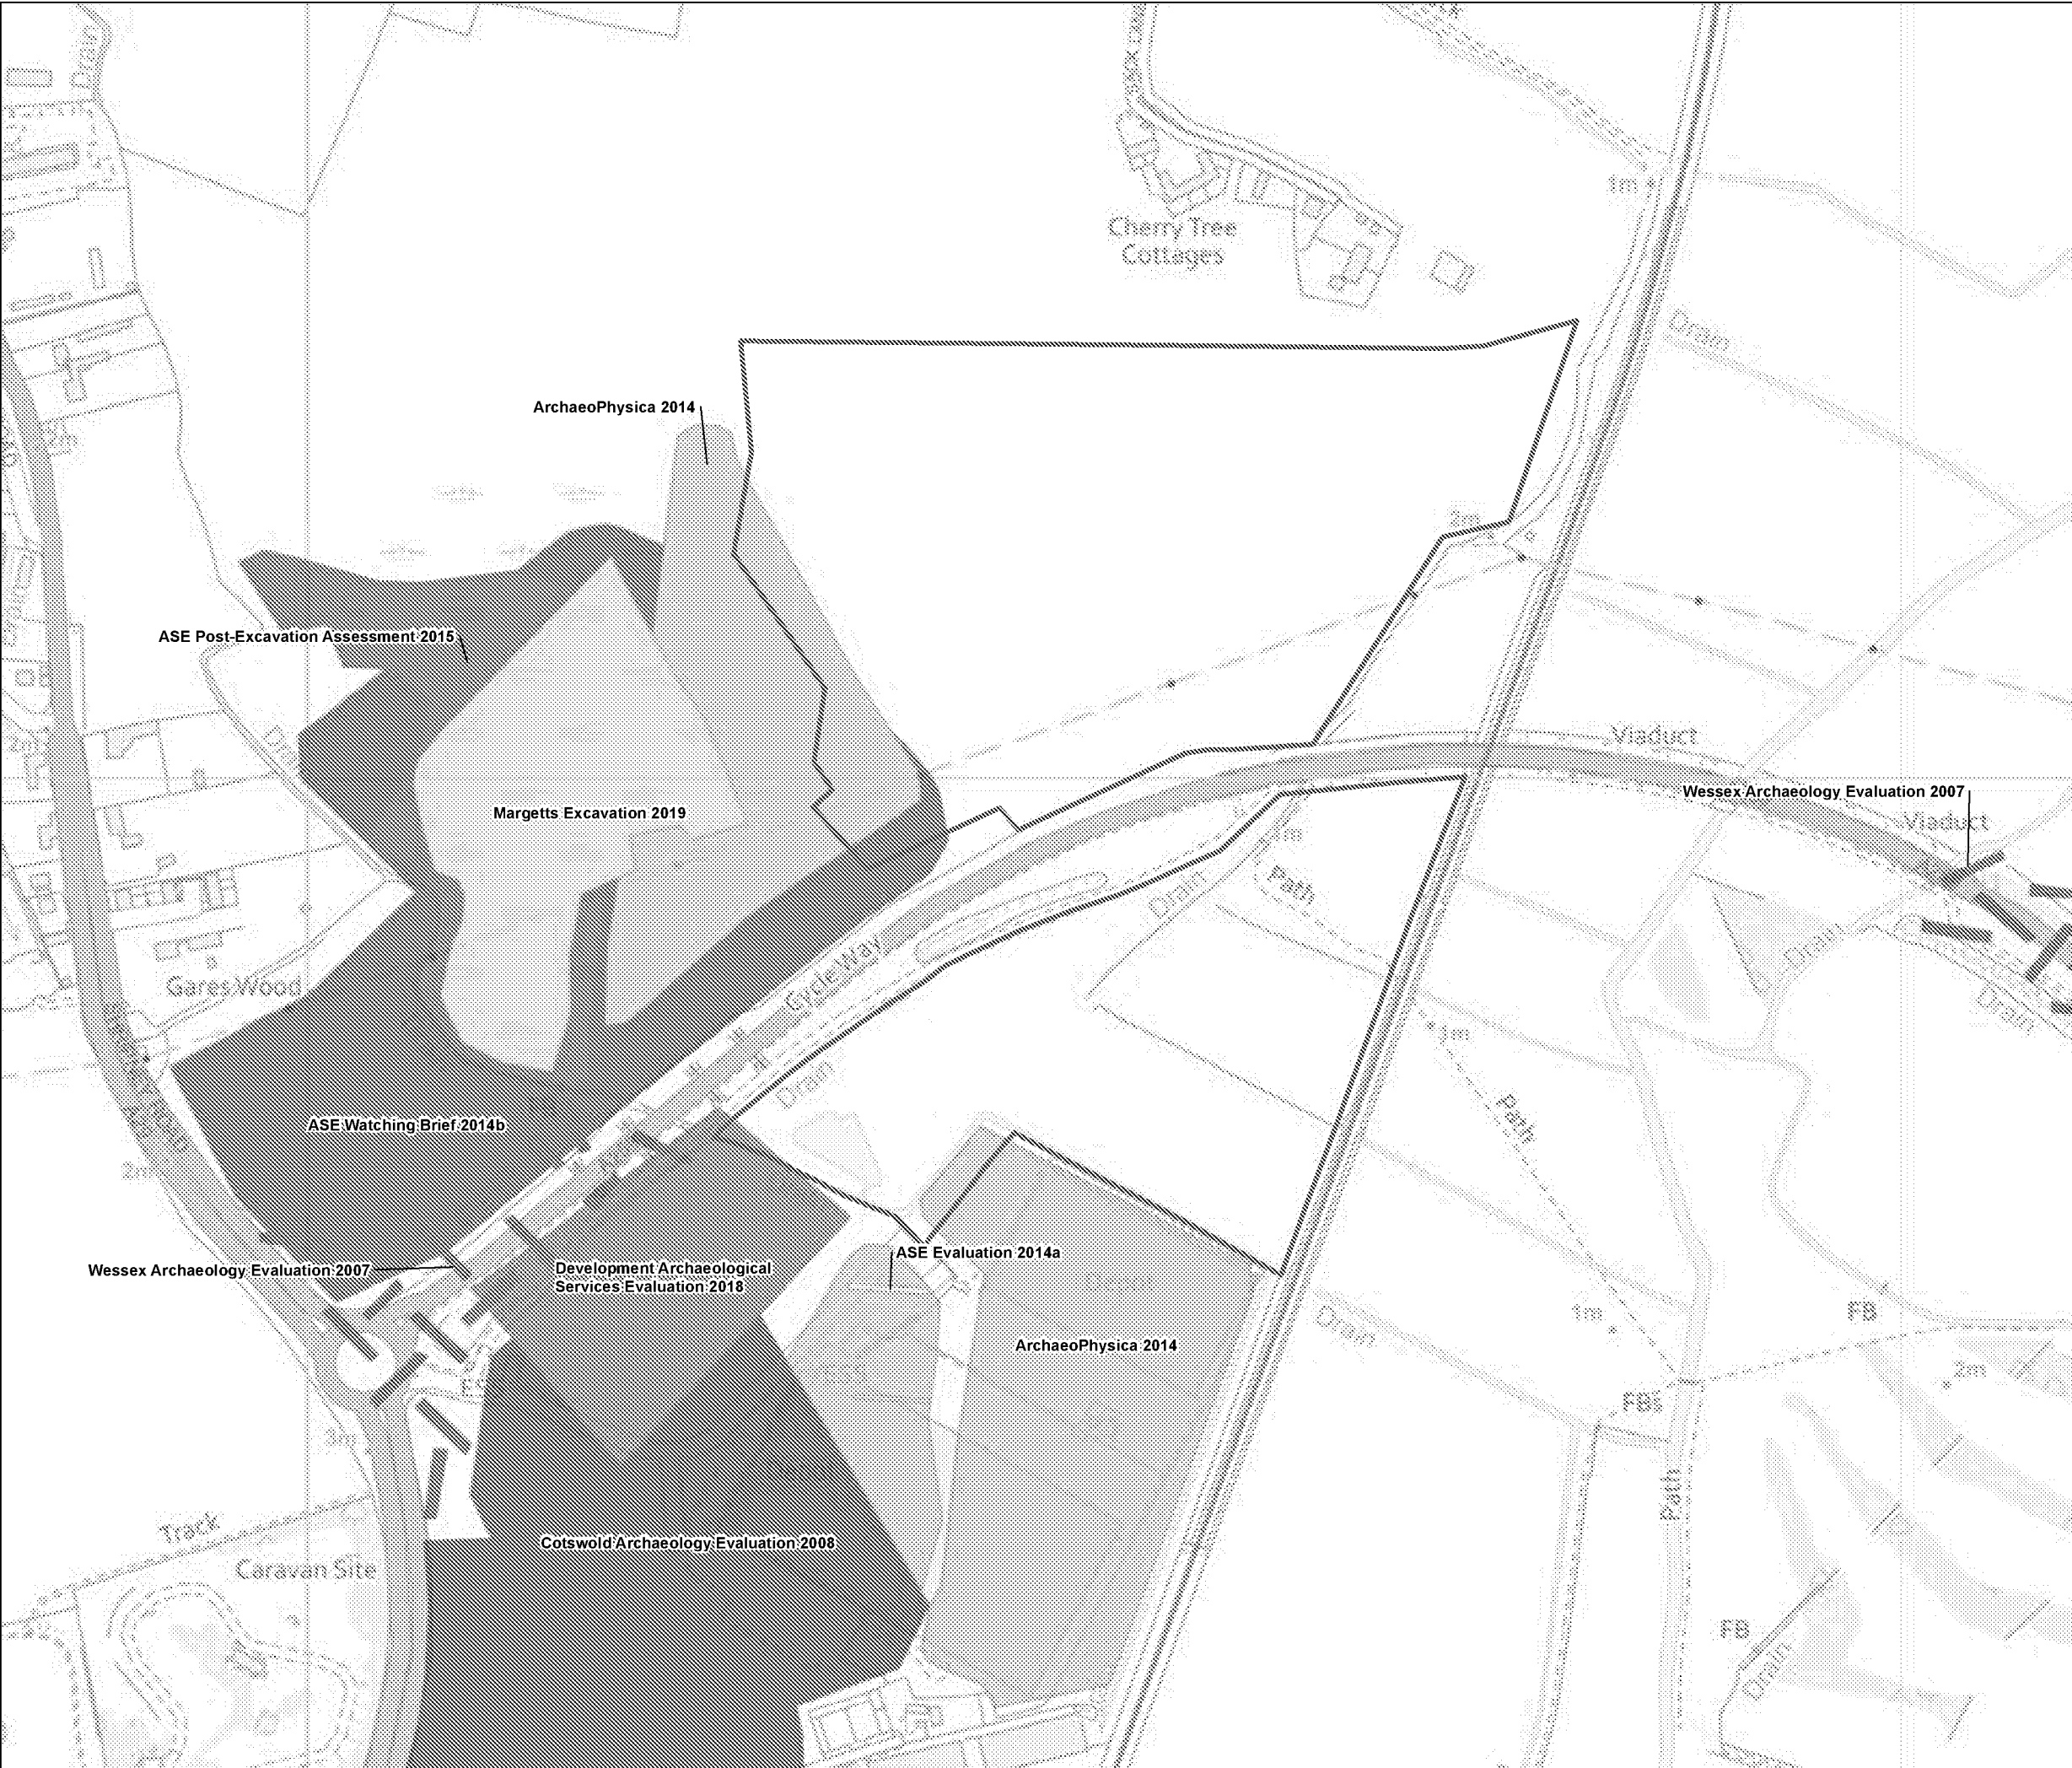
Figure 2b  
Plan of Previous Archaeological Work Within Immediate Area of Site

- Site Boundary
- 1km search radius
- Previous Archaeological Work:
  - ASE Evaluation 2014a
  - ASE Post-Excavation Assessment
  - ASE Watching Brief 2014b
  - ArchaeoPhysica 2014
  - Cotswold Archaeology Evaluation
  - Development Archaeological Services Evaluation 2018
  - Margetts assessment 2019
  - Wessex Archaeology Evaluation

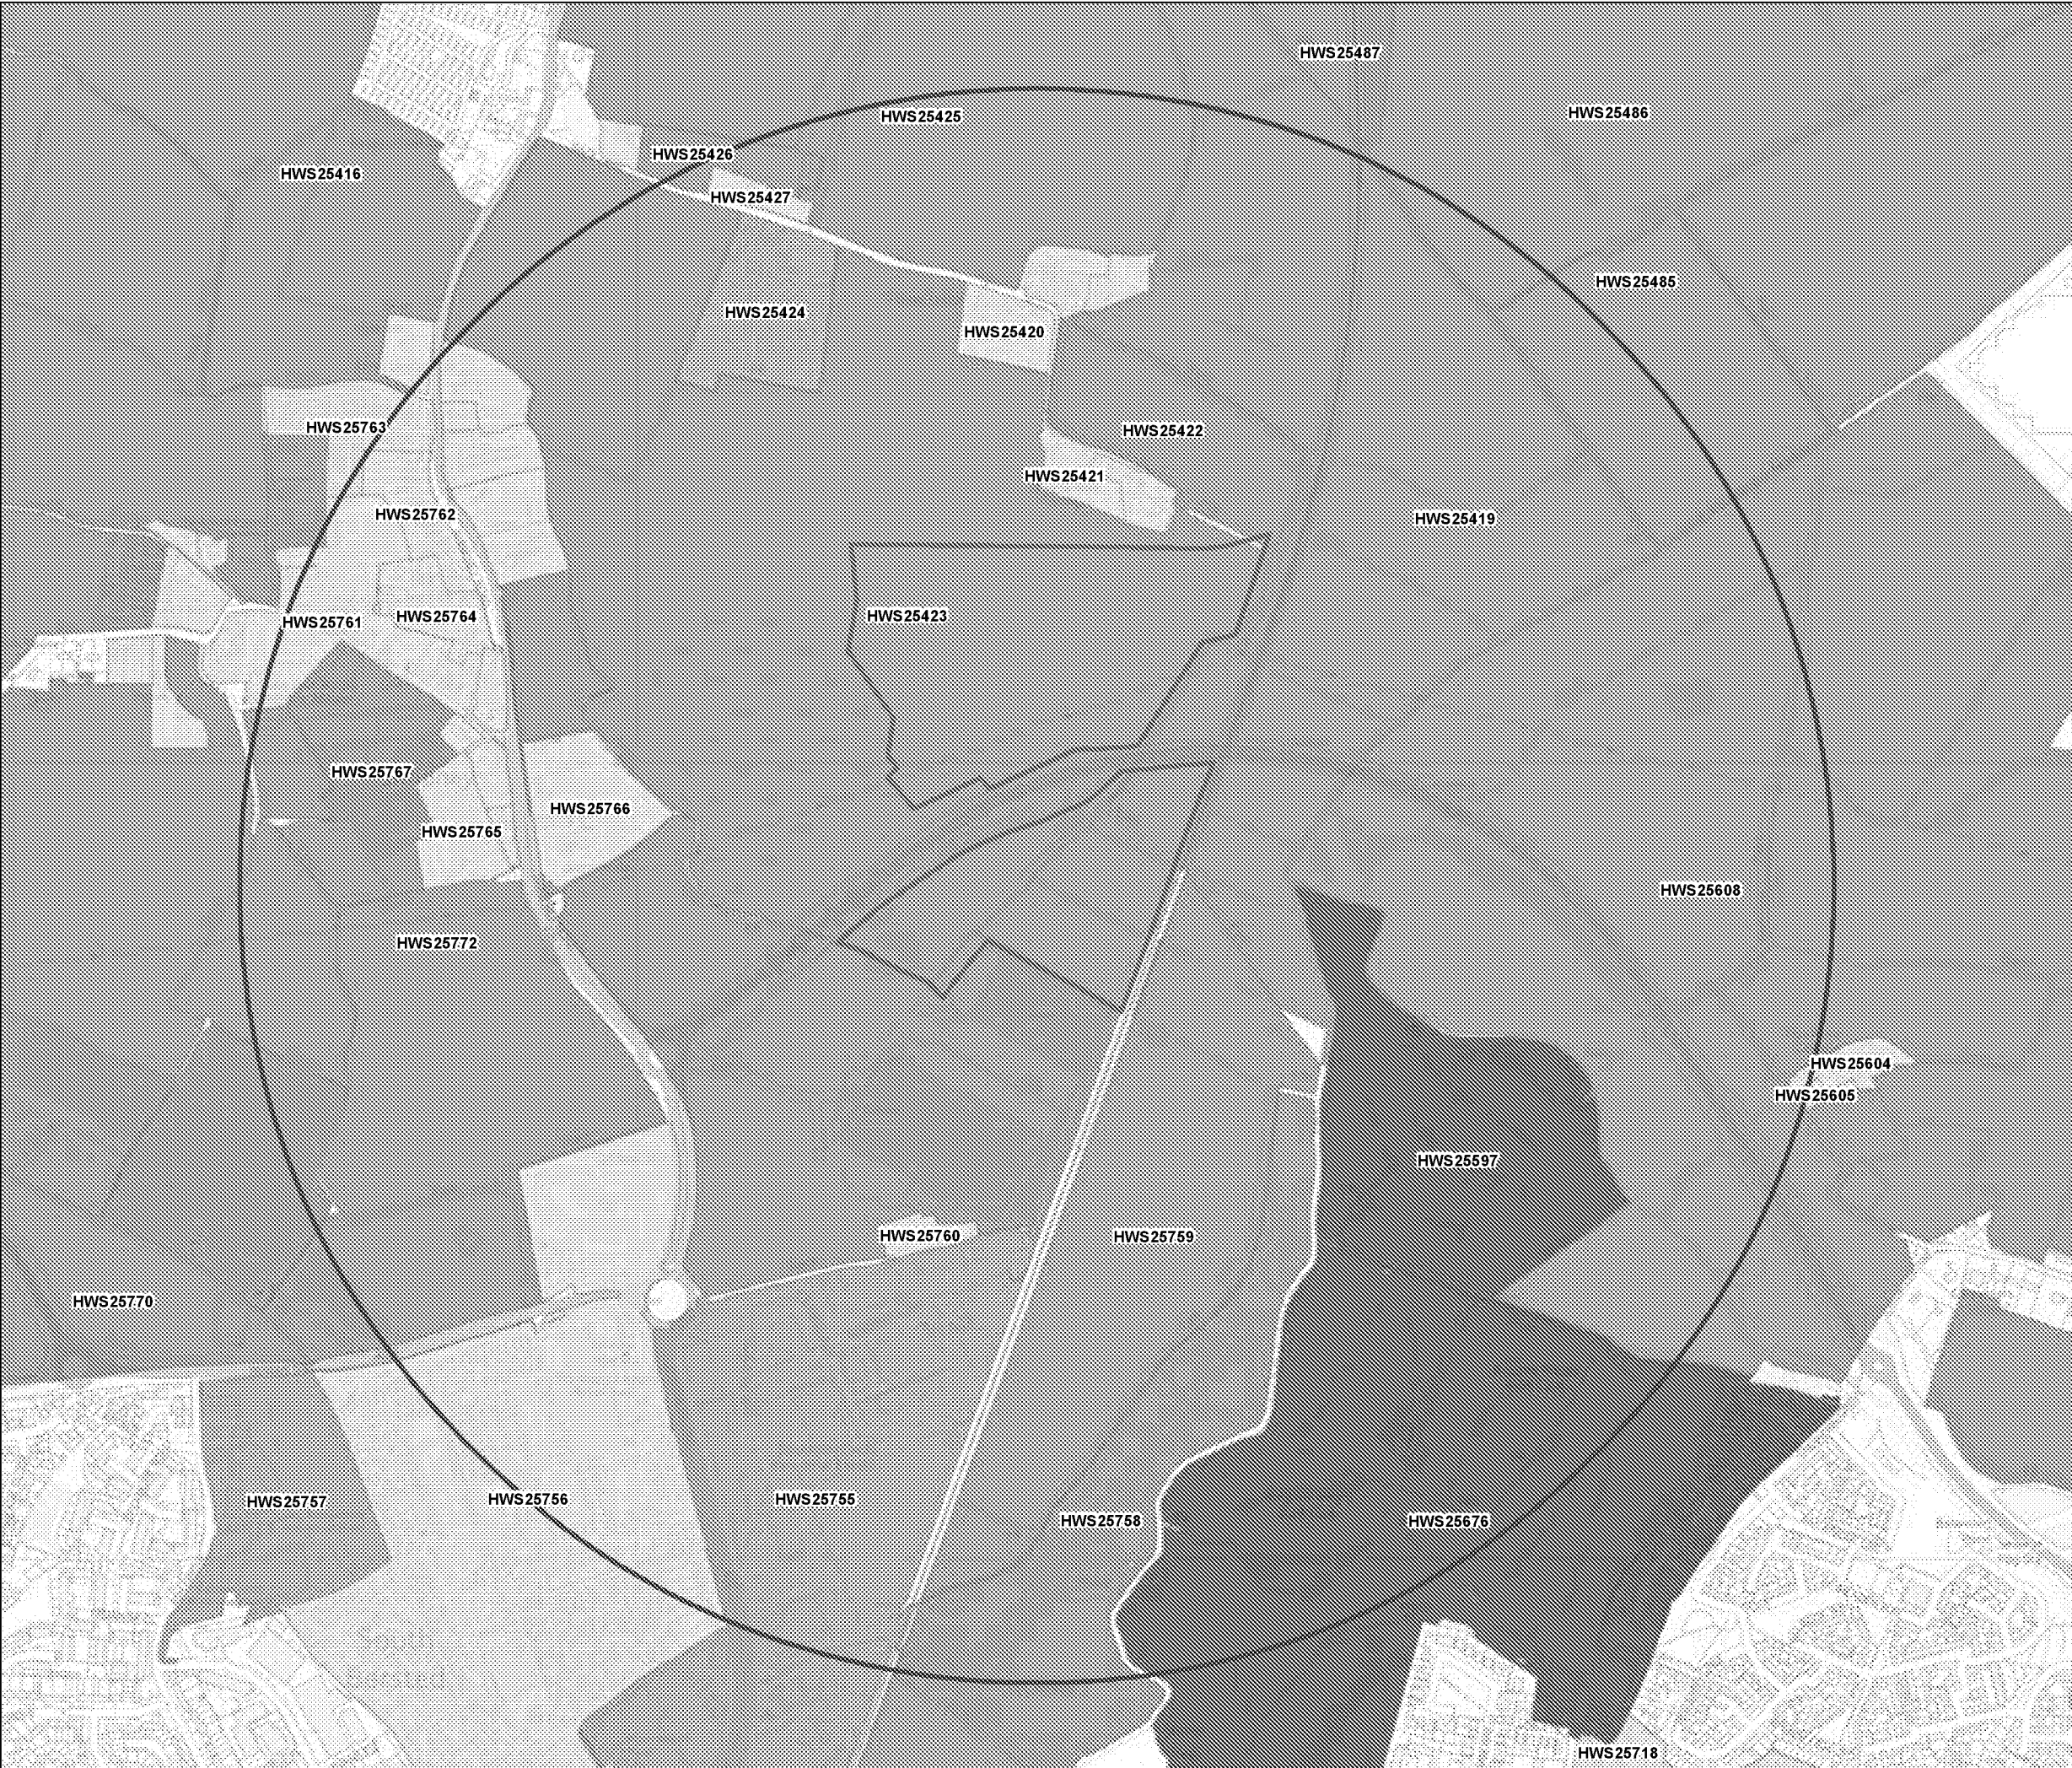
Figure 2c  
HLC Plot (Data from West Sussex  
HER)

- Site Boundary
- 1km search radius
- Historic Landscape Characterisation:
  - Communications
  - Fieldsapes
  - Horticulture
  - Industry
  - Recreation
  - Settlement

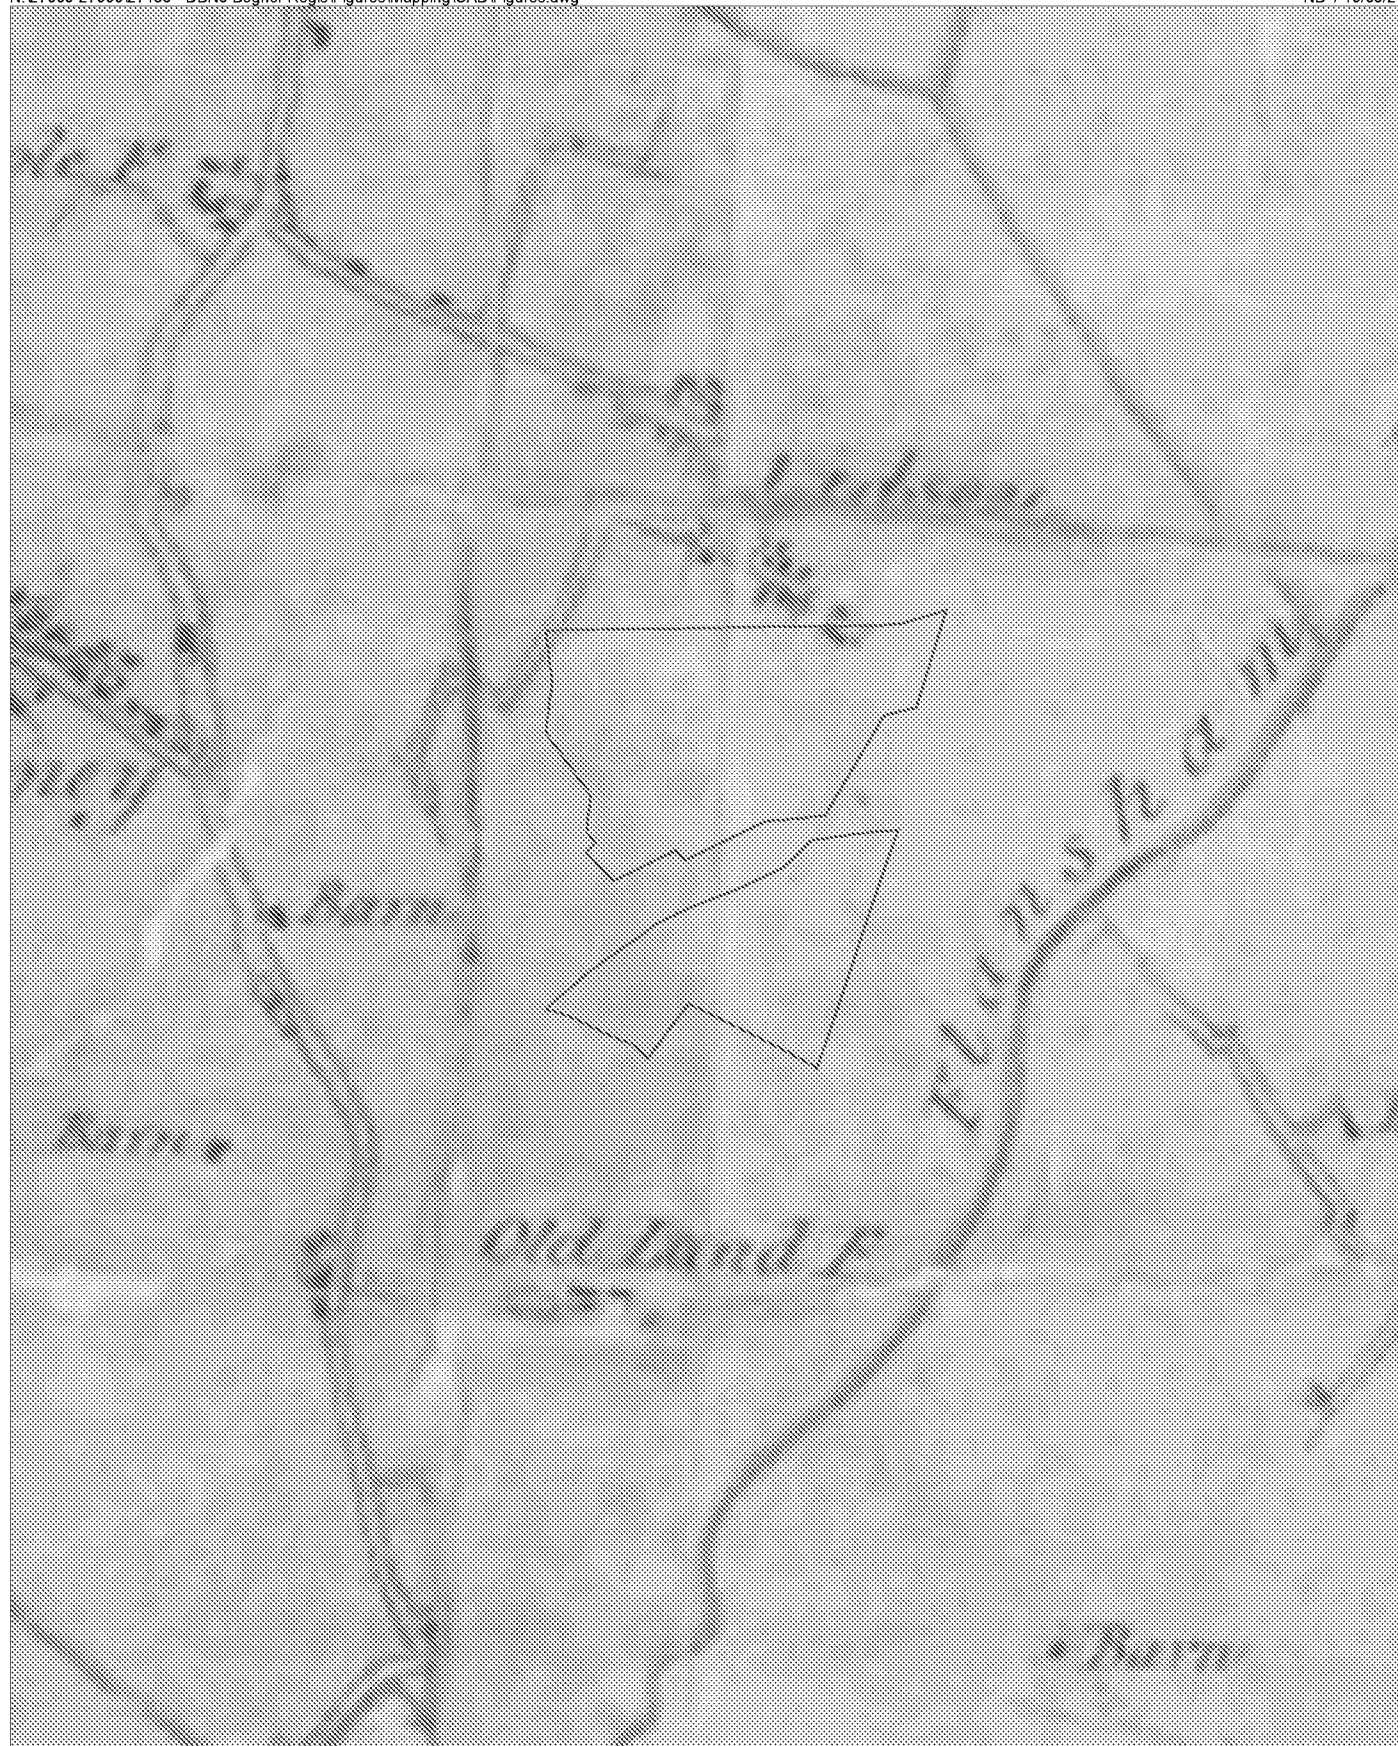
Figure 5

1778 Yeakell & Gardner Ma of  
Sussex

- 4.29 A similar situation is shown on a 1778 map (Fig. 5), with the southern part of the site possibly located within pasture near to the Lidsey Rife watercourse to the east. The northern part of the site appears to comprise open fields adjacent to a collection of cottages in the area of what is now Sack Lane at Lidsey to the immediate north. Possible trackways are shown within the site itself. The site is similarly shown on an 1805 Ordnance Survey Drawing (Fig. 6) when Oldlands Farm (HER Ref: MWS12726) was also shown to the south of the site. A number of HER records correspond to Post Medieval outfalls at Lidsey to the north of the site, which may be shown on these maps (HER Refs: MWS13133, MWS11973, MWS13090).

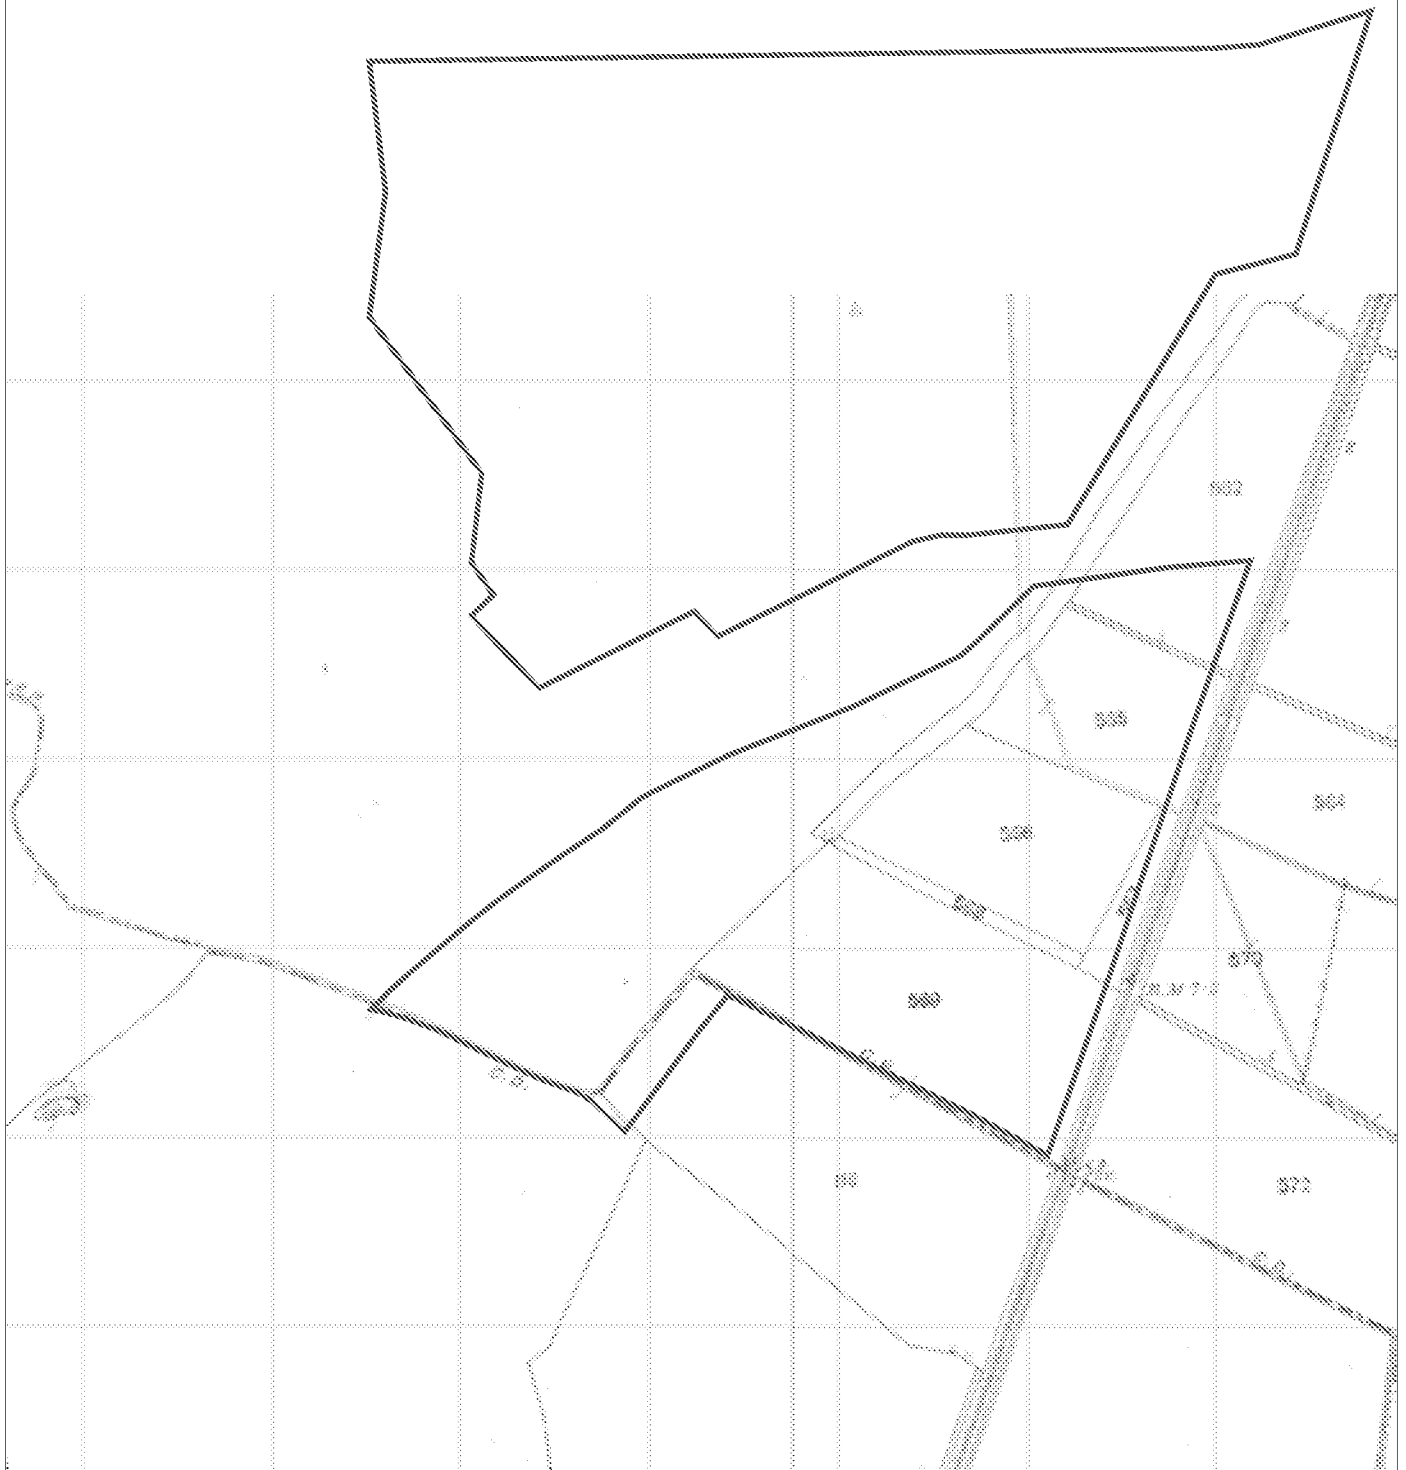
Figure 7

1842 South Bersted and 1846  
Aldingbourne Parish Tithe Maps

- 4.30 The 1842 South Bersted and 1846 Aldingbourne Parish Tithe Maps (Fig. 7) show the site in more detail than earlier mapping. It appears that the site is generally unchanged and utilised as arable and pastoral land. Alterations to internal field boundaries are shown on the 1876 Ordnance Survey plan (Fig. 8) whilst changes throughout the 20<sup>th</sup> century are generally limited to further minor field boundary changes and infilling of former drainage ditches. The trackway in the southern parcel had been removed by this time.

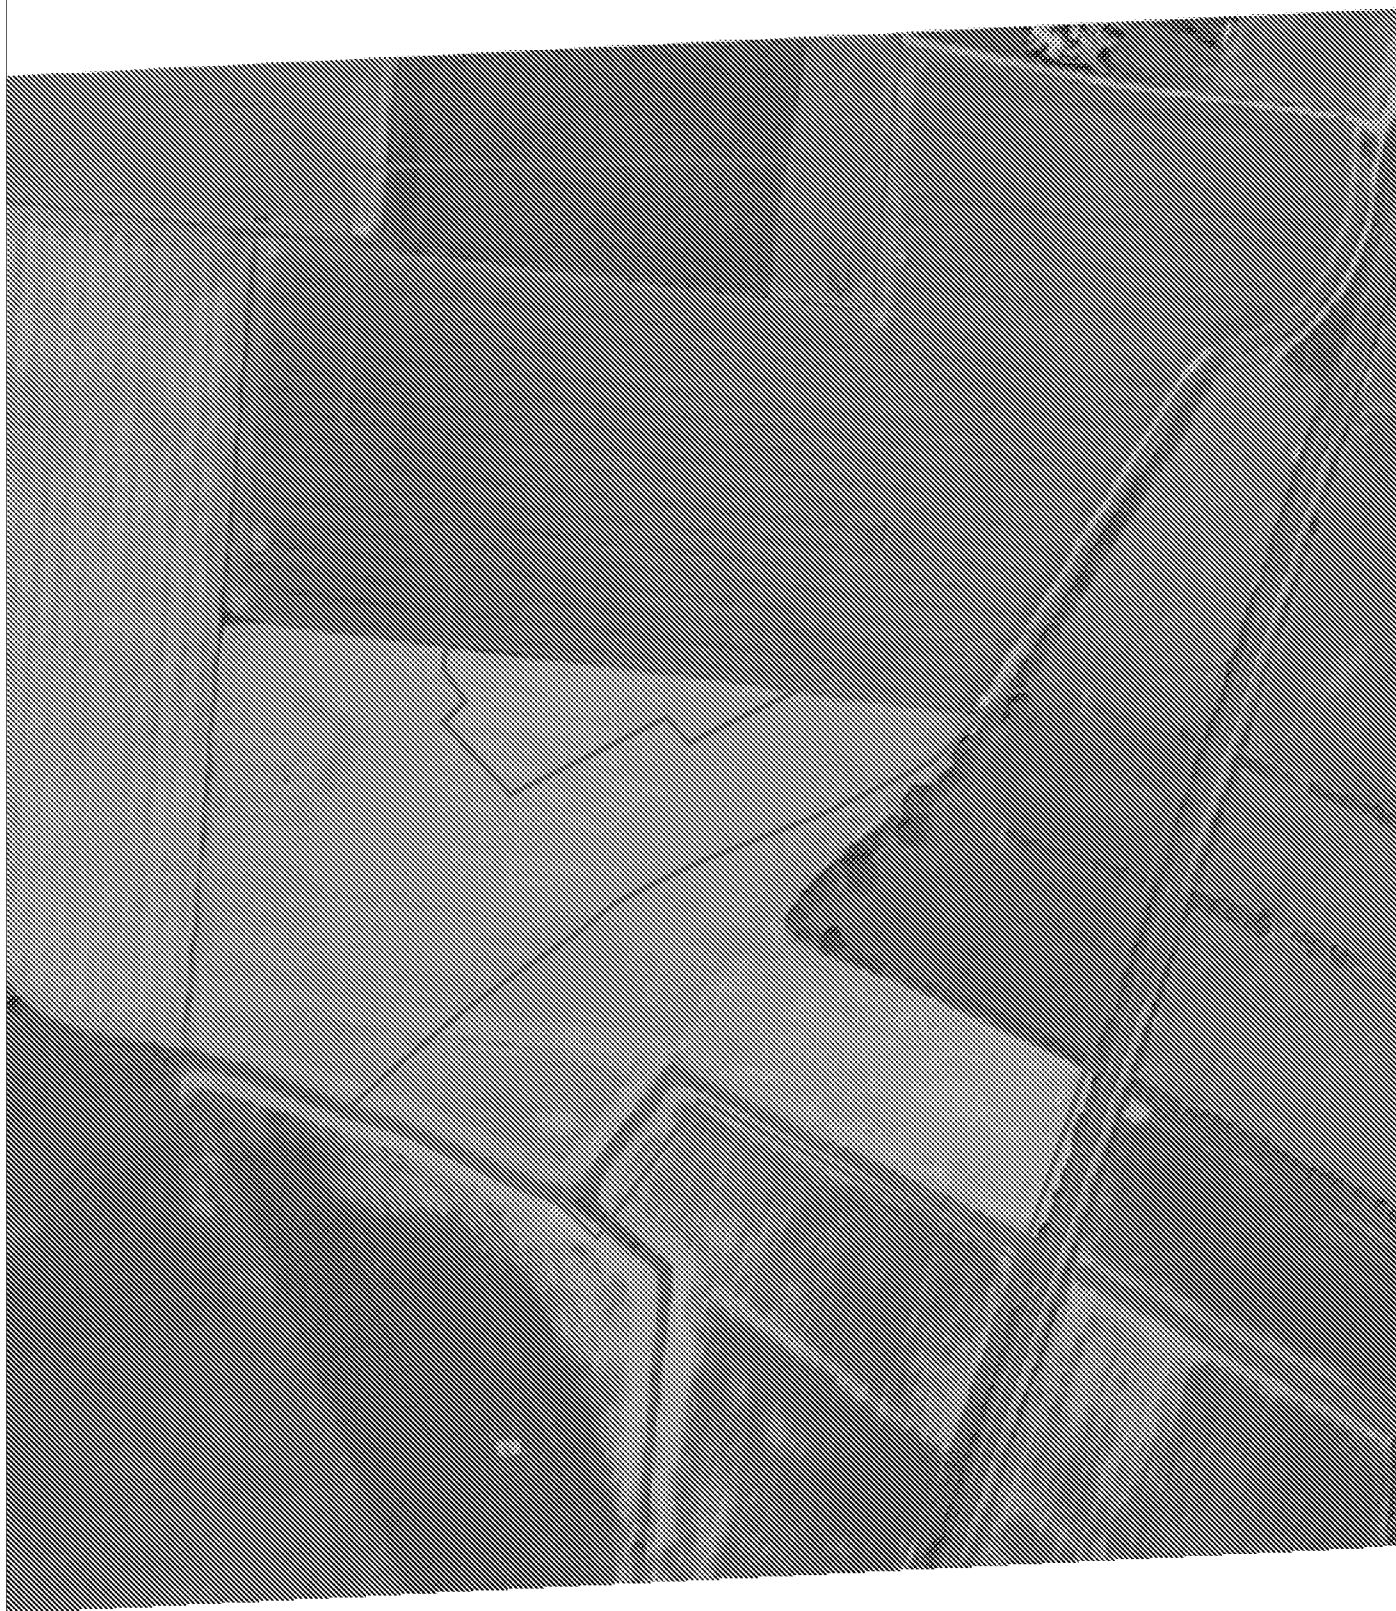
Figure 8

1876 Ordnance Survey Map
