# Preliminary Geo-Environmental Risk Assessment

Bognor Regis, Oldlands Farm PO22 6NN

Issued: September 2021

Delta-Simons Project No. 20-1543.04

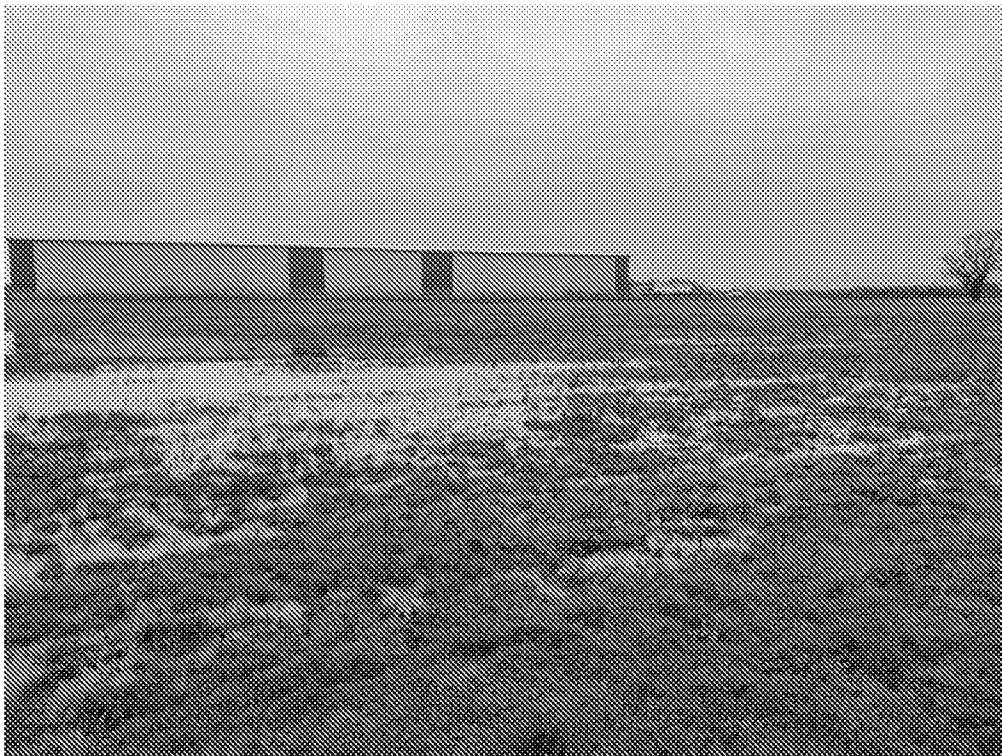
Photograph 2 --View from north of the site looking towards Rolls Royce facility with Site noted to be flooded.

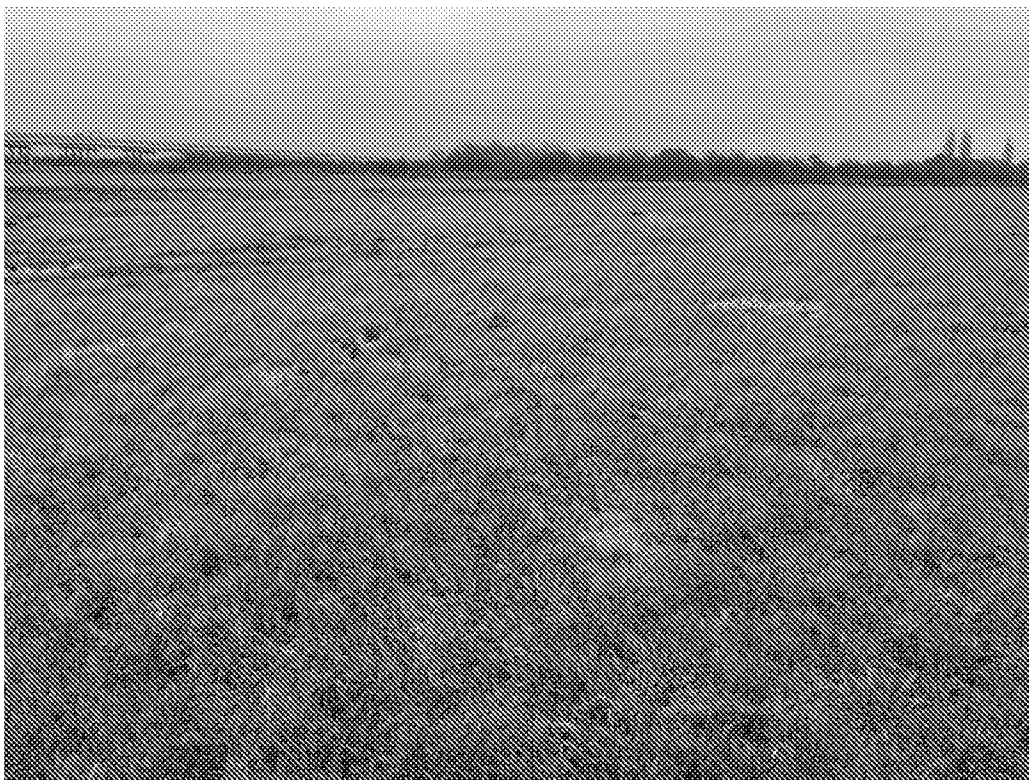
Photograph 4 --View East across saturated ground

| <b>Shallow Groundwater</b> | <p>Can generate difficulties when excavating, further discussion in the Groundworks section below. The Site was noted to be flooded during the winter period which may preclude construction activities during this period.</p> |

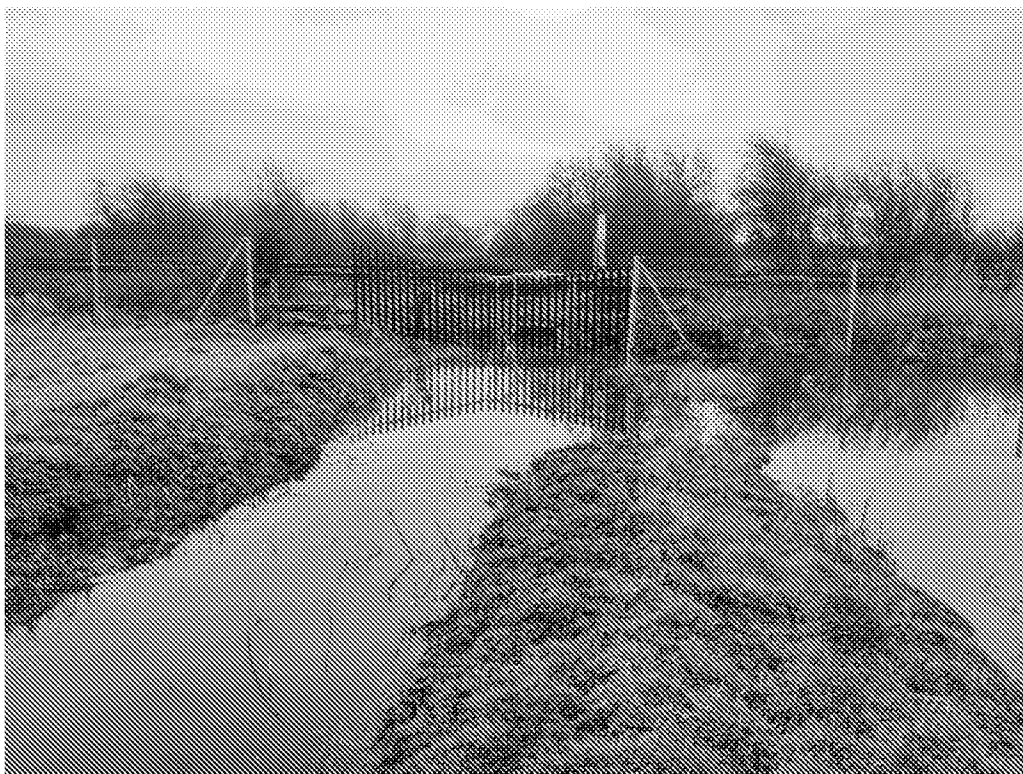
Photograph 6 – Flooded access onto railway line along southern boundary of the Site

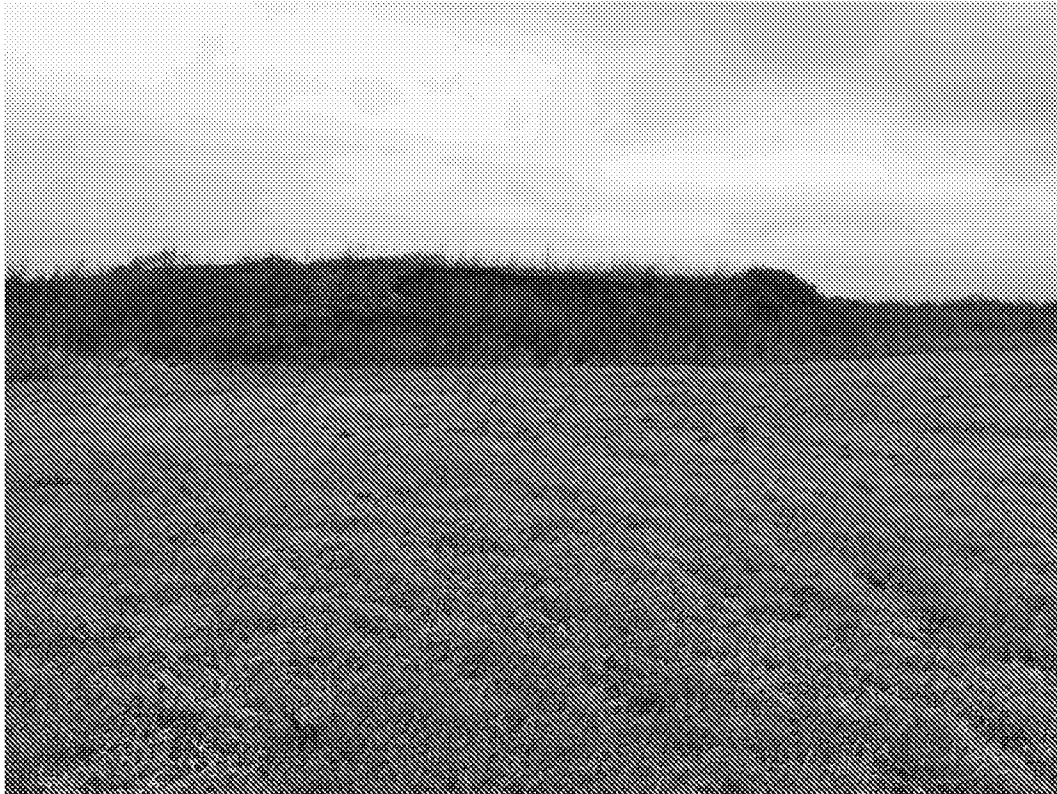
Photograph 7 –Stockpile of soil in south west of the Site.

| <b>Soils</b> | <p>The risk of the Site requiring widespread remediation to protect end users is considered to be low.</p> <p>Spoil left from previous excavations within Made Ground may be suitable for re-use as general fill. The underlying River Marine Deposits and River Terrace Deposits similarly should be suitable for re-use as general fill, all of which is subject to further testing and specification. It should be noted that soils extracted below the groundwater level are likely to be saturated and may require drying or extensive modification to enable the material to be suitable for reuse. Chalk deposits are likely to degrade during periods of poor weather and may become unsuitable for use.</p> |
