Plasticity Chart - All Soils  
Oldlands Farm, Bognor Regis

20-1543.07

# Preliminary UXO Risk Assessment

| <b>Project</b> | Oldlands Farm, Bognor Regis |

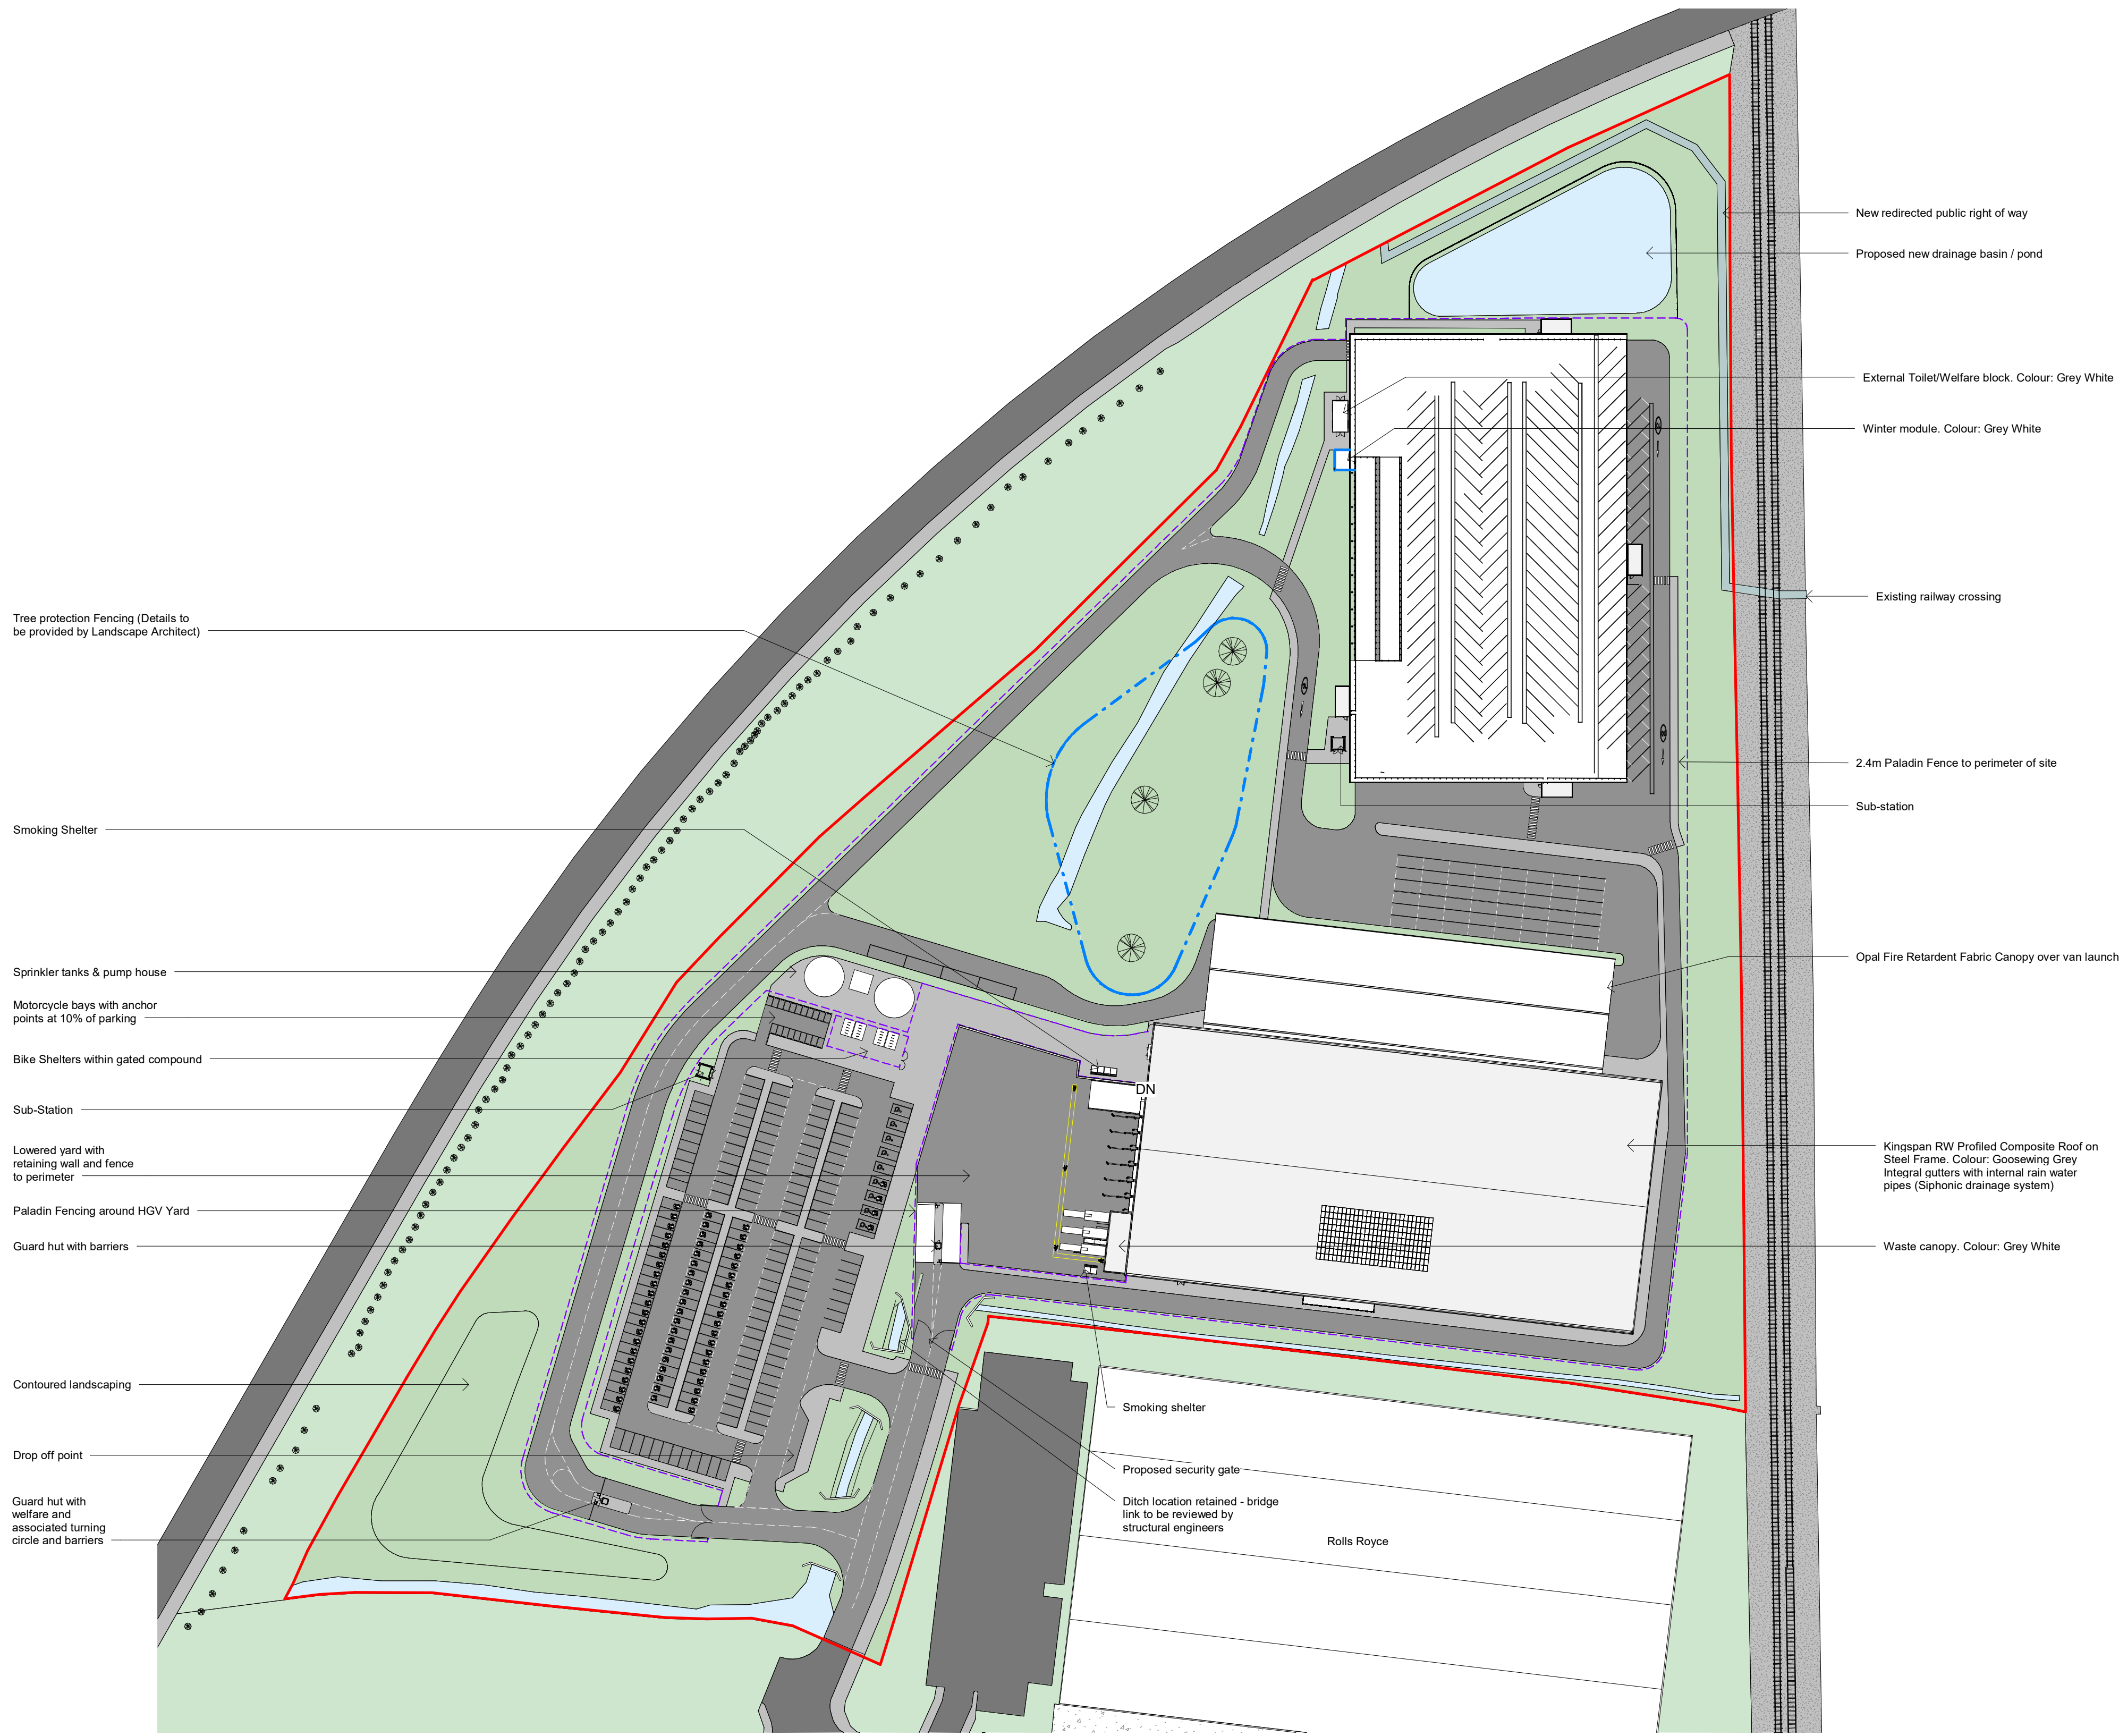
## Drawing 1 – Flood Compensation Area, Proposed Area

Proposed Site Plan  
1 : 1000
