# 1. SUMMARY

This buildings assessment has been prepared on behalf of Mr and Mrs A Dunn in order to obtain a full understanding of the fabric and history of the building known as The Manor House, Aldingbourne, and thereby advise proposals to extend and alter the house.

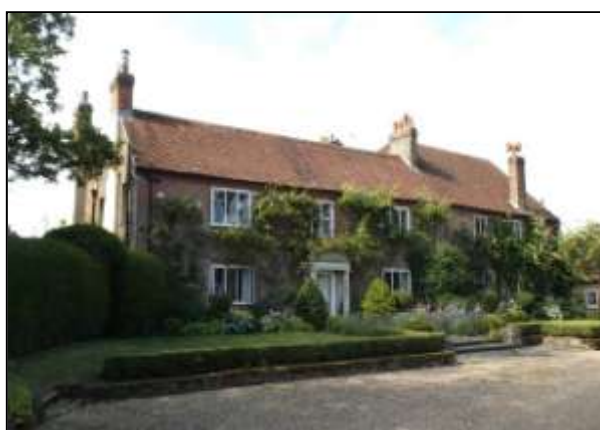
The principal, north front, which is partially hidden by vegetation, is of brick in two phases of construction with that at the west end clearly being a later addition to that at the east end, though both have three openings at each level. The main door, which is protected by a stone porch formed of stone columns supporting a triangular pediment, is in the centre of the earlier part of the house.

*The house from the north-east.*

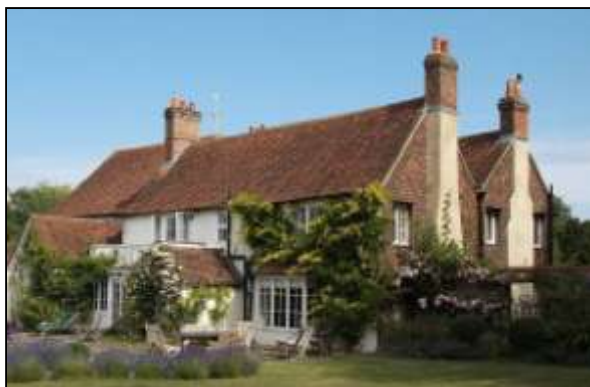
The south elevation has been altered on several occasions and is now mostly finished with render which is painted.

*The house from the south-east.*

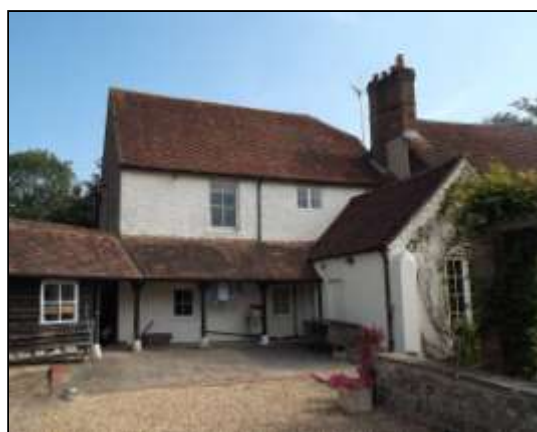
The brickwork of the west end of the north façade continues around the west end of the house which is contained under one large ridge. On the south side the wall is rendered with roughcast and painted white and the additions are mostly of painted brick.

*The house from the south-west.*

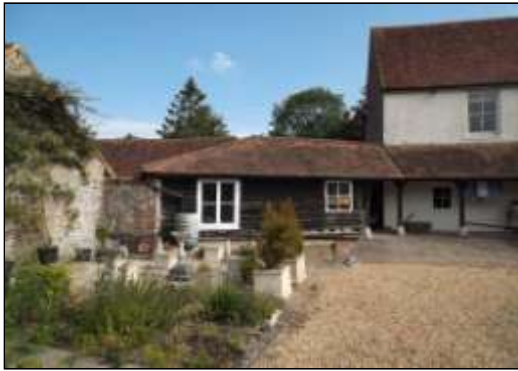
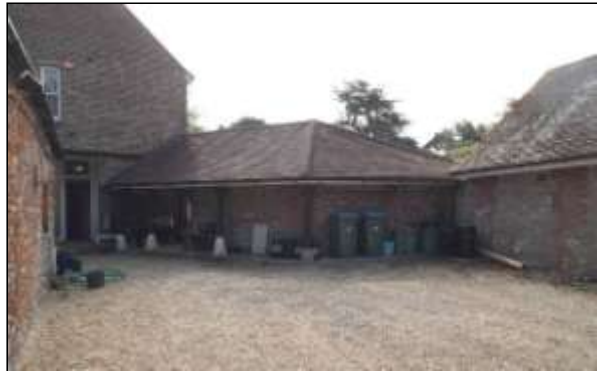
Attached to the south-west corner of the house is a partially open-sided, single-storey link, or veranda, to the former outbuilding which is now the separate dwelling known as Stable Cottage. It is partially of flint and brick and partially timber-clad under a tiled roof which is partially supported on columns and wooden posts. The cartographic evidence suggests that it was built between 1910 and 1938 (see Section 3). The building is now used as a potting shed and is of little architectural or historical interest.

*The potting shed and veranda, from the south (above left) and from the north-west (above right).*

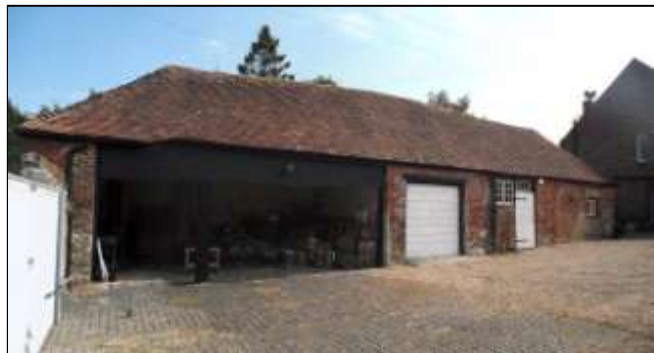
This is a former single-storey agricultural building, constructed of flint and brick under a tiled roof which is hipped at either end and supported on remnants of a brick dentilled eaves course. It was shown on the first edition of the Ordnance Survey map for which the survey was undertaken in 1874 (see Section 3) and may have been intended as a cart shed and stables. It has clearly been altered on several occasions and now includes an open-sided section at the west end; then a garage with up-and-over door; and then a shed at the east end.

*The garage and shed, from the south-west.*

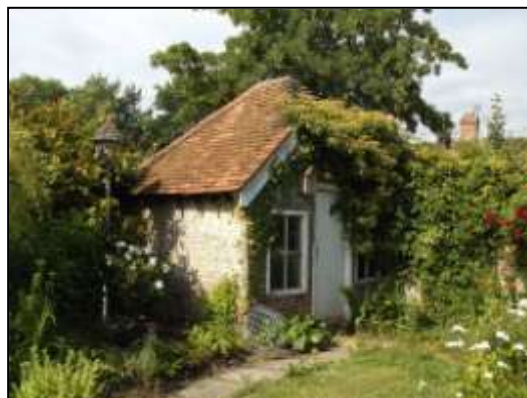
This is a small single-storey shed at the south-west corner of the walled garden attached to the rear of the house. It is built of flint with brick dressings under a pyramidal roof of tiles with a door and two flanking windows in the north side. It was shown on the first edition of the Ordnance Survey plan, for which the surveys were undertaken in 1874, and it was presumably designed as a potting shed.

*The potting shed, from the north-east.*

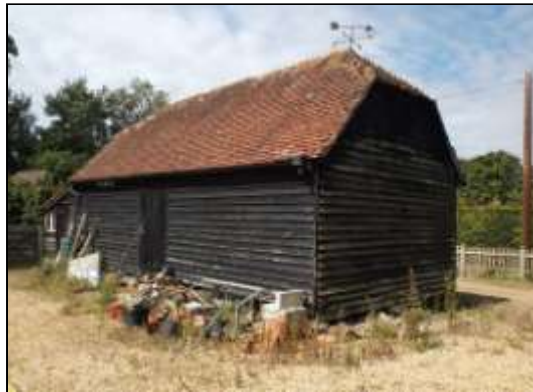
This is another former agricultural building which is constructed and clad in timber under a tiled roof which is half hipped at either end. It is supported on staddle stones and was presumably designed as a granary. It was shown on the first edition of the Ordnance Survey plan, for which the surveys were undertaken in 1874 (see Section 3), and now has a small lean-to addition on the south end. It is now used as a shed.

*The granary, from the north-east.*

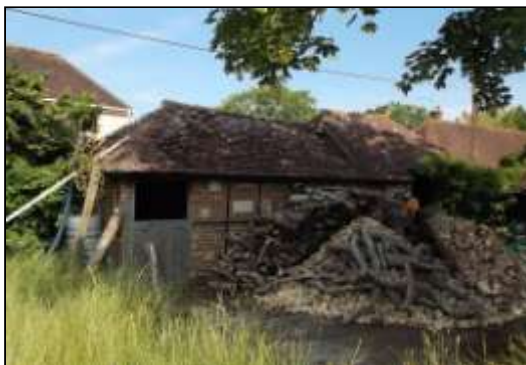
A pair of stables, built of brick with some timber framing in several stages and now under tiled roofs which are hipped at either end. They seem to have been shown on the first edition of the Ordnance Survey plan, for which the surveys were undertaken in 1874 (see Section 3), and appear to be in something close to their original form.

*The stables, from the east.*

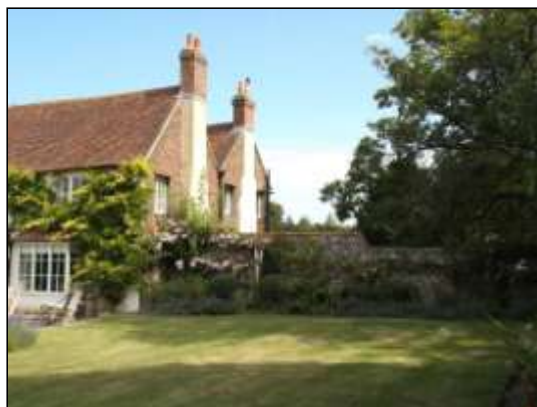
This is a flint wall with brick coping which extends eastwards from the south-east corner of the house. It was shown on the second edition of the Ordnance Survey plan, for which the revisions were undertaken in 1896 and seems to have formed part of an enclosed area to the east and north of the house (see Section 3).

*The garden wall to the east of the house, looking north.*

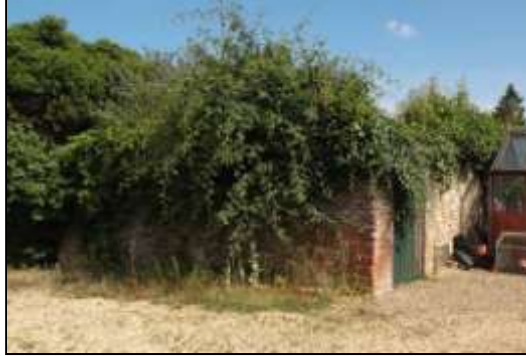
This is the brick wall now forming the property boundary between Stable Cottage and The Manor House on its west side. It was shown on the first edition of the Ordnance Survey plan, for which the surveys were undertaken in 1874 (see Section 3), and appears to have formed the boundary between the farmyard, to the west, and the garden of the house, to the east.

*The farmyard wall, looking north.*

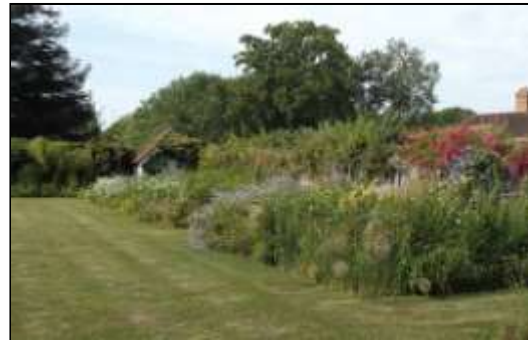
This is a tall flint wall with brick coping which was shown on the first edition of the Ordnance Survey plan, for which the surveys were undertaken in 1874 (see Section 3), and formed the west side of the walled garden on the south side of the house. At its south end is the potting shed (D).

*The west side of the walled garden, looking south-west.*

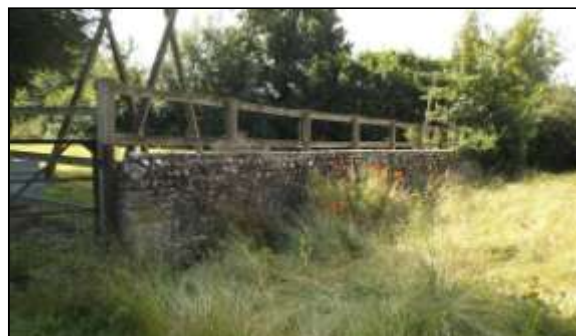
This is a low flint wall which was shown on the first edition of the Ordnance Survey plan, for which the surveys were undertaken in 1874, and seems to have formed the west side of an orchard which seems to have survived, at least in part, into the 1970s (see Section 3).

*The orchard wall, looking south.*

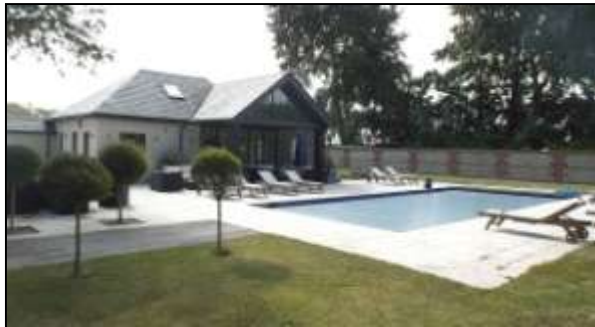
This is a building erected as recently as 2007-8 to serve as a plant room and changing room for the adjacent swimming pool which was built at the same time at the south-east corner of the property (see Section 3). It has flanking walls of flint with brick dressing which were erected at the same time.

*The pool room, pool, and walls, looking south-east.*

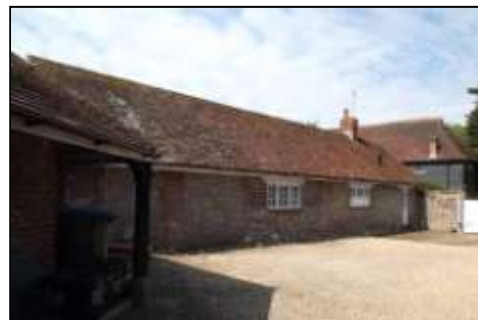
This is a modest, single-storey dwelling contained within a walled garden to the west of The Manor House. It is constructed of flint with brick dressings under a tiled roof which is gabled at either end. It is a conversion of a farm building which was not shown on the first edition of the Ordnance Survey plan, for which the surveys were undertaken in 1874, but it was shown on the second edition, for which the revisions were undertaken in 1896, and on the next edition, for which the revisions were undertaken in 1910, it was shown partially open-sided on its south side.

*Stable Cottage, from the north-east.*

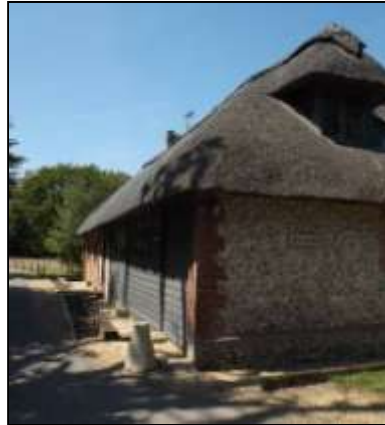
This is another residential conversion and extension of a former agricultural building to the north of The Manor House. It was shown on the first edition of the Ordnance Survey plan, for which the surveys were undertaken in 1874, and on the subsequent editions, for which the revisions were undertaken in 1896 and 1910, it was shown open on the south side. It has been extended on its north-west side and is of flint and brick, with some timber cladding, under a thatched roof which is hipped at either end.

*The Barn, from the north-east.*

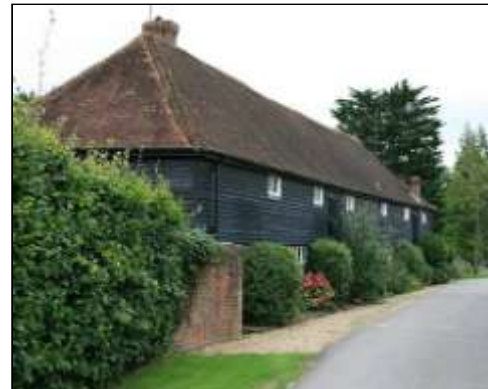
Another residential conversion of a former agricultural building to the west of The Manor House. It was shown on the estate plan of 1770 and on all editions of the Ordnance Survey plan (see Section 3) and is now a two-storey dwelling which is timber-clad under a tiled roof which is hipped at either end.

*Tithe Barn, from the south-east.*

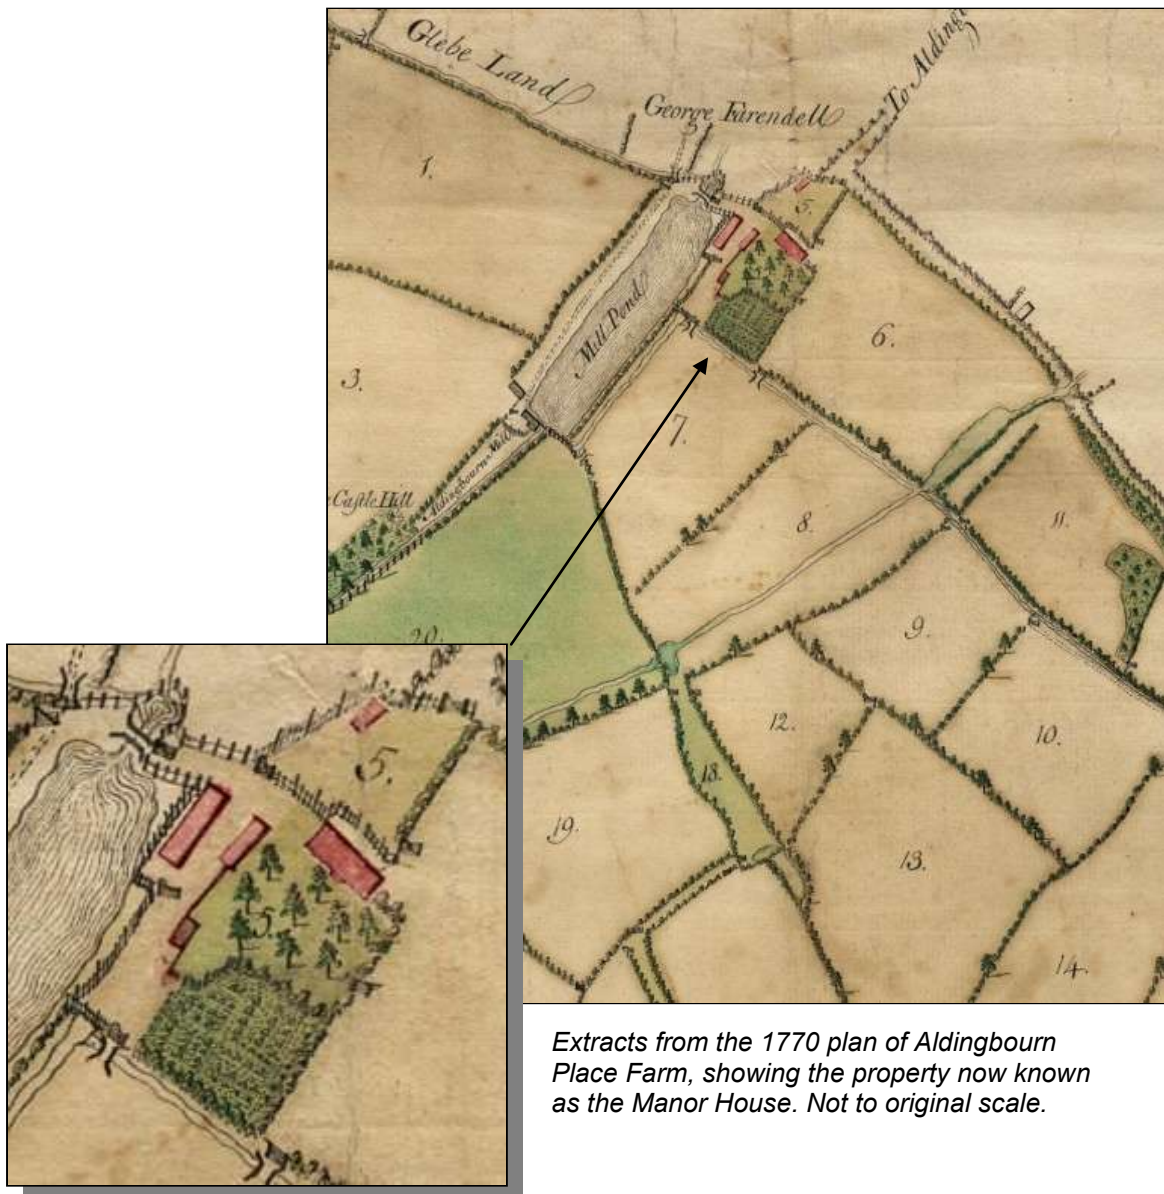
The 1770 plan covers quite a large area, evidently the same piece of land as that shown as 'Tithe Free' on the Aldingbourne Tithe Map of 1846 (see below). The only dwelling shown on the plan is near the top, in the position now occupied by the Manor House. It is identified as Plot 5 and described as 'The Garden, Orchard, House etc.' and can almost certainly be identified as the Aldingbourne Place Farm referred to in the title of the document. The plan also includes the mill, the millpond, the site of the castle at 'Castle Hill', and a large area of farmland to the south.

*Extracts from the 1770 plan of Aldingbourne Place Farm, showing the property now known as the Manor House. Not to original scale.*

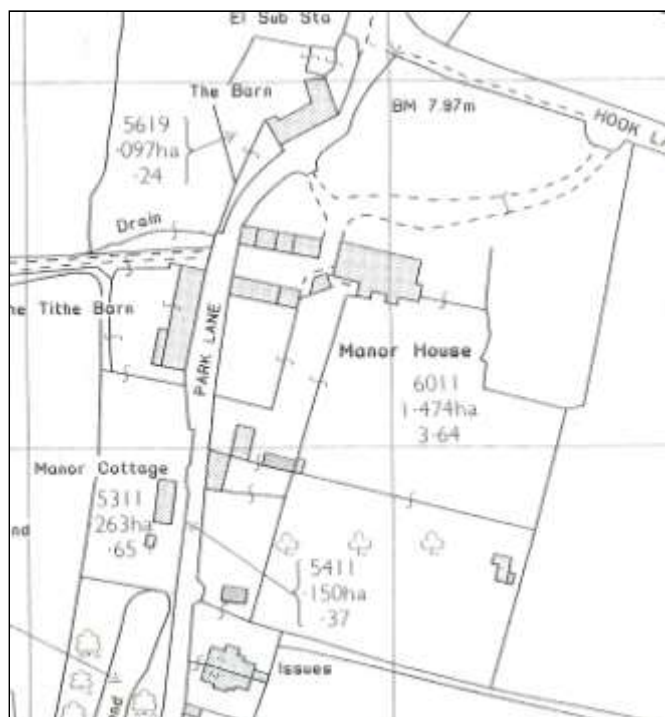
The revisions for the national grid edition of the Ordnance Survey 1:2500 plan were undertaken in 1974 and it was published in 1975. It shows the property as Manor House and the road bisecting the former farm buildings as Park Lane. Two of the former farm buildings appear to have been converted as houses – The Barn and Tithe Barn, and houses to the south were known as Manor Cottage and Nod 1 and 2 Park Lane (for further discussion see Section 4).

*Extract from the Ordnance Survey plan of 1974. Not reproduced to original scale.*

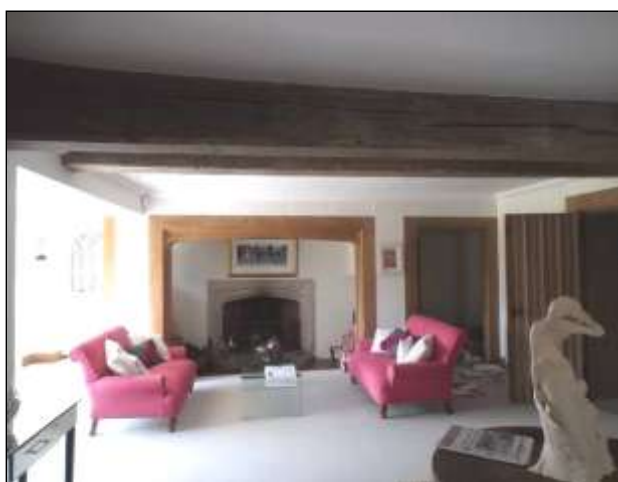
Internally at *ground level* there are a pair of substantial cross floor beams exposed in the ceiling about 1.4 metres apart – that to the east is 22 centimetres wide and at least 26 centimetres deep whilst that to the west of it is 22 centimetres wide and at least 14 centimetres. Both appear to be of oak and both are chamfered on the underside and there are traces of plain chamfer stops where the timbers have not decayed.

There appears to have been an inglenook fireplace and chimney stack at the west end of the building though these are now much altered and there is no evidence visible to indicate an early date. There is a chimneypiece and chimney stack at the east end but, again, there is no visible evidence for an early date.

*The ground floor of the house, looking west towards the possible inglenook fireplace and with the two cross beams in the foreground.*

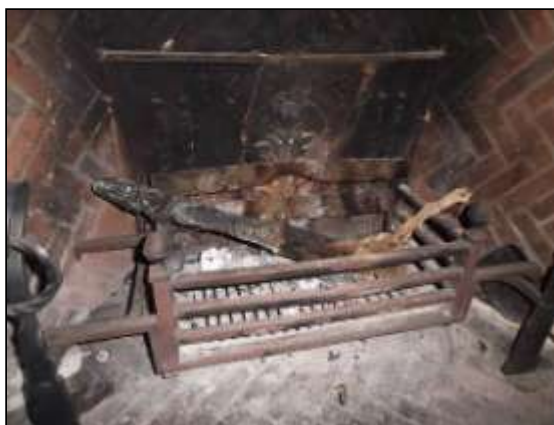
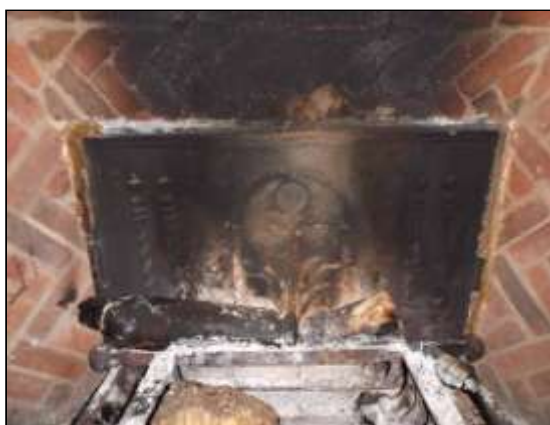
*The cast-iron firebacks in the inglenook (above left) and in the dining room (above right).*

There are a pair of identical cast-iron firebacks, both dated '1685' - one located at the rear of the inglenook fireplace and the other located in the back of the fireplace at the west end of the room to the north which is currently used as a dining room. Both are set in brickwork laid with a cement-based mortar in a style reminiscent of the first part of the twentieth century. No evidence has been found as to whether they belong to the house or that they have been introduced to it at a later date (see Overview and Date).

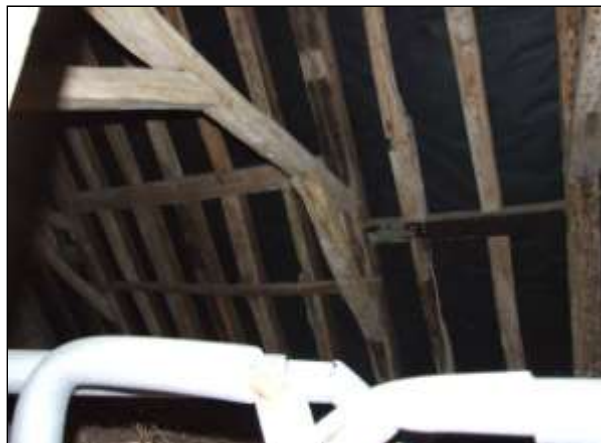
In its original form the present roof seems to have been formed of four intermediate *trusses* set between the brick gable ends. Each truss is formed of a *tie beam* supporting a pair of *principal rafters*, halved at the ridge, and between them is a *collar* supported by a pair of *straight braces* from the underside of the principal rafters to the underside of the collar. All these timbers are secured with *pegged, mortice-and-tenon joints*.

*Part of the roof frame, looking south-east.*

The remainder of the framing for the roof is formed by pairs of *purlins* in each bay, one on either side of the roof, which are tenoned into the sides of the principal rafters and secured with pegs. These are usually known as *butt purlins* or *tenoned purlins*. In this case the purlins are not at the same level in each bay, presumably to limit the amount of wood removed from the principal rafters for jointing at one point, and are known as *staggered purlins*.

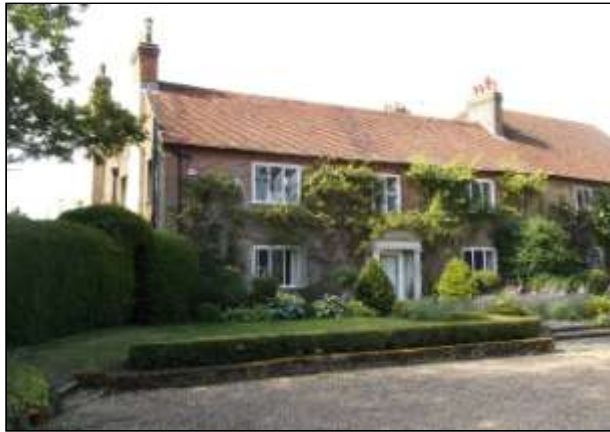
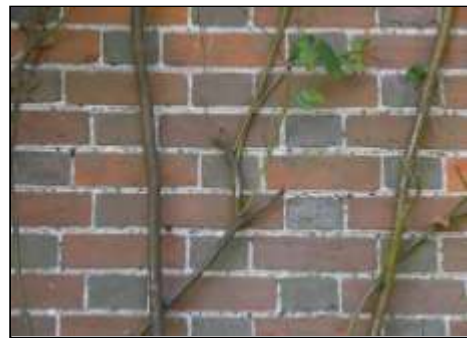
The addition was the same length as the original, ie about 14.5 metres and added about 5.1 metres to its width increasing the overall width to 10.9 metres. It was now in the form of a double-pile, two-storey dwelling with a pair of east-west ranges each with its own pitched roof terminating in a gable at either end. The north wall, which is 35 centimetres thick, is constructed of red bricks and grey headers laid in Flemish style in a lime-based mortar, with ten courses of brickwork giving a wall height of about 74 centimetres. The horizontal mortar joints include a struck line and many small holes suggesting that at some stage the wall may at some time have had something attached to it.

*General view of the north elevation, from the north-east (left) and some of the brickwork (above).*

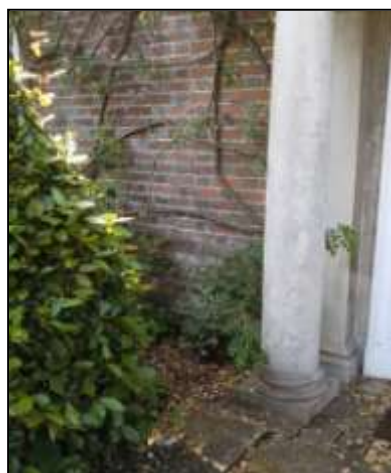
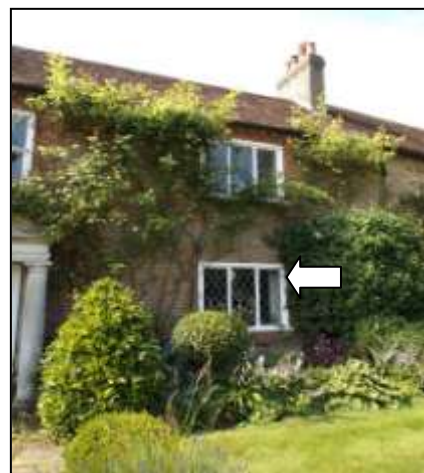
The lowest twelve or so courses project out from the wall face in the form of an offset plinth and there is a string of three courses of headers at first floor level, but these do not project beyond the face of the wall.

*The offset plinth (above left) and the string course (arrowed – above right).*

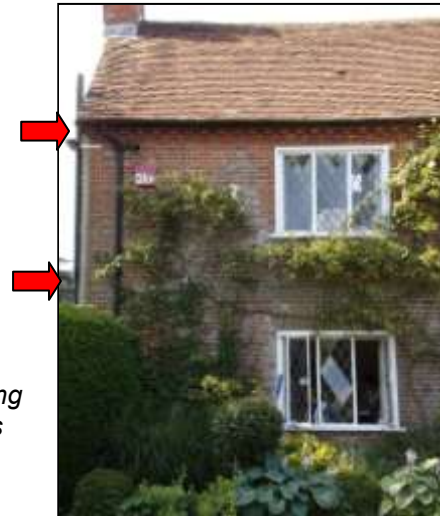
There is a projecting eaves cornice of bricks with the central of the three courses being in the form of brick dentils.

*The east end of the north elevation, showing the string course and dentilled eaves cornice (arrowed).*

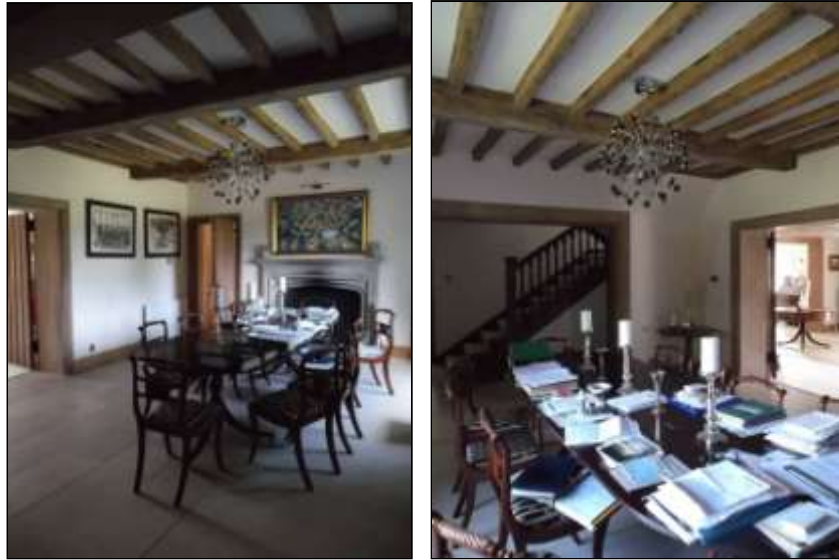
The existing staircase is a later replacement and the partition to the west of it has been opened up to give direct access to the space now used as a dining room. This preserves two main floor beams in the ceiling, which appear to be of oak and are both chamfered on the underside with traces of plain chamfer stops, and these support twelve sets of exposed floor joists. There is a stone chimney piece in the fireplace at the west end of the room and this contains one of the two cast-iron firebacks dated '1685'.

*The dining room, looking west (above left) and east (above right).*

The former partition at the west end of the dining room and the wall to the south have both been opened-up and outlined with moulded oak architraves which may have been original features recently cleaned or, more likely, later introductions.

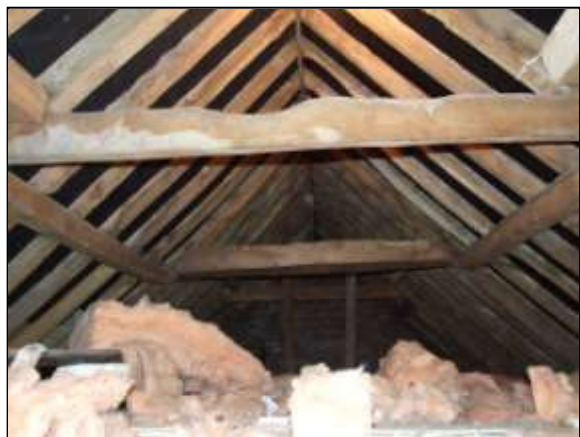
As with that to the south, it appears to be formed of four intermediate trusses between gable end walls, formed of *tie beams*, *principal rafters* and *collars*, all secured with *pegged mortice-and-tenon joints*, but lacking the *braces* linking the collars and rafters.

The roof, looking west.

The *purlins* are, once again, tenoned and pegged into the sides of the principal rafters and staggered along the line of roof. However, whereas in the original (Phase 1) structure the purlins lie within the same slope as the rafters, here they are square in section rather than rectangular and fitted parallel to the ground. They are secured to the principal rafters with *angled mortice-and-tenon joints*, in some cases with the tenon passing through the full thickness of the rafter and protruding on the other side.

As already noted above (Phase 1), the two forms of roof structure suggest that the roof here was later in date than that over the southern part of the house and a similar example at Rogate, with purlins laid parallel to the ground and angled tenons cut through the full thickness of the principal rafters, is dated by an inscription to '1790'. However, the technique may have been employed over a period of time and at Rogate later additions also employed the same technique.

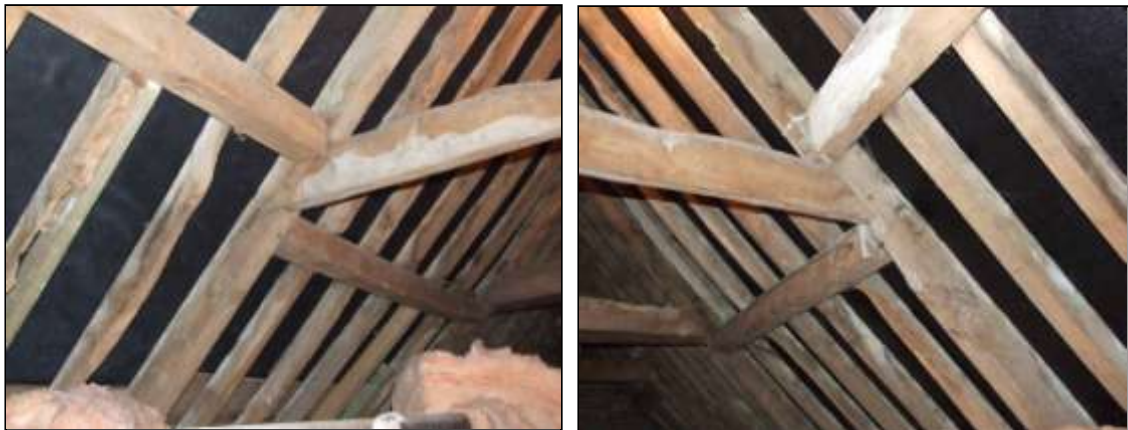
*The two ends of one of the trusses in the roof, looking east.*

The truss nearest the access hatch carries the carpenter's number 'III' on the principal rafter at either end, which suggests that the trusses may be numbered 1-4 from west to east.

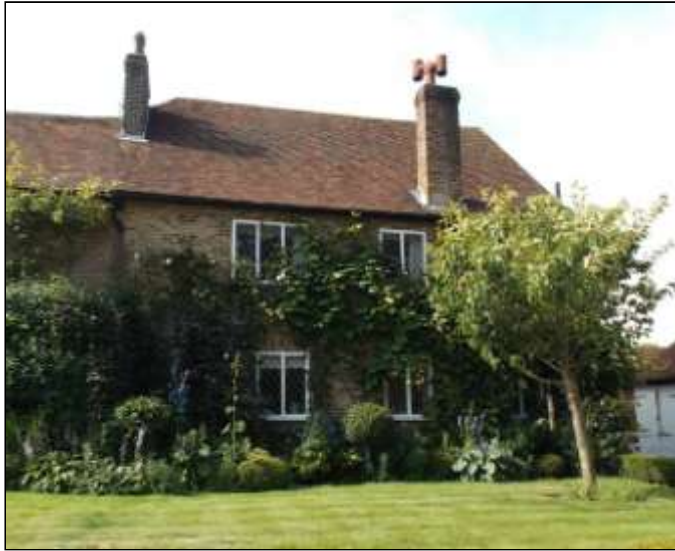
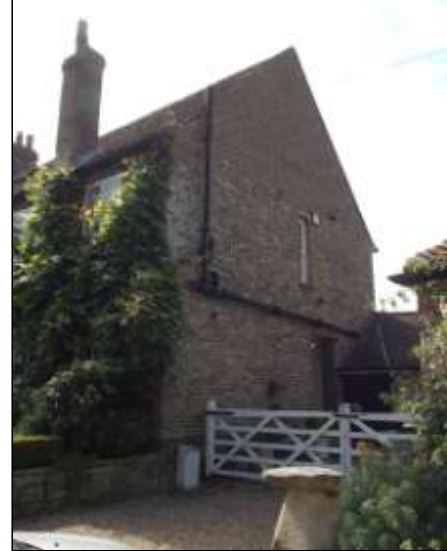
There are three window openings at each level on the north façade, those at ground floor level having curved heads formed of vertical stretchers bricks and those at first floor level having flat heads. There are indications that some of the window openings may have been widened.

The chimney stack at the west end of the Phase 2 extension seems to have been adapted to serve the east end of this extension at this time and there is also a chimney stack towards the west end of the north elevation which is probably a later insertion.

*The Phase 3 extension, from the north (above left) and from the north-west (above right).*

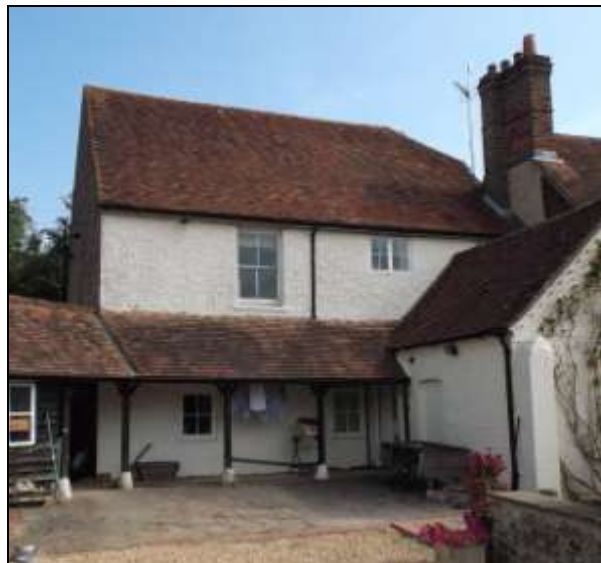
There have been several later additions to the south side of the extension and the brickwork is masked by render and paint. It now contains several openings at each level but it is not possible to determine which of them may be original features and which are later insertions.

*The south elevation of the Phase 3 extension, looking north.*

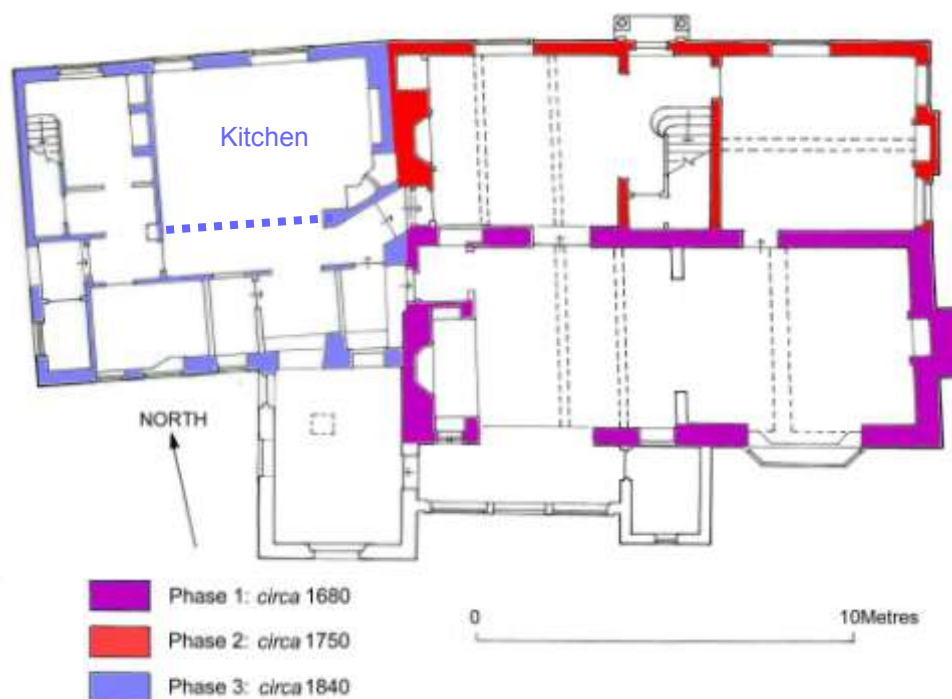
*Ground plan of the existing house, showing the Phase 3 extension (blue).  
Scale 1:200.*

The large room in the north-east corner may have contained a kitchen with the remainder of the relatively small ground floor spaces containing ancillary rooms, including a larder and a pantry. If the chimney stack on the north elevation was included at this time it would have served a small room at the north-west corner of the extension which may have been a servants' rest room.

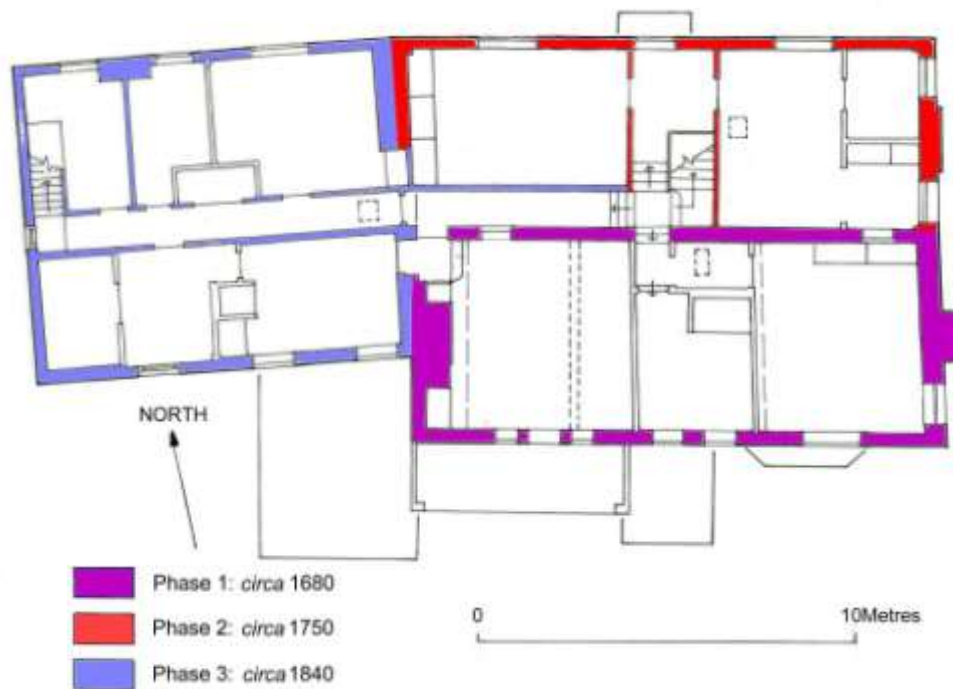
*First floor plan of the existing house, showing the Phase 3 extension (blue).  
Scale 1:200.*

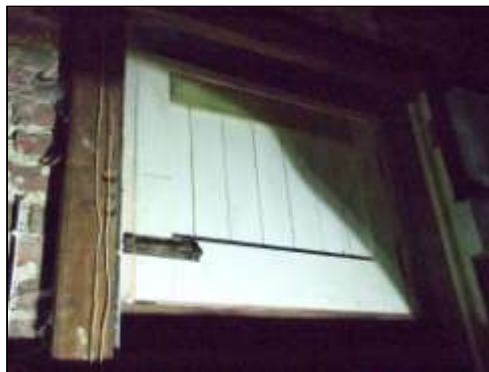
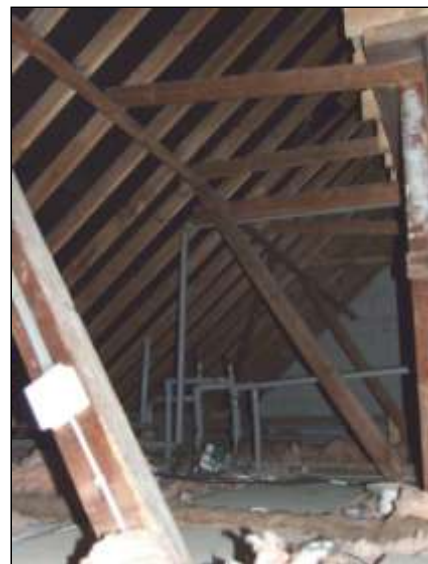
The roof structure, which is visible through a small loft hatch, seems to be of relatively recent original and comprises a series common rafters supported on purlins, with collars and raking struts – probably all of softwood.

*The door opening in the east gable of the extension (above) and the roof structure (right).*

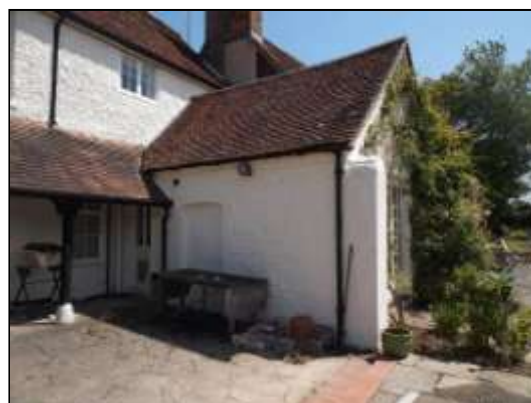
It is about 5.1 metres long and 4.3 metres wide and constructed of flints with brick dressings and a brick dentilled eaves course which is preserved on the west side and in the gable end on the south side. However, the two external elevations are painted and it is not possible to establish the colour or type of bricks employed in its construction.

It had an original door opening in the middle of the west side, with a curved head of bricks on end, but this has since been blocked with bricks that have also been painted. Attached to the south-west corner is a remnant of a brick and flint wall which formed part of the west wall of the walled garden to the south of the house (see Section 2 'J').

*The Phase 4 addition, from the west.*

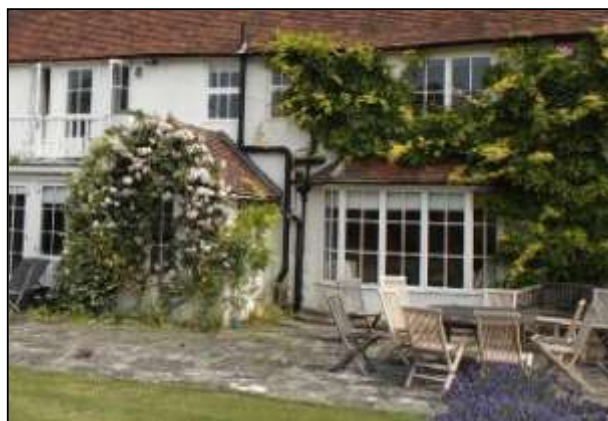
To the east of it is a shallow bay window with a tiled roof which may have been added at about the same time.

*The two Phase 5 additions, from the south.*

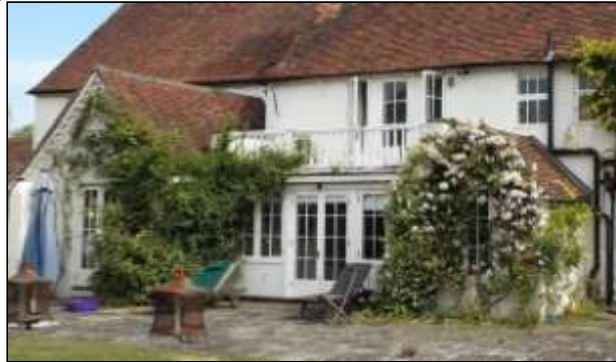
The main external addition has been the construction of a single-storey extension on the south side between the earlier (Phase 4 and 5) additions which has a flat roof that now forms a balcony to the master bedroom.

*The single-storey extension on the south side of the house, looking north.*

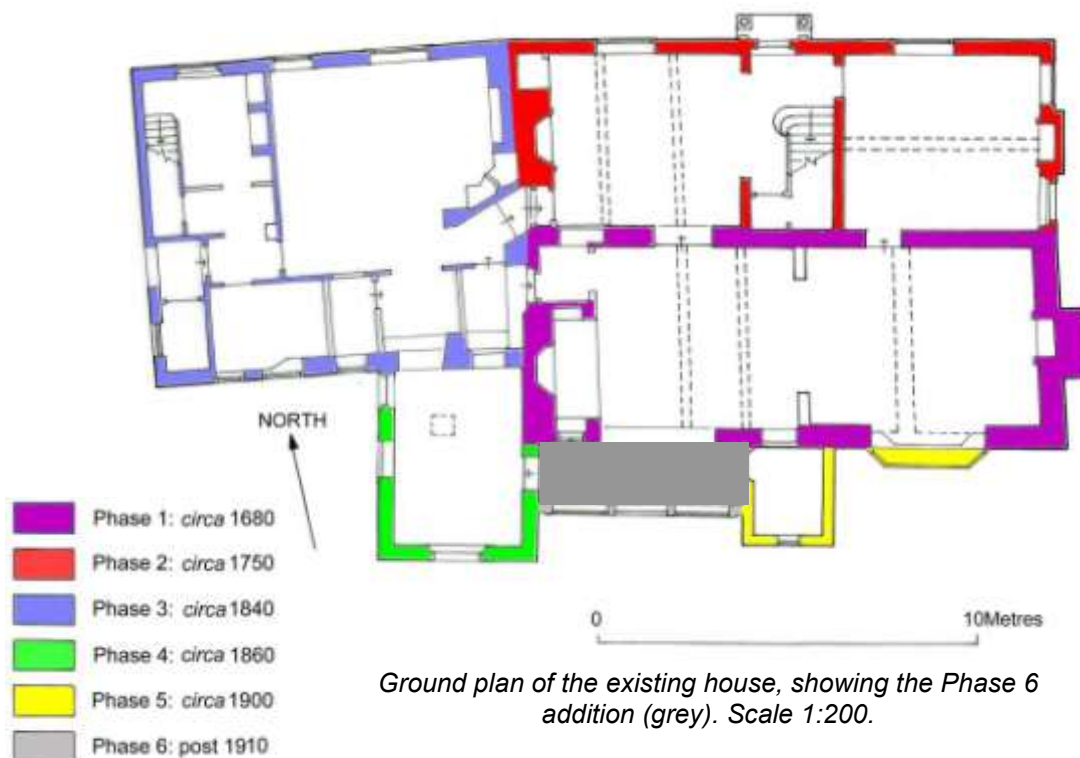
*Ground plan of the existing house, showing the Phase 6 addition (grey). Scale 1:200.*

Some time before the revisions were made for the 1938 edition of the Ordnance Survey plan the linking store and covered way, noted in the introduction (see Section 2), had been built at the south-west corner of the house.

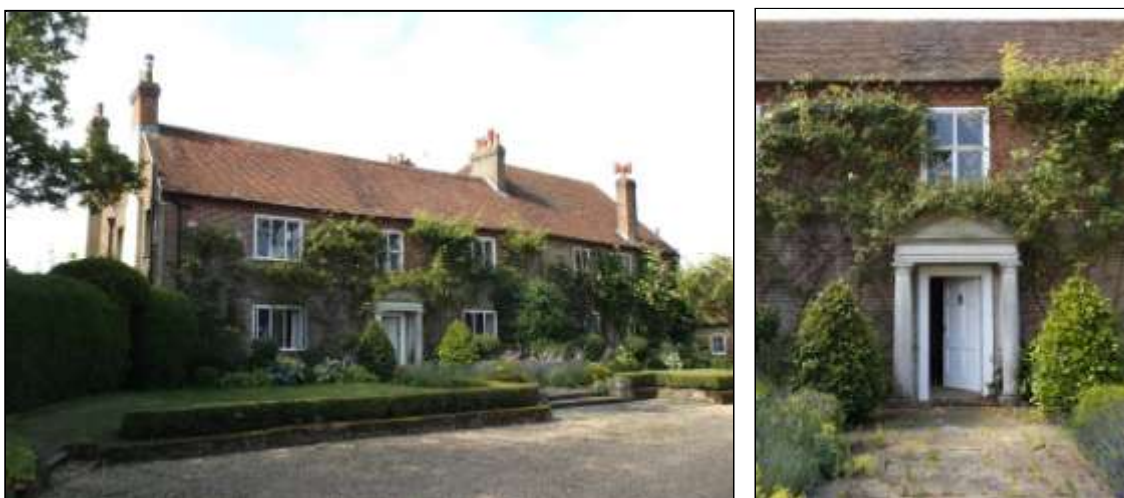
The *north elevation* is essentially as built in about 1750 (Phase 2) and extended in about 1840 (Phase 3). The porch may be an addition to the original house but no evidence has been found to indicate when this may have been. The windows are all casements with diamond-shaped leaded lights and the door has six panels.

*The Manor House, from the north-east, and the porch.*

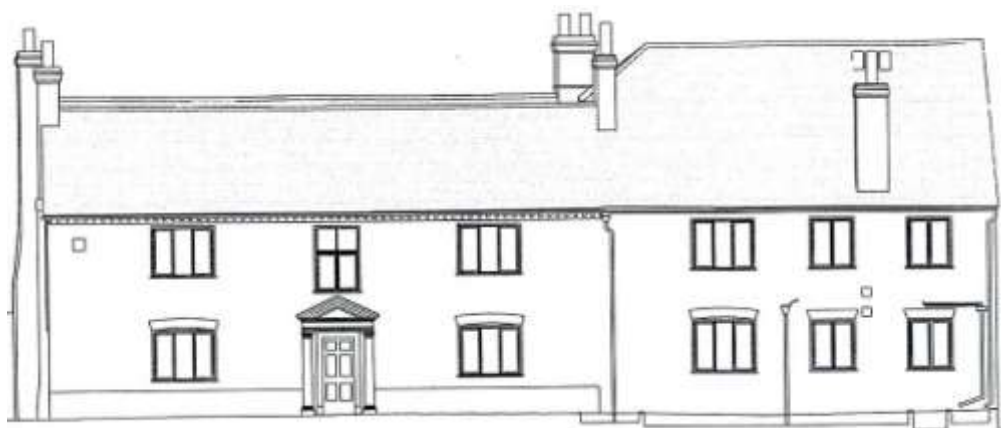
*The north elevation of the Manor House. Scale 1:200.*

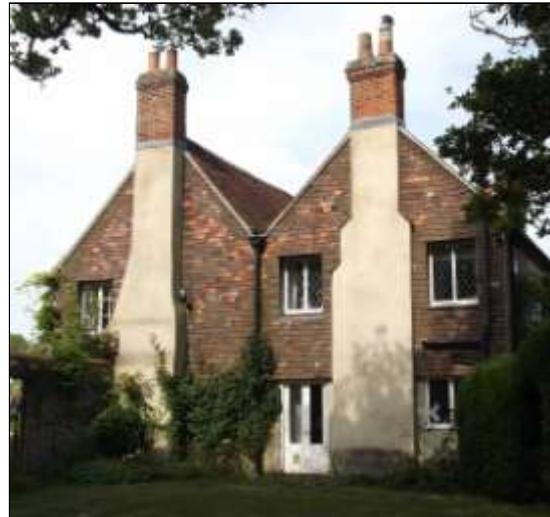
The *east elevation* comprises the two gabled ends of the original (Phase 1) house and the later (Phase 2) addition to it. The lower parts of these and the two chimney stacks are for the most part rendered whilst the upper parts are hung with tiles. The exposed brickwork in the upper sections of the two chimney stacks suggest that they have both been rebuilt in the late nineteenth or early twentieth century.

The elevation includes modern patio doors and four casement windows, three of which have diamond-shaped leaded lights.

*The east elevation of  
The Manor House.*

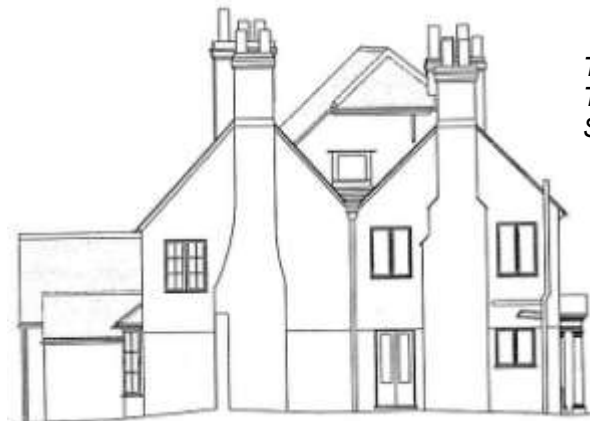
*The east elevation of  
The Manor House.  
Scale 1:200.*

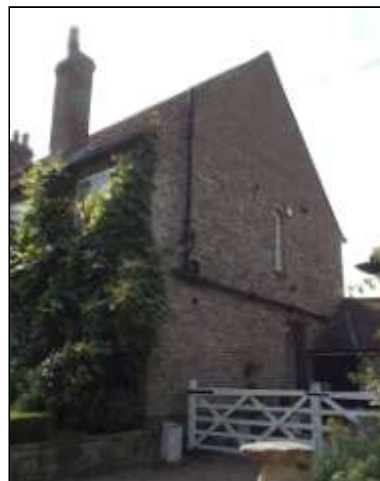
The *west elevation* is essentially as built in about 1840 (Phase 3) with parts of the original (Phase 1) and later additions projecting to the rear.

*The west elevation of the  
Phase 3 extension, looking  
south-east.*

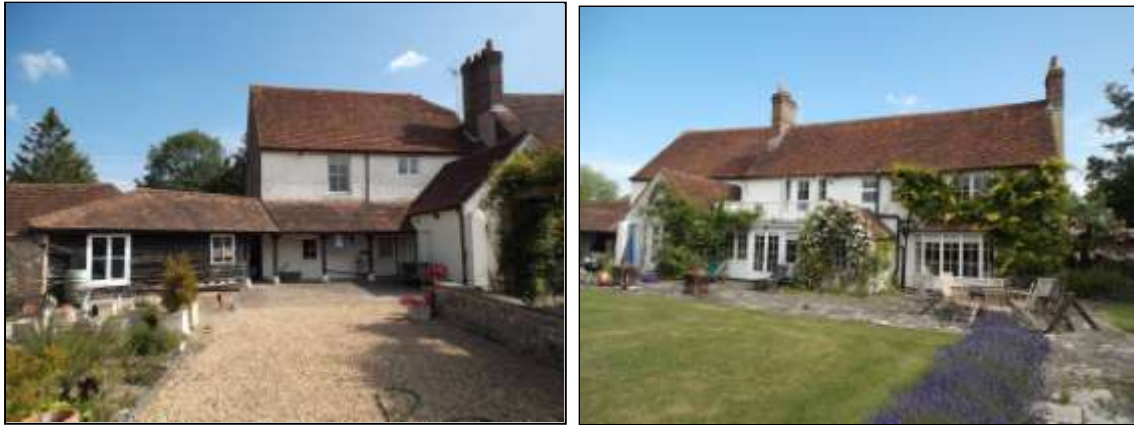
The *south elevation* is a mix of most of the phases of construction of the house, except for the (Phase 2) Georgian section of the frontage, but the earlier (Phase 1 and Phase 3) parts have been partially obscured, altered, and otherwise masked by later surfaces including render and paintwork.

*The south elevation of the house, viewed from the south-west (above left)  
and from the south-east (above right),*

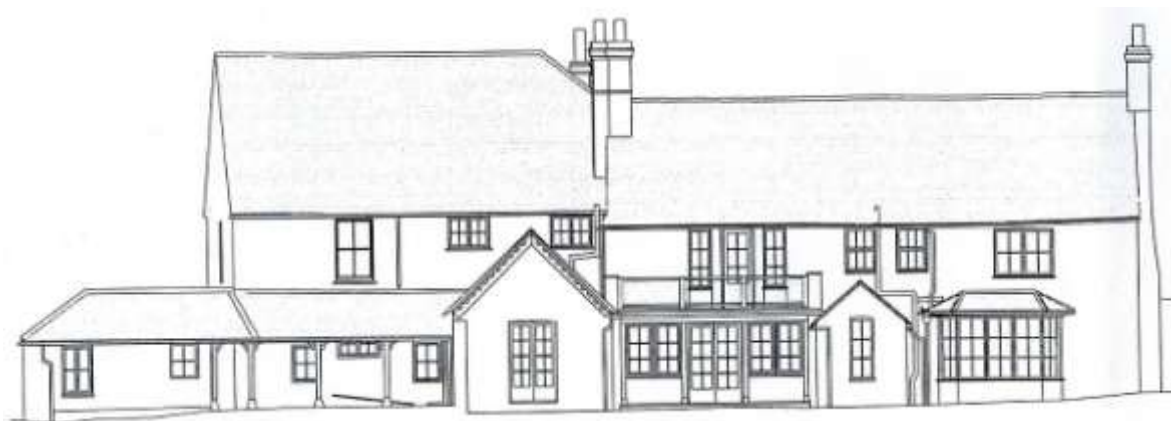
*The south elevation of The Manor House, including the linking structure at the west end.  
Scale 1:200.*

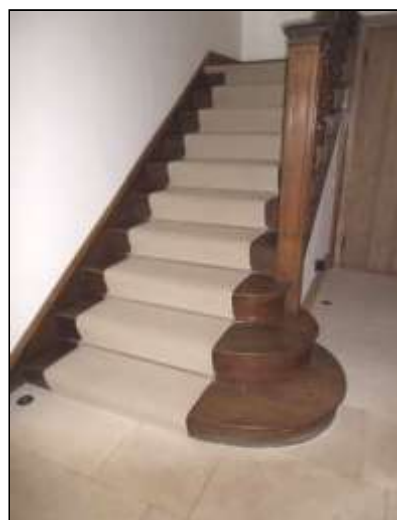
There are no surviving period features here – the staircase is a later insertion with a square wooden newel post and turned wooden balusters. The floor tiled.

*The staircase, looking south.*

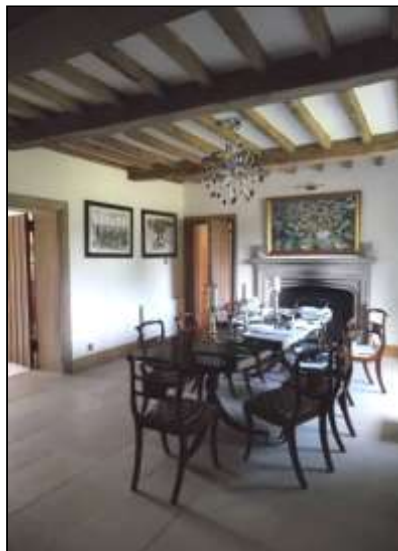
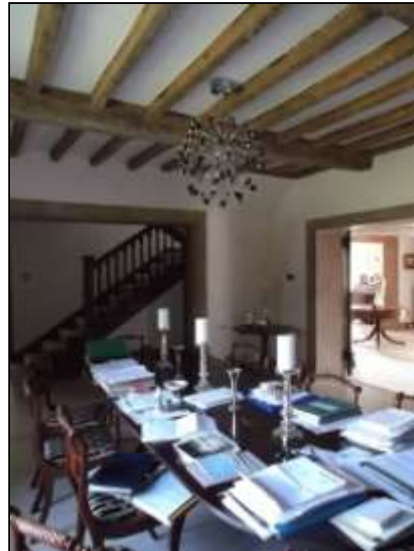
It has exposed floor beams and joists in the ceiling and a stone chimneypiece at the west end which is probably a later insertion. The fireplace contains a cast-iron fireback which is date '1685'.

*The dining room, looking west (above left) and east (above right).*

A trimmer has been inserted into the floor joist in the south-east corner of the ceiling to accommodate a turn in the adjoining staircase when it was re-ordered.

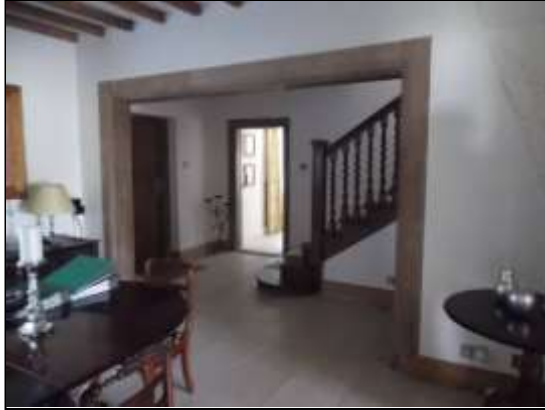
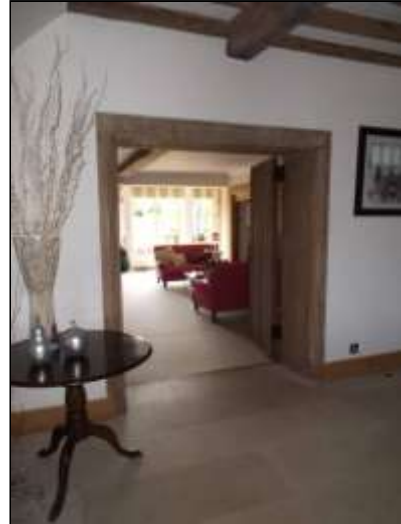
The east and south walls have been opened up to provide wider access into the adjoining spaces (Rooms G1 and G5) and the openings are both formed with moulded wooden architraves, probably oak. These have the appearance of previously having been painted but now cleaned and it is not clear whether they are original features or later insertions.

*The openings on the east side (above) and south side (right) of the dining room.*
