# 1. SUMMARY

This buildings assessment has been prepared on behalf of Mr and Mrs A Dunn in order to obtain a full understanding of the fabric and history of the building known as The Manor House, Aldingbourne, and thereby advise proposals to extend and alter the house.

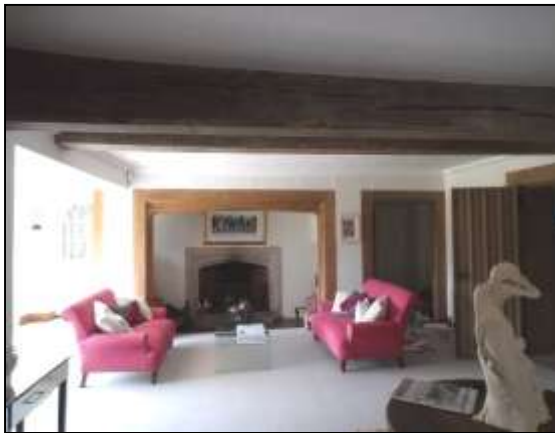
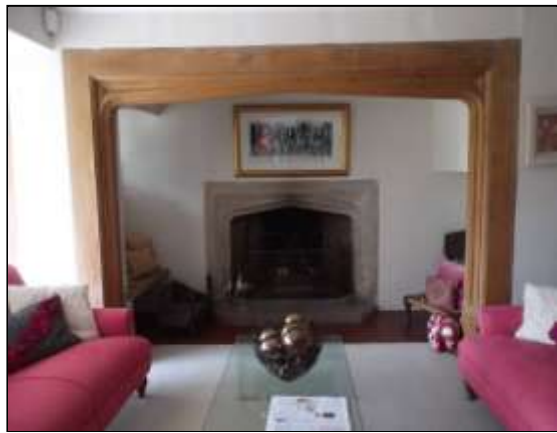
There are a pair of exposed floor beams in the ceiling and what appears to have been an inglenook fireplace at the west, which is now much altered and has a carved wooden surround to the opening and a stone chimneypiece which is probably a later insertion. The fireplace contains a cast-iron fireback date '1685'.

A door opening has been created to the north of the fireplace to give access to the later (Phase 3) service wing and the south wall has been opened-up to provide a wide access into the late (Phase 6) single-storey addition and the room has a simple modern cornice. The floor is carpeted.

*The lounge, looking west (above left) and a detail of the much-altered inglenook fireplace (above right).*

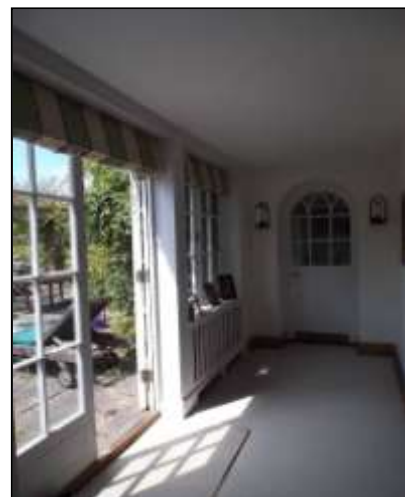
The door opening at the west end has a round head and matching glazing and this may be an original (Phase 4) feature.

*The passage, looking west.*

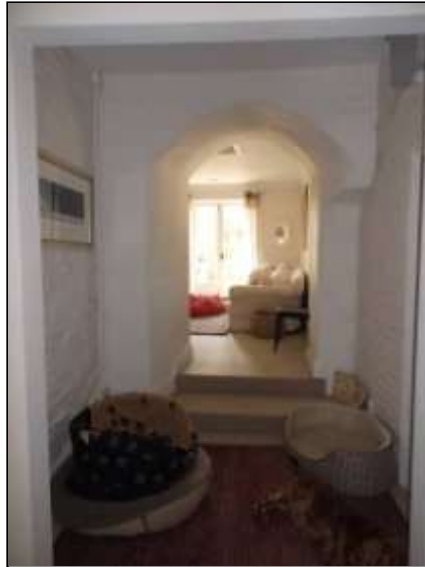
The pointed opening has been roughly cut through the south wall of the service wing and gives the misleading impression that it is older than it actually is.

*The lobby, looking south.*

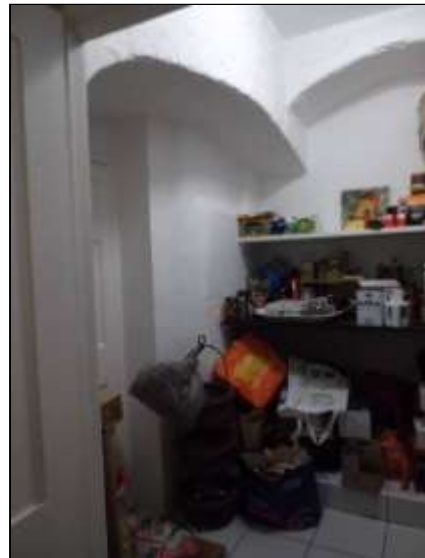
**Room G15:  
Larder**

This is a small room at the south-east corner of the service wing which has been linked through to the west end of the lounge (Room G5), by cutting through the masonry of the west wall of the original (Phase 1) house and inserting a brick relieving arch. It may also at some time have been linked through to the later (Phase 4) addition to the south (Room G16). It is now used as a larder.

The brickwork on the east and south sides has been roughly cut through and seems to give the misleading impression that the openings are older than they actually are.

*The larder, looking south.*

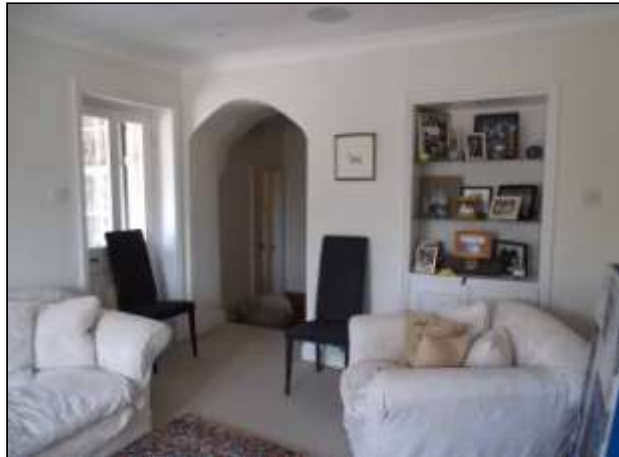
**Room G16:  
Play room**

It now has a window in the south elevation; an external door in the north-west corner; and two internal door openings on the north and east sides. It has a plain concave coving; the floor is carpeted; and the space is used as a play room.

*The play room, looking north-west.*

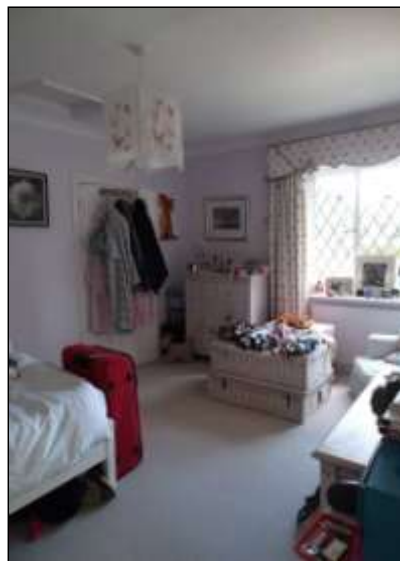
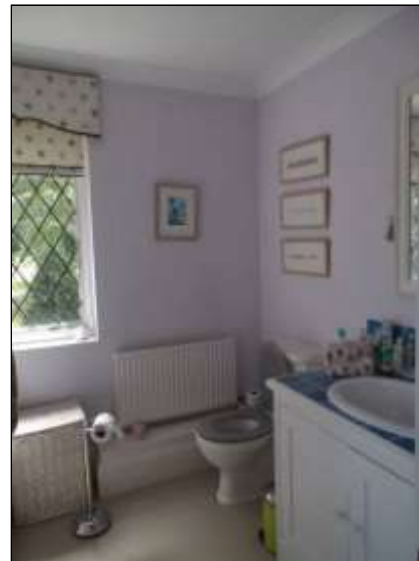
This is located at the north-east corner of the house and would have contained one of the principal family bedrooms of the later (Phase 2) Georgian dwelling. It may have been heated but there is no longer any trace of a fireplace at the east end.

It is now subdivided to comprise a bedroom with en-suite bathroom in the north-east corner. The space preserves no period features but a simple concave coving has been added in the bedroom, which contains a loft hatch.

*The bedroom, looking north-west (above left) and the bathroom, looking south-east (above right).*

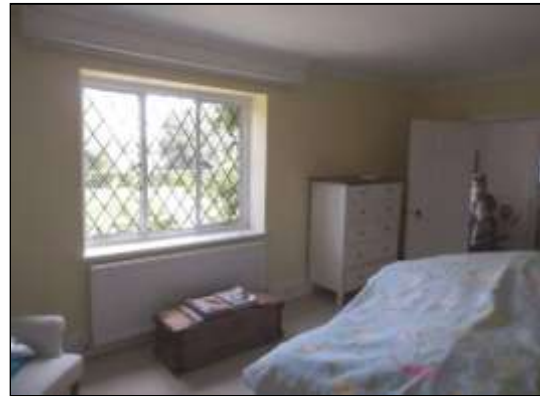
### Room F3: Bedroom

It still serves as a bedroom but no period features survive. A simple concave coving has been added and there are built-in wardrobes at the west end.

*The bedroom, looking north-east.*

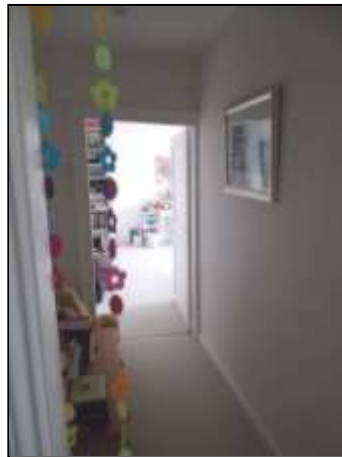
**Room F4: Passage**

This is a short passage leading off the top of the landing and giving access to a bedroom and family bathroom on its south side (F5 and F6).

It contains no period features but it does include a loft hatch.

*The short passage, looking east.*

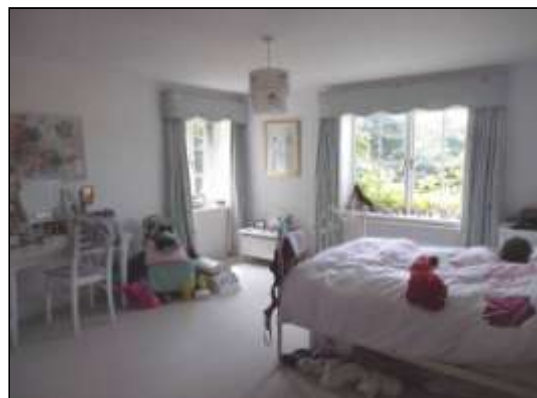
**Room F5: Bedroom**

It is still in use as a bedroom but contains no period features.

*The bedroom, looking south-east.*

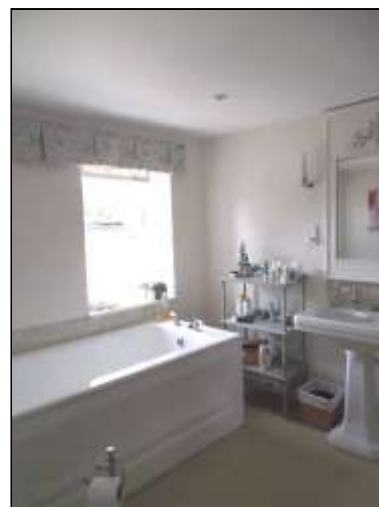
#### Room F6: Bathroom

It is now a family bathroom and contains no period features.

*The family bathroom, looking south-west.*

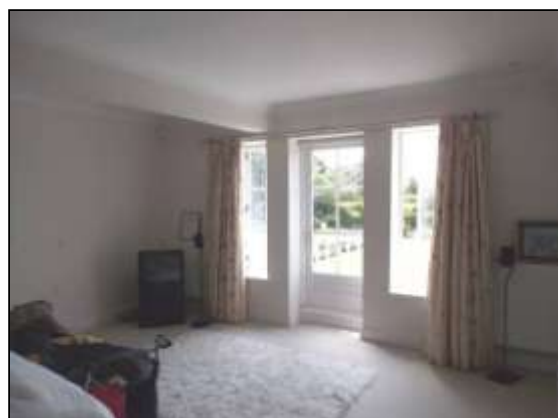
#### Room F7: Bedroom

It includes a dropped beam in the ceiling part way along its length and built-in wardrobes around the chimney stack at the west end, which may well have contained a fireplace. It also has plain concave coving.

A door opening has been created on the south side to give access to a balcony over the later (Phase 6) ground floor extension and an opening has been created at the north end of the west wall to give access to an adjoining room in the later (Phase 3) extension which has been converted for use as an en-suite bathroom. It now serves as the master bedroom of the house.

*The master bedroom, looking north-west (above left) and south-east (above right).*

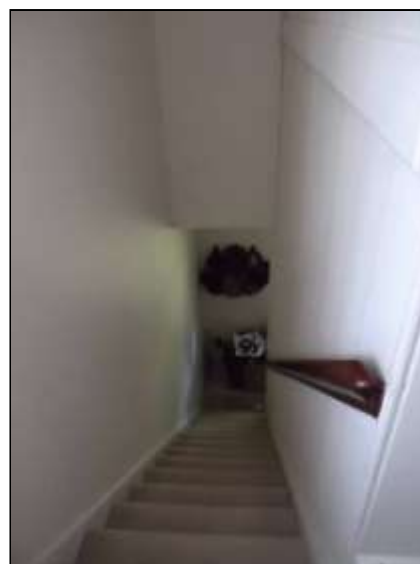
This is continuation of the narrow passage leading from the main family stairs, through the later (Phase 3) extension, to the secondary stairs at the west end, which may have been for the servants. It linked the family end of the house with the service end and served bedrooms on either side, some of which were probably used by the servants.

The passage and stairs contain no period features but the passage has an airing cupboard on its north side and a loft hatch at its east end.

*The servants' passage, looking west (above left)  
and the servants' stairs (above right).*

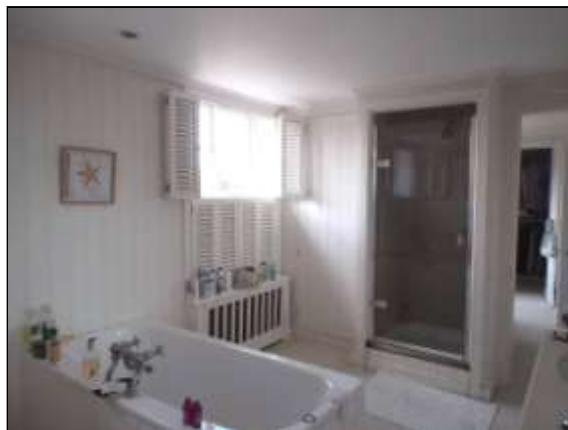
### Room F10: Bathroom

It may have been heated by a fireplace on the east side but this is no longer visible.

The room is now an en-suite bathroom linked through to the master bedroom on its east side (Room F7) and to a dressing room and walk-in wardrobe on its west side (Room F11). There is also an access from the passage on its north side (Room F9). It contains no period features.

*The en-suite bathroom, looking west.*

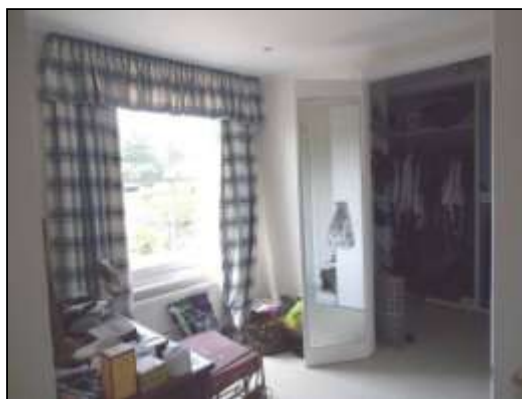
### Room F11: Dressing room and wardrobe

This is located at the south-west corner of the later (Phase 3) extension to the house and was probably intended for use as a servant's bedroom.

It is now subdivided and contains a dressing room and walk-in wardrobe linked through to the en-suite bathroom for the master bedroom (F10). There is also a direct access from the passage on its north side (F9). The dressing room has plain concave coving.

*The dressing room and wardrobe, looking south-west.*

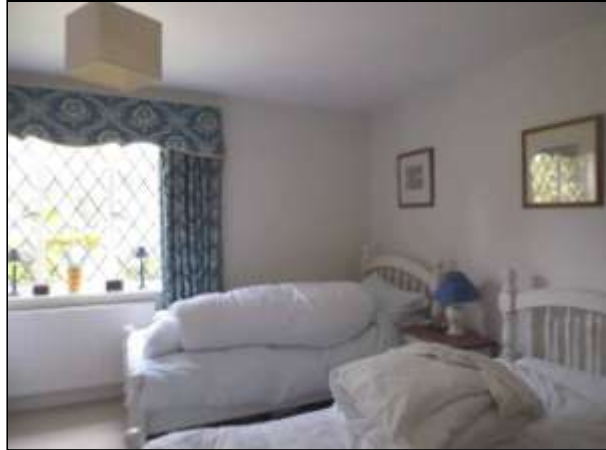
### Room F12: Dressing room and wardrobe

It is still in use as a bedroom but has no surviving period features.

*The bedroom, looking north-east.*

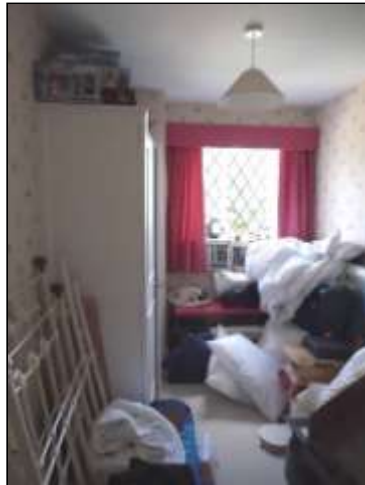
### Room F13: Bedroom

A small room on the north side of the later (Phase 3) extension to the house which was probably intended as a servant's bedroom.

It is still in use as a bedroom but has no period features.

*The bedroom, looking north.*

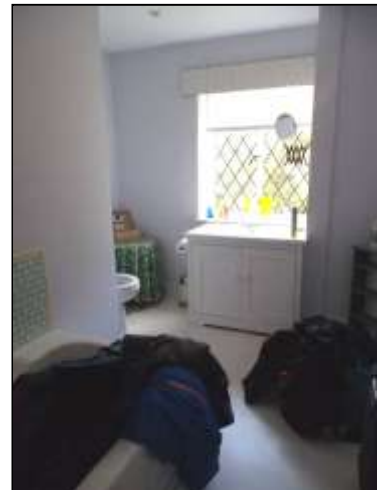
### Room F14: Bathroom

A small room on the north side of the later (Phase 3) extension to the house which was probably intended as a servant's bedroom. It is L-shaped in plan to fit around the servants' stairs.

It is now a family bathroom and has no period features.

*The bathroom, looking north.*

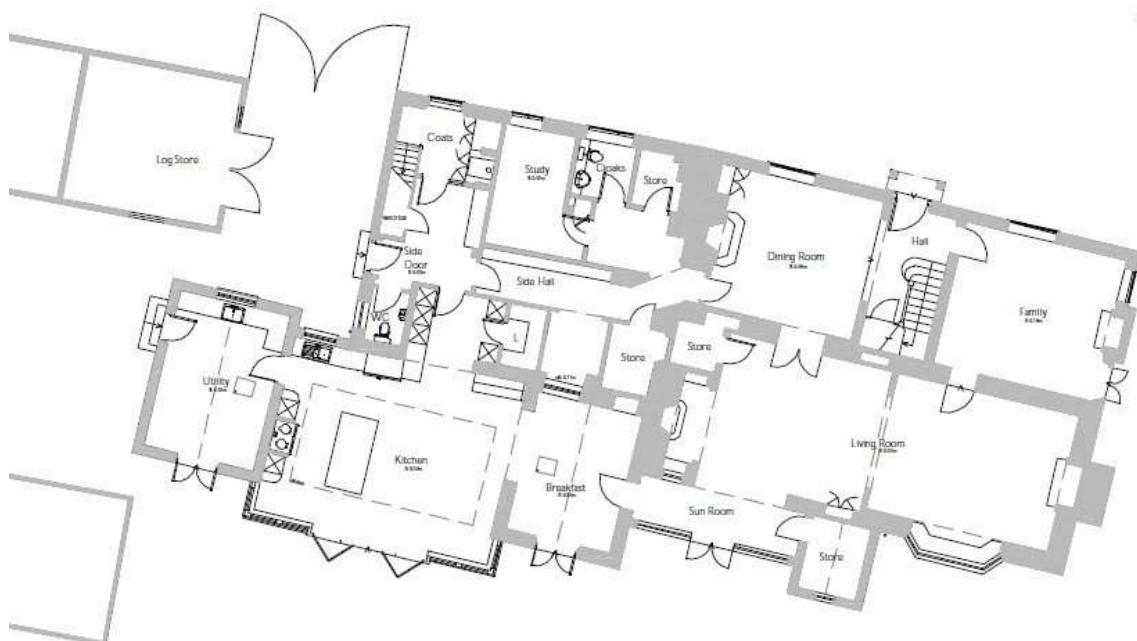
*The existing ground floor plan (left) and the proposed ground floor plan (below). Not to scale.*
