## First floor plan | existing

## EXSITING PLANS

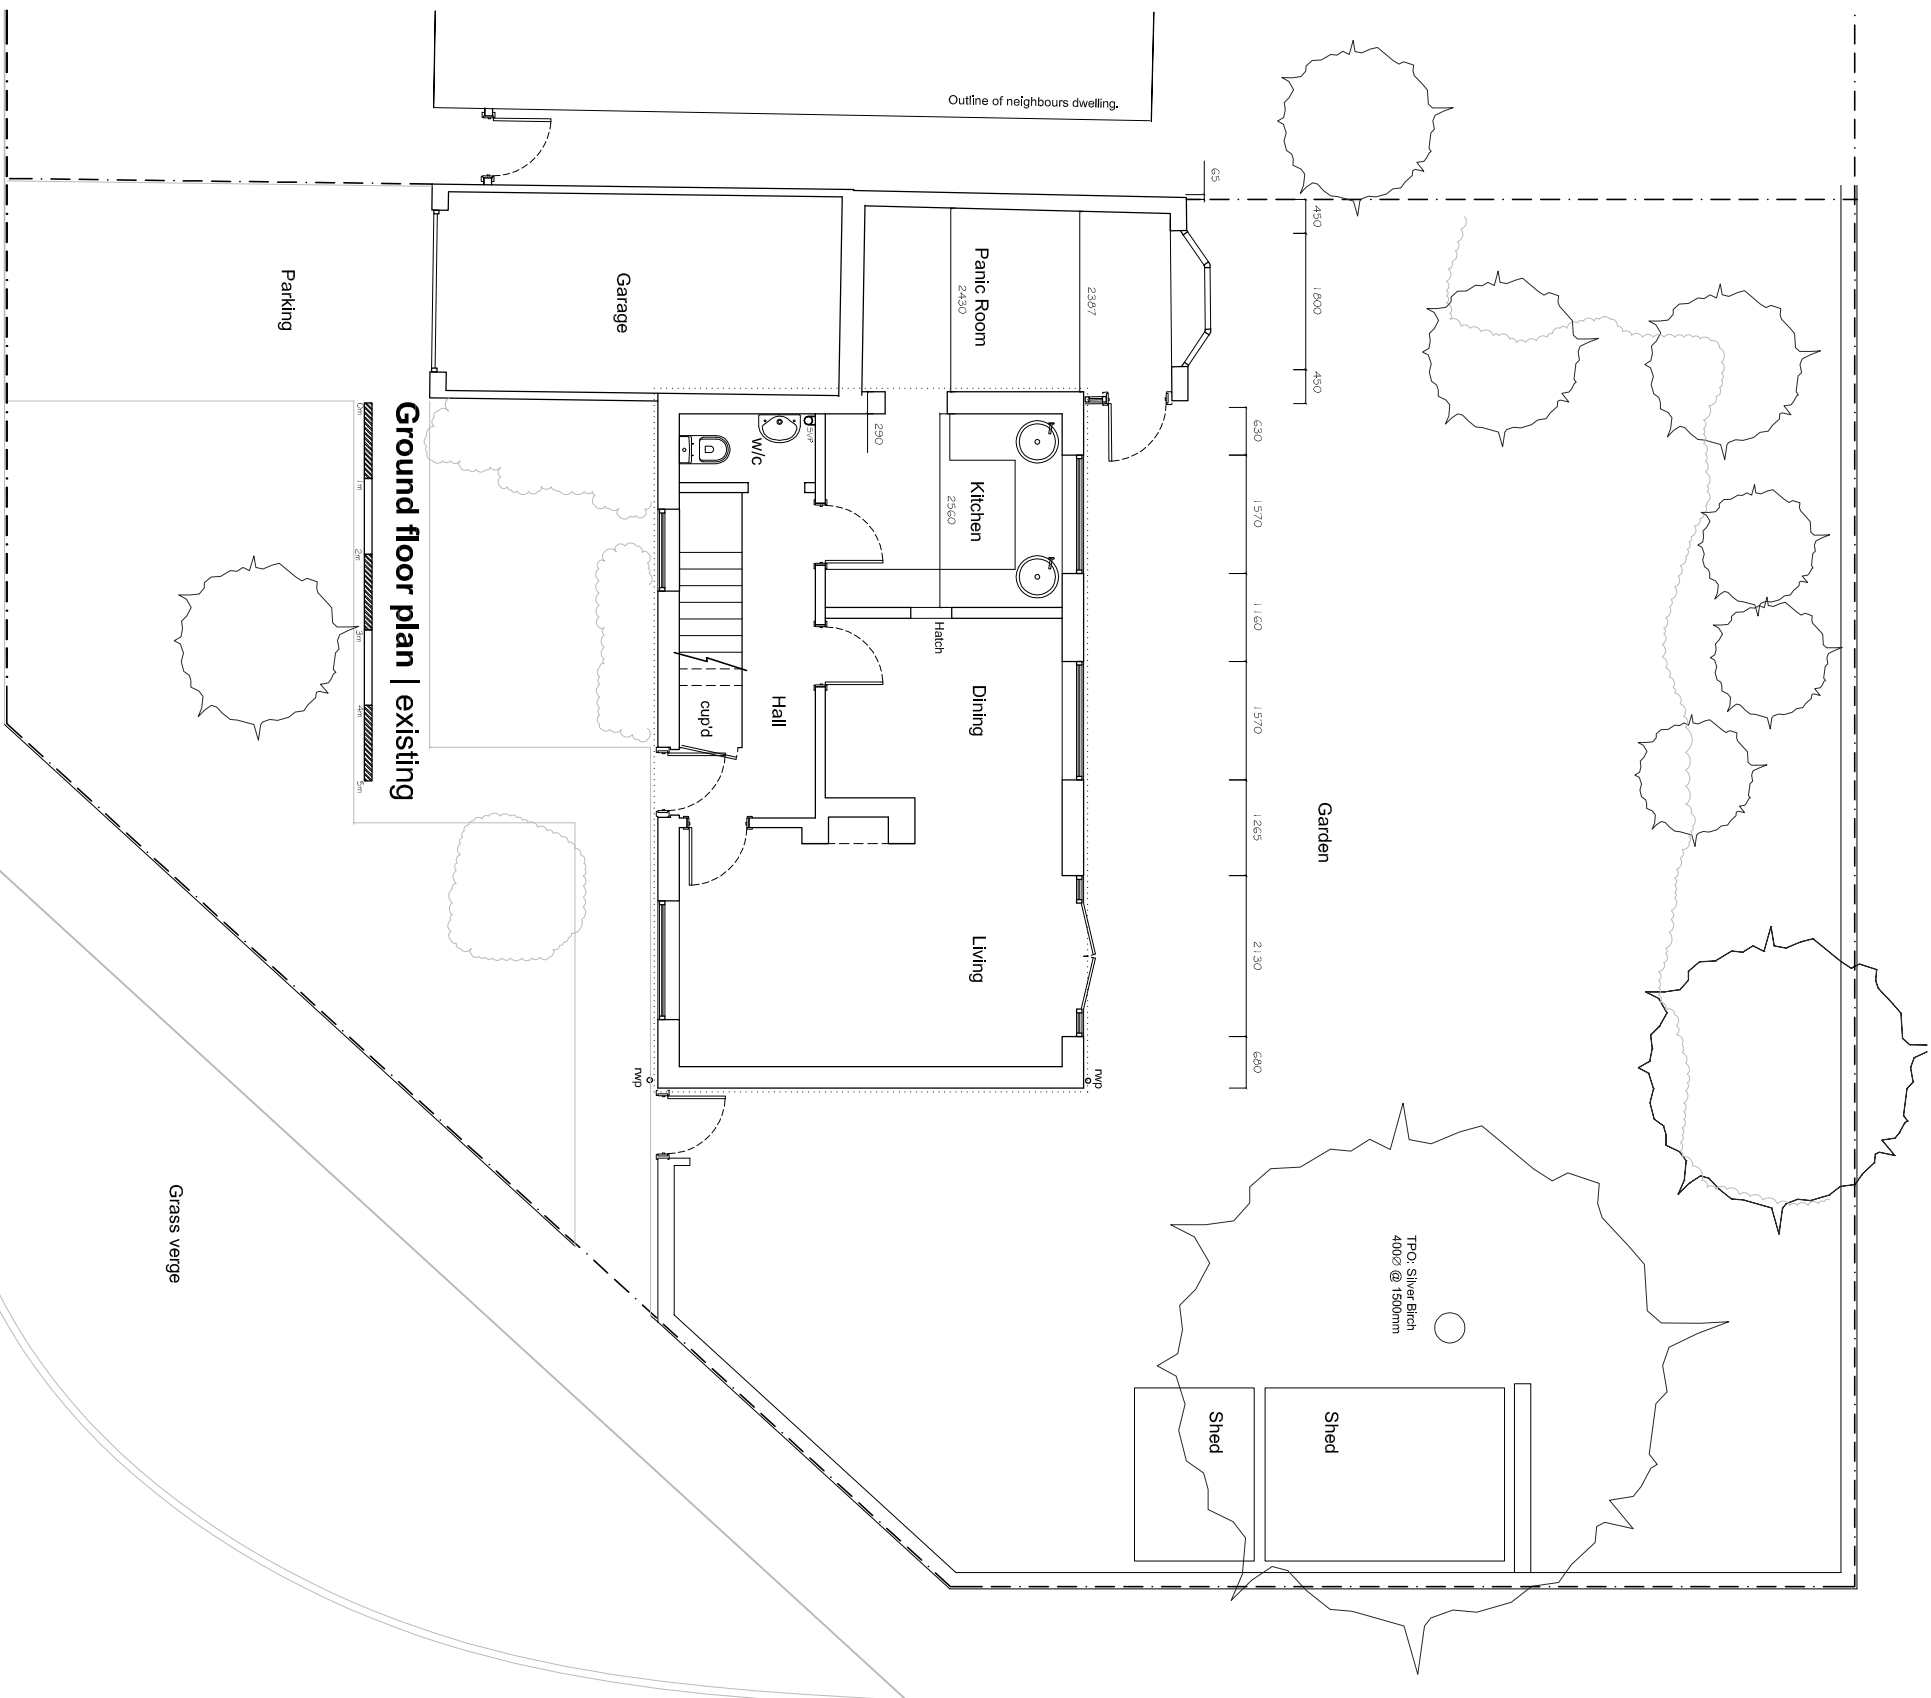
Confirm FF inner wall faces are 50mm set back from GF. Is this because of timber frame detail on upper floor hidden by tile hanging?
