## **28 Kingsway**

### **Aldwick, Bognor Regis, West Sussex**

- Preliminary Ecological Appraisal Survey Report
- Bat Roost Assessment Survey

| Document Reference | LLD1227 |

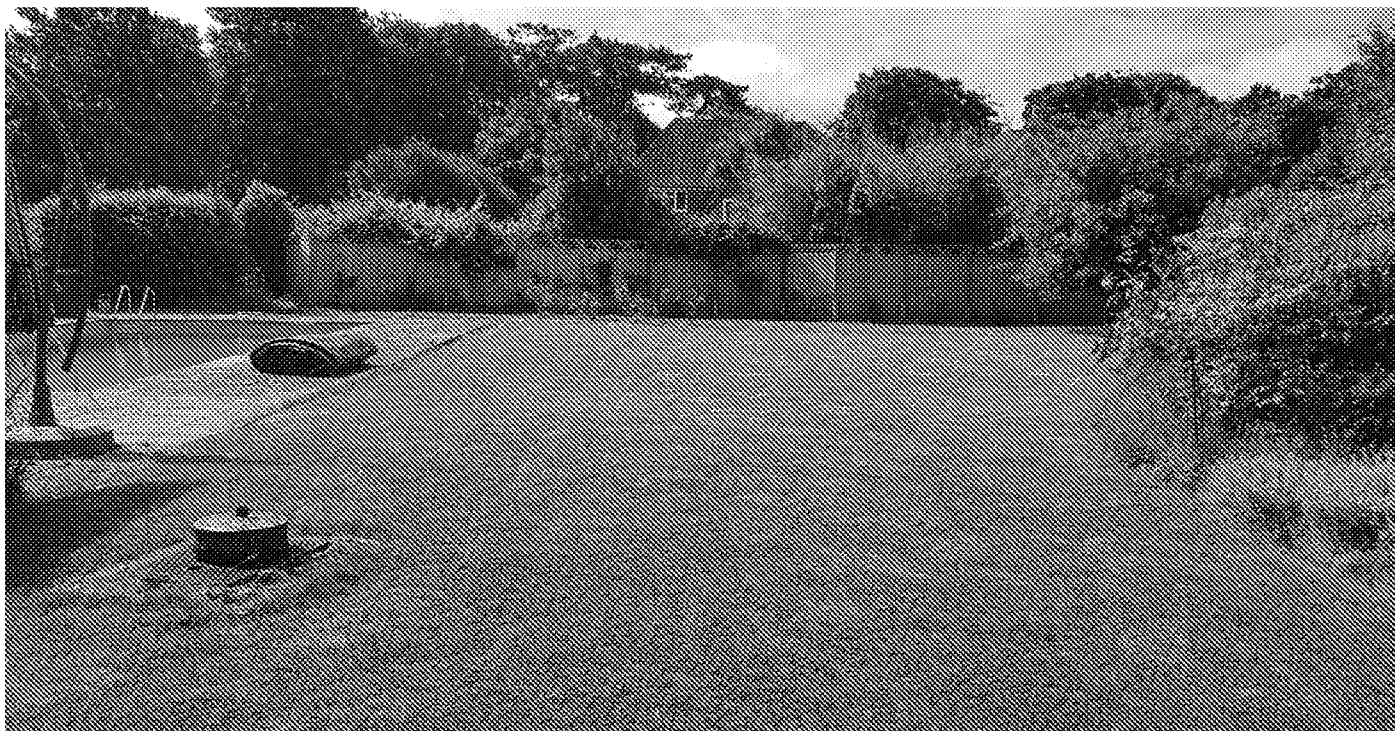
Photograph No. 1 - View across the development site towards the south.

4.2.3 The existing site is currently utilised as a residential garden with the habitats present on site reflecting this. The area is dominated by amenity grassland with introduced shrubs and tree line to the site edges (*Refer to Photograph No. 01 & 02 – Appendix No. 01*).

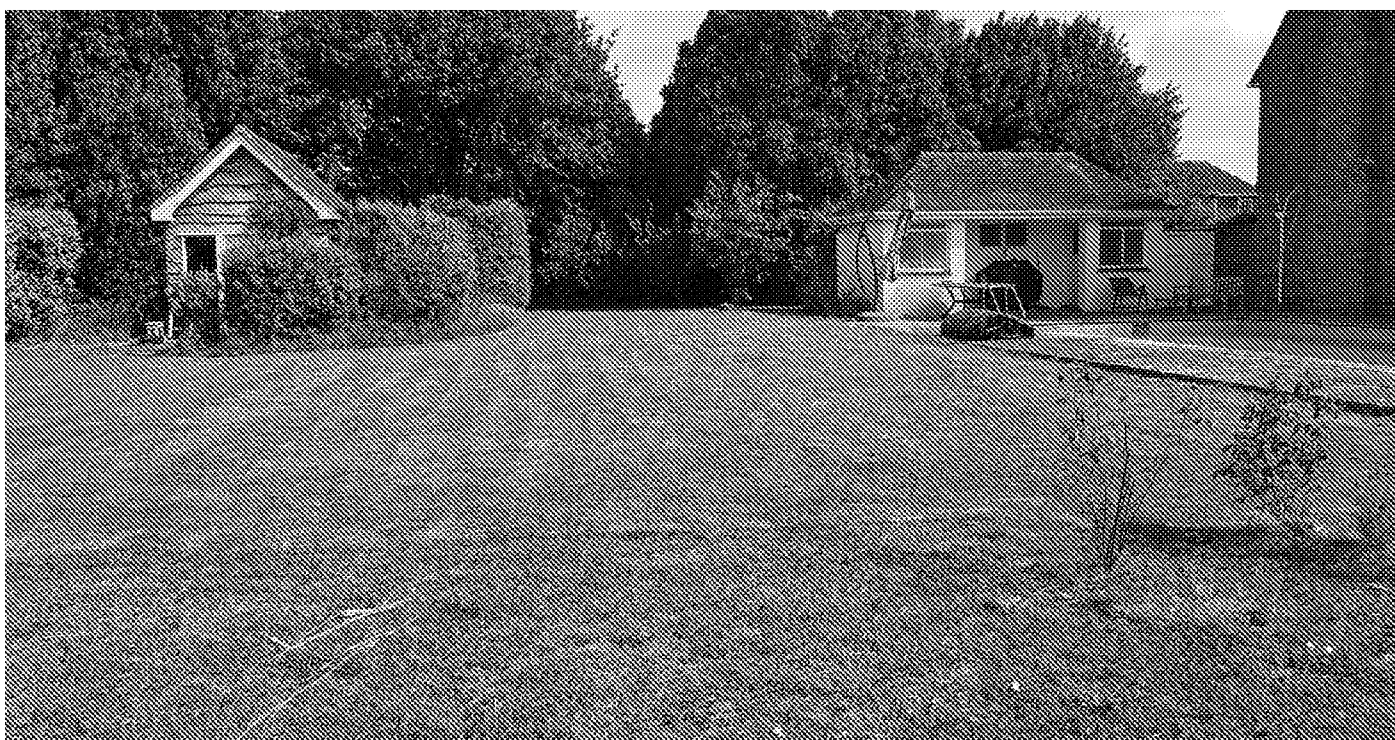
Photograph No. 2 - View across the development site to the north.

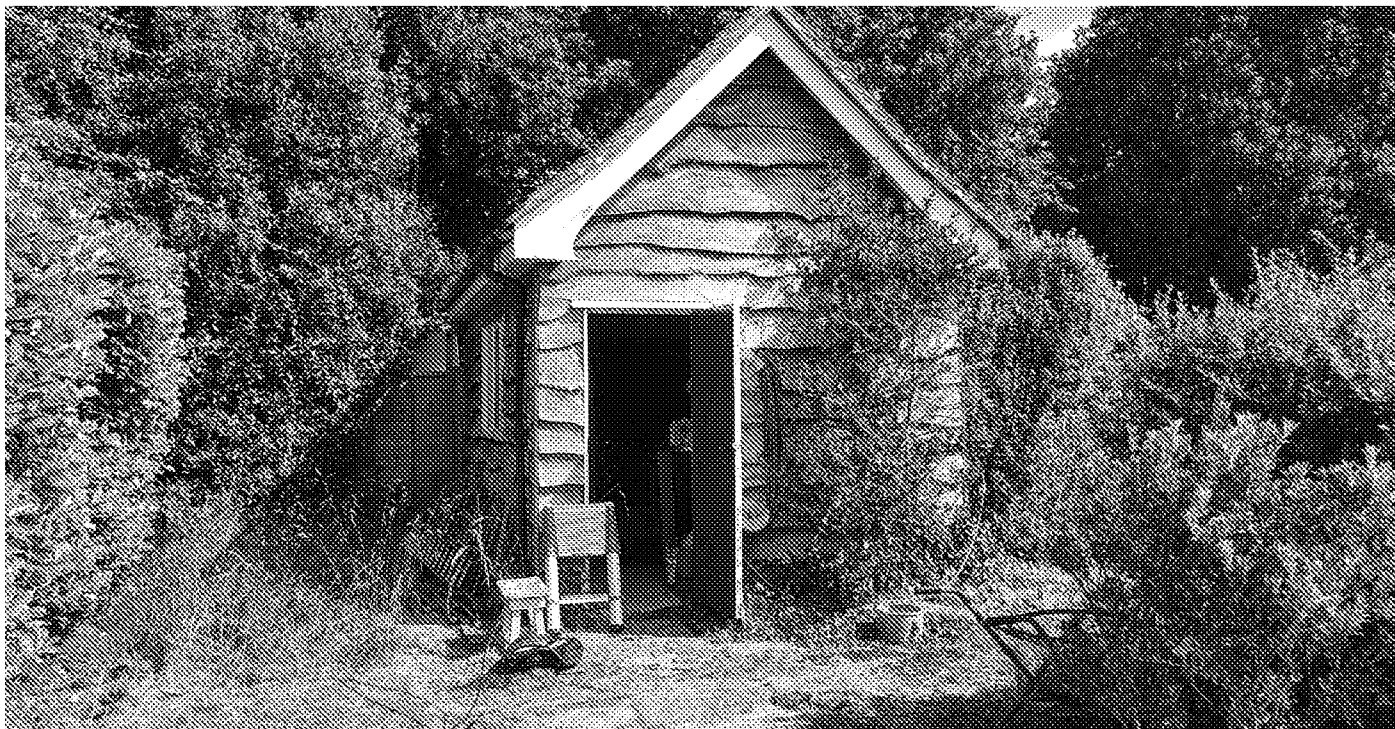
- 4.2.9 A single-storey detached garage (**Building No. 02**), clad in timber, is located towards the north-eastern corner of the site. Much of the cladding has lifted potentially allowing access beneath however these areas were inspected with an endoscope and found to show no evidence of bat usage such as smoothing of the wood or grease marking. No bat droppings were identified either stuck to the external walls of the building or the vegetation beneath.

- 4.2.10 The building has a clay tile roof, in poor condition, with many slipped / broken tiles present. Closer inspection of this area using ladders and a high-powered torch revealed that the majority of crevices were cobweb covered. The roof surface and guttering were examined for the presence of bat droppings, no evidence was located.

Photograph No. 3 - Building No. 02: No evidence of bats was recorded anywhere within this building.

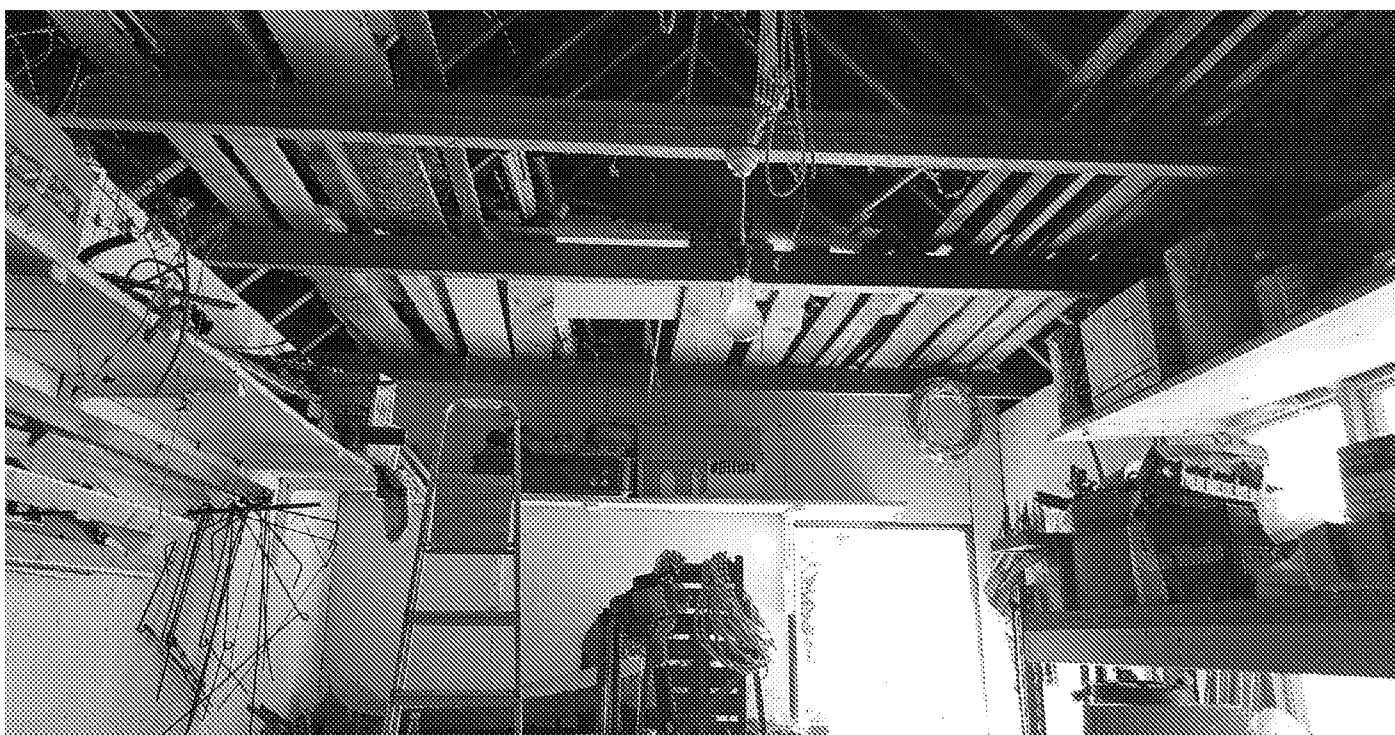
Photograph No. 4 - Internal view of Building No. 02: No evidence of bats was recorded anywhere within this building.

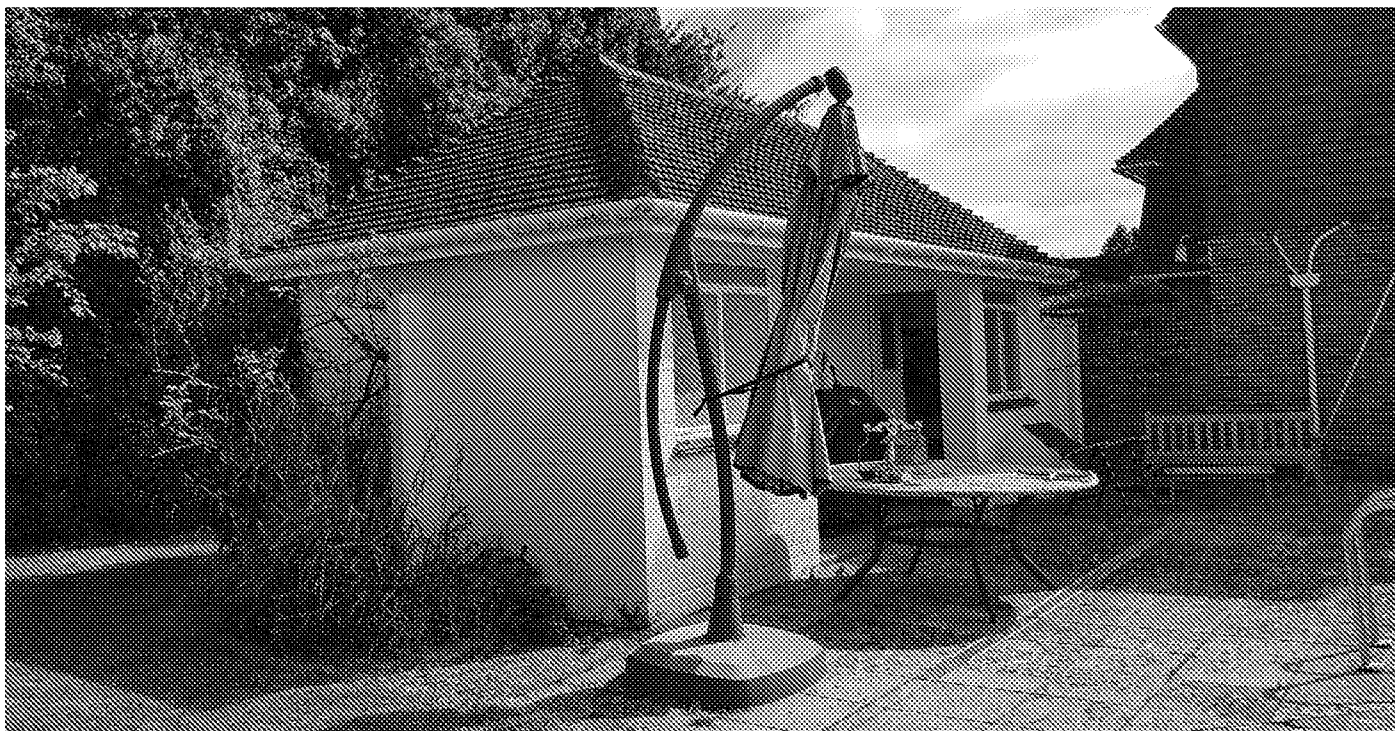
- 4.2.8 The pool house (**Building No. 01**) is of a single-storey brick construction with clay tile roof. The roof is in good condition with no areas of slipped or broken tiles noted. All window ledges and external walls were inspected for signs of bats; no evidence was noted.

Photograph No. 5 - External view of Building No. 01; the building is considered to offer 'negligible' bat roost suitability.

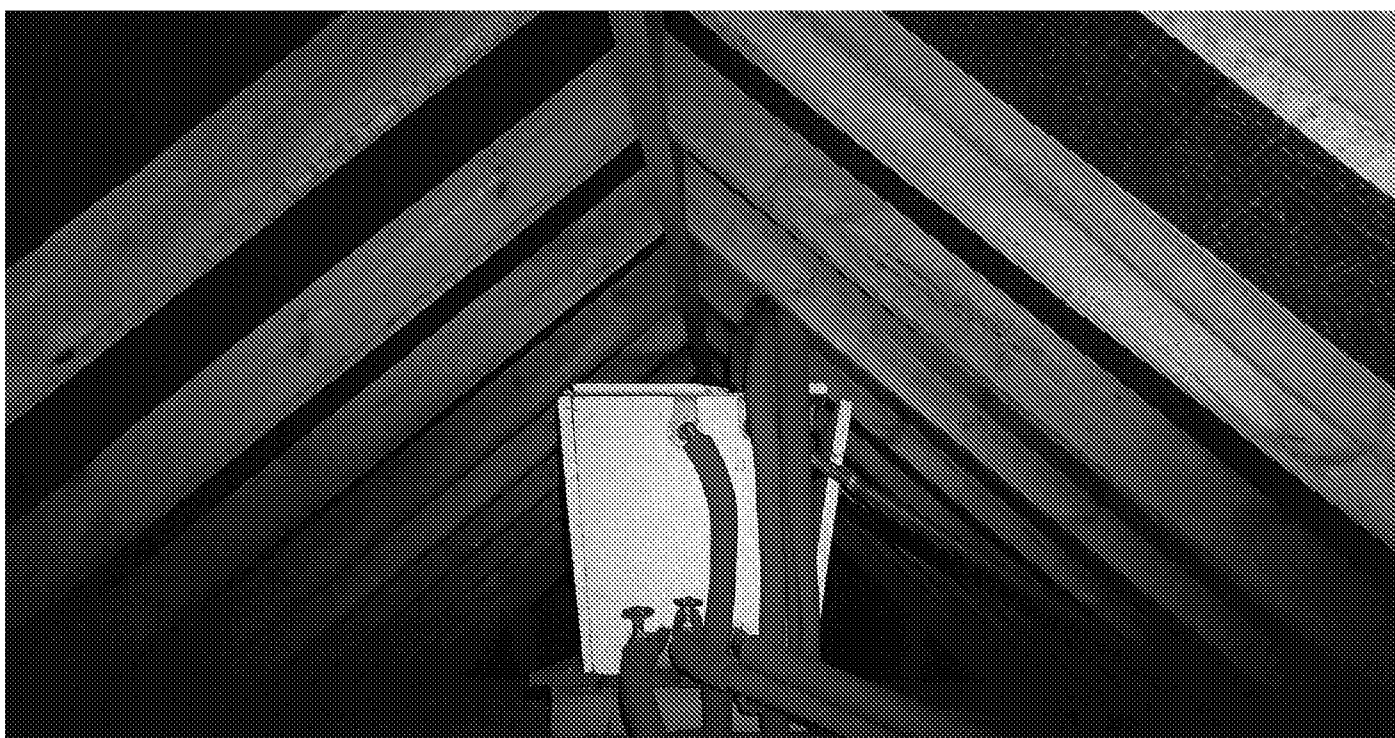
- 4.2.11 **Building No. 01** has a single loft space formed of roof trusses backed by bitumen roofing membrane. Height to the ridge was c. 1.2 metres with a small water tank to the centre of the void. No evidence of bats such as droppings, urine splashes or grease marks were noted within the roof void.
- 4.2.12 **Building No. 02** is utilised for storage and is light internally due to the presence of 2 no. windows. No evidence of bats was noted anywhere within the building.

Photograph No. 6 - Internal view of Building No. 01: No evidence of bat usage was recorded within this building.
