## **Bat Scoping Report**

**19 & 21 Nyewood Lane, Bognor Regis**

**24th October 2018**

**Project No: P2972**

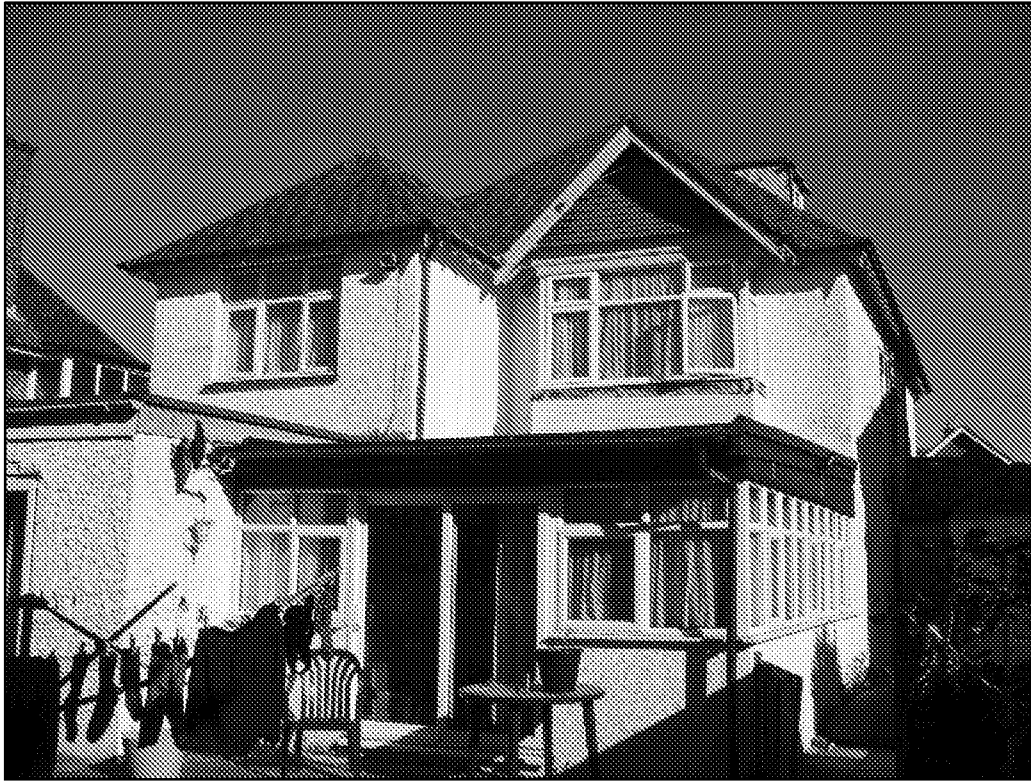
| Building Inspected | Description of features | Assessment of potential (Collins 2016) |
|---|---|---|
| Building A | <p>The building is constructed from rendered clay brick, with a complex multi-faceted clay tiled roof (Photo 1, Section 3.6). The roof was comprised of a combination of hipped and gabled styles, with dormer windows. Hanging tiles were present on the front and rear elevations. The windows were framed with wood. A single-storey, flat-roofed extension was present on the west side of the building. The roof covering on the extension was of bitumen.</p> <p>The interior of the building was found to have two discrete roof voids. V1 (Figure 2) was found to have an open wooden frame lined with bitumen roofing felt. Some tears to the lining were noted. Fibreglass insulation was present throughout. Two water tanks were present. No evidence of bats was found within V1.</p> <p>V2 (Figure 2) was of a similar construction to V1. V2 comprised a much larger space and encircled the inside of the lower part of the roof. Several tears were noted within the roof lining in V2 (Photo 2, Section 3.6). No</p> | Low bat roost potential |

**Photograph 1.** Showing the west elevation of Building A.

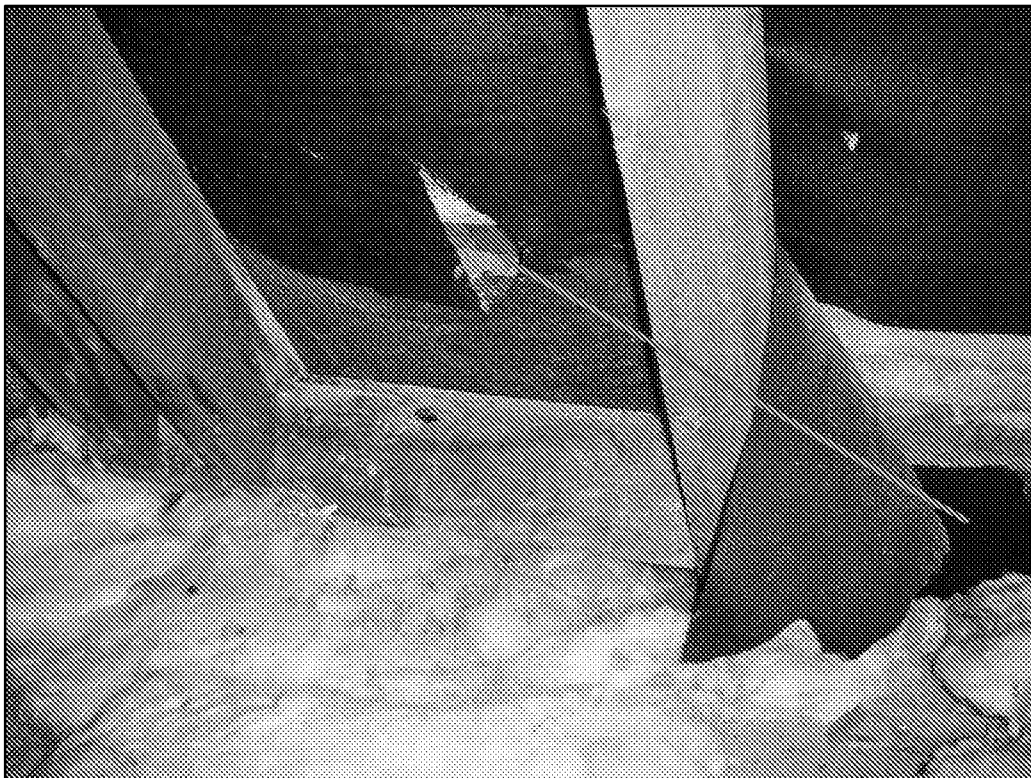
**Photograph 2.** Showing torn roof lining in V2.

During building works, care should be taken to avoid using breathable roofing membranes, such as 'Tyvec,' along with other modern types of bitumen felt that contain polypropylene filaments (for example type 5U), where any roof or hanging tiles with gaps may be used, as these can cause serious harm to bats through entanglement.

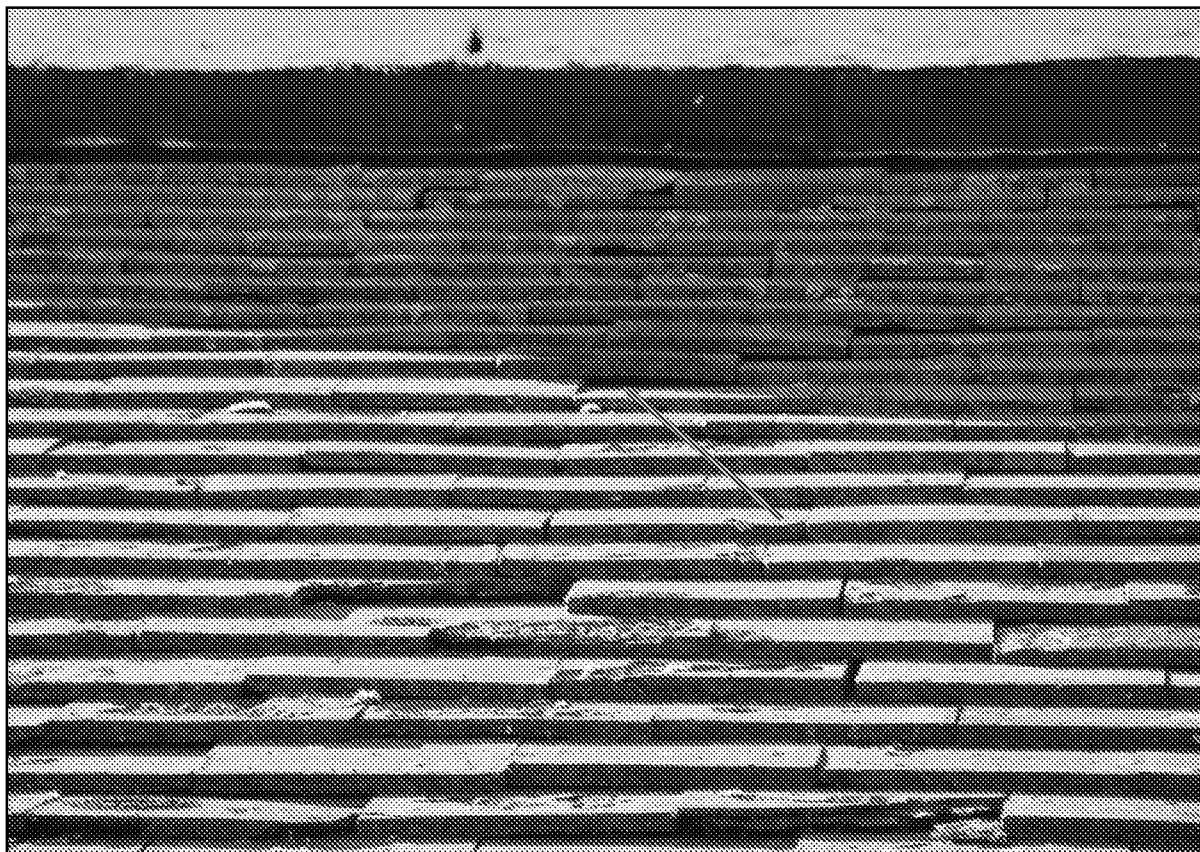
| Building Inspected | Description of features | Assessment of potential (Collins 2016) |
|---|---|---|
| | <p>evidence of bats was found within V2. Some bird dropping were noted within V2.</p> <p>Several PRFs were found during the external inspection of the building. These were mainly associated with missing and broken roof tiles (Photo 3, Section 3.6) and gaps behind hanging tiles (Photo 4, Section 3.6). There were notable gaps between the soffit box and the wall on the north elevation. A hole was present in the render between the window and the underside of the soffit on the north elevation (Photo 5, Section 3.6). No evidence of bats was found during the external inspection.</p> | |

**Photograph 3.** Showing gaps under missing, broken and lifted roof tiles on Building A.

In accordance with the Bat Conservation Trust guidelines, **the overall potential for Building A to support bats is rated as 'Low' and therefore, one bat emergence/re-entry survey is required to determine the importance of this building for bats.** To ensure adequate coverage of all potential roost features, it is estimated that **three observers will be required for the survey visit.**

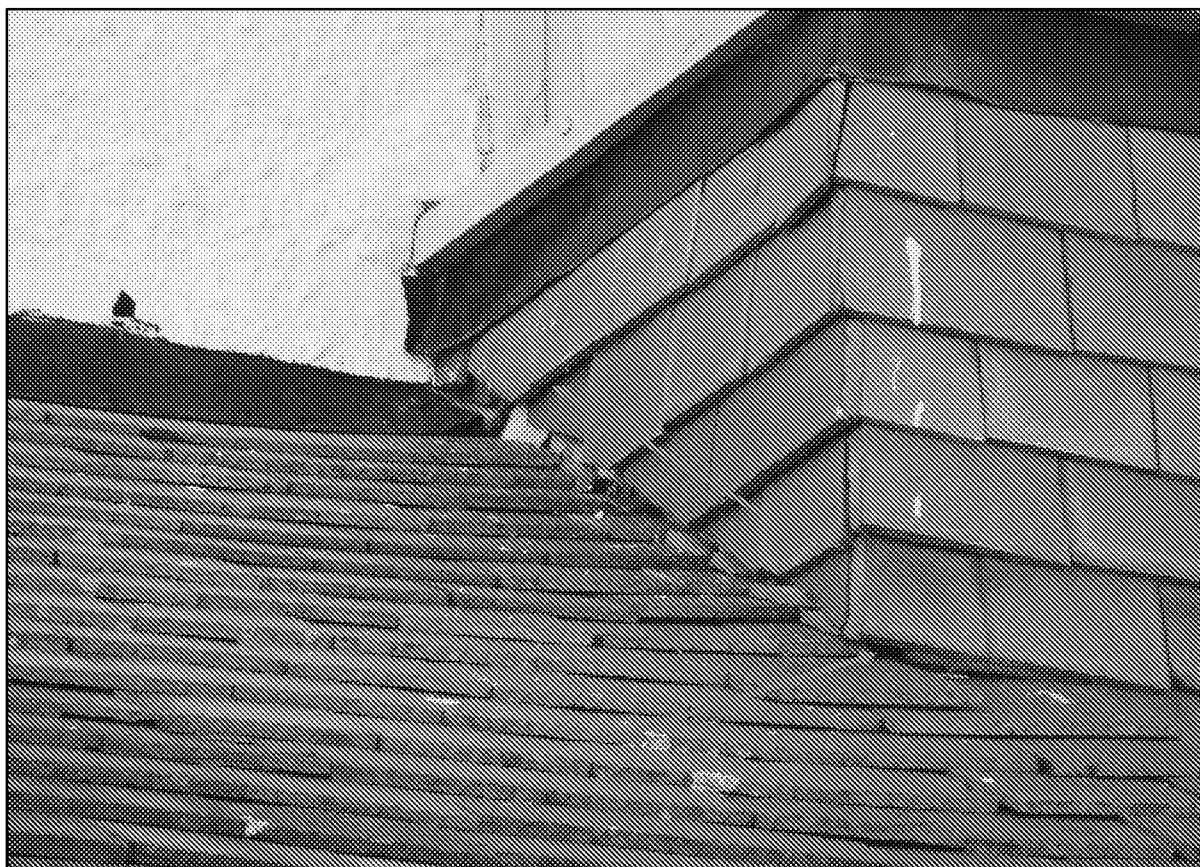
**Photograph 4.** Gaps associated with hanging tiles on Building A.

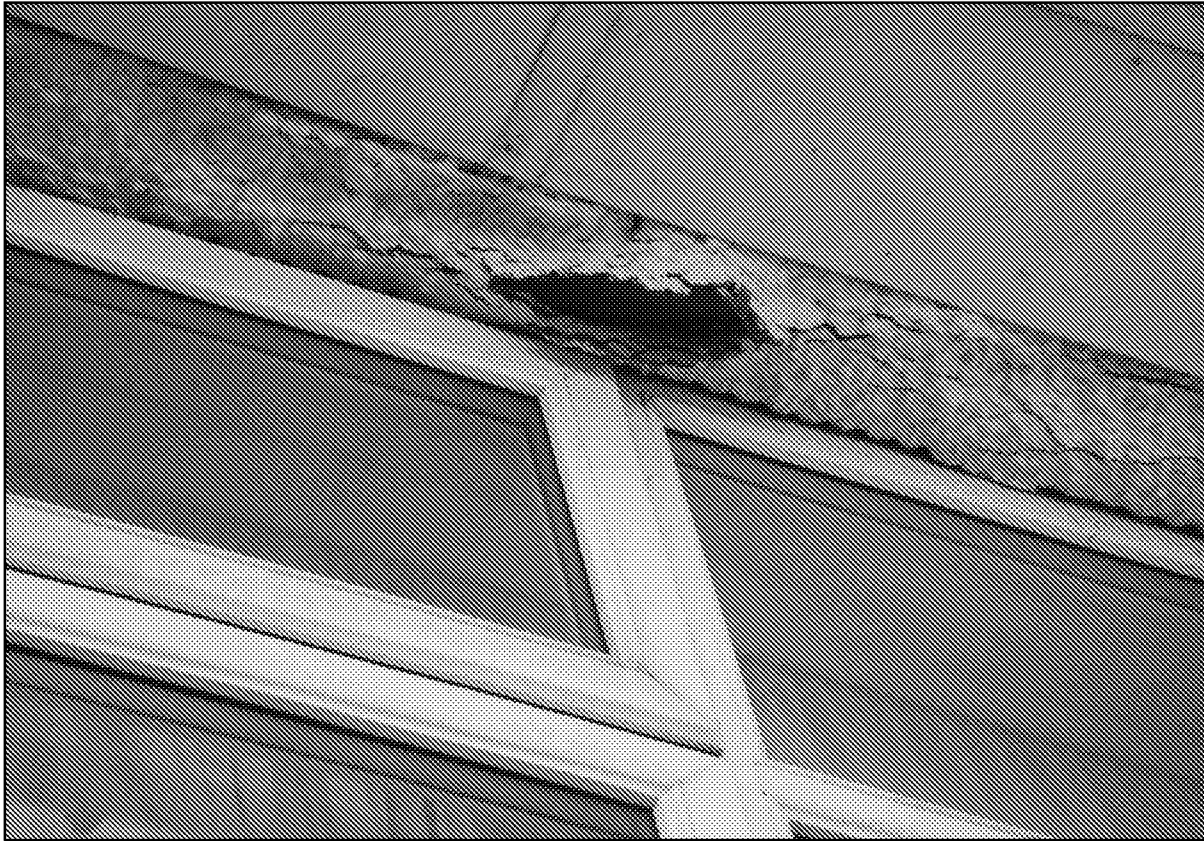
**Photograph 5.** Showing hole in render between wall and soffit on the north elevation of Building A.

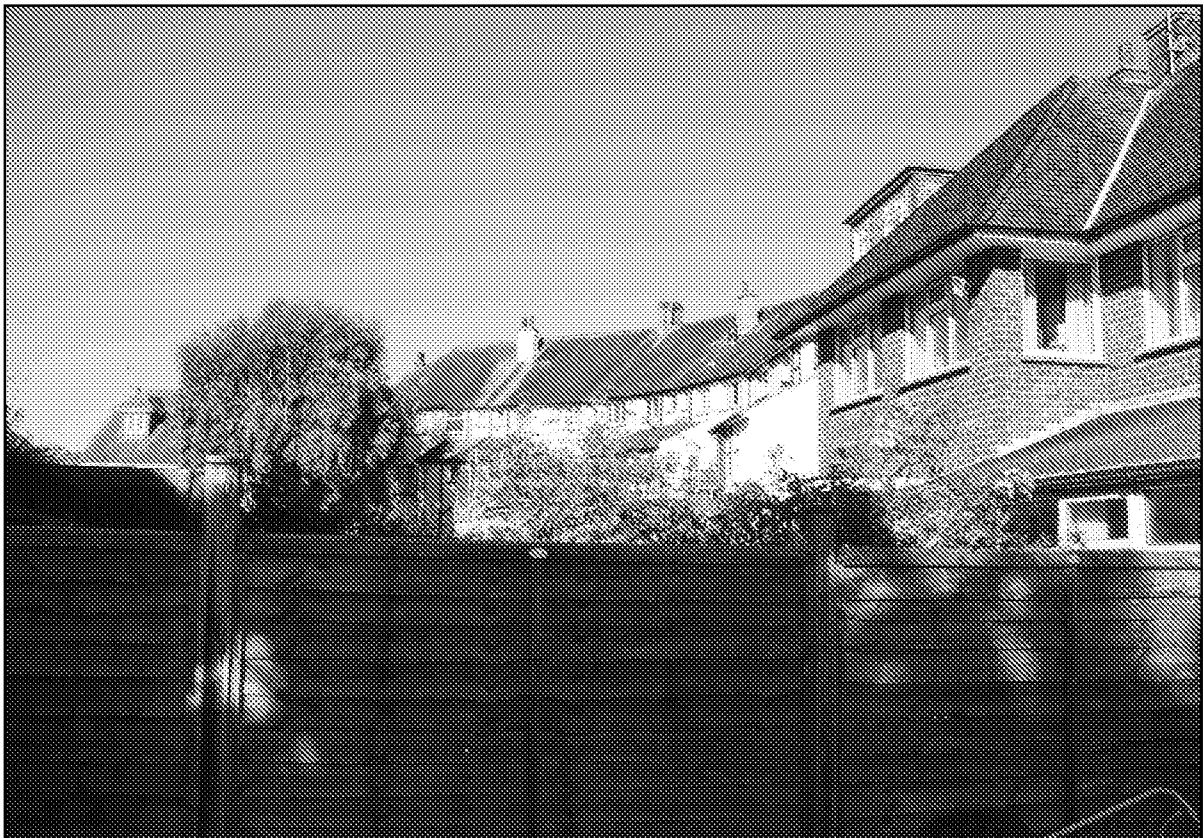
A lack of mature woodland, hedgerows and tree-lines within and surrounding the site (photo 6, Section 3.6), indicated that there was negligible potential within the site to support hazel dormice *Muscardinus avellanarius*. There were a few potential features in the building that might potentially accommodate house sparrow *Passer domesticus* and starling *Sturnus vulgaris*, which commonly nest in buildings. No evidence of active bird nests was found within the building.

**Photograph 6.** Looking north from the site, showing surrounding habitat.
