**FORMER SANDMARTINS CARE HOME
KINGS PARADE, BOGNOR REGIS
WEST SUSSEX PO21 2QY**

DISMANTLING & DEMOLITION
(Including the removal & disposal of all non-licensed ACM's)

SCOPE OF WORKS

ASBESTOS SURVEY REPORT

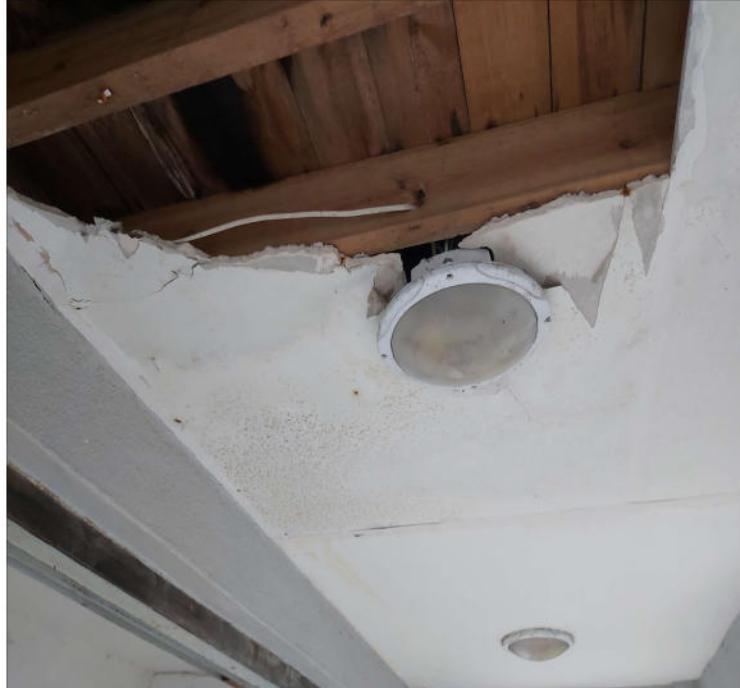
SAMPLED MATERIALS
SAMPLE NO 1
ENTRANCE PORCH CEILING– CEMENT BOARD

Sample 1	
Sample reference	SM1
Internal/external	EXTERNAL
Level	GROUND
Product description	CEMENT BOARD
Amount	7 SQ MTS
Accessibility	USUALLY ACCESSIBLE, LIKELY TO BE DISTURBED
Asbestos Type	NO ASBESTOS DETECTED

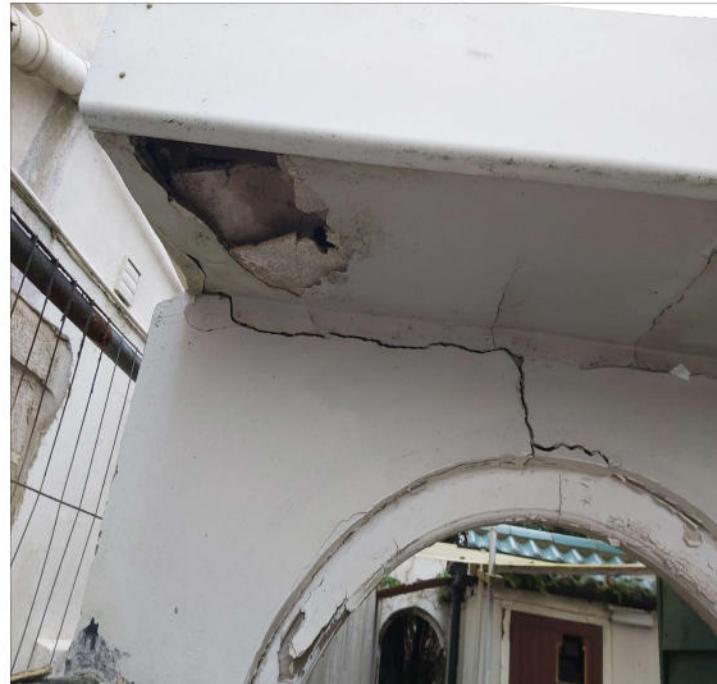
SAMPLED MATERIALS
SAMPLE NO 2
ROOF SOFFITS– CEMENT PANEL

Sample 2	
Sample reference	SM2
Internal/external	EXTERNAL
Level	GROUND / ROOF
Product description	CEMENT PANELS
Amount	25 SQ MTS
Accessibility	USUALLY ACCESSIBLE, LIKELY TO BE DISTURBED
Asbestos Type	NO ASBESTOS DETECTED

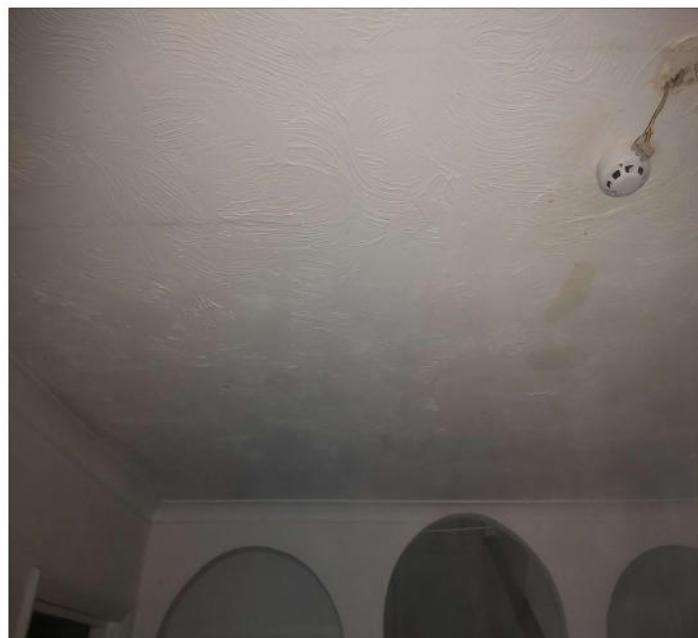
SAMPLE NO 3

HALL 7 GROUND FLOOR CEILINGS – TEXTURED CEILING

Sample 3	
Sample reference	SM3
Internal/external	INTERNAL
Level	GROUND
Product description	TEXTURED COVERING
Amount	25 SQ MTS
Accessibility	USUALLY ACCESSIBLE, LIKELY TO BE DISTURBED
Asbestos Type	NO ASBESTOS DETECTED

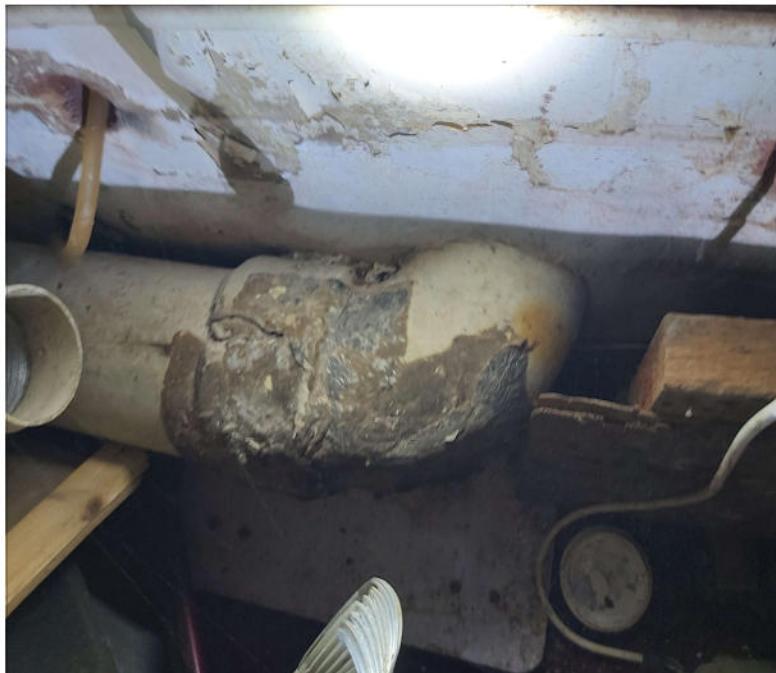
SAMPLED MATERIALS
SAMPLE NO 4
ELECTRIC CUPBOARD – CEMENT SOIL PIPE

Sample 4	
Sample reference	SM4
Internal/external	INTERNAL
Level	GROUND
Product description	CEMENT PIPE
Amount	2 MT RUN
Accessibility	USUALLY ACCESSIBLE, LIKELY TO BE DISTURBED
Asbestos Type	CHRYSOTILE

Sample Reference	SM4
Product type	1
Extent of damage/deterioration	3
Surface treatment	1
Asbestos type	1
TOTAL	6
LOW POTENTIAL TO RELEASE FIBRES

Sample Reference	Location	Material	Quantity
SM4	GROUND FLOOR ELECTRIC CUPBOARD	CEMENT SOIL PIPE	2 MT RUN
Date analysed	Asbestos Type	Material assessment	Action
14 FEBRUARY 2025	CHRYSOTILE	6	<i>REPAIR / MANAGE</i>

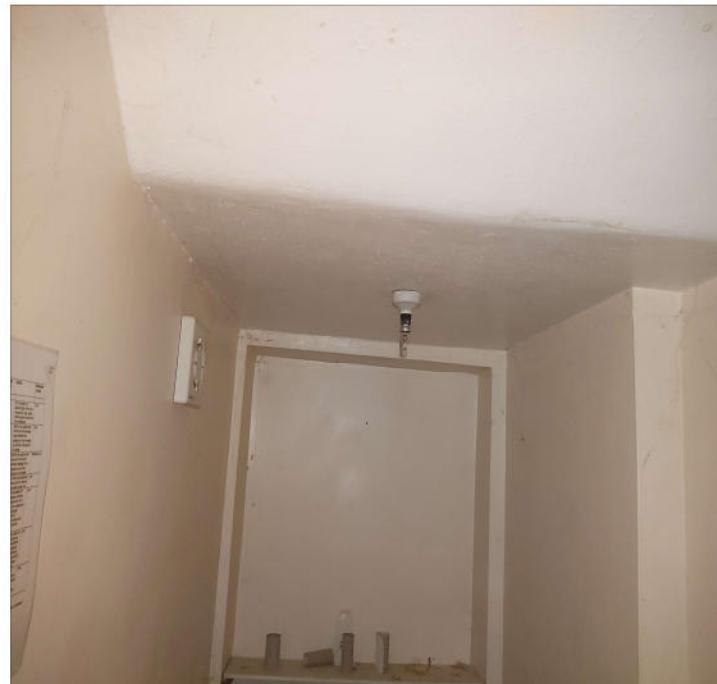
SAMPLED MATERIALS
SAMPLE NO 5
WC CEILING – TEXTURED COVERING

Sample 5	
Sample reference	SM5
Internal/external	INTERNAL
Level	GROUND
Product description	TEXTURED COVERING
Amount	4 SQ MTS
Accessibility	USUALLY ACCESSIBLE, LIKELY TO BE DISTURBED
Asbestos Type	CHRYSSOTILE

Sample Reference	SM5
Product type	1
Extent of damage/deterioration	3
Surface treatment	1
Asbestos type	1
TOTAL	6
LOW POTENTIAL TO RELEASE FIBRES

Sample Reference	Location	Material	Quantity
SM5	DOWNSTAIRS WC CEILING	TEXTURED COVERING	4 SQ MTS
Date analysed	Asbestos Type	Material assessment	Action
14 FEBRUARY 2025	CHRYSOTILE	6	<i>REPAIR / MANAGE</i>

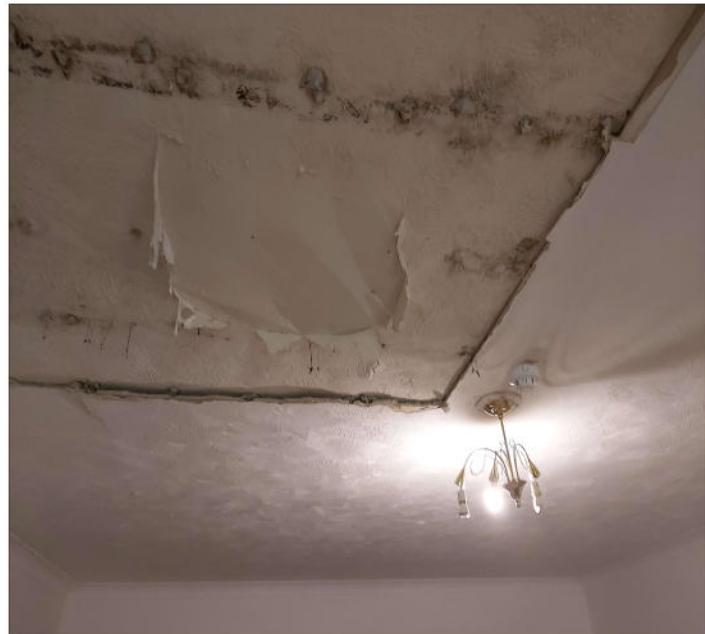
Sample 6

ORIGINAL LOUNGE CEILING – NOW OVERBOARDED -

TEXTURED COVERING

Sample reference	SM6
Internal/external	INTERNAL
Level	GROUND
Product description	TEXTURED COVERING
Amount	35 SQ MTS
Accessibility	USUALLY ACCESSIBLE, LIKELY TO BE DISTURBED
Asbestos Type	CHRYSSOTILE

Sample Reference	SM6
Product type	1
Extent of damage/deterioration	3
Surface treatment	1
Asbestos type	1
TOTAL	6
LOW POTENTIAL TO RELEASE FIBRES

Sample Reference	Location	Material	Quantity
SM6	DOWNSTAIRS LOUNGE ORIGINAL CEILING – NOW OVERBOARDED	TEXTURED COVERING	35 SQ MTS
Date analysed	Asbestos Type	Material assessment	Action
14 FEBRUARY 2025	CHRYSOTILE	6	<i>REPAIR / MANAGE</i>

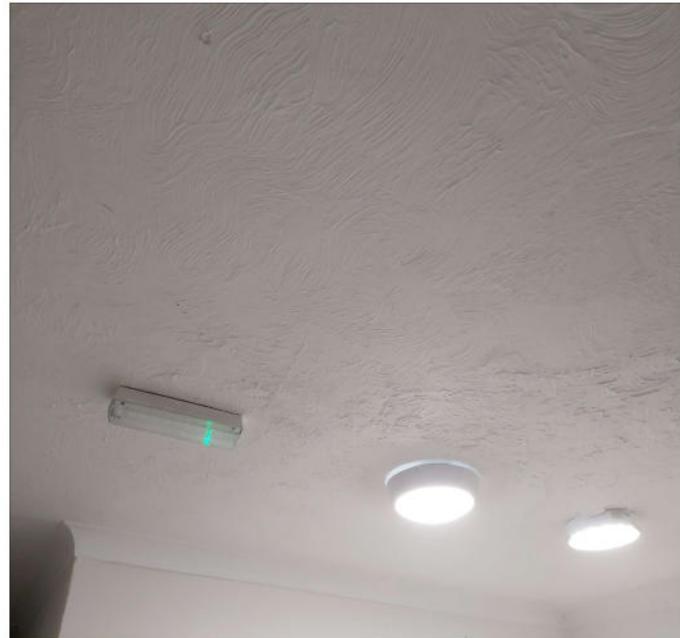
SAMPLED MATERIALS
SAMPLE NO 7
FIRST FLOOR CEILINGS - TEXTURED COVERING

Sample 7	
Sample reference	SM7
Internal/external	INTERNAL
Level	FIRST
Product description	TEXTURED COVERING
Amount	THROUGHOUT
Accessibility	USUALLY ACCESSIBLE, LIKELY TO BE DISTURBED
Asbestos Type	NO ASBESTOS DETECTED
