The development SoWL, which proposes introducing a roundabout and clear span bridge, fails to meet **Arun Local Plan Policy W DM2 Flood Risk** criteria **b), d) and f) .**

The applicant does not satisfactorily demonstrate that introduction of the clear span bridge and roundabout to the north of the site will not increase flood risk elsewhere, or if potential mitigation or exceedance measures, such as creating temporary storage, areas may be needed.

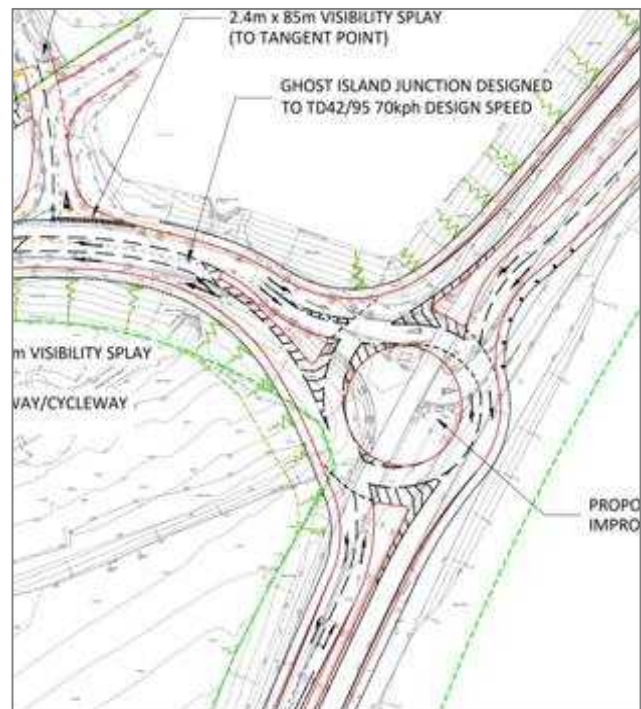
Fig 1. Extract from the plan submitted with A/110/20/RES

**THE ROUNDABOUT:** Fig 1 shows the new embankments (green squiggles) required to accommodate the new roundabout will result in loss of storage capacity to both the Black Ditch flood plain south of Water Lane, and the Surface Water Balancing Pond to the north. See Appendix A.

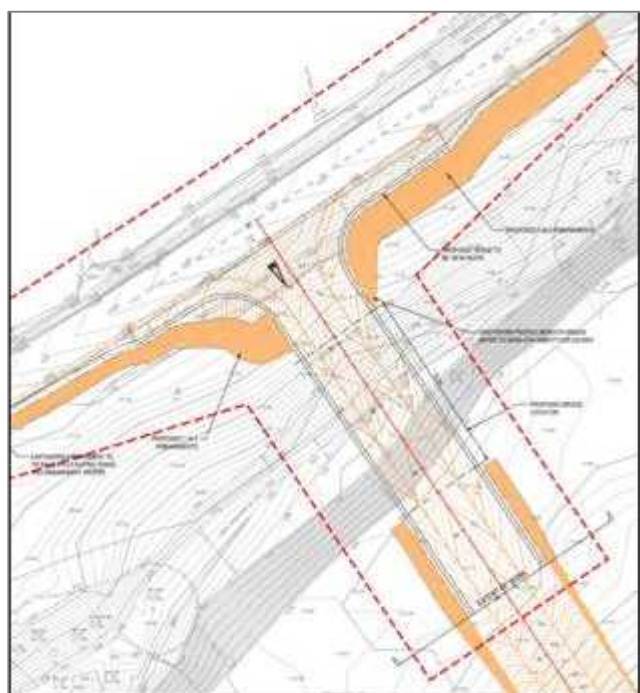
Fig 2. Extract from Bridge Contour Plan submitted with A/40/18/OUT

**THE CLEAR SPAN BRIDGE:** Fig 2 shows the proposed earth embankments WILL ALSO encroach into the Black Ditch flood plain south of Water Lane, further reducing it's capacity. The modelling done by EVA is used to demonstrate the bridge meets the 600mm clearance required by the EA. The Applicant seems to have achieved this.

The **Stantec Technical Note** point 6 considers the encroachment *"will only reduce flood plain storage by a small amount."*

It is not clear however, what the cumulative impact of the loss of flood storage capacity is, what a "small" reduction to flood plain storage equates to, or if any compensation measures or mitigation may be required, regardless of the type of bridge design.

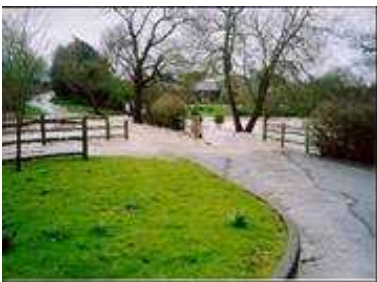
Avenals Farm pond overflows as the flow exceeds the capacity of the culvert under the access road

The Avenal's Farm picture also shows additional water flowing in through the access, as water that has run off the fields to the north and down Water Lane finds its level.

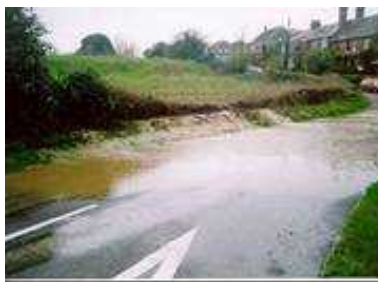
Water pours onto the road from Avenals Pond (left) and the SoWL site

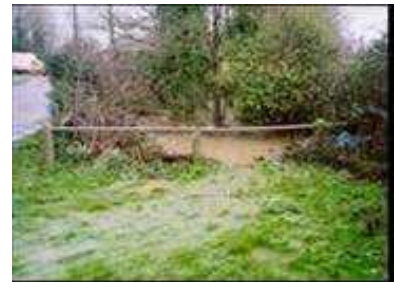
Entrance to Weavers Hill culvert overflowing onto Water Lane

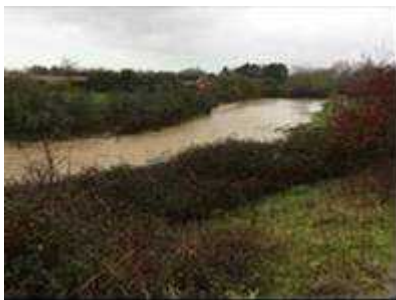
5<sup>th</sup> March 2020 (13:06)

Comparing the flood profile at the northern edge of the bank against the contours in the various Plans provided, it appears that natural winter water levels frequently spread out across the shallow basin to reach 11m+ above sea level (AOD). See Appendix C .

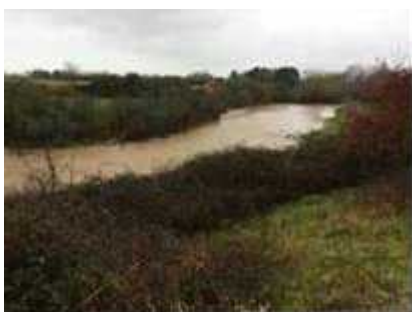
Black Ditch flood plain (13:06)

**The Black Ditch Culvert (Weavers Hill):** Images from 5<sup>th</sup> March 2020 show the water level at the "Weavers Hill" culvert captured by the EA Webcam, as well as the Black Ditch catchment water levels have been forwarded to WSCC. No flooding resulted from this rainfall event.

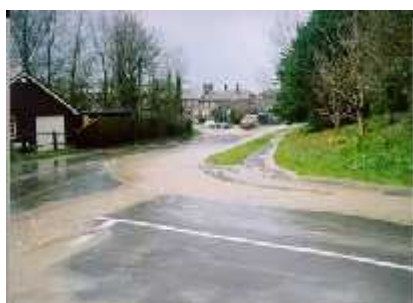
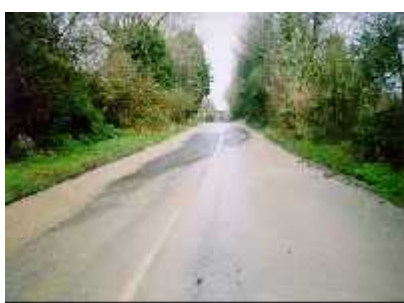
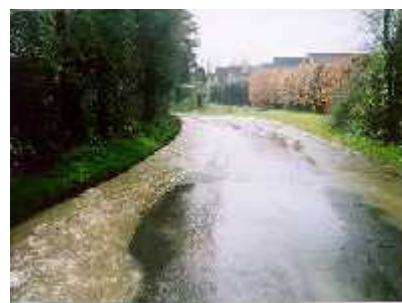
Water flows along Water Lane and is joined by flows (top) from Weavers Hill and (right) from Dappers Lane

Water flowing south down Dappers Lane.

Any Climate Change hydrological modelling needs to take this site into consideration as well as the third **strategic site at Dappers Lane**. Many photographs exist that show water flowing down the southern part of Dappers Lane reach the Black Ditch, if and when it can. These include the following taken on 18<sup>th</sup> March 2002.

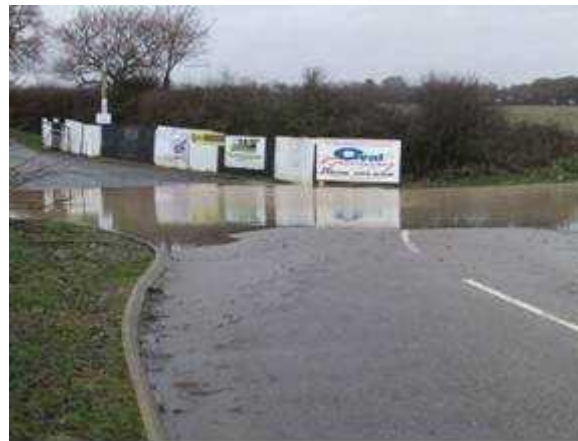
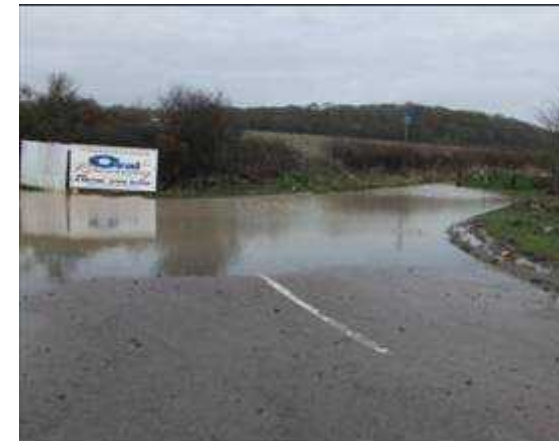
**Photos taken 14 Feb 2014** at 16:07 and 16:08 at the entrance to the Oval Raceway show flooding from the land north of Water Lane and the upper Black Ditch . On the far right hand side of the 2<sup>nd</sup> photo (taken a few minutes later) you can just make out the Pond is level with the road. With nowhere else to go water continues to collect as can be measured by the road markings.

In periods of heavy rainfall (as shown in the above photos) the area floods across the entrance to the Oval Raceway.

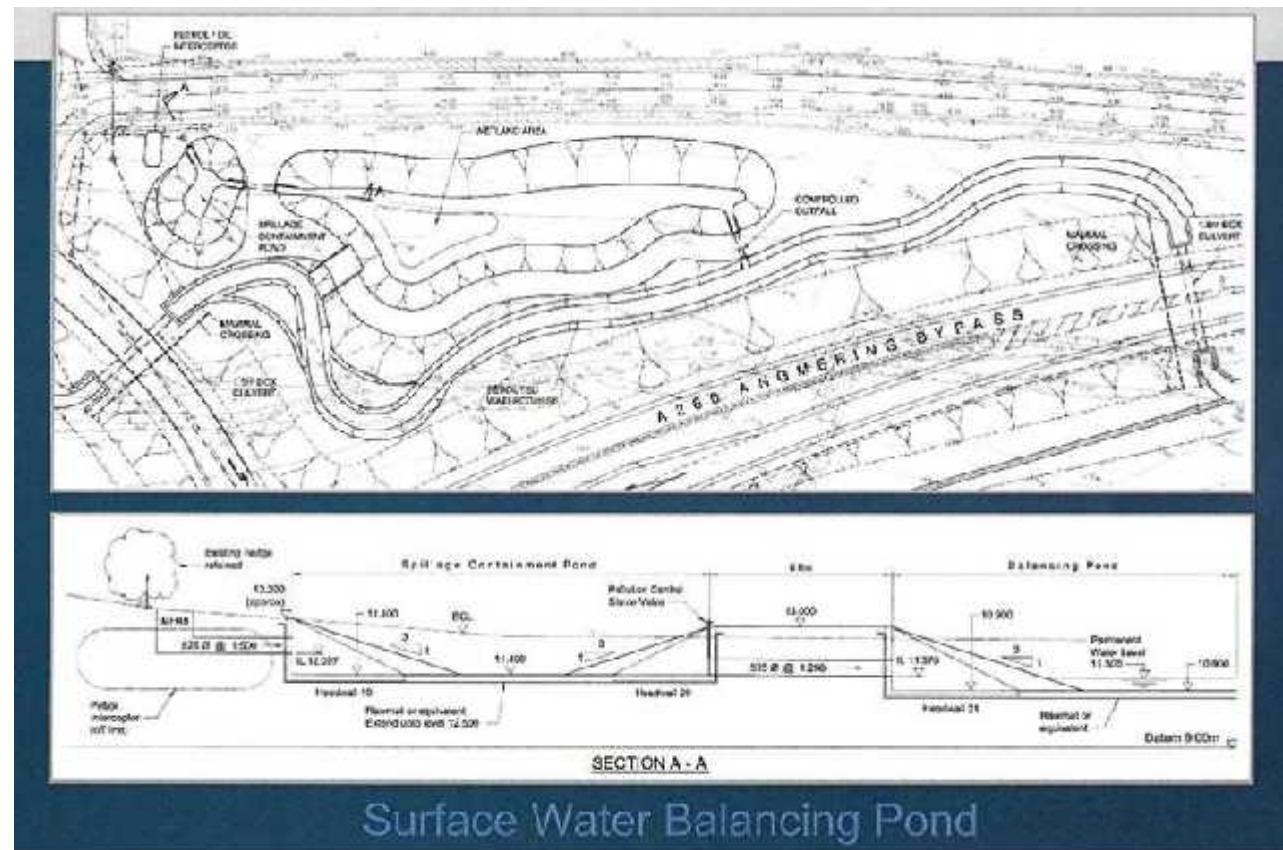
The following slide is from the Peter Brett Associates presentation for the Roundstone Lane (Bramley Green) drainage solution. It gives technical details, contour heights etc of the proposed upstream Surface Water Balancing Pond at the junction of the Angmering A280 bypass and Water Lane. Labelled as a “balancing pond”, the diverted Black Ditch can be seen running through from right to left.

The run off from the Oval Raceway and to the fields north of Water Lane enter top right, as well as some drainage from the highway.

It passes first through the petrol / oil interceptor. This operates just like a road gully so oil sits on the top and petrol sits there and evaporates. It then flows into a spillage containment pond. If a tanker overturned and spillage went into the road drainage system, an outlet valve on the pond would be closed with the hope it could be recovered because of damage it could cause.

The Wetland Area is environmental. It also cleans up what comes in and exits through the controlled outfall to the Black Ditch. If that is overwhelmed, it appears to exit through a spillway on the south west of the Wetland Area.

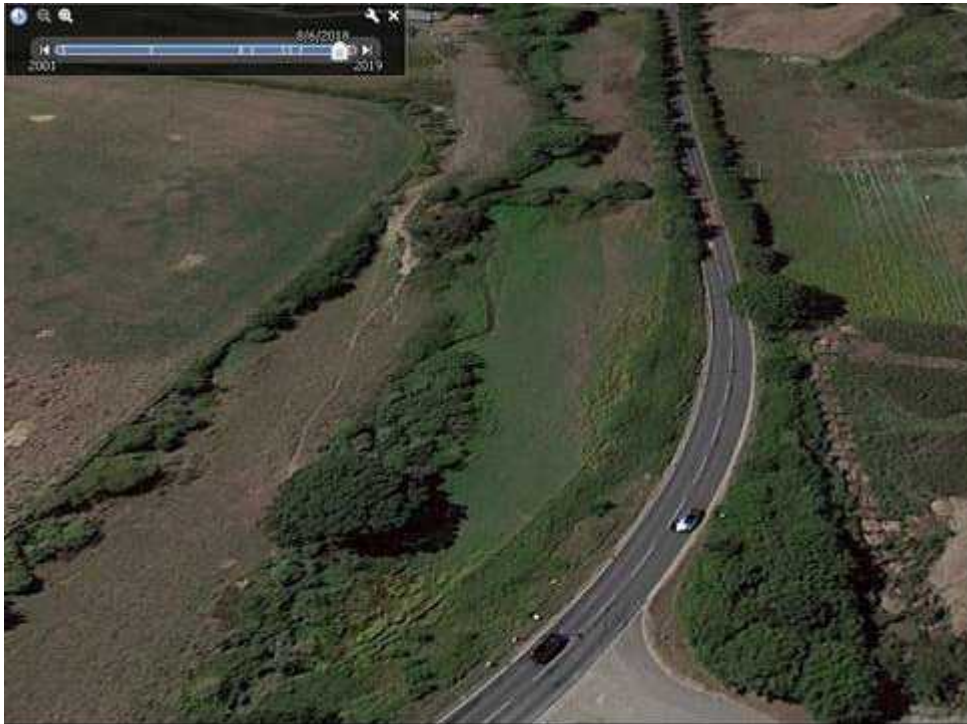
**Black Ditch Floodplain:** Google Earth 6 Aug 2018 looking West

Comparing the images left to actual photographic evidence (below) suggests normal winter water levels reach to the bottom of the bank below the fence line at the north east corner of the site, somewhere between the 11m and 11.5m AOD marks.

The contour of the water line and topography of the site suggests the water level was slightly higher than the 11m AOD, which dips away sharply from the bank at this point. This can be seen more clearly on the next page.

The direction the 1<sup>st</sup> and 2<sup>nd</sup> photos were taken from can be judged by the shadow of the sign post in front of the black car on the satellite image above. The 3rd picture would have been taken roughly opposite the silver car.

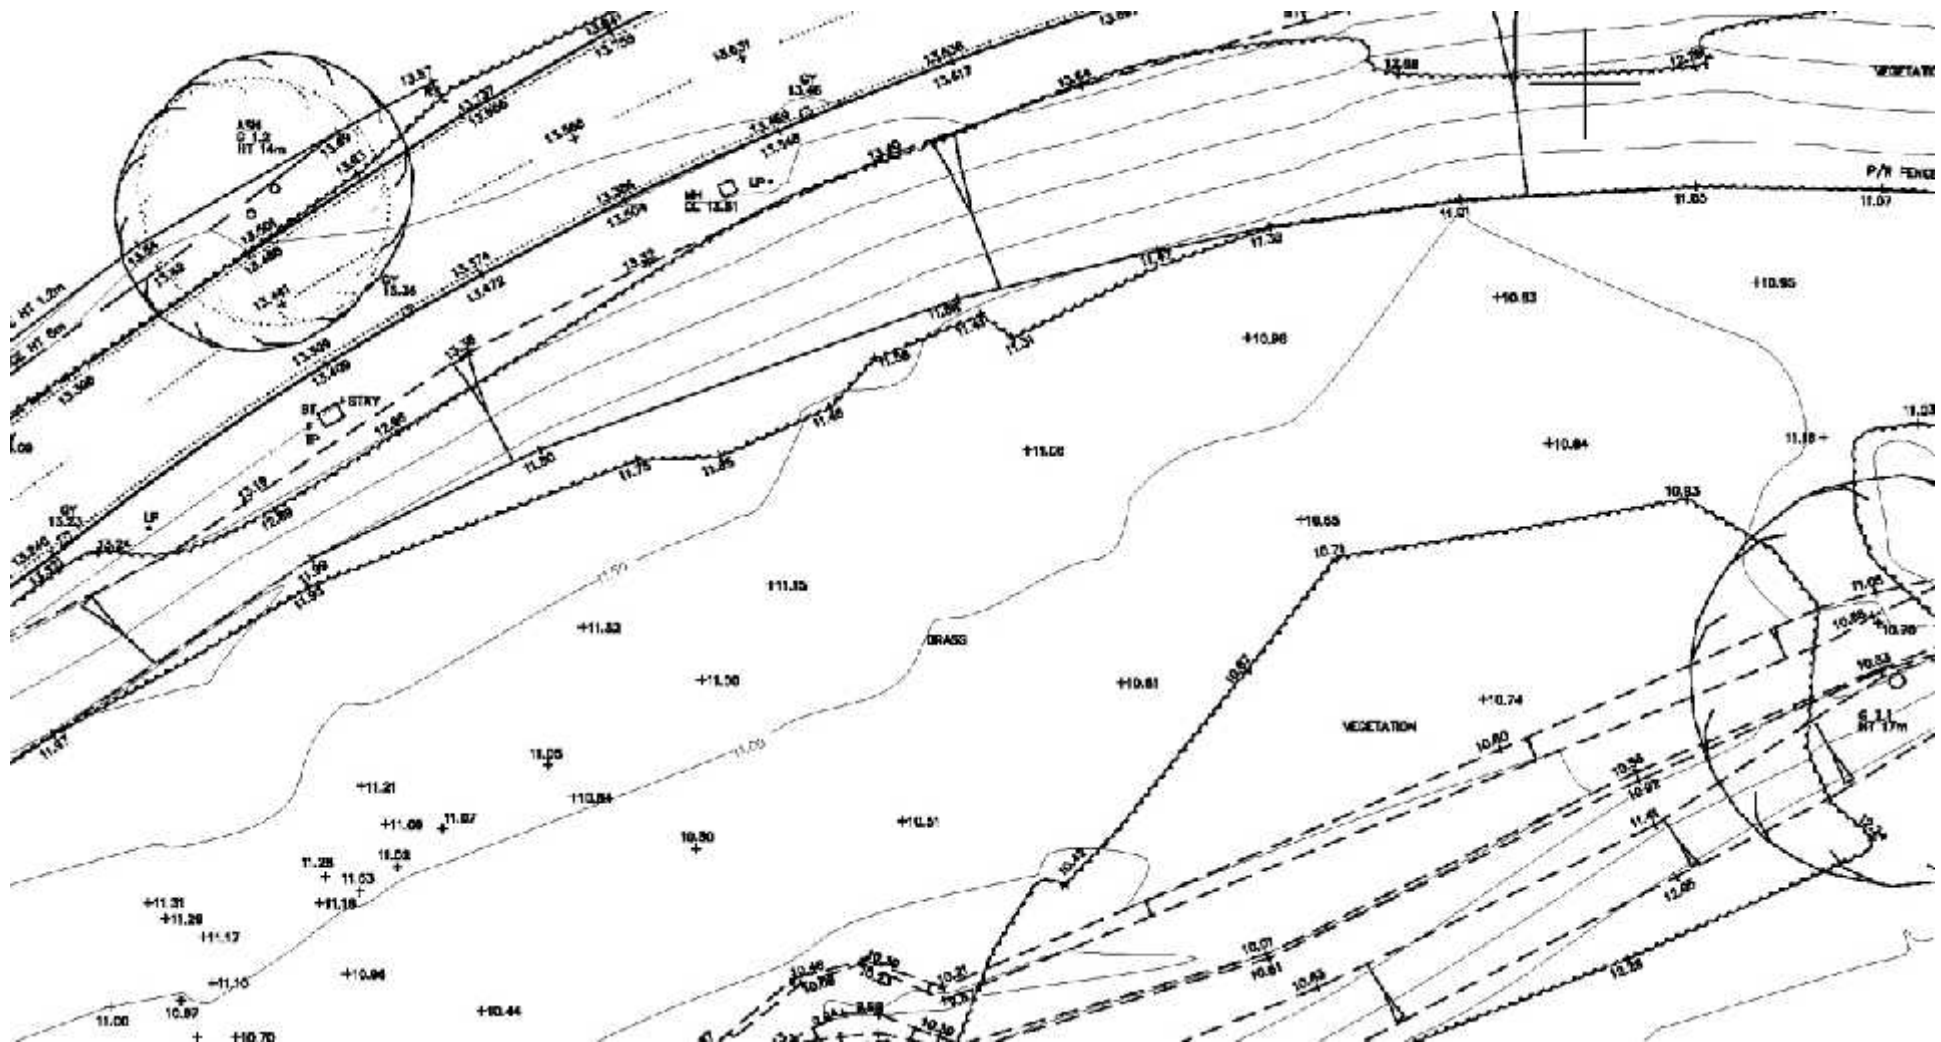
You can see the contour heights more clearly in the extract from the “mksurveys Topographical Survey 2015” on P47 of the A/99/17/OUT idom Merebrook FRA May 2017:, which overlays the traditional contour map with the more accurate Lidar (satellite) data that pinpoints and records elevations on the earths surface. The 11.5m AOD line mirrors almost exactly regular winter water levels.

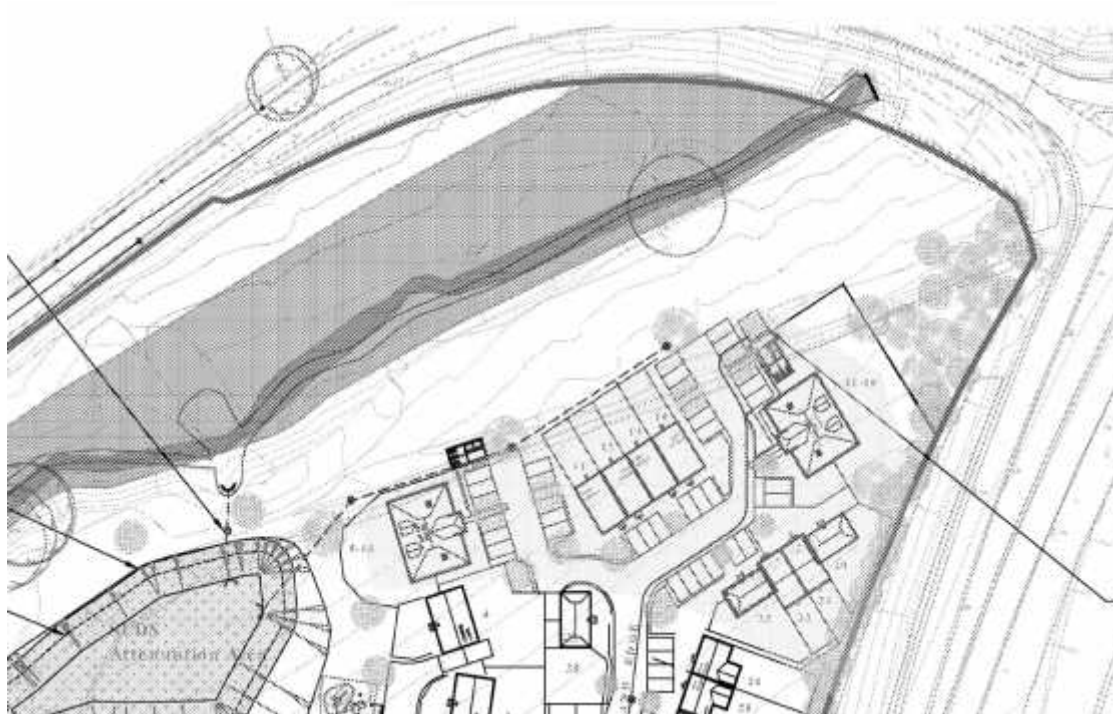
In this extract from Dwg Sth-301-001, dated Aug 2016 on page 86 of the FRA, the shaded area shows the *“1000 year (0.1 AEP) flood risk envelope. 2010 Infoworks fluvial levels supplied by EA superimposed on detailed topographic survey.”*

It looks suspiciously like the regular winter water levels experienced now, that show Angmering appears to be at risk from a 1 in 5 to 1 in 10 year flood event and casts severe doubts on the integrity of the FRA.
