# **Outbuildings at Decoy Cottage, Decoy Lane, Poling, W.Sussex. BN18 9QA.**

## **Phase 1 Daytime Bat Assessment**

**January 2022**

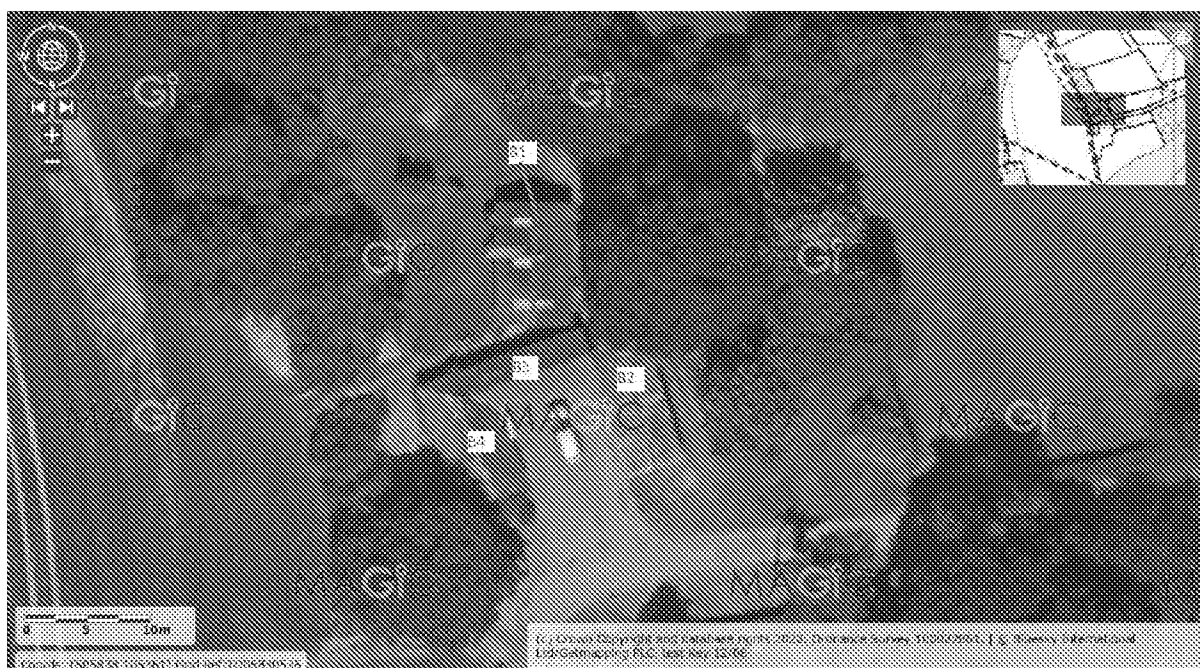
**Figure 3:** Building locations. B1 is a brick and mortar barn, B2 is a wooden stable and tack-room, B3 is a wood and concrete stable storage unit and B4 is a brick and mortar garage / workshop.

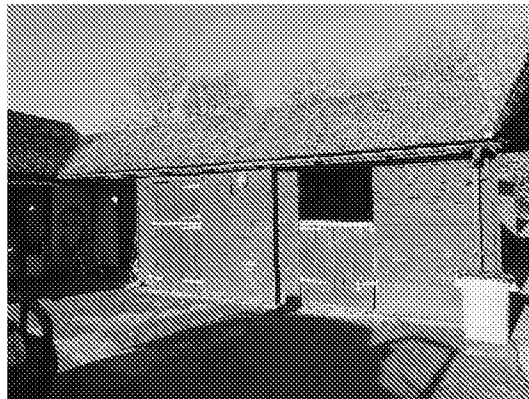
**Building 3:** Single storey, concrete and wooden shiplap clad ancillary storage area for stables (e.g. hay & feed etc). Roof covering is of corrugated concrete asbestos sheets. No internal evidence of bats having accessed the building and no external roosting opportunities detected. Links to B4.

**Figure 9.** Showing shiplap clad front of Building 3.
