# **Ecological Impact Assessment with Phase 2 Bat Survey Work**

Former BMW Garage, Water Lane, Angmering,  
Littlehampton BN16 4EH

August 2021

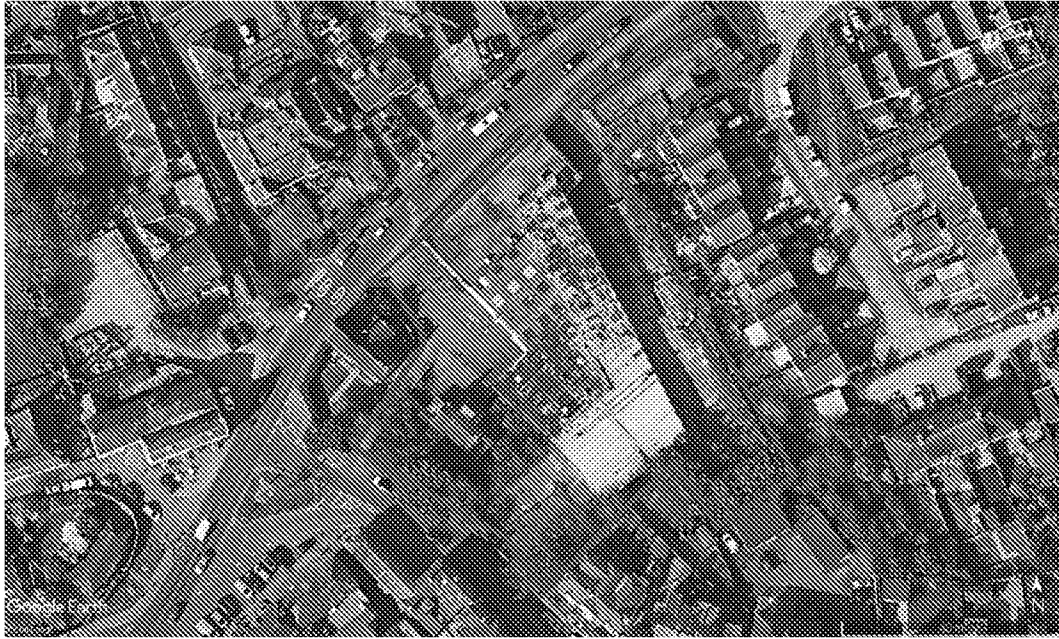
The site is approximately 0.44 hectares and is located within the centre of Angmering. The site is surrounded by residential buildings. The derelict site consists of motor vehicle showrooms, workshops, offices, an outbuilding, a courtyard with a large carport with brick pillars and a small derelict cottage (figure 1).

Figure 1. Aerial view of the site, the approximate site area outlined in red (aerial image Copyright Google Earth).

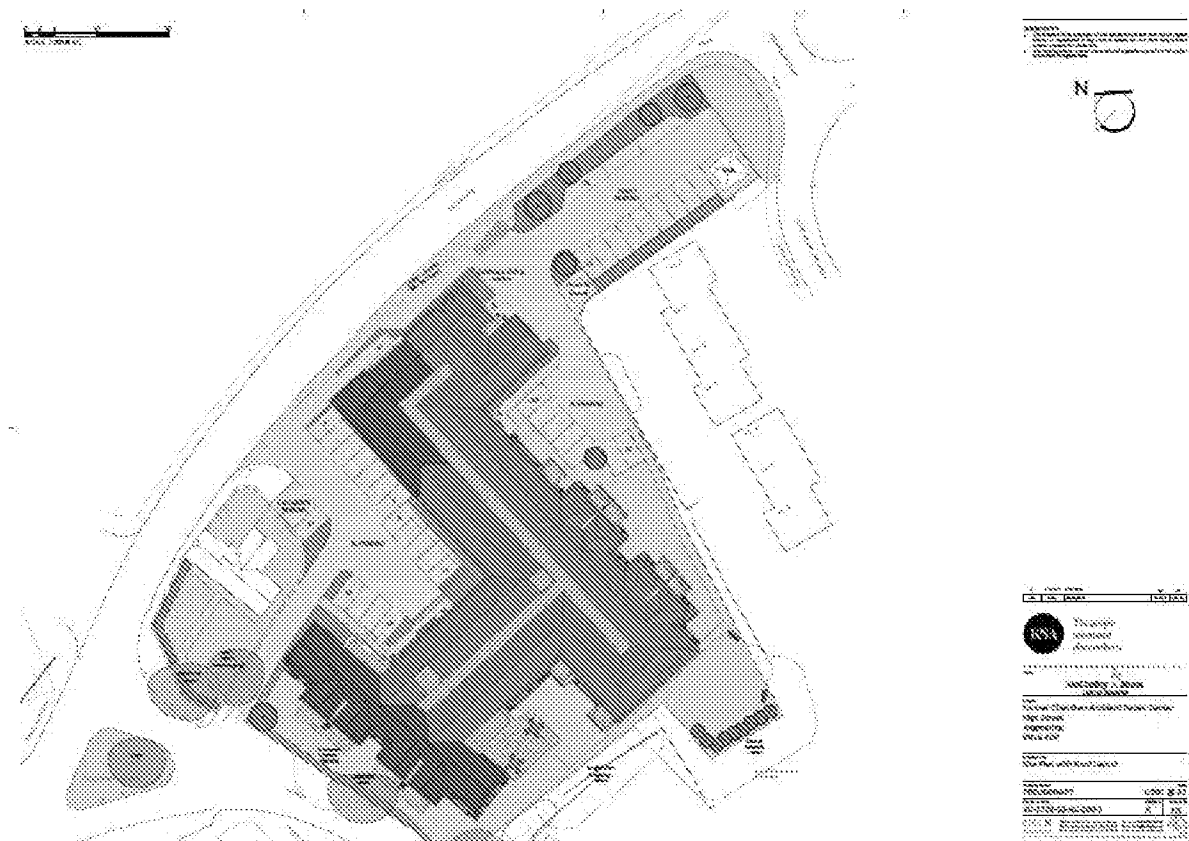
The current proposal involves demolishing all the buildings/structures on the site to develop 33 retirement living apartments and associated parking (figure 2).

Figure 2. Proposed development plan (Copyright KSA Architects Limited).

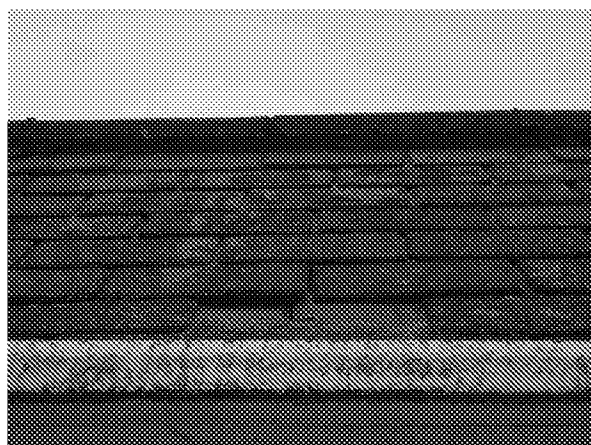
- All the buildings within the site were assessed for any bat roosting potential. The showroom, offices and workshop buildings were very unfavourable for roosting bats and had a complete absence of potential bat roosting points, as there were no loft spaces, no roof tiles and no holes noted on the soffits. However, the large carport had slate roof tiles which were loose or missing in areas and the ridge tiles had areas of mortar missing, these features created potential roosts for crevice dwelling bats (photo 1, 2 & 3). The cottage was in poor condition and has been unoccupied for some time. The loft space within the cottage had no evidence of bat activity but loose areas of bituminous lining were noted. This had the potential to allow access from outside. There were several gaps present under the clay roof tiles and hanging tiles on the rear dormer window of the cottage, that had bat roosting potential (photo 4, 5 & 6).

Photo 2: The missing roof tiles on the carport.

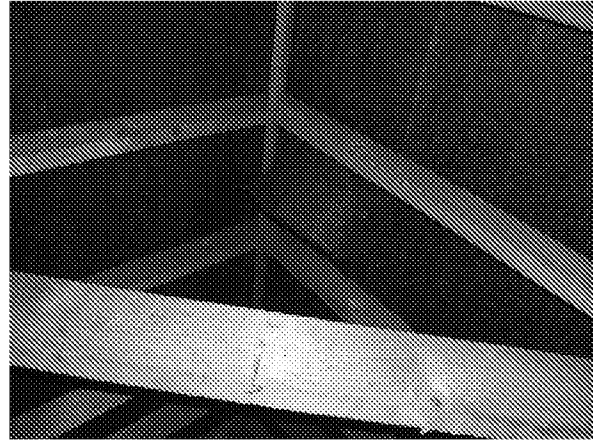
Photo 4: The loose bituminous lining in the loft of the cottage.

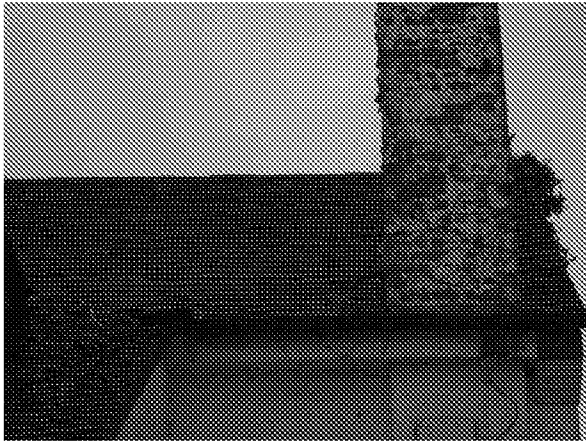
Photo 5: The cottage with gaps under the tiles.

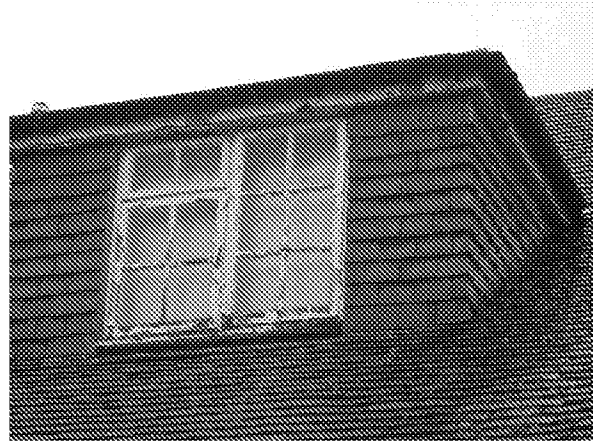
Photo 6: The dormer window on the cottage with loose hanging tiles.

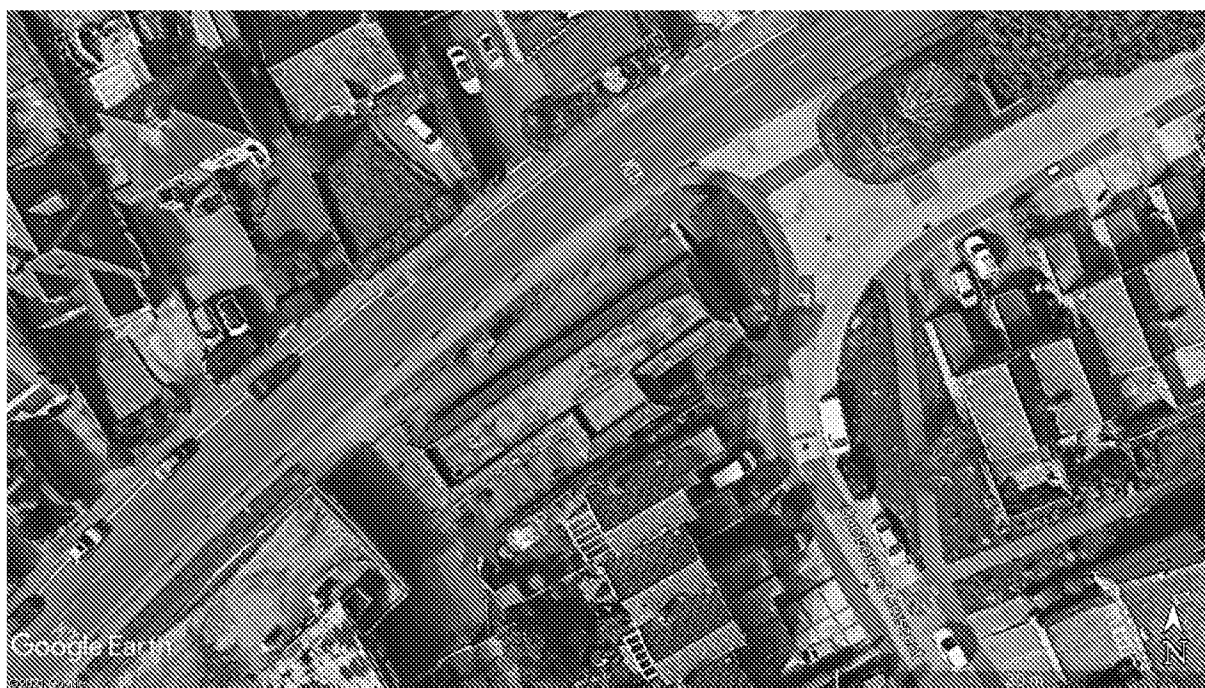
| Date of Survey Visit | Start and end times and time of sunset | Structure reference/ location | Equipment used | Weather |
|---|---|---|---|---|
| <b>Comments:</b> | The position of the four surveyors and camcorder/cameras are in Figure 3 & 4, four surveyors and two camcorder/cameras were used – Jennifer Chamblor (2020-45160-CLS-CLS, ACIEEM), David King, Kate Chadwick and Laura Cowley. | | | |

Figure 3. Aerial view of the carport being surveyed with red stars showing where the surveyors were positioned and the blue star was where the camcorder was positioned during the dusk and dawn survey (aerial image Copyright Google Earth).

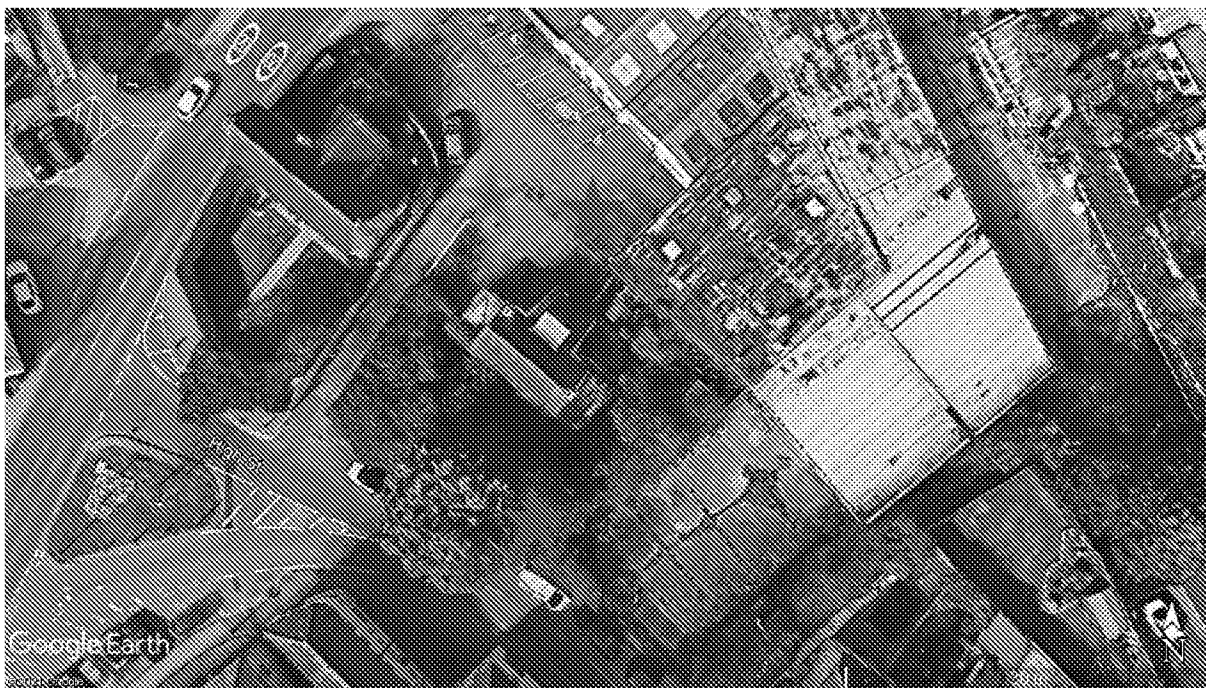
| Date of Survey Visit | Start and end times and time of sunset | Structure reference/ location | Equipment used | Weather |
|---|---|---|---|---|
| <b>Comments:</b> | The position of the four surveyors and camcorder/cameras are in Figure 3 & 4, four surveyors and two camcorder/cameras were used – Jennifer Chambler (2020-45160-CLS-CLS, ACIEEM), Jonathan Crewe (2016-19524-CLS-CLS, ACIEEM), Kate Chadwick and Laura Cowley. | | | |

Figure 4. Aerial view of the cottage being surveyed with red stars showing where the surveyors were positioned and the blue star was where the camcorder/camera was positioned during the dusk and dawn survey (aerial image Copyright Google Earth).
