**CRETE NURSERY, DAPPERS LANE, ANGMERING, BN16 4EN**

Crete Nurseries,  
Dappers Lane,  
Angmering,  
West Sussex,  
BN16 4EN

**RE: Winter Groundwater Monitoring and Soil Infiltration Rates at Crete Nurseries**

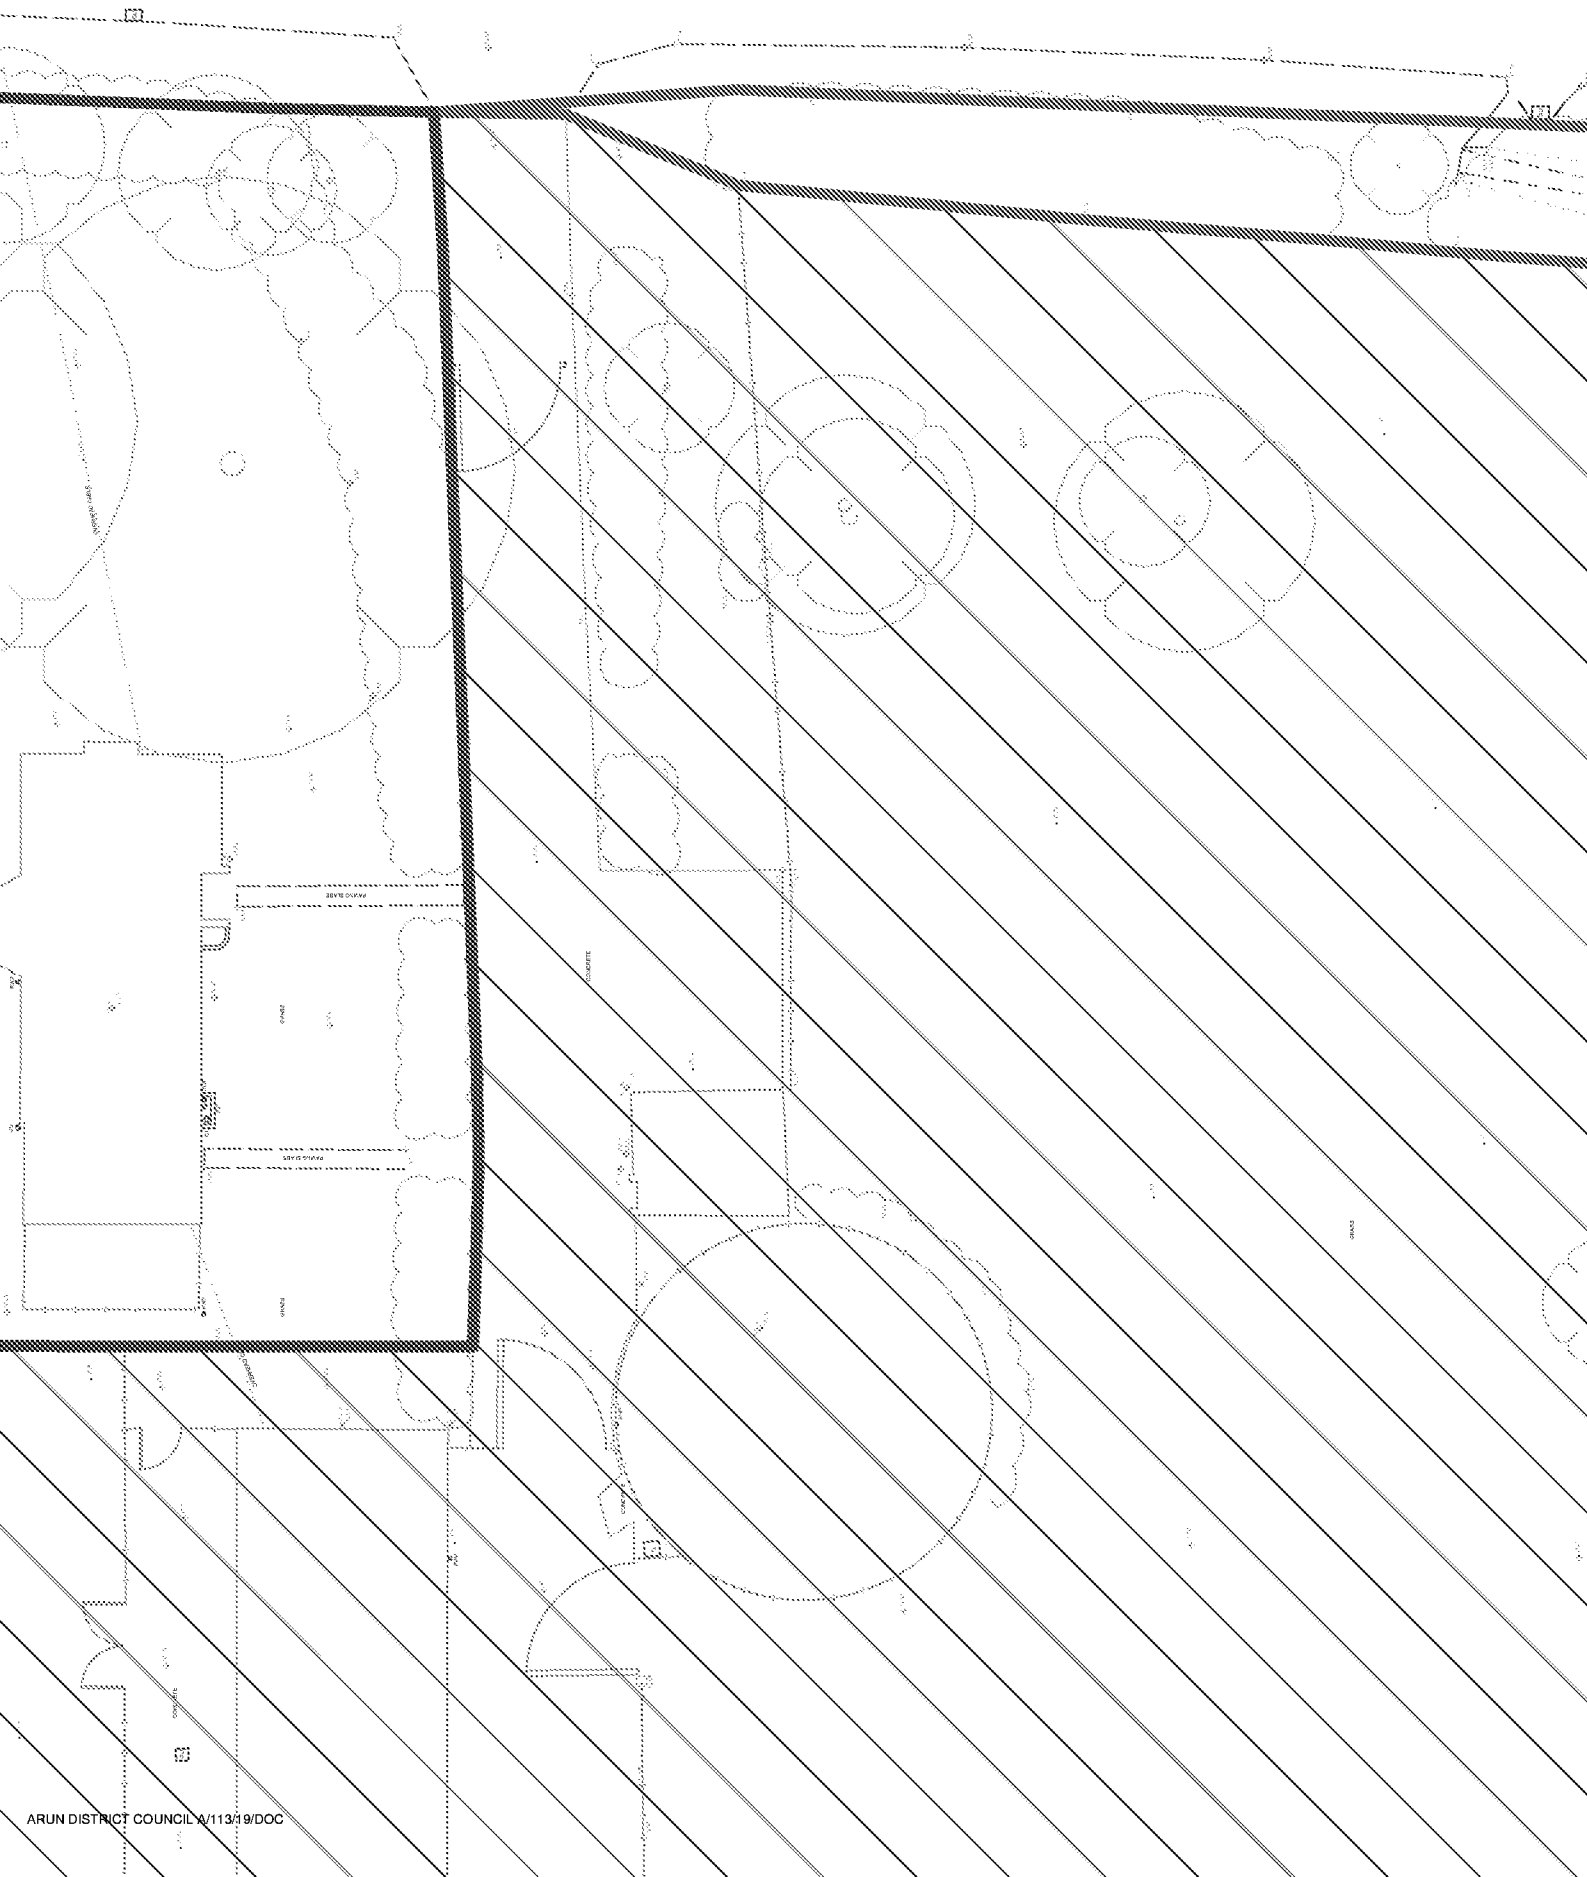
A site plan indicating intrusive positions is enclosed.

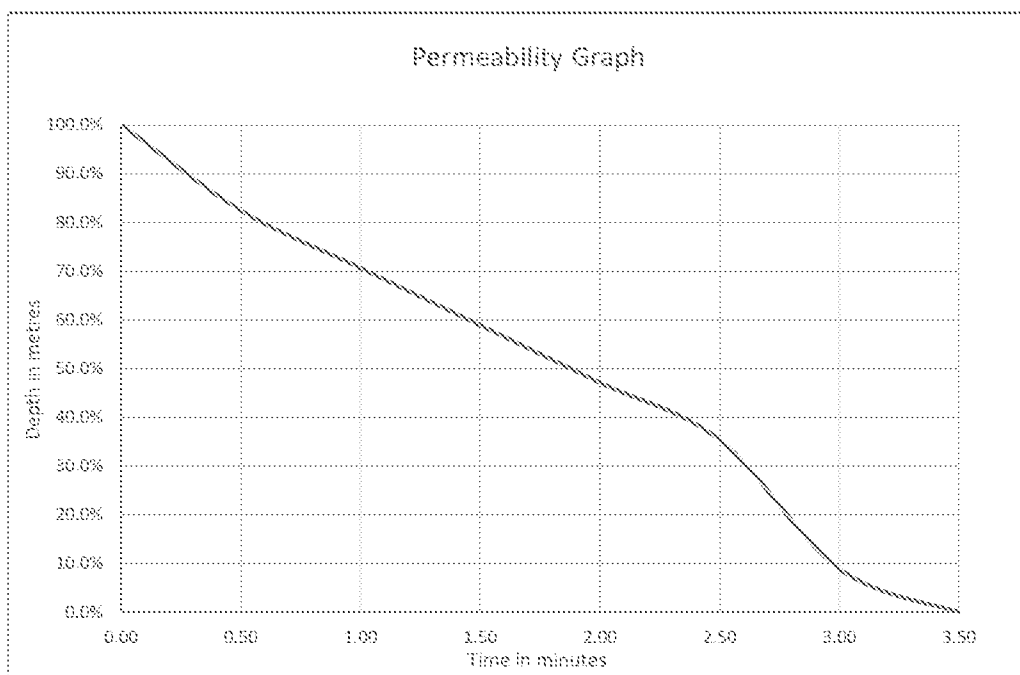
Test 3

INFILTRATION CALCULATED FROM 75%-25% WATER DEPTH RANGE

5.13E-04

| Trial Hole ID | Test | Pit Depth (m) | Time at 75% (mins) | Time at 25% (mins) | Permeability Coefficient (m/s) | Drainage Conditions |
|---|---|---|---|---|---|---|
| | 3 | 0.90 | 0.80 | 2.70 | $5.13 \times 10^{-4}$ | Good |

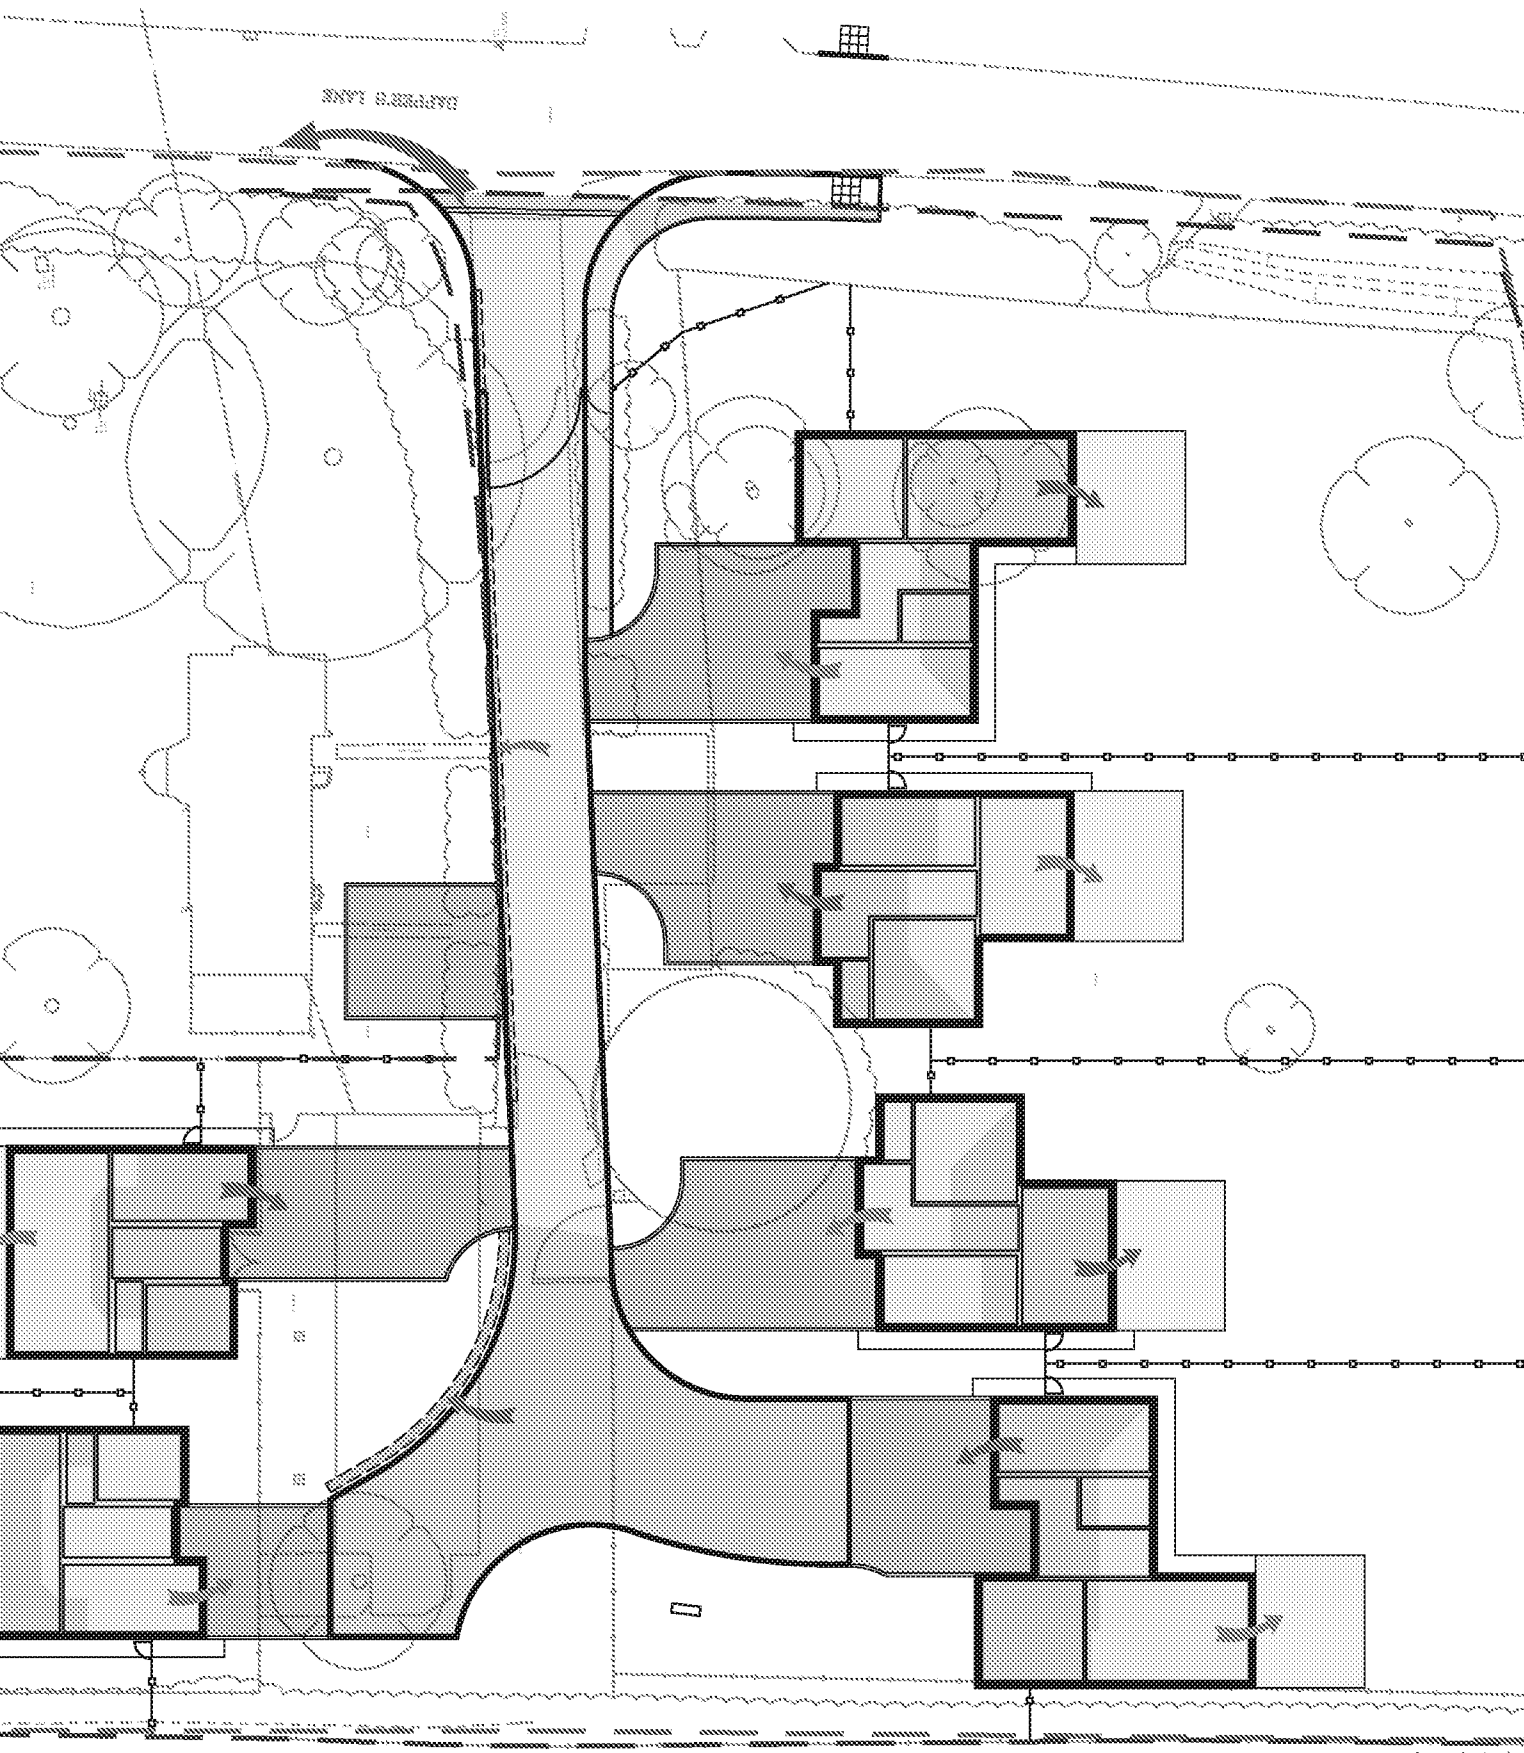
## Permeable Private Driveway - suitable for medium vehicle use & SuDS compliant

- If the substrate is silty, then this may need to be stabilised or partially removed and replaced with sub-base/granular capping, in accordance with Highways Agency design manual for roads and bridges.

- This specification is based on normal good practice for resin bound surfacing, and does not absolve the specifier from designing a base construction suitable for the expected loadings of traffic and ground conditions existing on a given site.
