# Road Safety Audit Report

Incorporating  
Stage 1 Completion of Preliminary Design

## Proposed Development Access off the A259 New Road, Rustington

**Client:**  
Commercial Development Projects Ltd

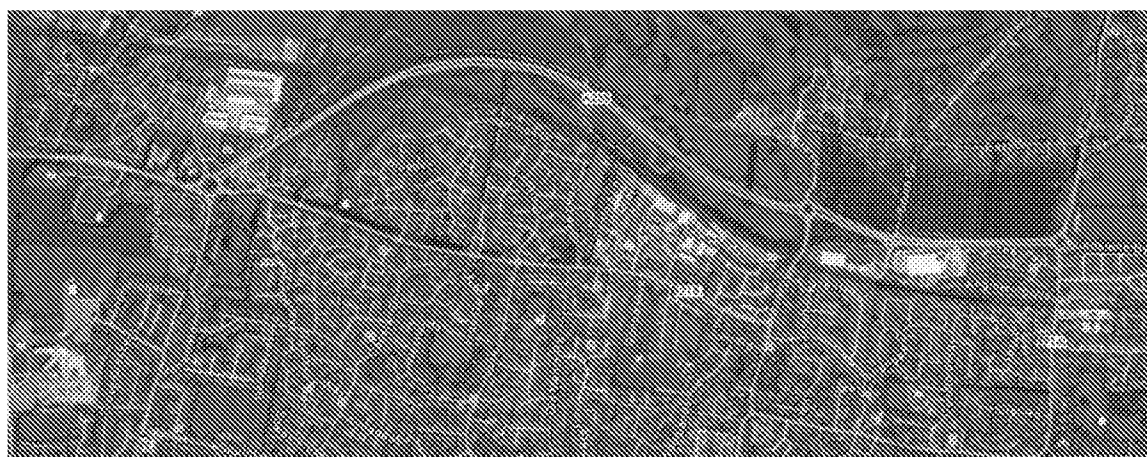
**Figure 1: Location of the proposed works**

- 1.2 The location of the works is illustrated at Figure 1 below, whilst Figure 2 illustrates the proposals that are subject to this Audit and detailed on drawing number C697/101 revision C provided with the Audit Brief.

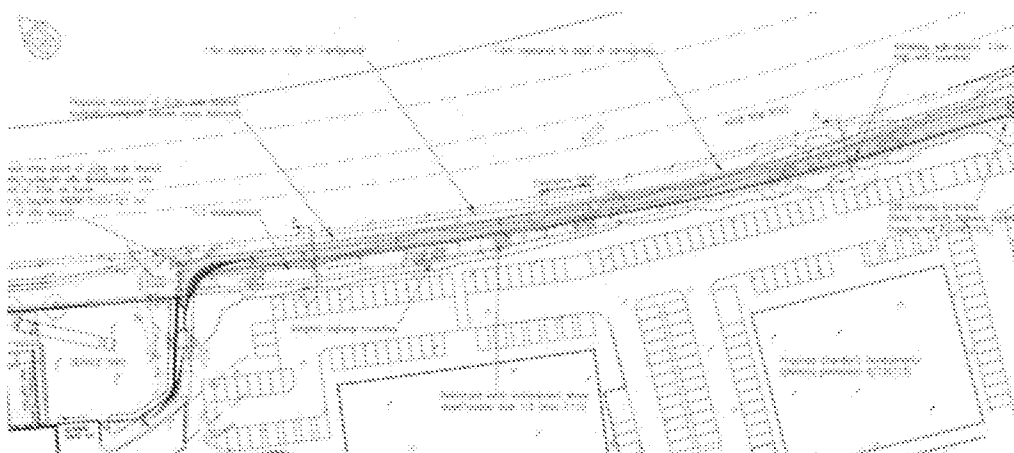
**Figure 3: Extract of proposed footway / cycleway link**

- 1.14     As part of the proposals, a 3.0 metre shared surface footway/cycleway link is to be provided to link the eastern side of the site, to the recently constructed facility associated with the adjacent retail development. The footway / cycleway associated with the adjacent consented development, links to the existing facility along Mill Lane, to the east.

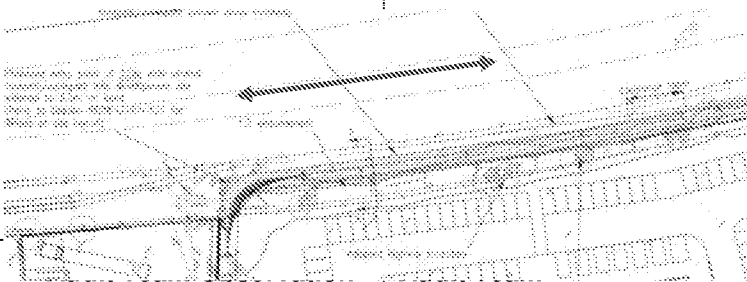
| Audit Item No. | Audit Team Observation | Audit Team Recommendation | Design Team / Scheme Response |
|---|---|---|---|
| A.1.1 | <p><b>PROBLEM</b> <i>Inadequate weaving length</i></p> <p><b>Accident Type</b> <i>Side swipes / rear end shunts</i></p> <p><b>Location</b> <i>East of proposed deceleration lane</i></p> <p>It was apparent from the site visit, that the recently constructed acceleration lane associated with the adjacent development, to the east, merges with the A259 channel line approximately 40 metres to the east of the proposed deceleration lane. Therefore vehicles exiting the adjacent development will be in conflict with vehicles entering the proposed development which are likely to be changing lanes simultaneously. This may result in side swipes and shunts along the recently constructed acceleration lane where vehicles are not able to merge onto the A259 from the adjacent development.</p> | <p>It is recommended that a weaving length in accordance with the standards contained within DMRB (the Design Manual for Roads and Bridges) is provided.</p> | |

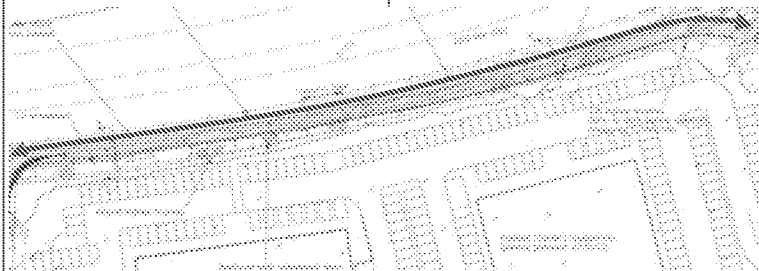
| A.4.1 | <p><b>PROBLEM</b>      <i>No Vehicle Restraints provided</i></p> <p><b>Accident Type</b>      <i>Vehicle NMU collision</i></p> <p><b>Location</b>      <i>Adjacent to proposed footway / cycleway link</i></p> <p>The Cross Sections illustrated on the scheme drawings, identify that a retaining wall and 1 metre rail are to be provided to ensure that NMU's do not fall to the south into the adjacent site, however no Vehicle Restraints are illustrated. It is noted that Vehicle Restraints are to be provided alongside the development but not alongside the proposed footway / cycleway link.</p> | <p>It is recommended that a Vehicle Restraint System similar to the recently constructed measure, is provided.</p> | |

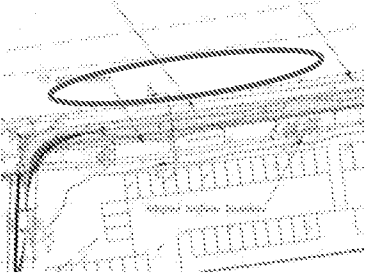
| A.5.1 | <p><b>PROBLEM</b> <i>Faded road markings</i></p> <p><b>Accident Type</b> <i>Vehicle collisions</i></p> <p><b>Location</b> <i>Alongside proposed footway / cycleway</i></p> <p>The A259 road markings alongside the proposed footway / cycleway appear to be faded. This is an existing issue, however observations show that the recently constructed scheme has re-laid markings adjacent to the works. There will therefore be a gap in the markings which could confuse drivers.</p> | <p>It is recommended that the A259 road markings are re-laid alongside the entire scheme.</p> | |
