# Road Safety Audit Report

**Incorporating  
Stage 1 Completion of Preliminary Design**

## **Proposed Development Access off the A259 New Road, Rustington**

**Client:**  
Commercial Development Projects Ltd

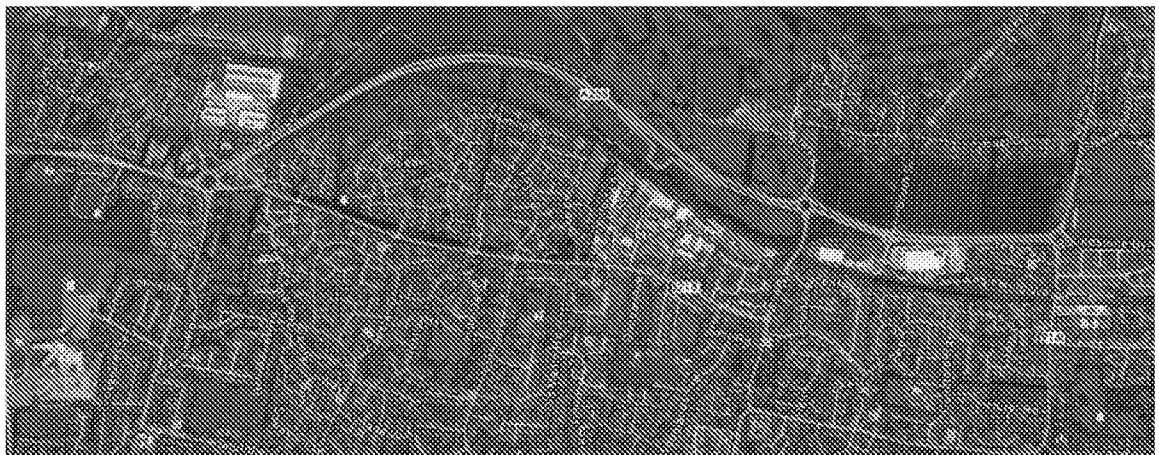
**Figure 1: Location of the proposed works**

- 1.2 The location of the works is illustrated at Figure 1 below, whilst Figure 2 illustrates the proposals that are subject to this Audit and detailed on drawing number C697/101 revision C provided with the Audit Brief.

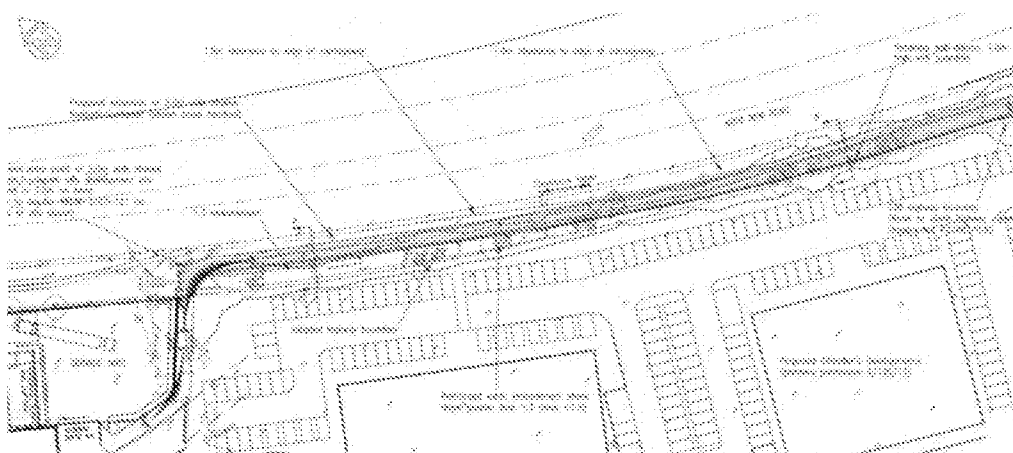
**Figure 3: Extract of proposed footway / cycleway link**

- 1.14      As part of the proposals, a 3.0 metre shared surface footway/cycleway link is to be provided to link the eastern side of the site, to the recently constructed facility associated with the adjacent retail development. The footway / cycleway associated with the adjacent consented development, links to the existing facility along Mill Lane, to the east.

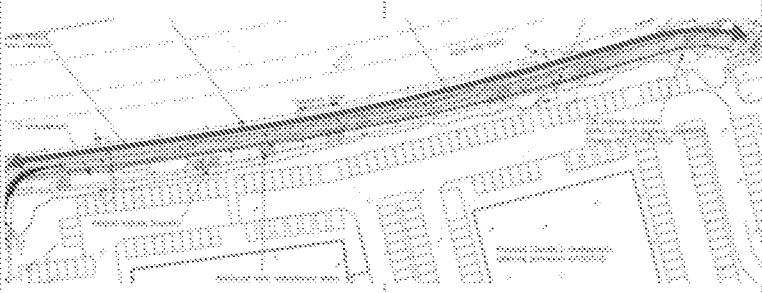
| A.4.1 | <p><b>PROBLEM</b>      <i>No Vehicle Restraints provided</i></p> <p><b>Accident Type</b>      <i>Vehicle NMU collision</i></p> <p><b>Location</b>      <i>Adjacent to proposed footway / cycleway link</i></p> <p>The Cross Sections illustrated on the scheme drawings, identify that a retaining wall and 1 metre rail are to be provided to ensure that NMU's do not fall to the south into the adjacent site, however no Vehicle Restraints are illustrated. It is noted that Vehicle Restraints are to be provided alongside the development but not alongside the proposed footway / cycleway link.</p> | <p>It is recommended that a Vehicle Restraint System similar to the recently constructed measure, is provided.</p> | <p>Refer to Redwood Partnership response dated 15<sup>th</sup> March 2017, Ref 3167D5</p> |
