# Road Safety Audit Report

Incorporating  
Stage 1 Completion of Preliminary Design

## Proposed Development Access off the A259 New Road, Rustington

**Client:**  
Commercial Development Projects Ltd

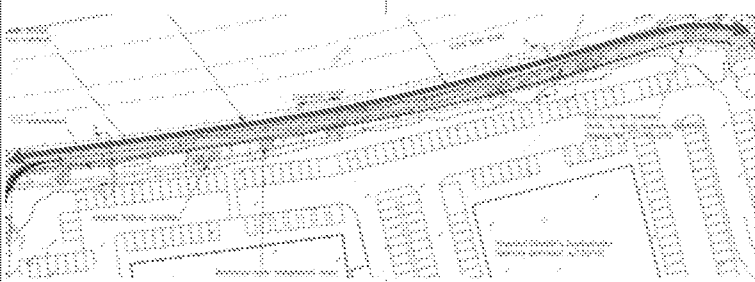
| Audit Item No. | Audit Team Observation | Audit Team Recommendation | Design Team / Scheme Response |
|---|---|---|---|
| A.4.1 | <p><b>PROBLEM</b>      <i>No Vehicle Restraints provided</i></p> <p><b>Accident Type</b>      <i>Vehicle NMU collision</i></p> <p><b>Location</b>      <i>Adjacent to proposed footway / cycleway link</i></p> <p>The Cross Sections illustrated on the scheme drawings, identify that a retaining wall and 1 metre rail are to be provided to ensure that NMU's do not fall to the south into the adjacent site, however no Vehicle Restraints are illustrated. It is noted that Vehicle Restraints are to be provided alongside the development but not alongside the proposed footway / cycleway link.</p> | <p>It is recommended that a Vehicle Restraint System similar to the recently constructed measure, is provided.</p> | <p>Refer to Redwood Partnership response dated 15<sup>th</sup> March 2017, Ref 3167D5</p> |
