# **Waterton House – Design and Listed Building Statement**

**Project: Waterton House**

**Address: Waterton House, Angmering, West Sussex, BN16 4JR**

**Date: 25 Jan 2021**

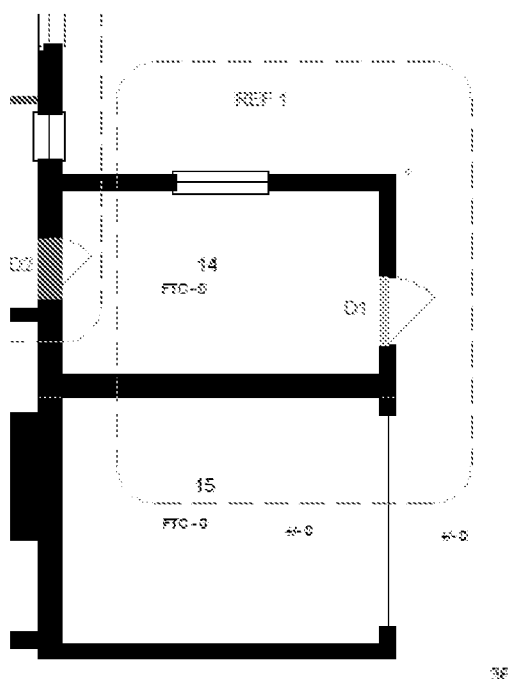
Figure 1 Ground Floor Plan Ref 1

**Description** – the two storerooms (14 & 15) were probably the stables, and the room above (22), the hayloft.

**Change of use** – the proposal is to make room 14 into a utility room.

**Material properties – room 14** - the wall construction is masonry, faced on the exterior side with flint, with brick piers to form structural openings. The interior walls are finished in a traditional lime render, with a lime finish. The exterior door into room 14 is a traditional stable door. The window is a half-moon casement, timber construction, painted white.

**Alterations** – create a structural opening between the kitchen and room 12. The opening to be formed from brick piers, the piers toothed into the existing wall and bonded using lime mortar, and a timber lintel, left exposed; door: a brace and ledge matchboard door with wrought iron strap hinges and latch handle, black finish; wall finish: lime mortar wall finish to be feathered into the existing finish; decorative finish: lime wash; existing stable door: retained but sealed shut and boarded over on the interior side with a temporary timber structure, finished with a Heraklith board

or similar substrate appropriate to a lime plaster finish; ceiling, fireproofing exposed joists: use a non-destructive approved fire sealant (Envirograf) to provide 30 minutes protection (SE to assess the depth of joists and advise on the need for, and the exact increase in fire rating required to meet Building Control approval. Other finishes: all additional finishes, where specified, will be non-destructive in terms of the historical building fabric.

**Impact on Heritage Asset – low.** The work is in the interior of the property and will have no significant impact on the quality and appearance of the asset. The existing exterior structural opening and doorway will be retained to maintain the visual character of the property.

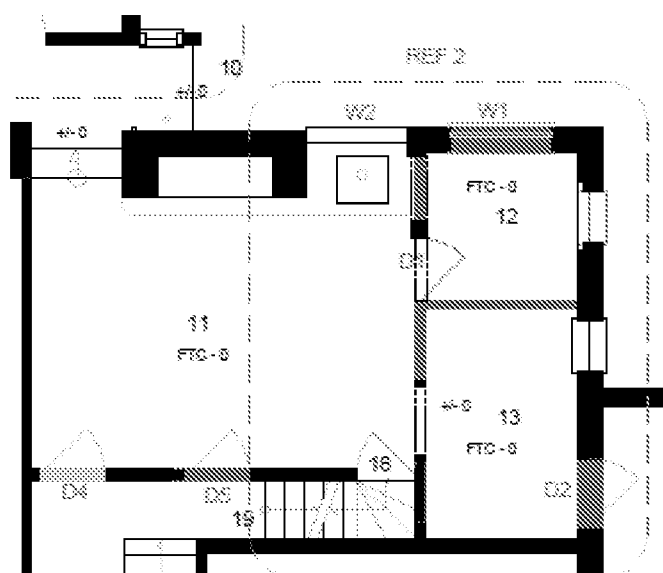
Figure 2 Ground Floor Plan Ref 2

**Description** – the proposal splits into two sections, the partitions between the rooms removed to create an open-plan kitchen-diner, along with the installation of two new windows in the west elevation, ref W1 and W2.

**Material properties** – partitions - the existing partitions comprise original timber posts and beams, some of which are exposed, and infill and panelling, the exact specification, unknown; windows – one casement window, circa 1980's.

**Partitions** - remove the infill material, **leave all posts and beams in situ**. Where required, repair the posts and beams to ensure structural integrity. Where new elements need to be installed to ensure structural integrity, these will be sympathetic to the existing original structure – timber, matching, and installed in accordance with traditional craft techniques.

**Description** – reinstate the original doorway, D5, into the kitchen (11).

Remove the existing door, D4, and fill in the structural opening with timber frame construction faced with plasterboard, finished in plaster, to match the existing wall. If the existing wall finish is lime plaster, then the substrate should be Heraklith board finished in lime plaster. In either case, the finish to match the existing wall finish.

Structural opening D4 – open up original opening, carefully; door: re-use the door from D5, if it fits, or, commission a new 6 panel door to match the existing original doors on the ground floor of the property; finish: white, painted.

**Existing casement** – a pair of single pane casement windows, painted white. The age of the unit is circa 1980's. The structural opening has also been modified, the cill raised to 1050mm to accommodate a kitchen unit. The original window cill was approximately 600mm from the finished floor level. Since the kitchen is part of the original building, circa 1600's, the current doorway, to the left of the chimney breast, would probably have been a matching window.

**New casement** – the proposal is for a pair of casement windows, with 4 over 2 glass panes per casement, the glass, 4mm float held in place with putty; the finish, painted white; ironmongery: cast, black finish. Note: the profiles are based on traditional narrow sections suited to 4mm float.

**Window, new, ref W1** – create new structural opening for a double casement window that matches W2 above.

**Structural opening** – form a new structural opening to match the width and height of the opening for the window ref W2. The work includes installing a lintel, and dressing the reveals with brick, the surrounding flint toothed into the brickwork; cill: stone, painted finish; mortar: lime mortar to be used for all new work and repairs; finish: painted white, to match the existing exterior finish; interior face of lintel: timber beam to match the existing in the kitchen area.

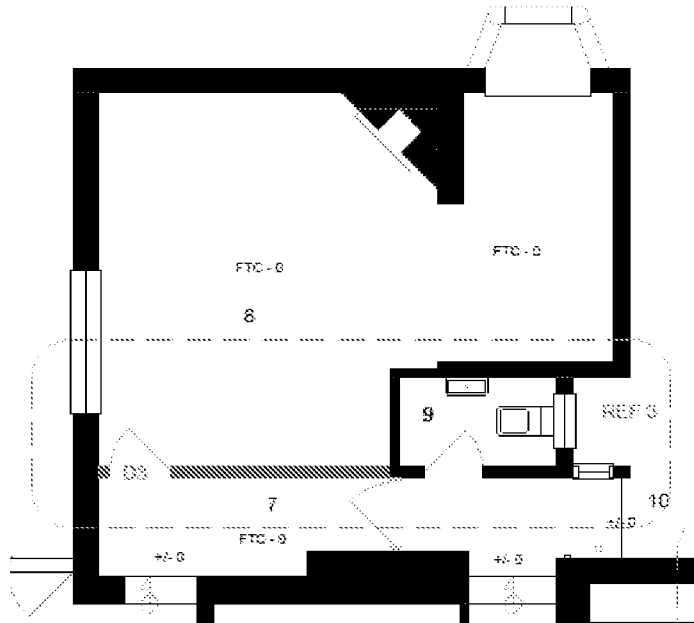
*Figure 3 Ground Floor Plan Ref 3*

**Description** – remove the existing solid structural wall.

**Existing** - solid structural wall, exact composition to be determined but probably brick as the section of the building was constructed circa 1930's – there is an inscription on the beam within the sitting that states, "1930's". Decorative elements – there are no unusual details that could be of historical significance e.g., no cornice, dado rail, panelling or other elements that would be of particular interest.

**Proposal** – remove the wall, carefully. Finishes: make good the ceiling and floor with finishes that match the existing materials. Where the floor is made good, the surrounding boards are to be lifted and re-laid in a way that continues the general floorboard pattern of the room.

**Impact on Heritage Asset** – low. The work applies to the interior of the property and does not impact on any interior features.

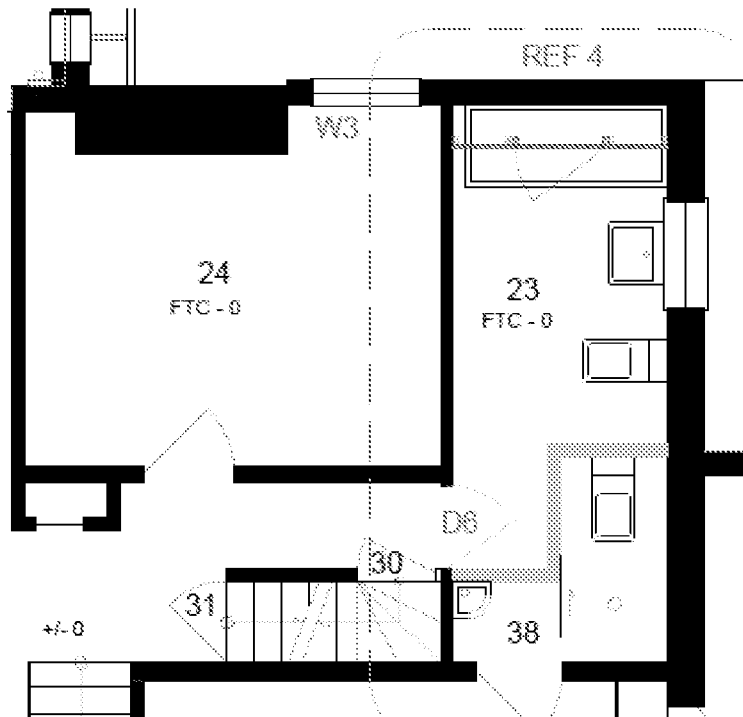
Figure 4 1st Floor Plan Ref 4

**Description** - subdivide the existing bathroom to create: - a bathroom, ref 23, and ensuite for the bedroom ref 21, and replace the window ref W3.

**Existing** – Bathroom, 2 exterior walls and two partition walls shared with the adjoining bedrooms. The room includes 1 casement window, circa 1980's. The floor finish is not known but probably timber boards. The partition walls are traditional beam and post construction with infill, the exact composition not known but probably not wattle and daub judging by the finish. The bathroom is relatively modern, as are the finishes and cupboard. There are no intrinsic original features in the bathroom.

**Proposal** – to subdivide the room by installing a plasterboard partition, as per the drawing; the existing doorways, from the hallway to the bathroom, and from the bedroom to the new ensuite, are retained; the work will not involve alterations to the original partition walls which, on the bedroom side room ref 24, have historical significance; new window: see next section for details.

**Description** - new double casement to replace existing casement.

**Existing** – single pane double casement, circa 1980's.

**Proposal** - a pair of double casement windows, with 4 over 2 glass panes per casement, the glass, 4mm float held in place with putty; the finish, painted white; ironmongery: cast, black finish. Note: the profiles are based on traditional narrow sections suited to 4mm float.
