# Land west of Arundel Road, Angmering

Preliminary risk assessment

Project no. 301954 R01 (00)

SEPTEMBER 2017

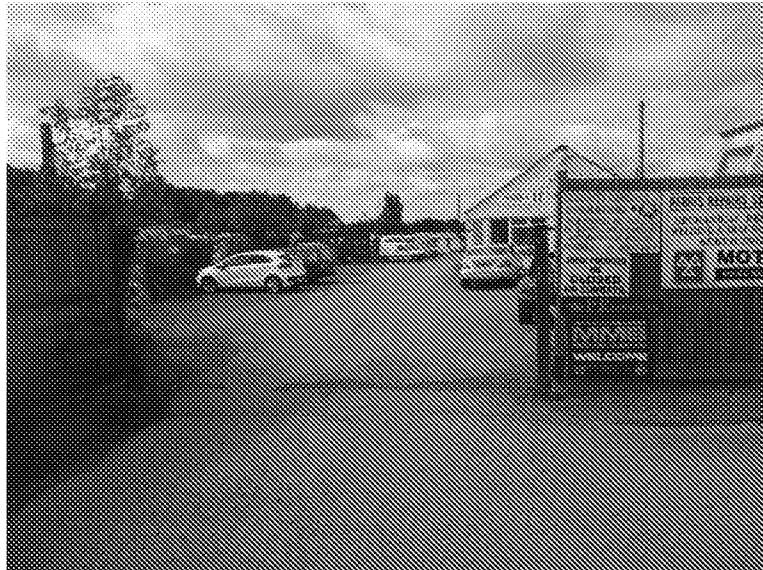
| PHOTOGRAPHIC LOG | | |
|---|---|---|
| Photo no.<br>1 | Date:<br>14/09/2017 | |

| PHOTOGRAPHIC LOG | | |
|---|---|---|
| Description:<br>An entry to a section of the small commercial and light industrial area off the road accessed via Arundel Road. | | |

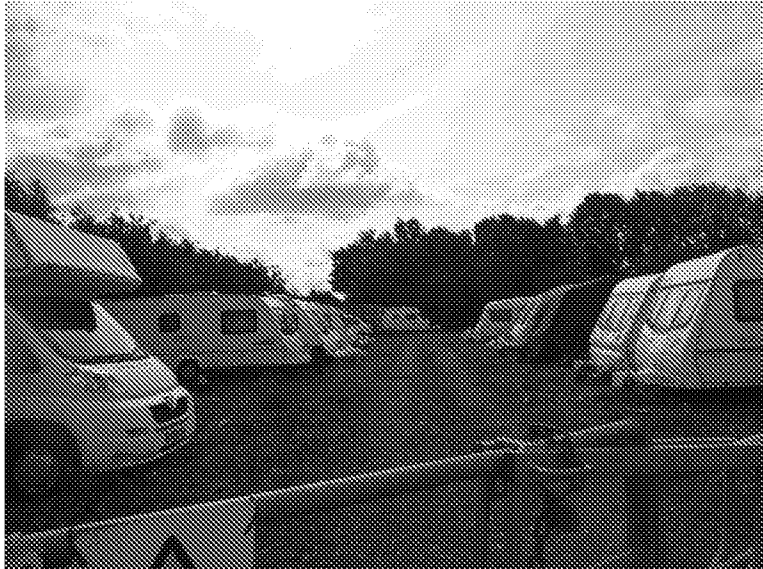
| Photo No.<br>2 | Date:<br>14/09/2017 | |

| Description:<br>Caravan storage park in the small commercial and light industrial area. | | |

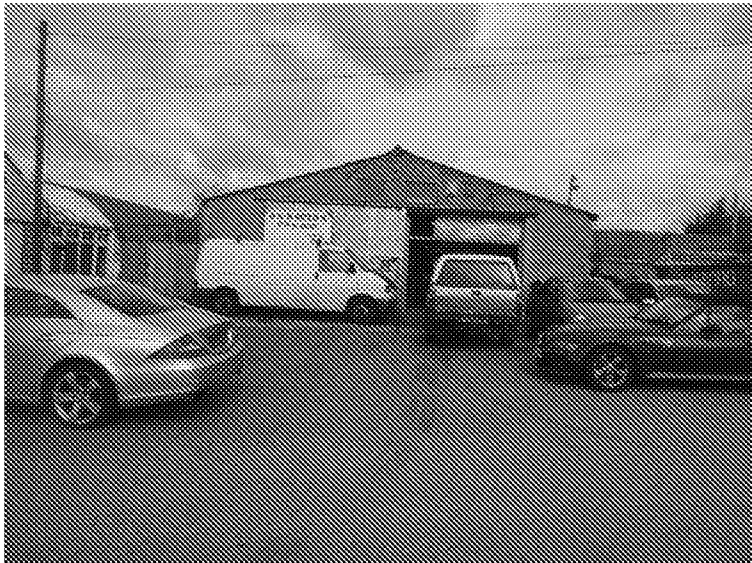
| <b>Photo No.</b><br>3 | <b>Date:</b><br>14/09/2017 | |

| <b>Description:</b><br>A & B Autos service, repair and MOT garage. | | |

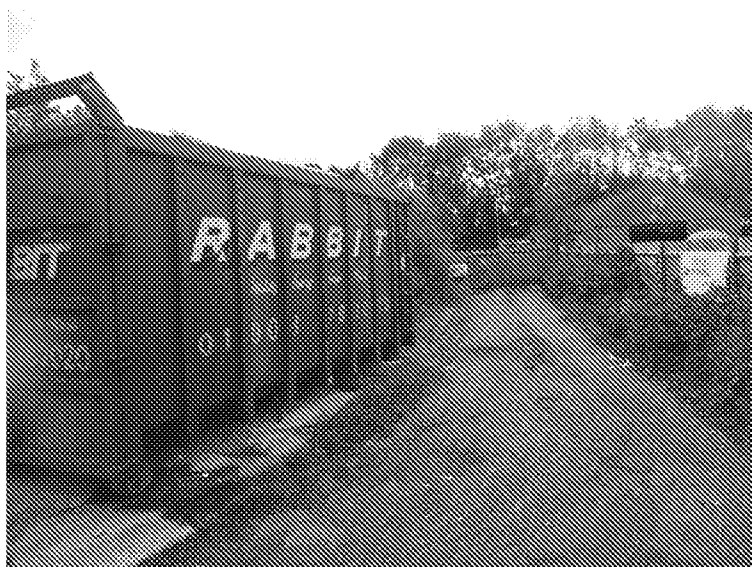
| <b>Photo No.</b><br>4 | <b>Date:</b><br>14/09/2017 | |

| <b>Description:</b><br>Va Signs at the end of a road. | | |

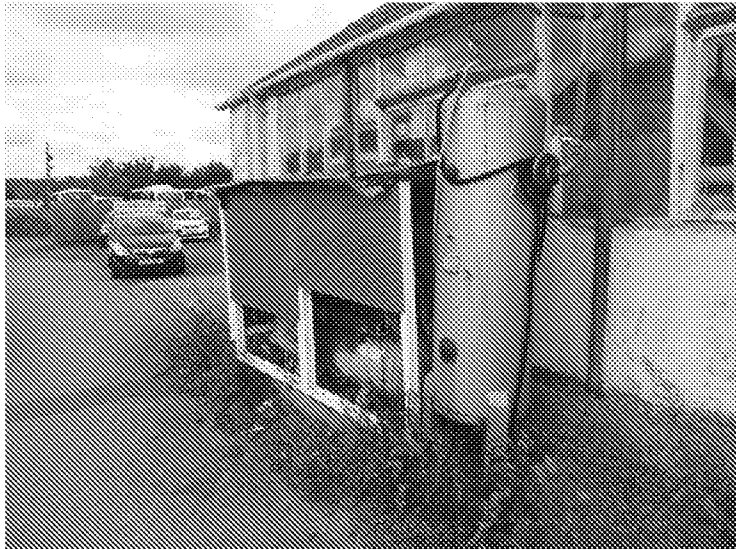
| <b>Photo No.</b><br>5 | <b>Date:</b><br>14/09/2017 | |

| <b>Description:</b><br>Small above ground storage tanks. | | |

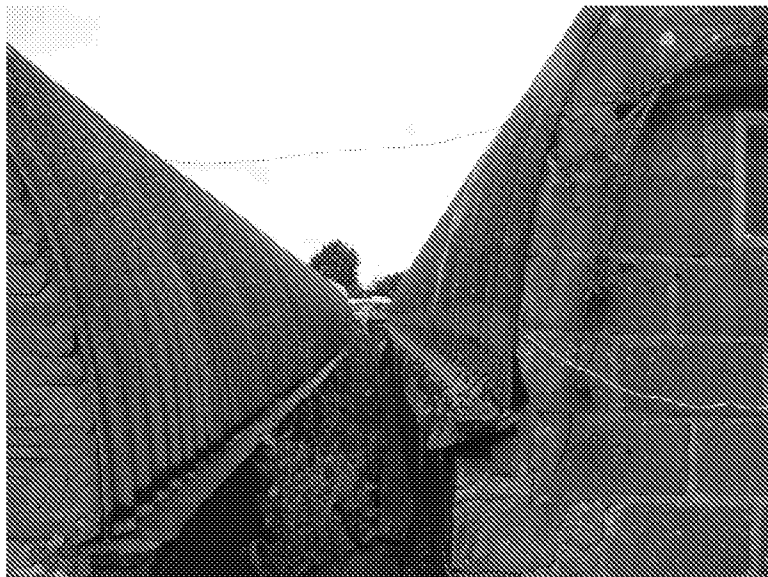
| <b>Photo No.</b><br>7 | <b>Date:</b><br>14/09/2017 | |

The south-east of the site comprises a mixture of land uses, including a caravan, coach and minibus storage area (see photograph 2 in Appendix C), printing facilities (Va Signs and The Design Studio), auto repair garages (VW Spares, Angmering Auto Services and Parris Repairs Service) and a door, window and conservatory manufacturing and installation business (Horizon Windows). Some of the buildings are in a state of disrepair with the majority of the buildings having roofs which are considered likely to comprise asbestos containing materials (ACM), illustrated in photograph 7 in Appendix C.

| <b>Description:</b><br>The roofs of on-site buildings with the potential presence of ACM. | | |

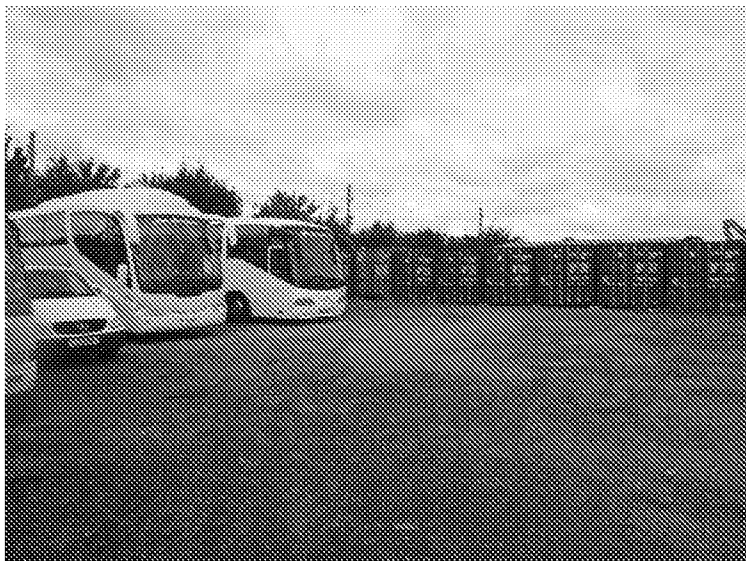
| <b>Photo No.</b><br>8 | <b>Date:</b><br>14/09/2017 | |

| <b>Description:</b><br>Storage containers adjacent to the coach and minibuses parking area. | | |

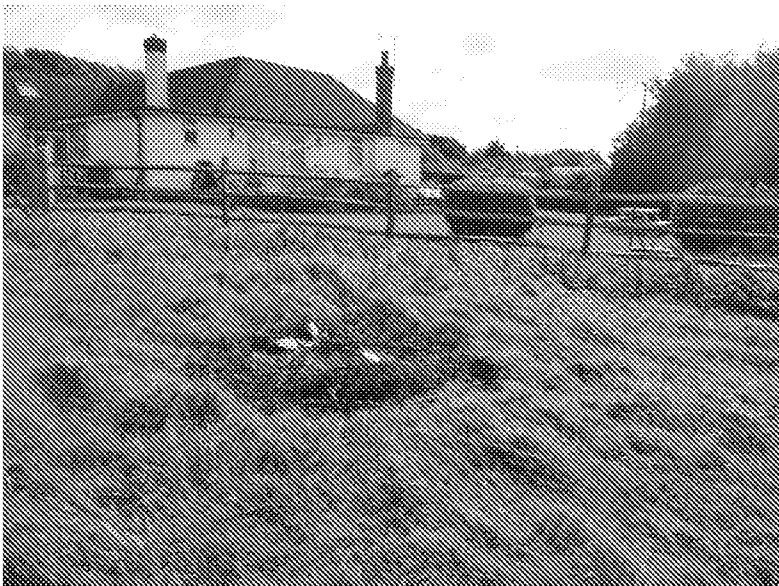
| <b>Photo No.</b><br>12 | <b>Date:</b><br>14/09/2017 | |

| <b>Description:</b><br>The rear of New Place Bungalow with evidence of a bonfire in the adjacent field. | | |

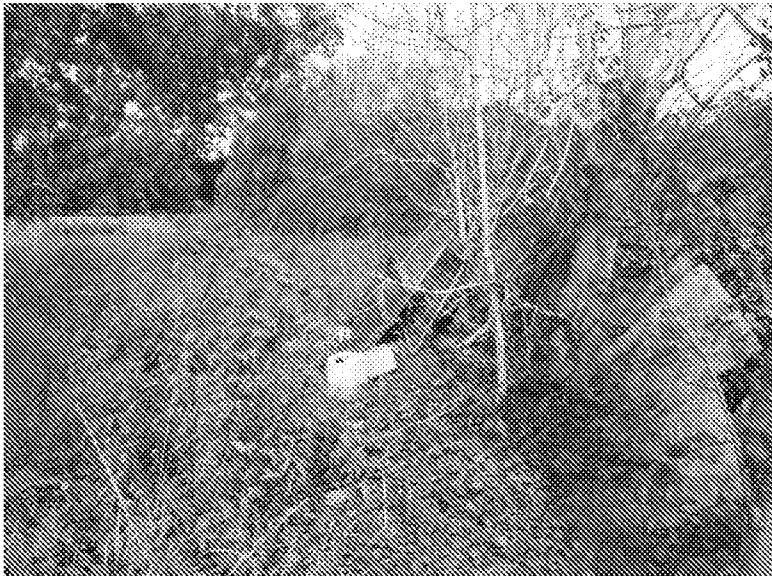
| <b>Photo No.</b><br>14 | <b>Date:</b><br>14/09/2017 | |

| <b>Description:</b><br>An area of scrubland in the north-east of the site. | | |

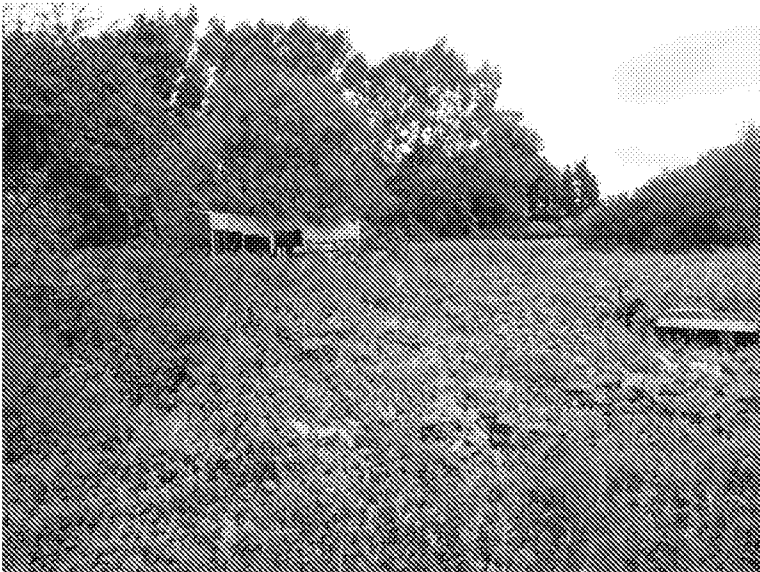
| <b>Photo No.</b><br>15 | <b>Date:</b><br>14/09/2017 | |

| <b>Description:</b><br>Disused building in the scrubland in the north-east of the site. | | |

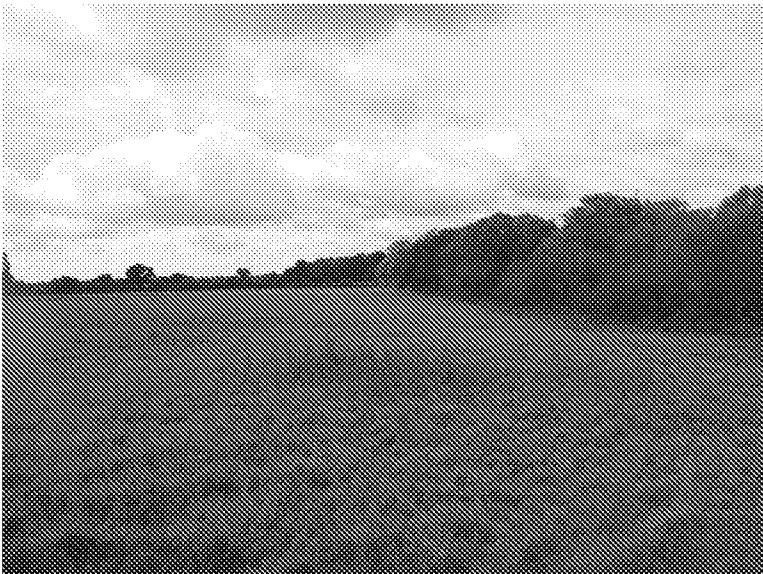
| <b>Photo No.</b><br>16 | <b>Date:</b><br>14/09/2017 | |

| <b>Description:</b><br>Grassland in the north of the site, showing the wooded area beyond | | |
