# Phase 2: Site Investigation Report

Project Reference: P19.117/SIR

**Merry England Nurseries**

GD Concepts Ltd

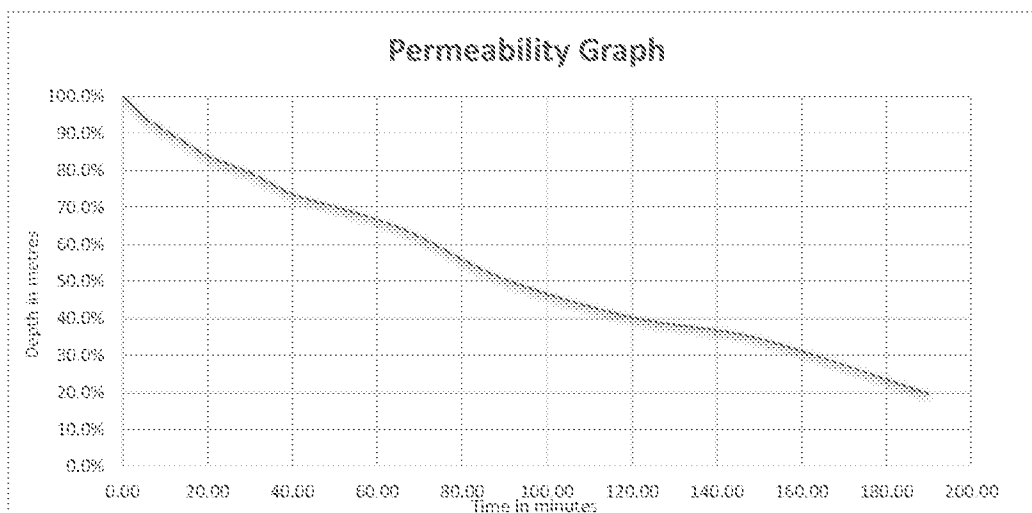
1.37911E-05

Soil infiltration testing was completed within TP1, TP2 and TP3 in accordance with the testing standards identified in BRE 365: 2016 'Soakaway Design'. The tests included the squaring of the pit sides before filling with potable water, the subsequent decline in water level was measured to allow determination of the coefficient of permeability (k); using this testing method, the rate of outflow between 75% and 25% effective depths are used to determine the infiltration rate.

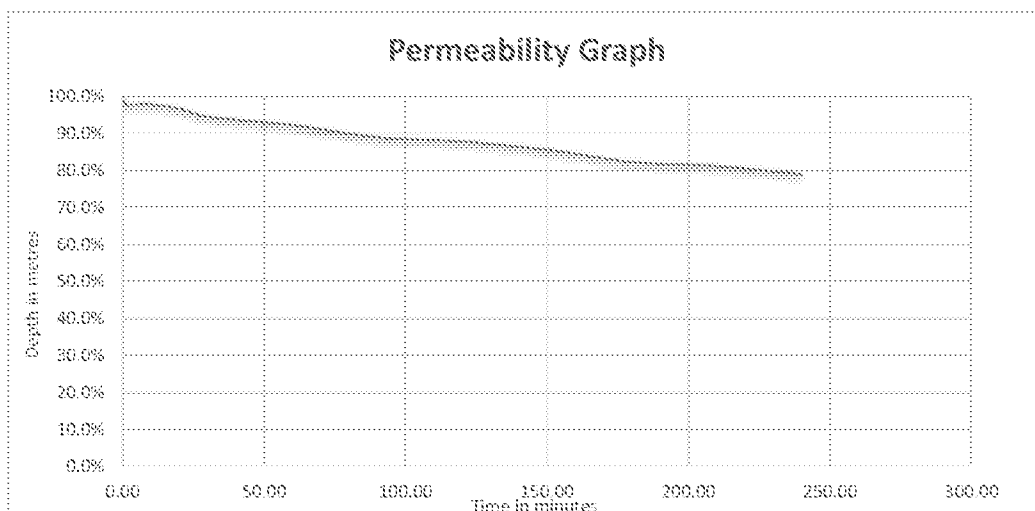
### Infiltration Rate

3.05172E-06

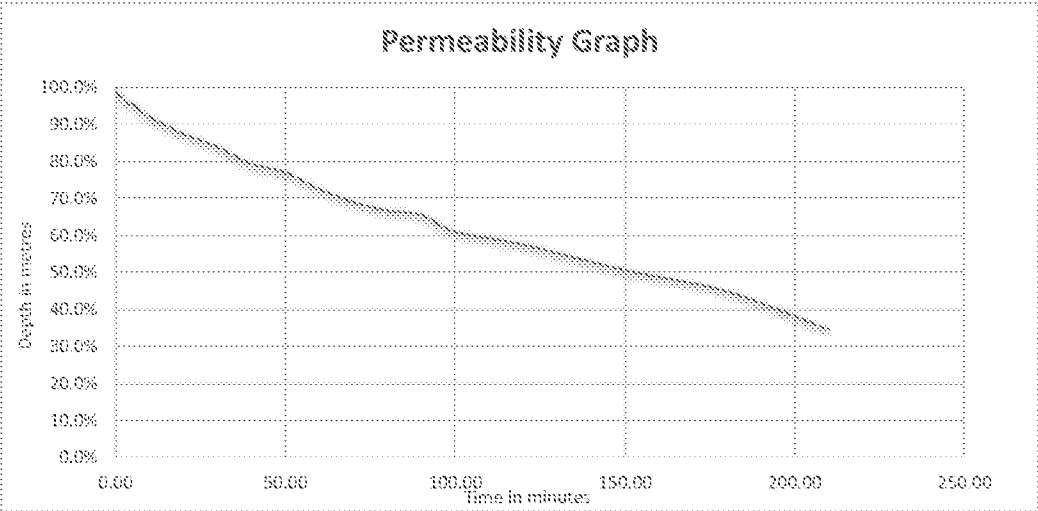
| <b><u>Infiltration Rate</u></b> | <b><u>from 75%-25%</u></b> | <b>1.08557E-05</b> | <b>(Estimated)</b> |
