**RE: Former West End Nursery, Angmering - Validation Plot 268**

**1. BACKGROUND**

### 3. SITE INSPECTION

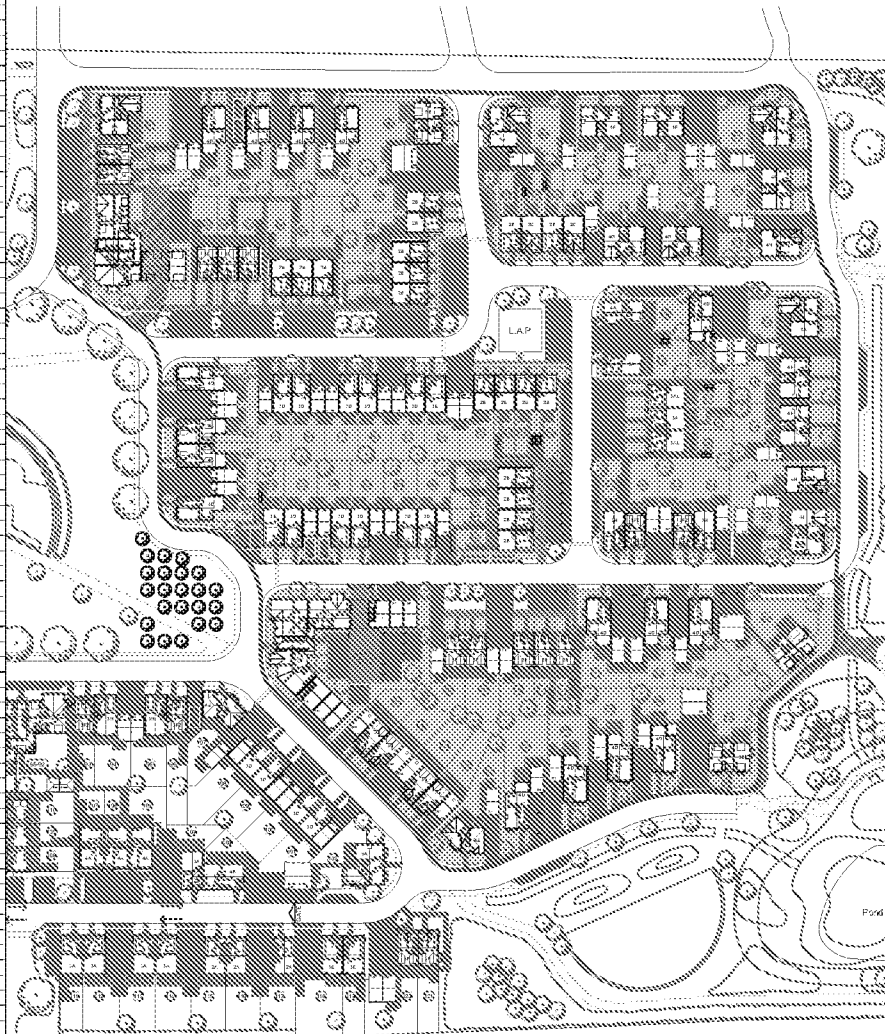
| Figure 1 | Capping layer requirements (Plots 201-307) |

A plan showing the capping layer requirements for Phase 2B is presented as **Figure 1**. The validation certificates for the imported topsoil are presented in **Appendix D**.

- Phase 2A Boundary
- 450mm Capping Layer Required
- 600mm Capping Layer Required

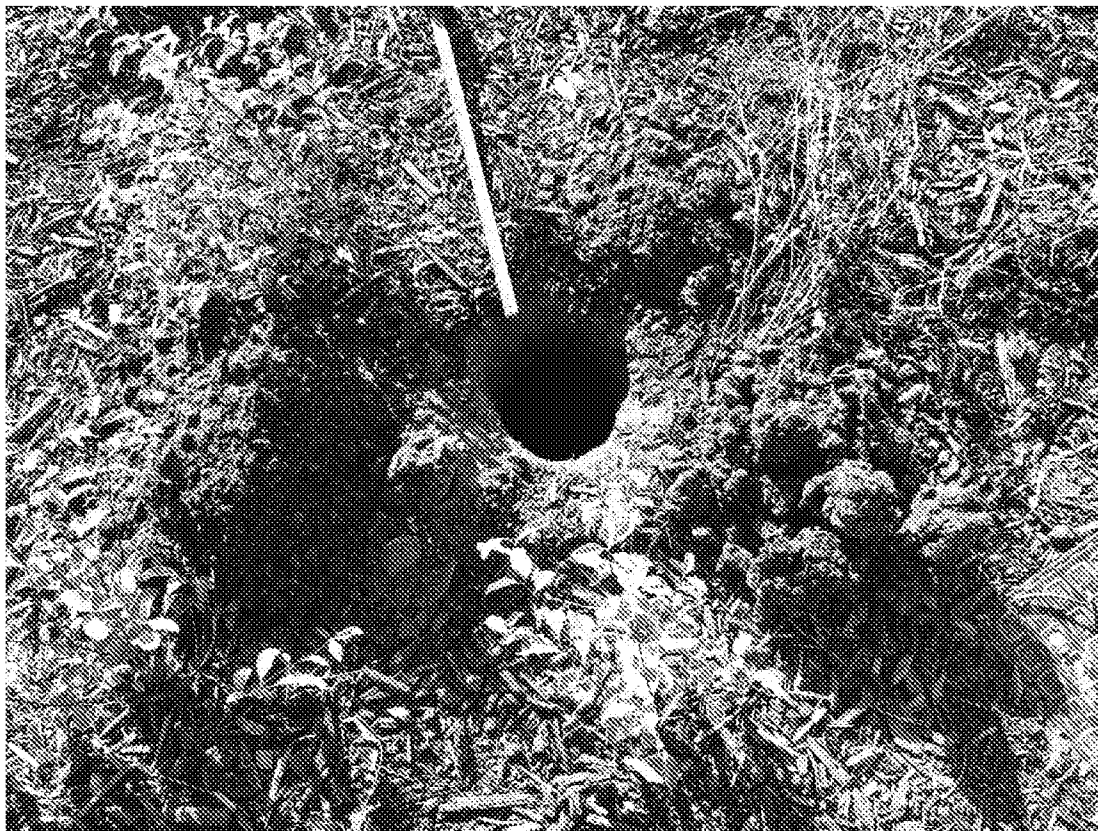
Photo No.  
1

Overview of  
Plot 268 front  
garden

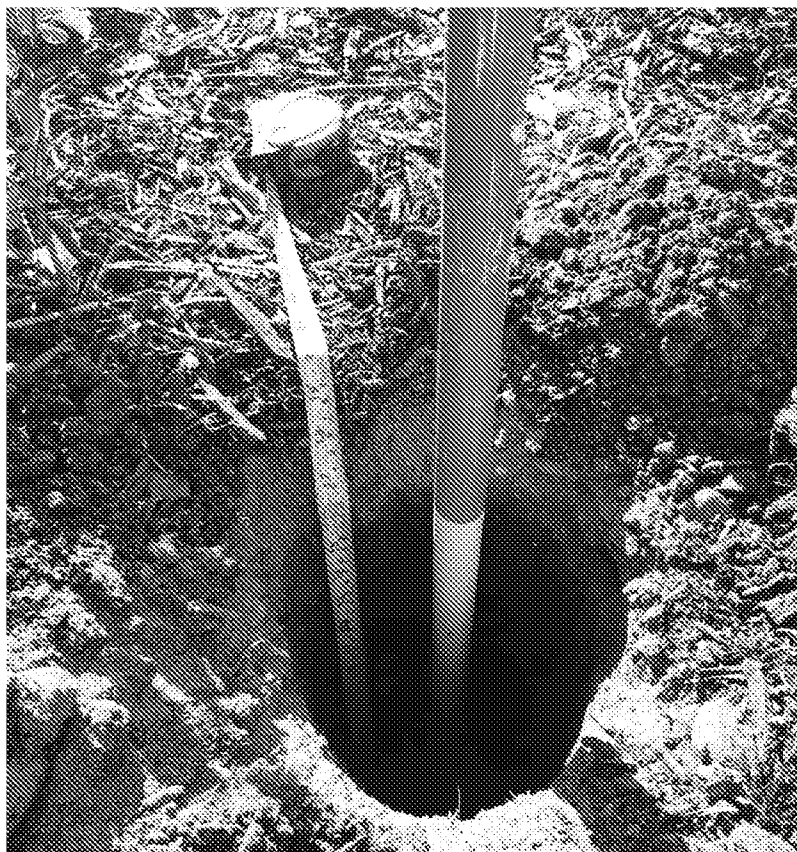
Photo No.  
2

The depth of the capping layer within the front and rear gardens of Plot 268 was found to be at least 450 mm. It is considered that this demonstrates compliance of the specified capping layer remedial measures.

View of the  
capping in  
Plot 268 front  
garden – at  
least 450 mm  
thick

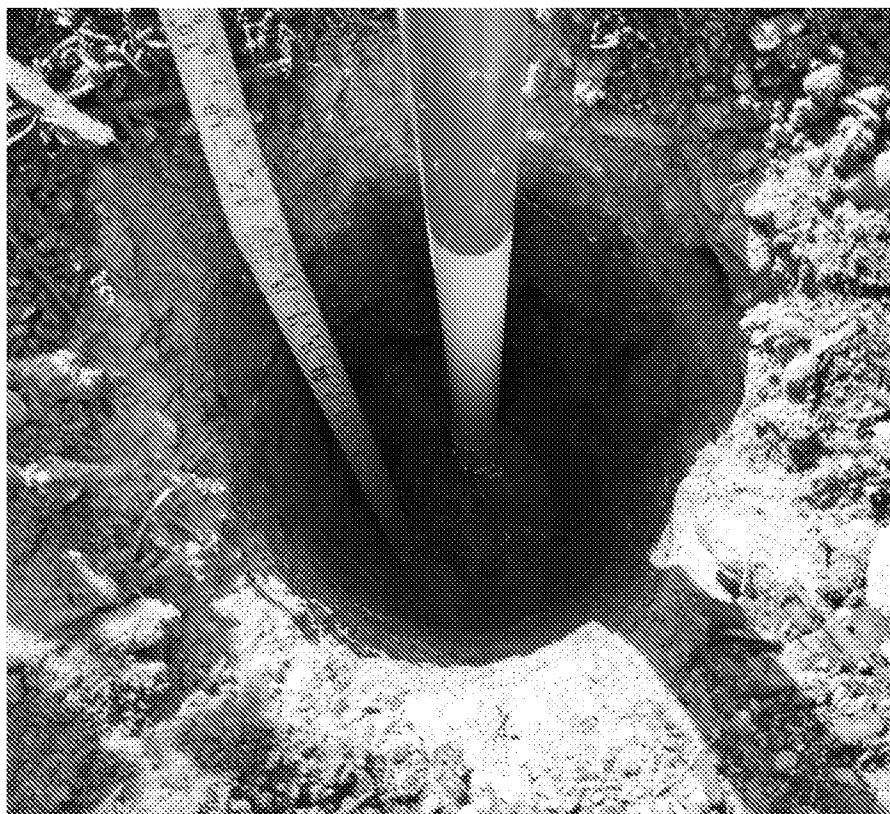
Photo No.  
3

View of hand  
dug pit in the  
front garden  
of Plot 268

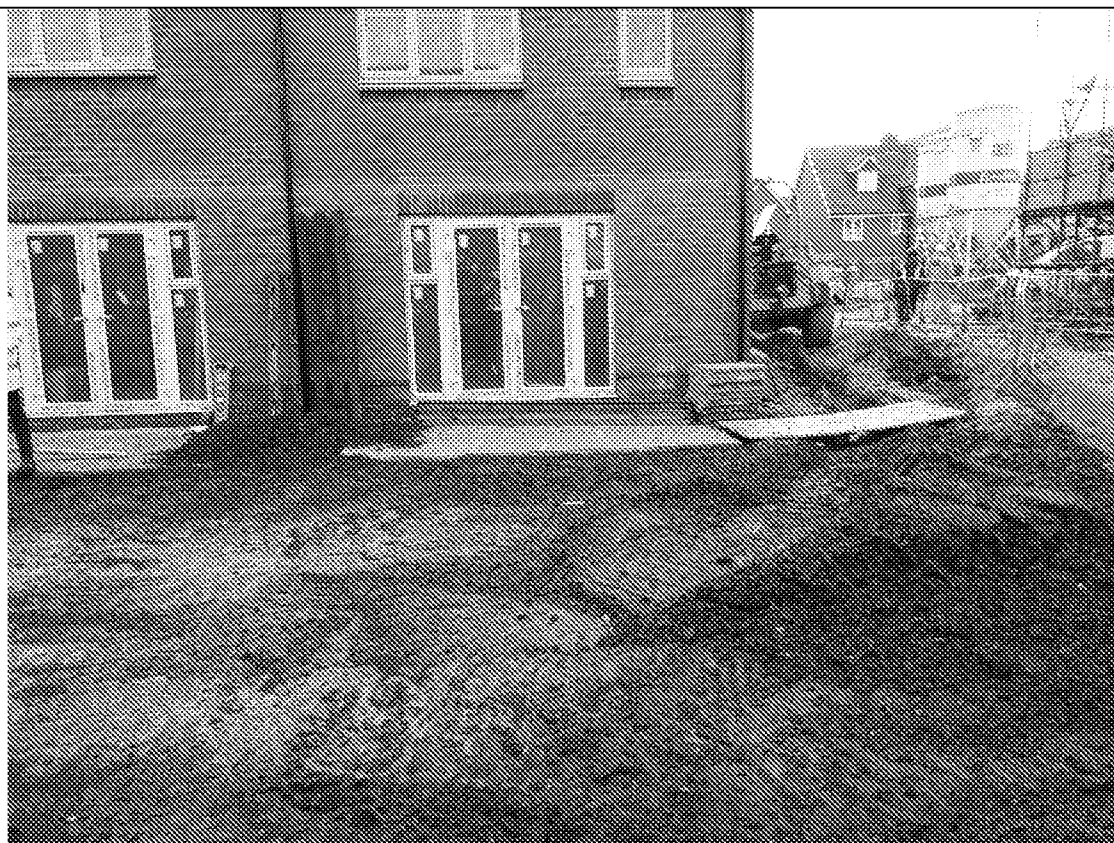
Photo No.  
4

Overview of  
Plot 268 rear  
garden

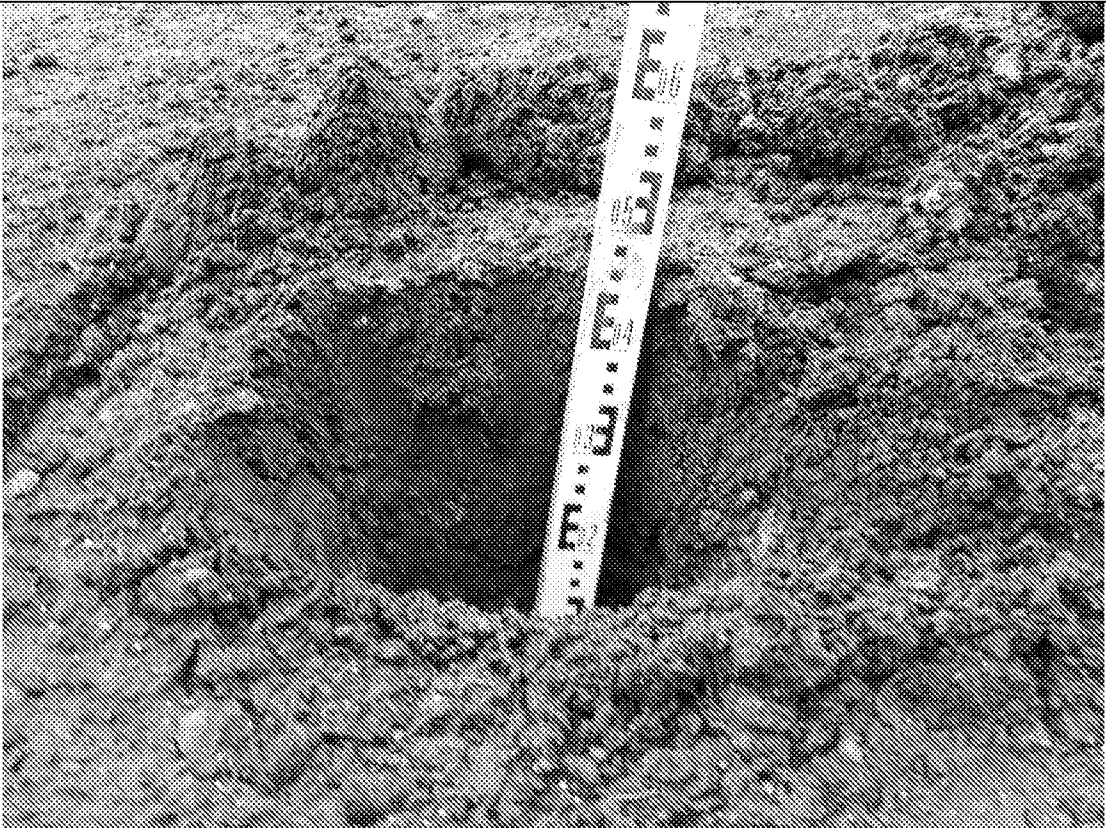
| <p><b>Photo No.</b></p> <p>5</p> <p><b>Date:</b></p> <p>11/02/2020</p> <p>View of the capping in Plot 268 rear garden – at least 450 mm thick</p> | |

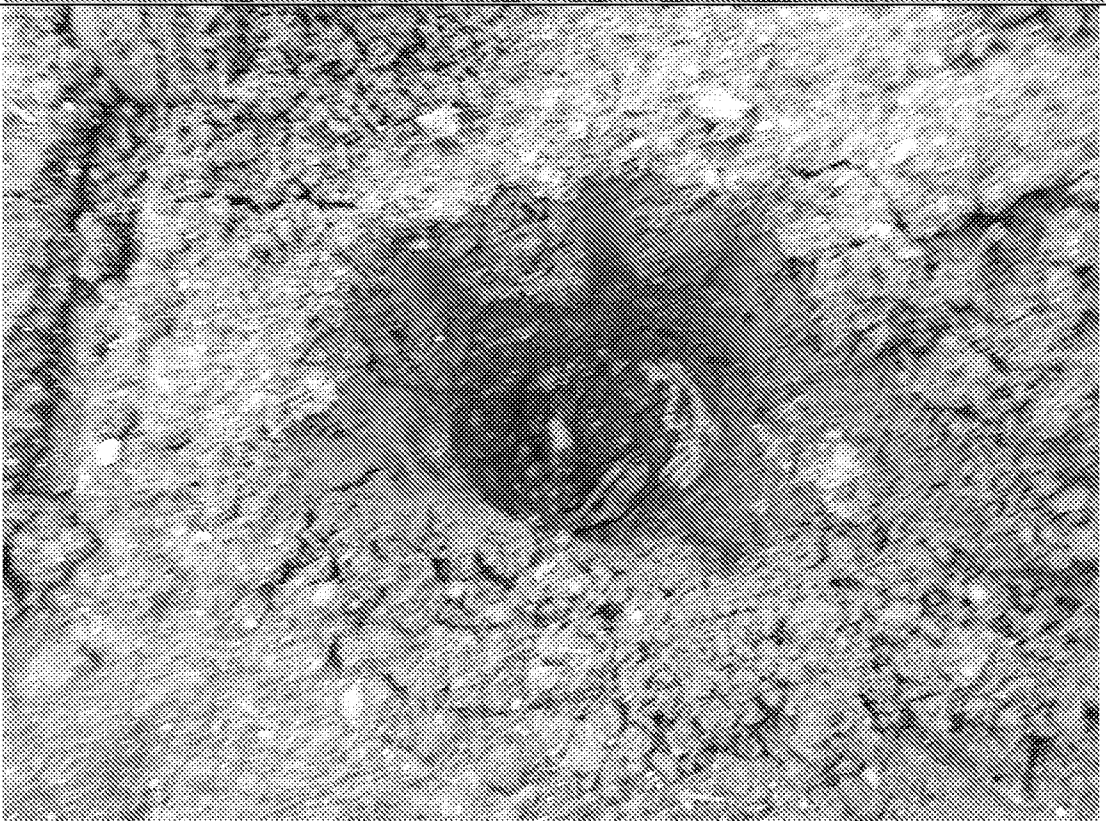
| <p><b>Photo No.</b></p> <p>6</p> <p><b>Date:</b></p> <p>11/02/2020</p> <p>View of hand dug pit in the rear garden of Plot 268</p> | |
