Our Ref: 27621 L67 (00) / EC

29<sup>th</sup> July 2020

**RE: Former West End Nursery, Angmering - Validation Plot 218 - 220**

RSK attended site on 21<sup>st</sup> July 2020 to inspect and validate the capping layer (topsoil/subsoil) within the rear and front garden areas of Plots 218 - 220. Photographs from the site inspection works are presented in **Appendix B**. One hand-excavated inspection pit was completed in the front and rear gardens of Plots 218 - 220. In accordance with the remedial strategy specification, validation pits were hand-excavated to a minimum depth of 450 mm below the existing ground level, to allow for sampling of soils. The inspection pit logs are presented in **Appendix C**.

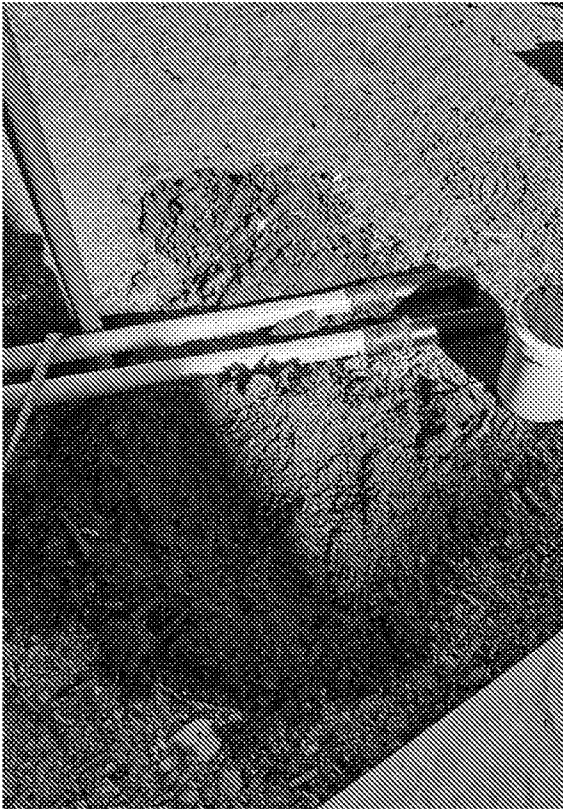
| <p><b>Photo No.</b><br/>1</p> | |

| <p>Overview of Plot 218 front garden</p> | |

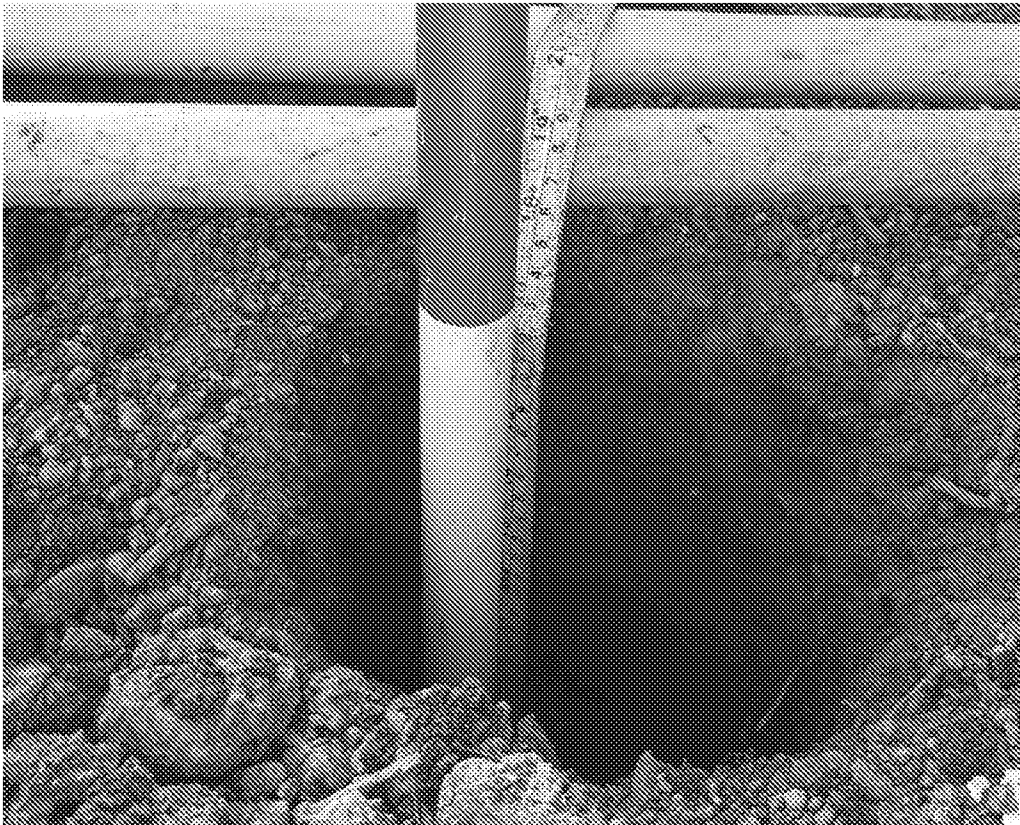
| <p><b>Photo No.</b><br/>2</p> | |

| <p>View of the capping in Plot 218 front garden – at least 450 mm thick</p> | |

The depth of the capping layer within the front and rear gardens of Plots 218 - 220 was found to be at least 450 mm. It is considered that this demonstrates compliance of the specified capping layer remedial measures.

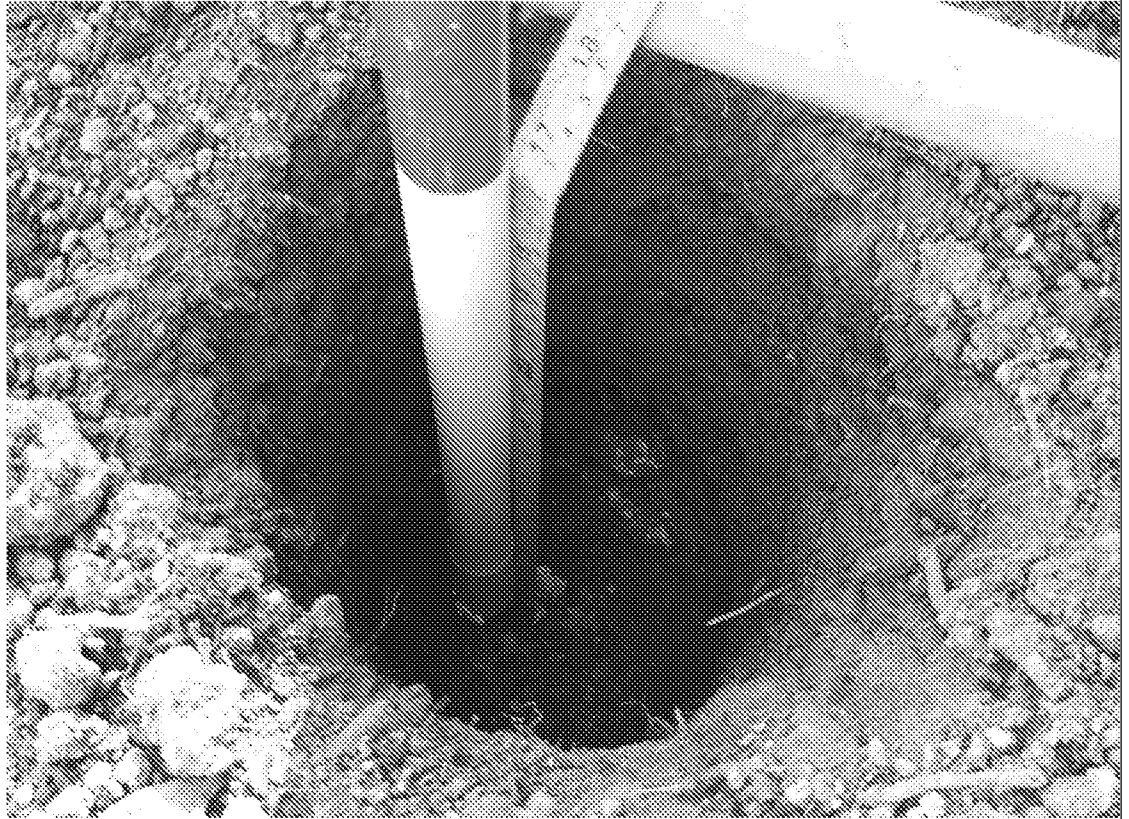
Photo No.  
3

View of hand dug pit in the front garden of Plot 218

The topsoil generally comprised at least 150 mm dark brown occasionally light brown slightly gravelly silty SAND or sandy SILT with frequent organic matter, where gravel is subrounded fine to medium flint. The topsoil was followed by subsoil. The subsoil comprised orangish brown gravelly sandy CLAY, where sand is fine to coarse, and gravel is subangular to subrounded fine to coarse flint and chalk.

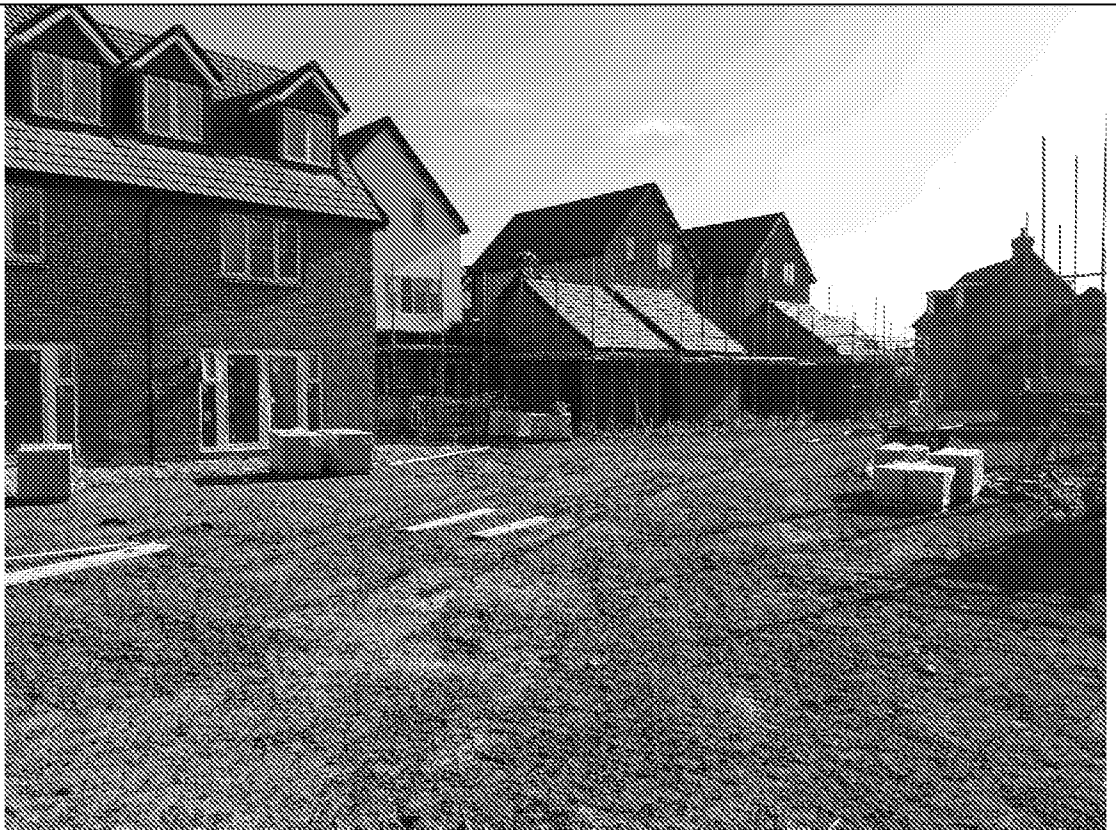
Photo No.  
4

Overview of Plot 218 rear garden

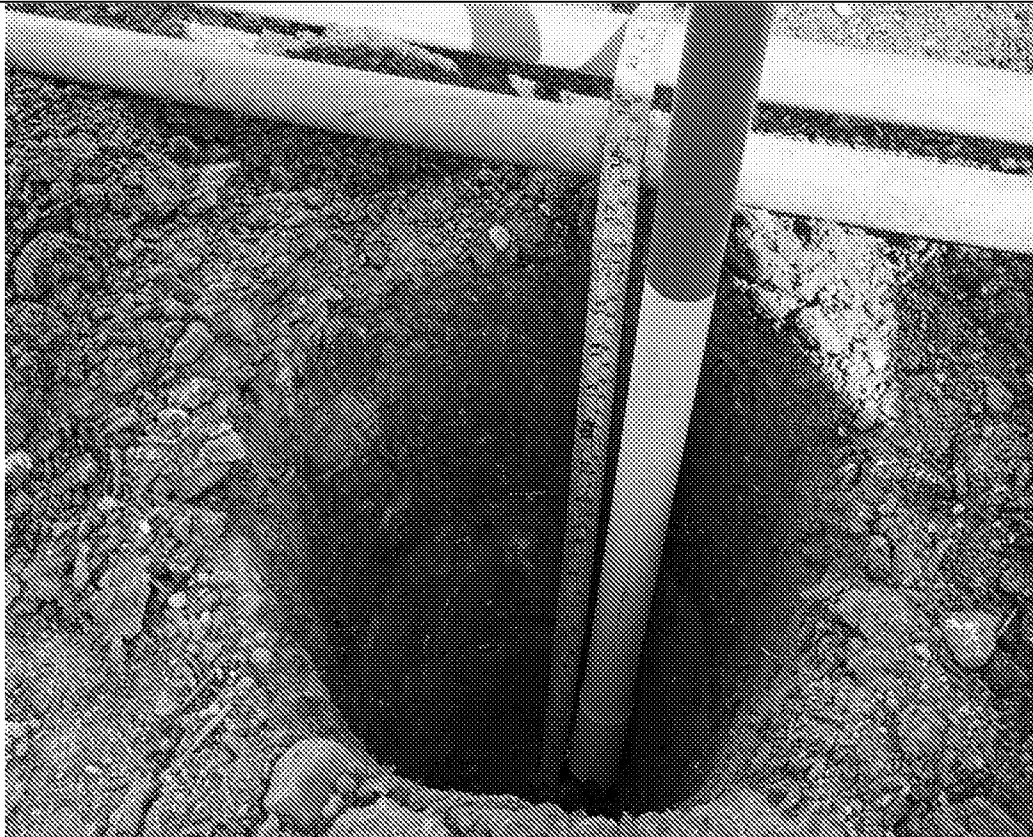
| <p><b>Photo No.</b></p> <p>5</p> <p><b>Date:</b></p> <p>21/07/2020</p> <p>View of the capping in Plot 218 rear garden – at least 450 mm thick</p> | |

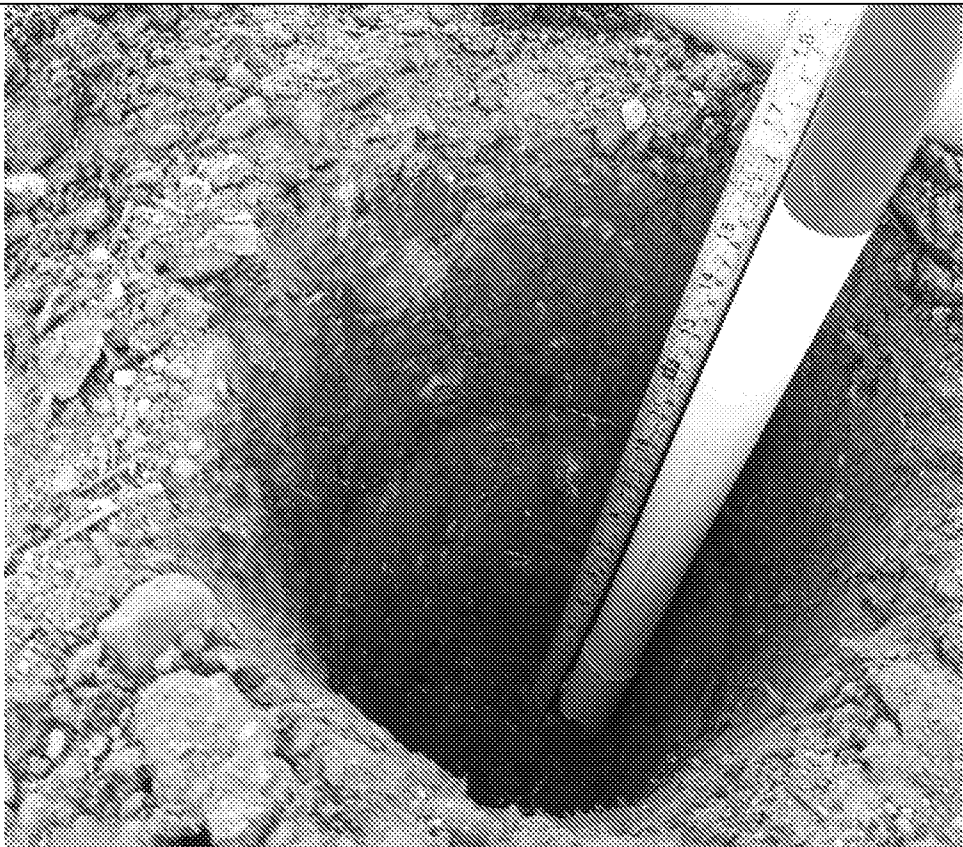
| <p><b>Photo No.</b></p> <p>6</p> <p><b>Date:</b></p> <p>21/07/2020</p> <p>View of hand dug pit in the rear garden of Plot 218</p> | |
