| PHOTOGRAPHIC LOG | |
| Site Location: Land at West End Nursery, Angmering | |

## **APPENDIX C**

### **HAND PIT LOGS**

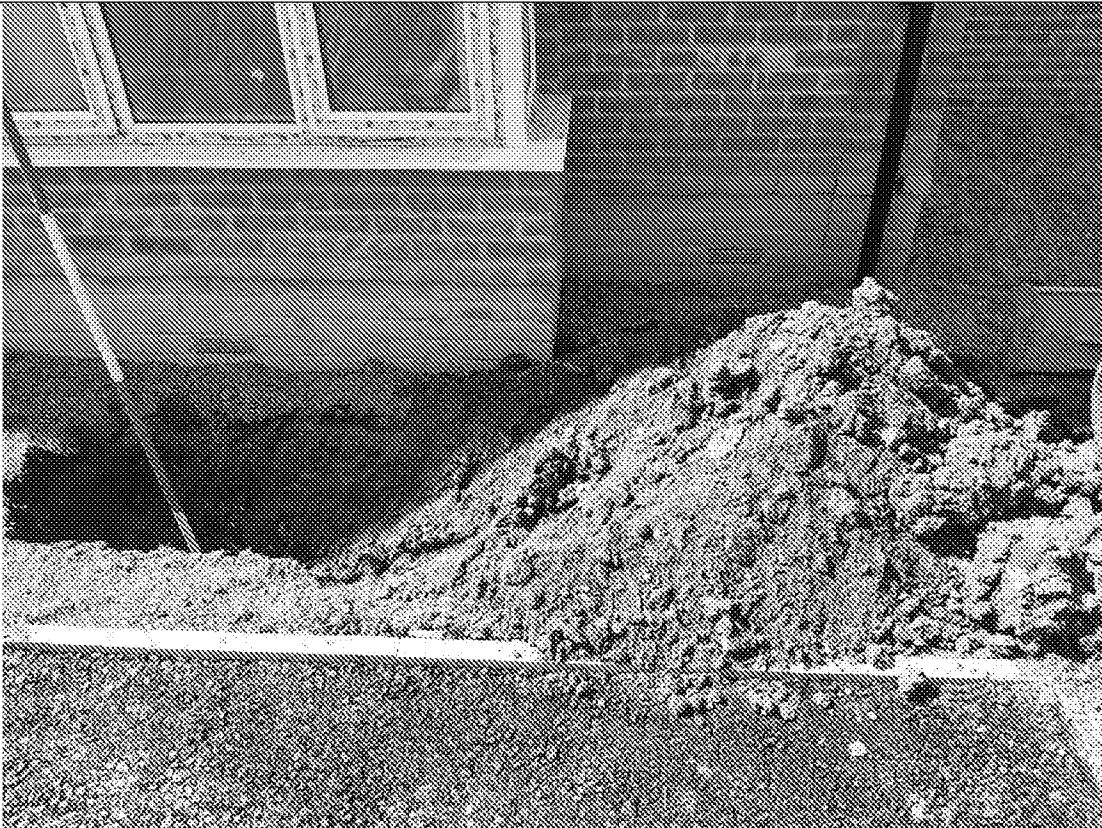
| PHOTOGRAPHIC LOG | |
|---|---|
| Photo No.<br><b>19</b><br>Date:<br>21/07/2020 | <p>Overview of Plot 224 front garden</p> |

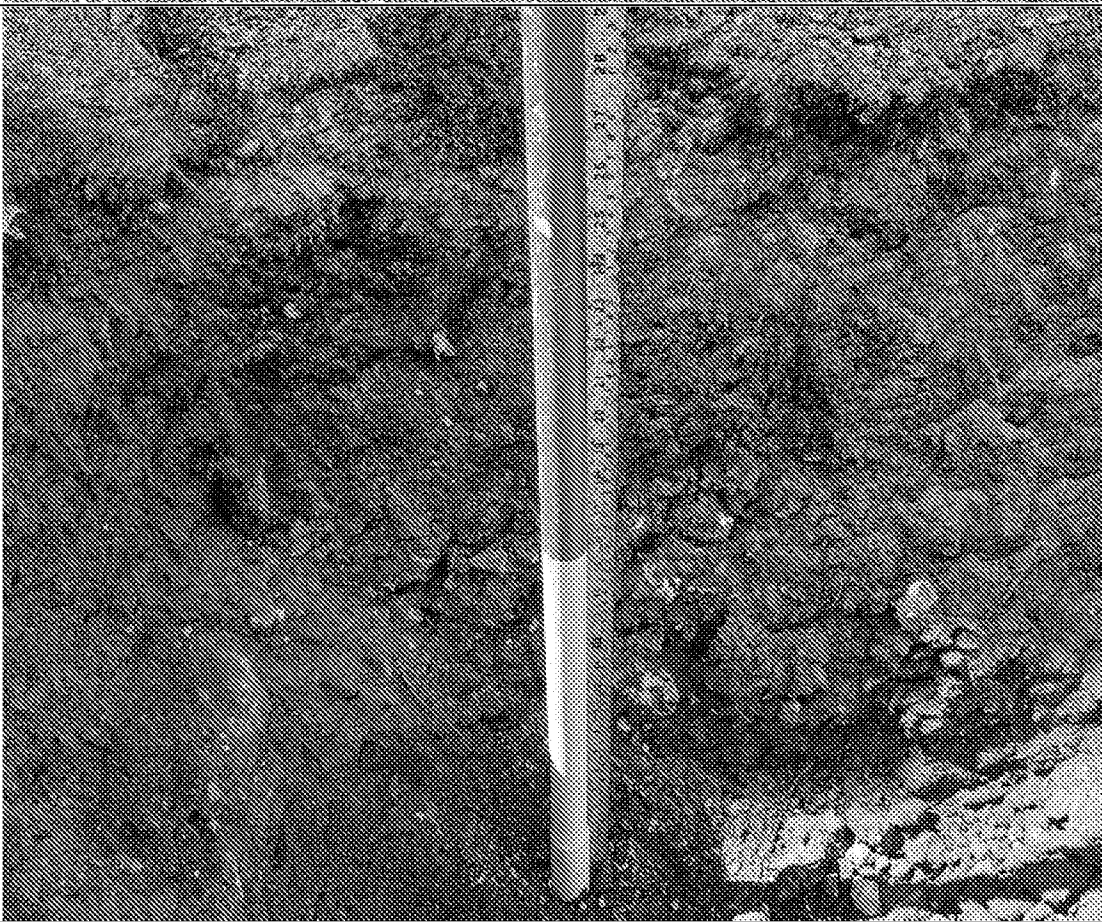
| PHOTOGRAPHIC LOG | |
|---|---|
| Photo No.<br><b>20</b><br>Date:<br>21/07/2020 | <p>View of the capping in Plot 224 front garden – at least 600 mm thick</p> |

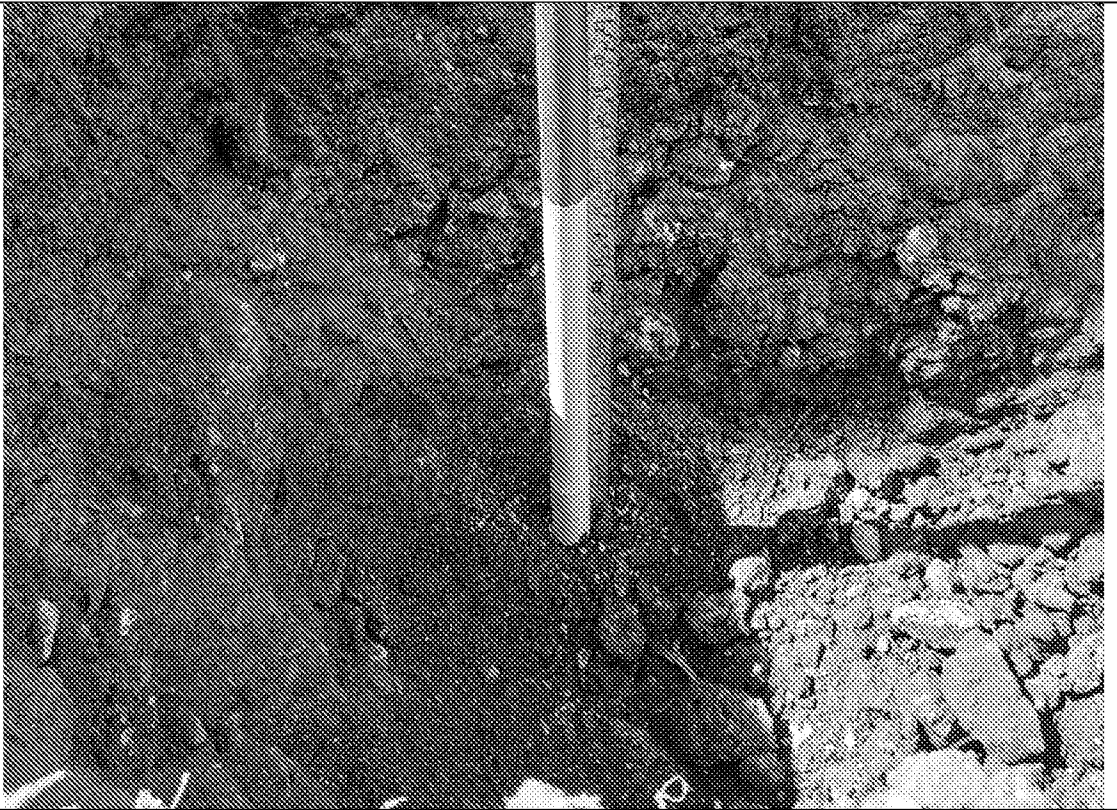
| <p>Photo No.</p> <p><b>21</b></p> <p>Date:</p> <p>21/07/2020</p> <p>View of hand dug pit in the front garden of Plot 224</p> | |

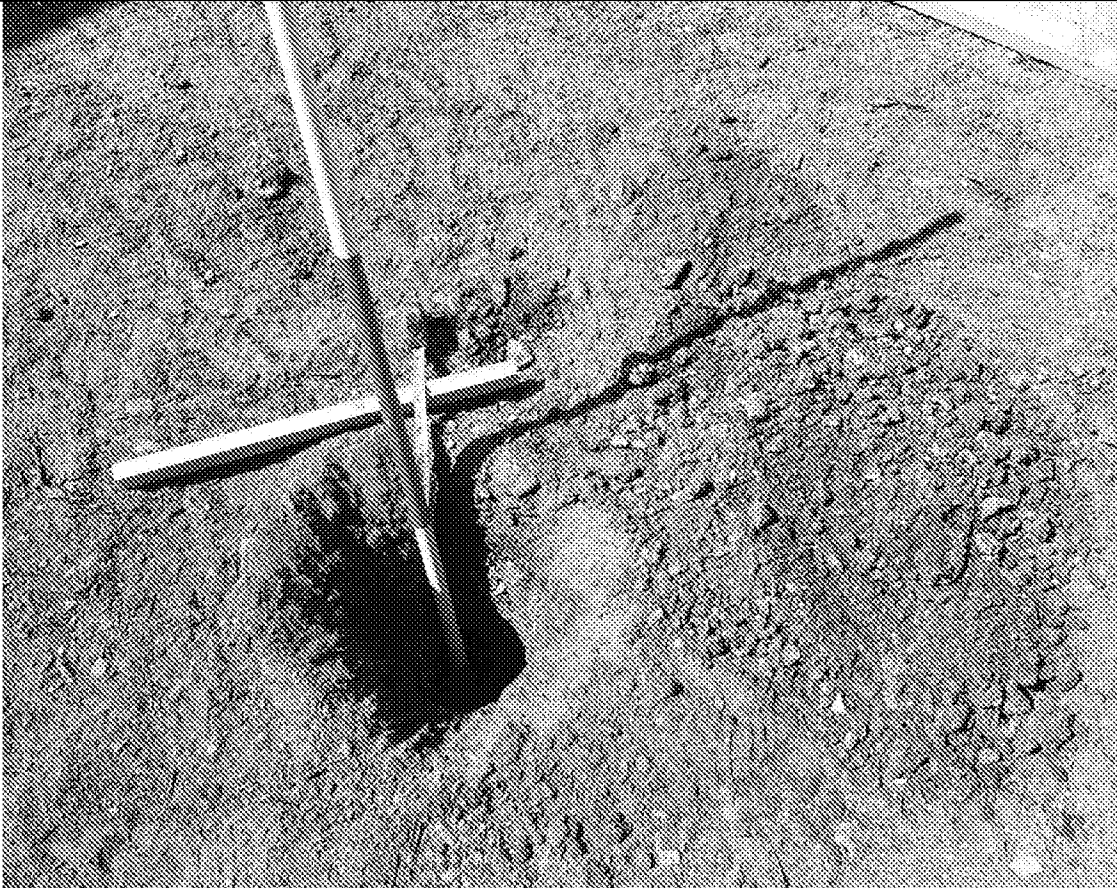
| <p>Photo No.</p> <p><b>22</b></p> <p>Date:</p> <p>21/07/2020</p> <p>Overview of Plot 224 rear garden</p> | |

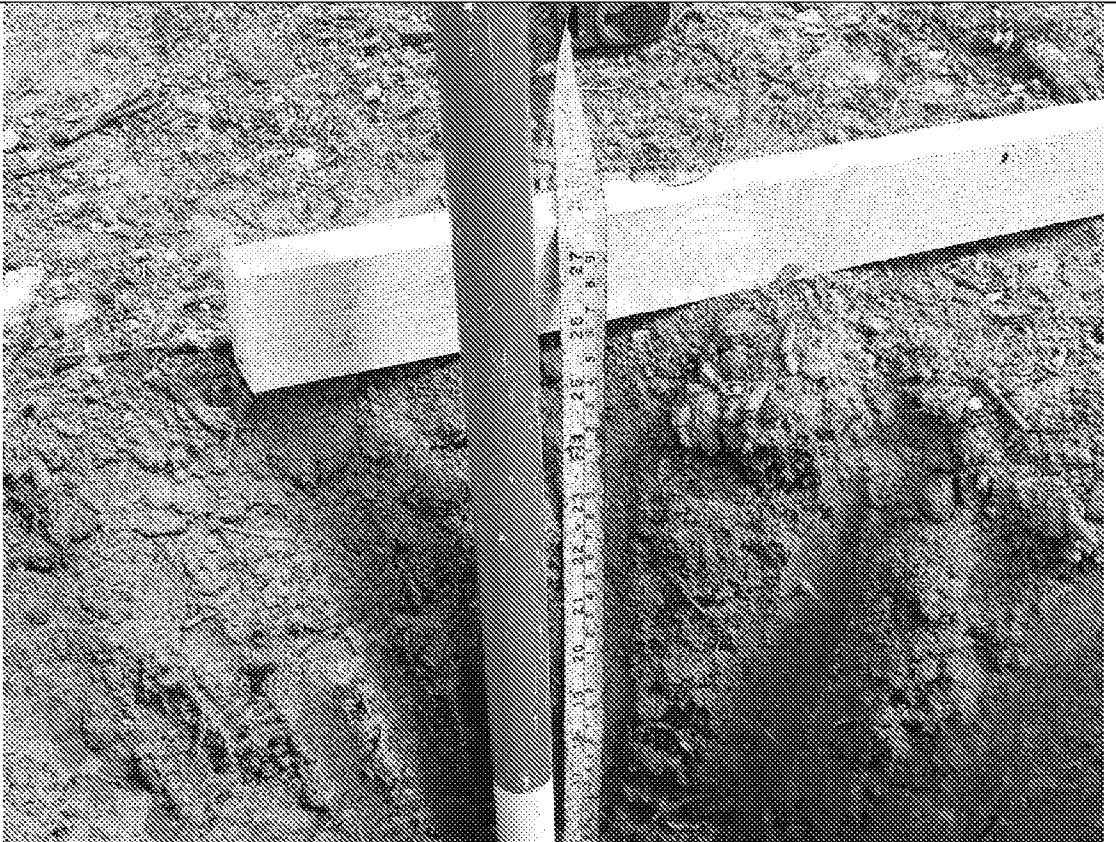
| PHOTOGRAPHIC LOG | |
|---|---|
| Photo No.<br><b>23</b><br>Date:<br>21/07/2020 | <p>View of the capping in Plot 224 rear garden – at least 600 mm thick</p> |

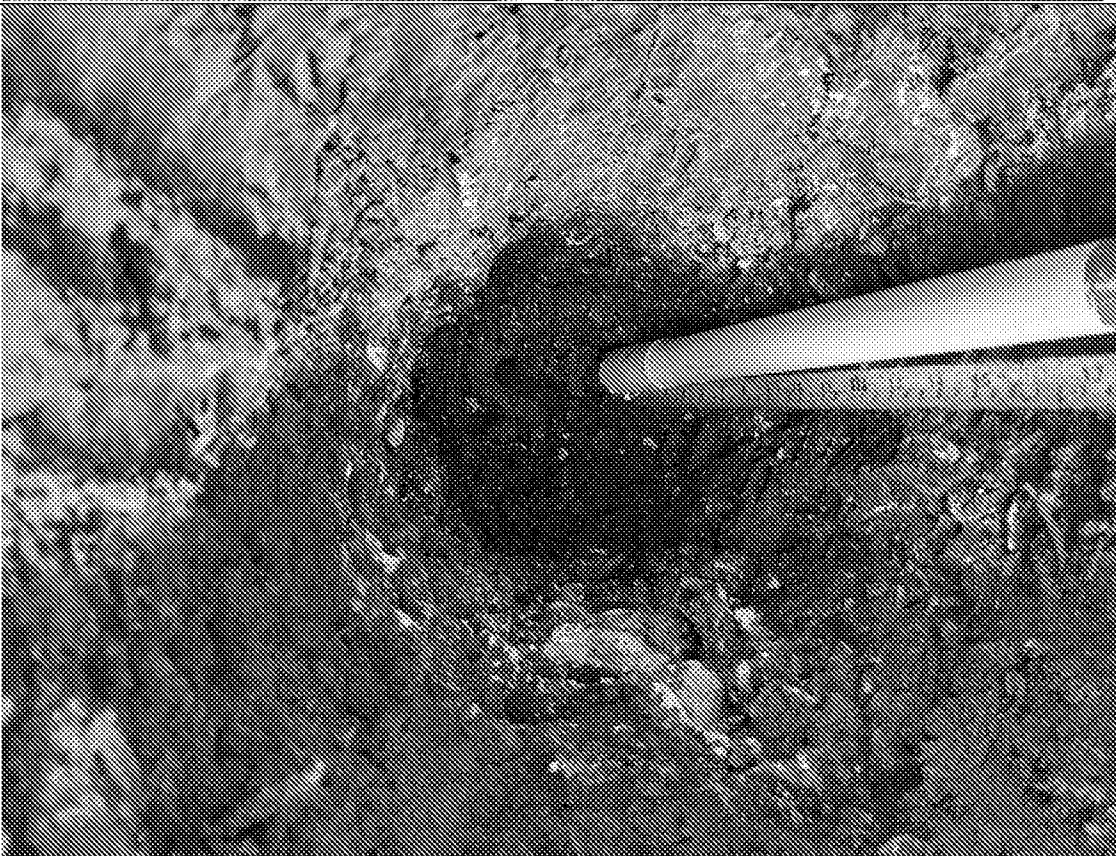
| PHOTOGRAPHIC LOG | |
|---|---|
| Photo No.<br><b>24</b><br>Date:<br>21/07/2020 | <p>View of hand dug pit in the rear garden of Plot 224</p> |

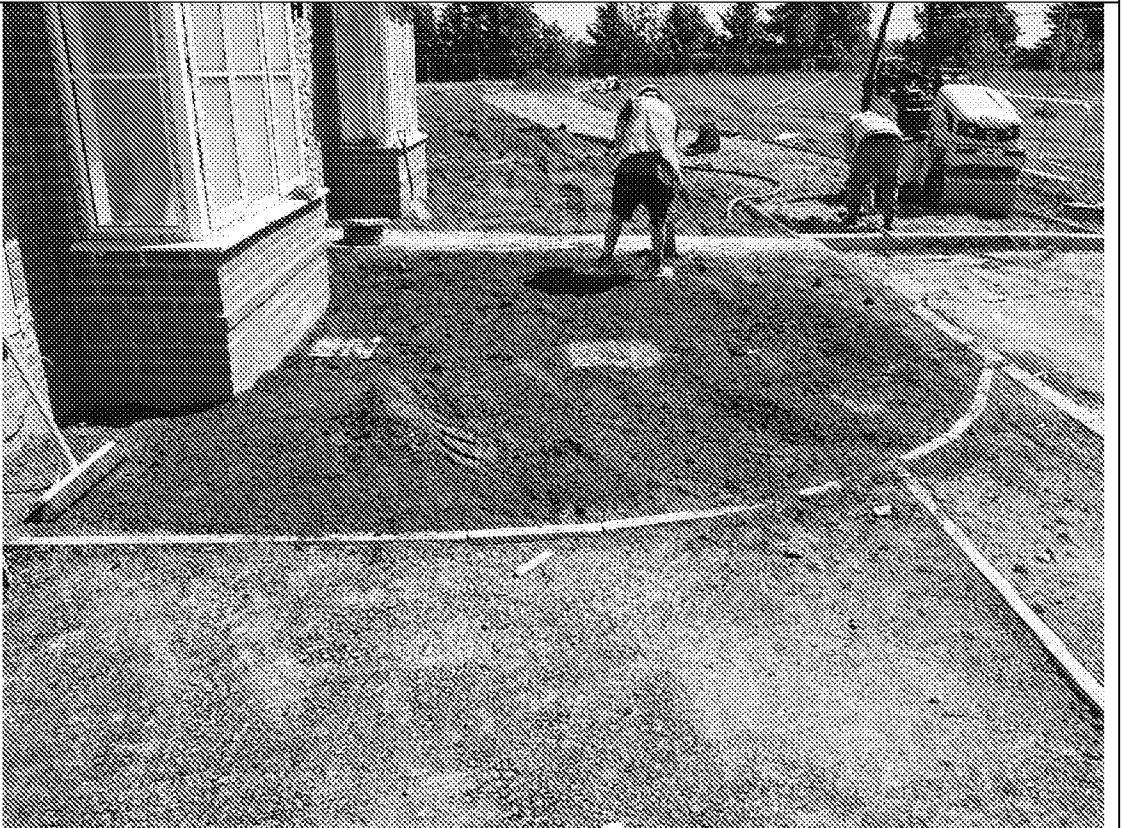
| <p>Photo No.<br/>25</p> <p>Date:<br/>21/07/2020</p> <p>Overview of Plot 225 front garden</p> | |

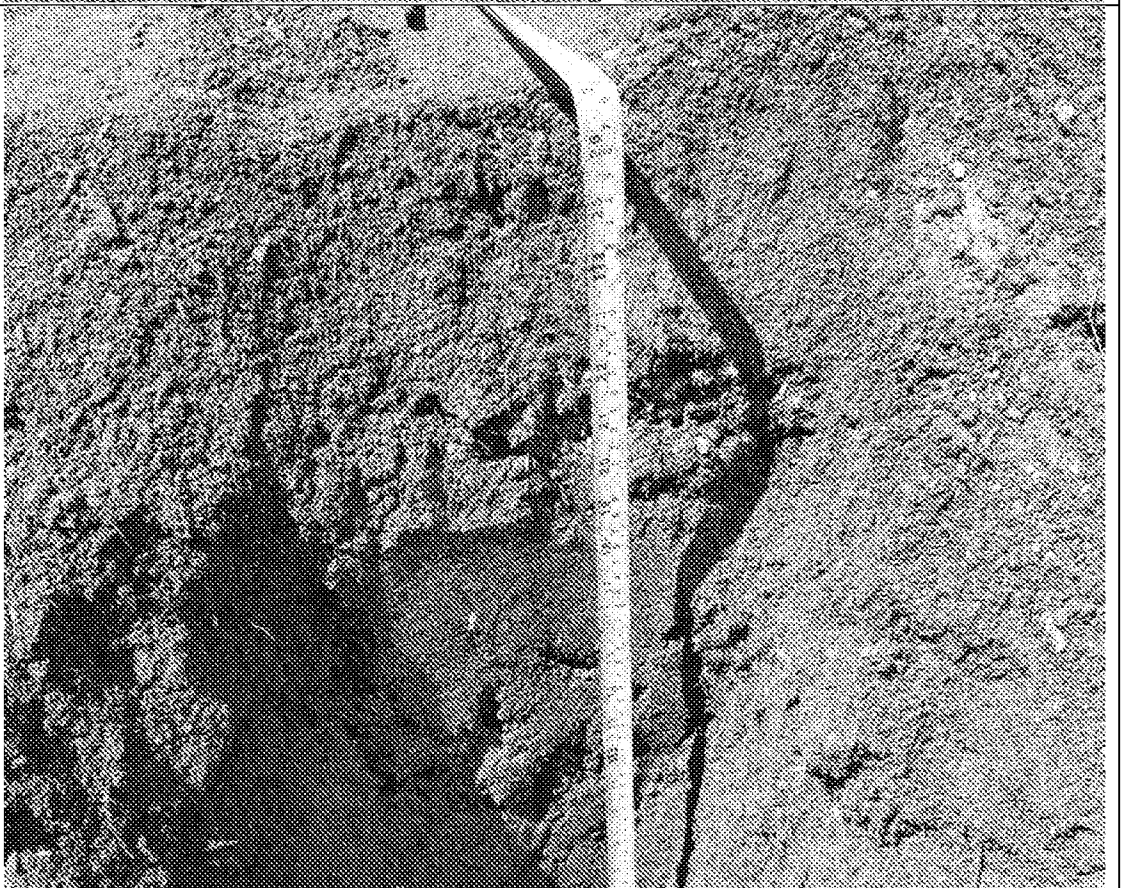
| <p>Photo No.<br/>26</p> <p>Date:<br/>21/07/2020</p> <p>View of the capping in Plot 225 front garden – at least 600 mm thick</p> | |

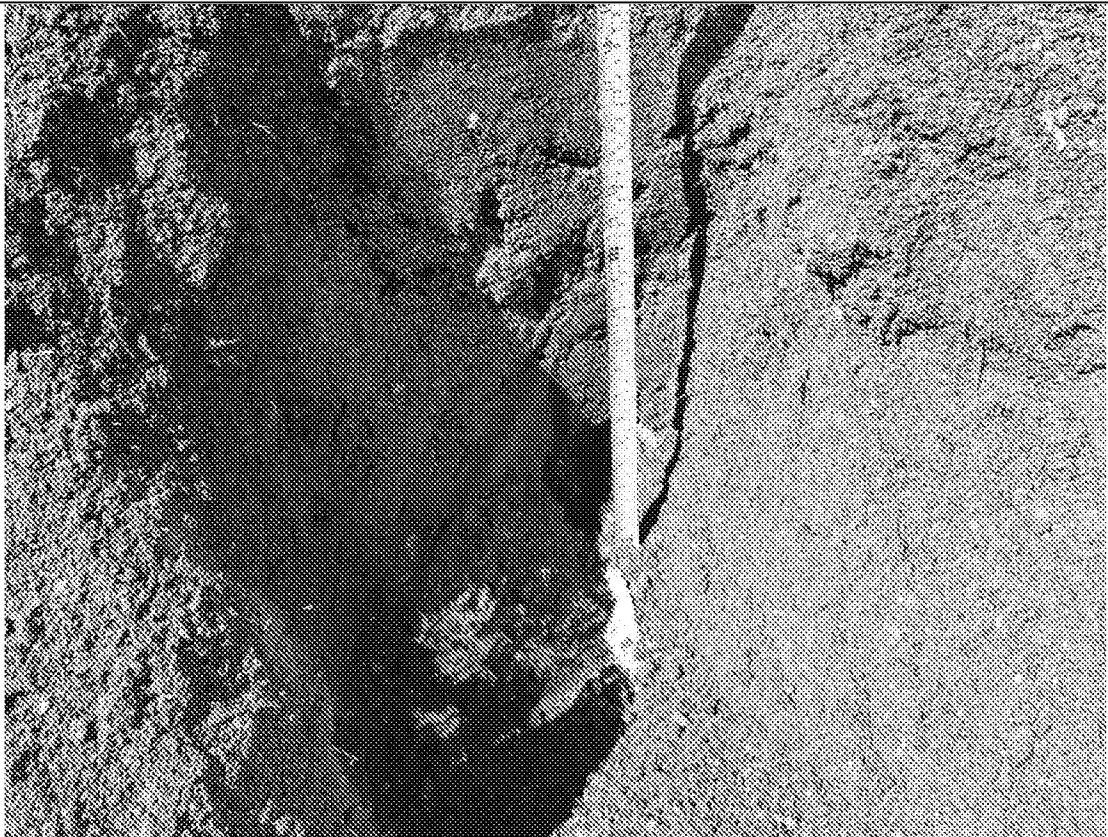
| <p>Photo No.<br/>27</p> <p>Date:<br/>21/07/2020</p> <p>View of hand dug pit in the front garden of Plot 225 with membrane marker.</p> | |

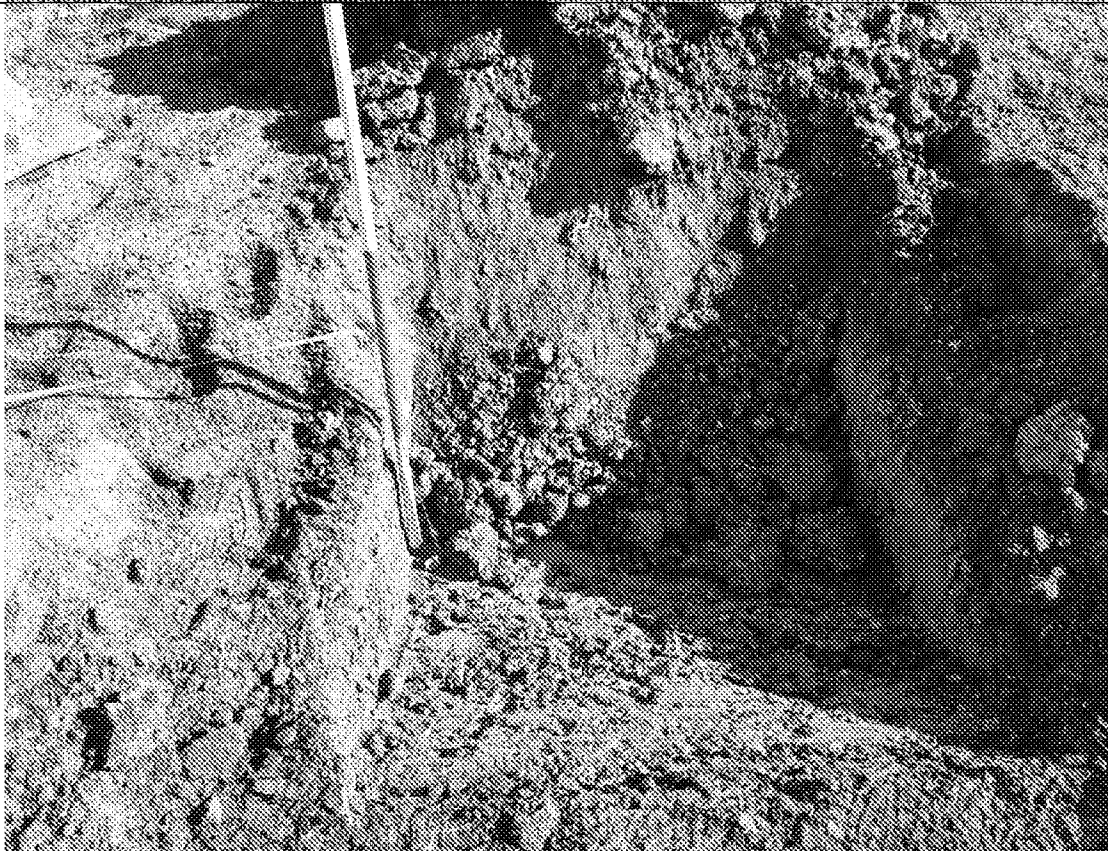
| <p>Photo No.<br/>28</p> <p>Date:<br/>21/07/2020</p> <p>Overview of Plot 225 rear garden</p> | |

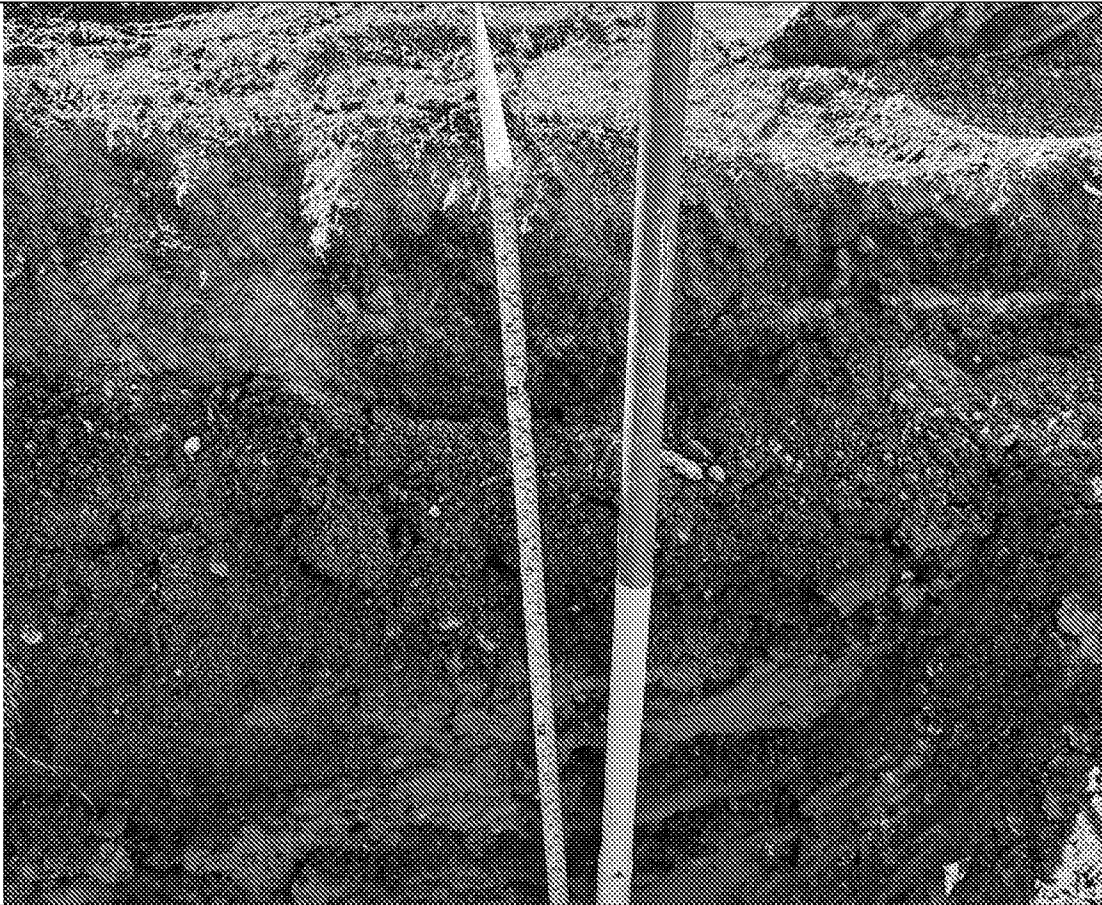
| <p><b>Photo No.</b><br/><b>29</b></p> <p><b>Date:</b><br/>21/07/2020</p> <p>View of the capping in Plot 225 rear garden – at least 600 mm thick.</p> | |

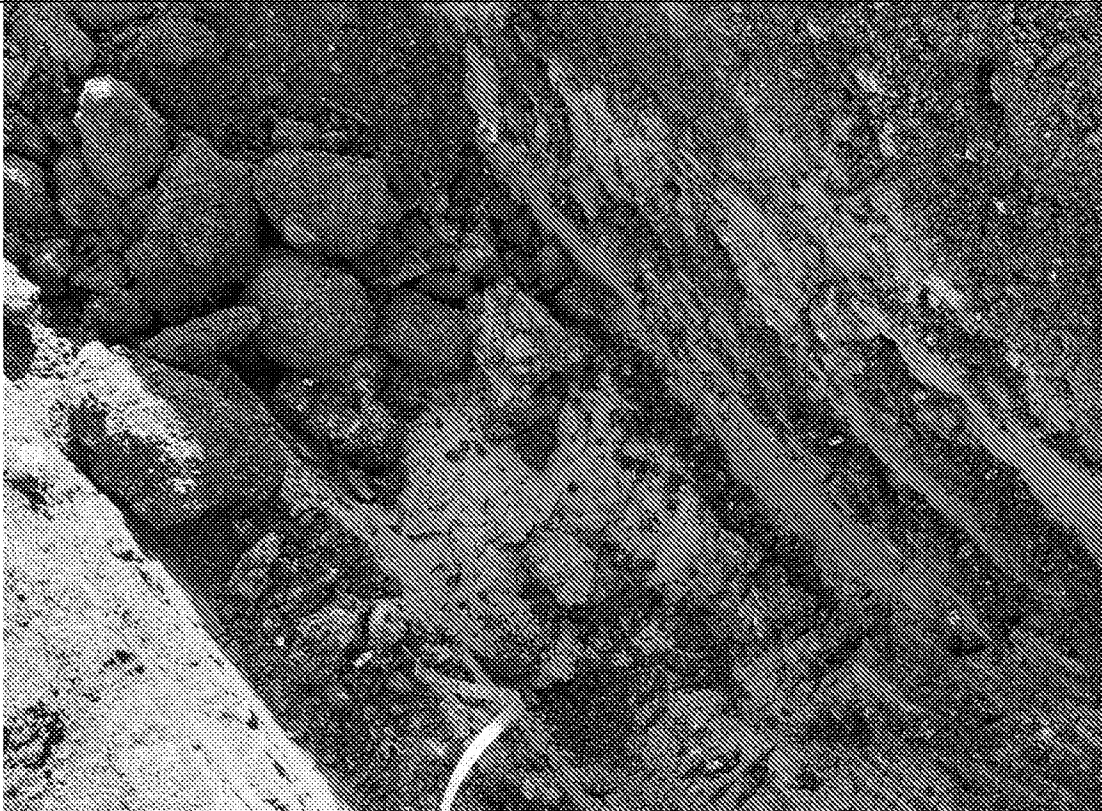
| <p><b>Photo No.</b><br/><b>30</b></p> <p><b>Date:</b><br/>21/07/2020</p> <p>View of hand dug pit in the rear garden of Plot 225</p> | |

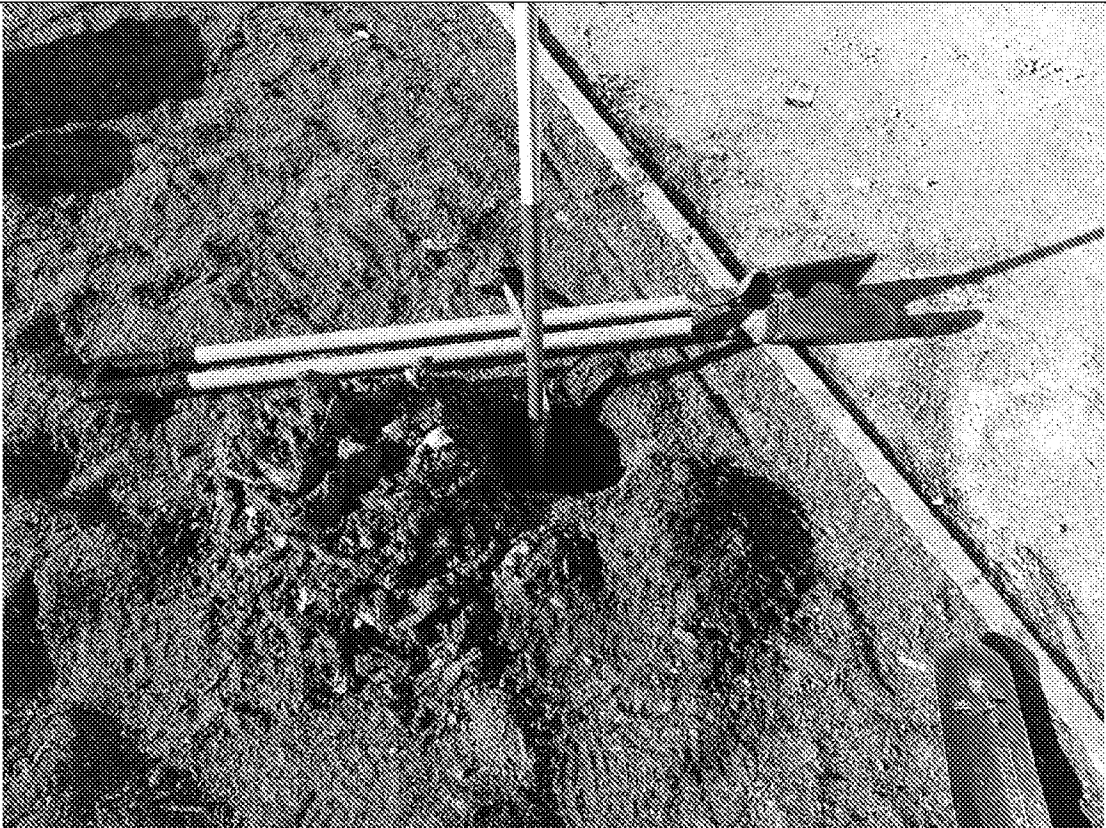
| PHOTOGRAPHIC LOG | |
|---|---|
| <b>Photo No.</b><br><b>31</b> | |

| PHOTOGRAPHIC LOG | |
|---|---|
| Overview of Plot 228 front garden | |

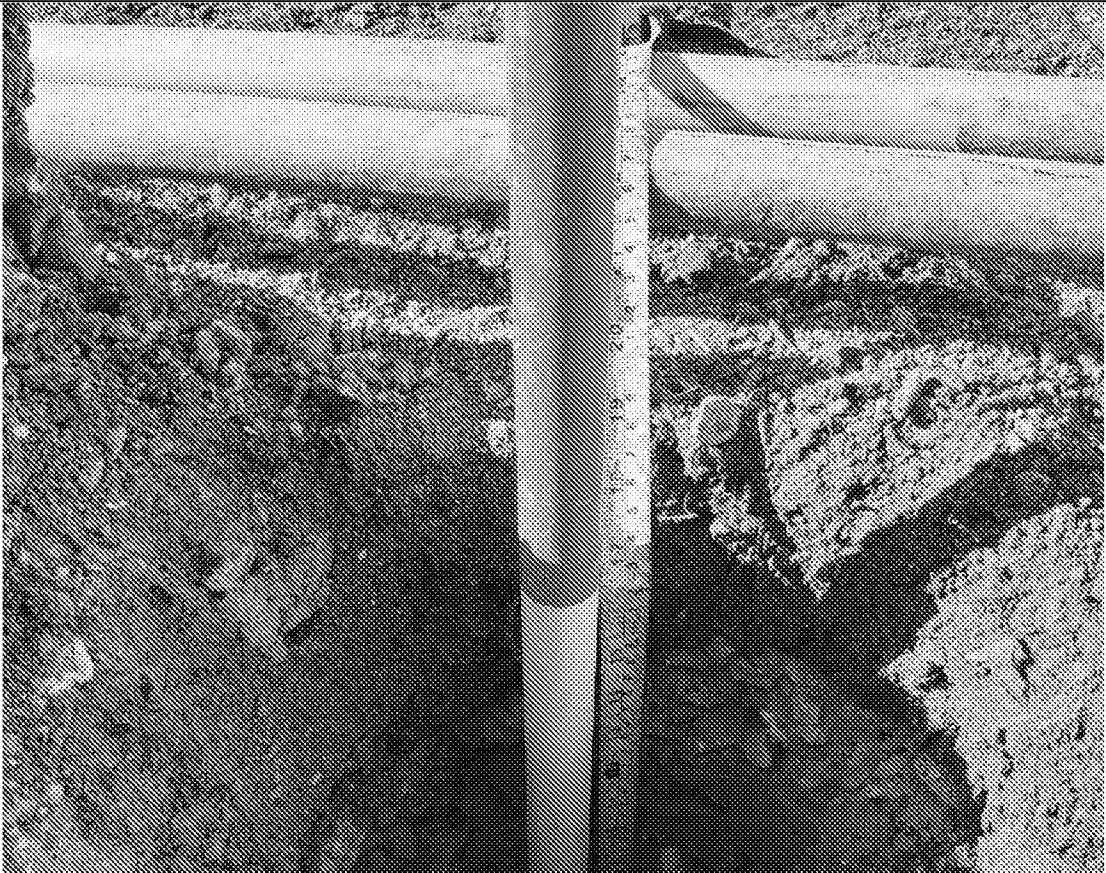
| PHOTOGRAPHIC LOG | |
|---|---|
| <b>Photo No.</b><br><b>32</b> | |

| PHOTOGRAPHIC LOG | |
|---|---|
| View of the capping in Plot 228 front garden – at least 450 mm thick | |

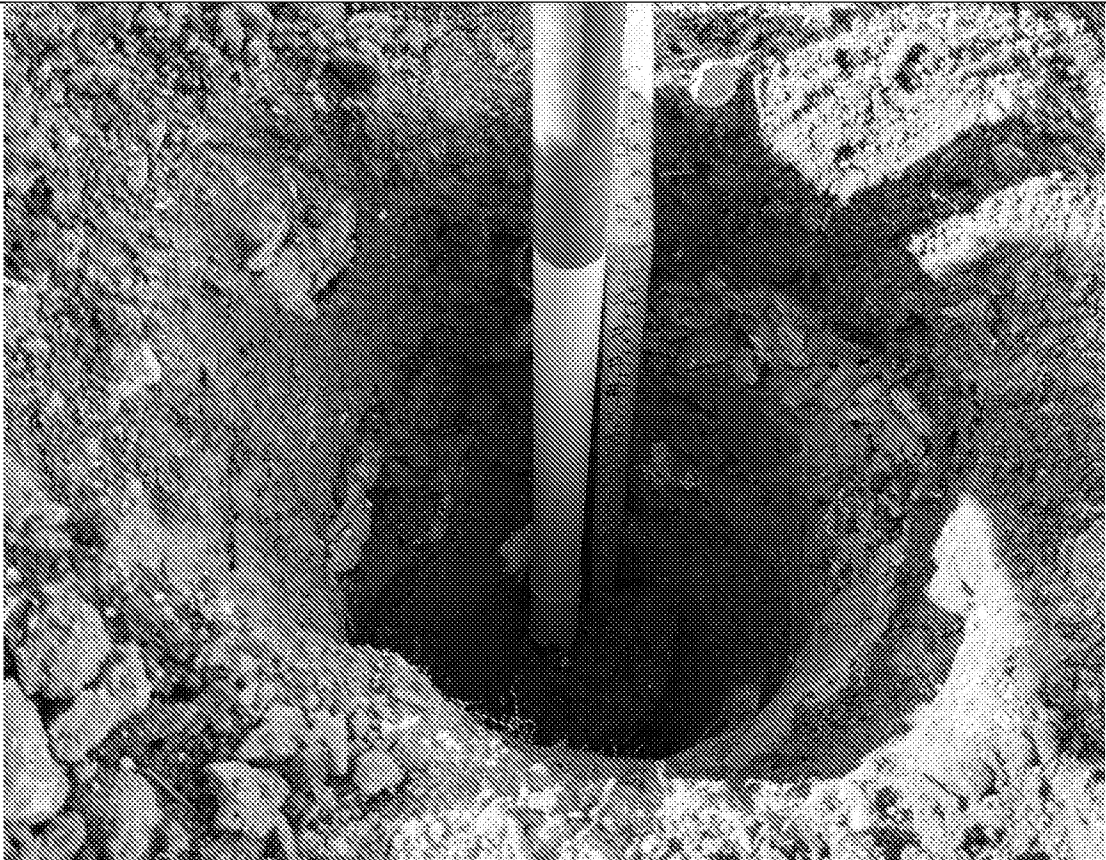
| <p>Photo No.<br/><b>33</b></p> <p>Date:<br/>21/07/2020</p> | |

| <p>View of hand dug pit in the front garden of Plot 228</p> | |

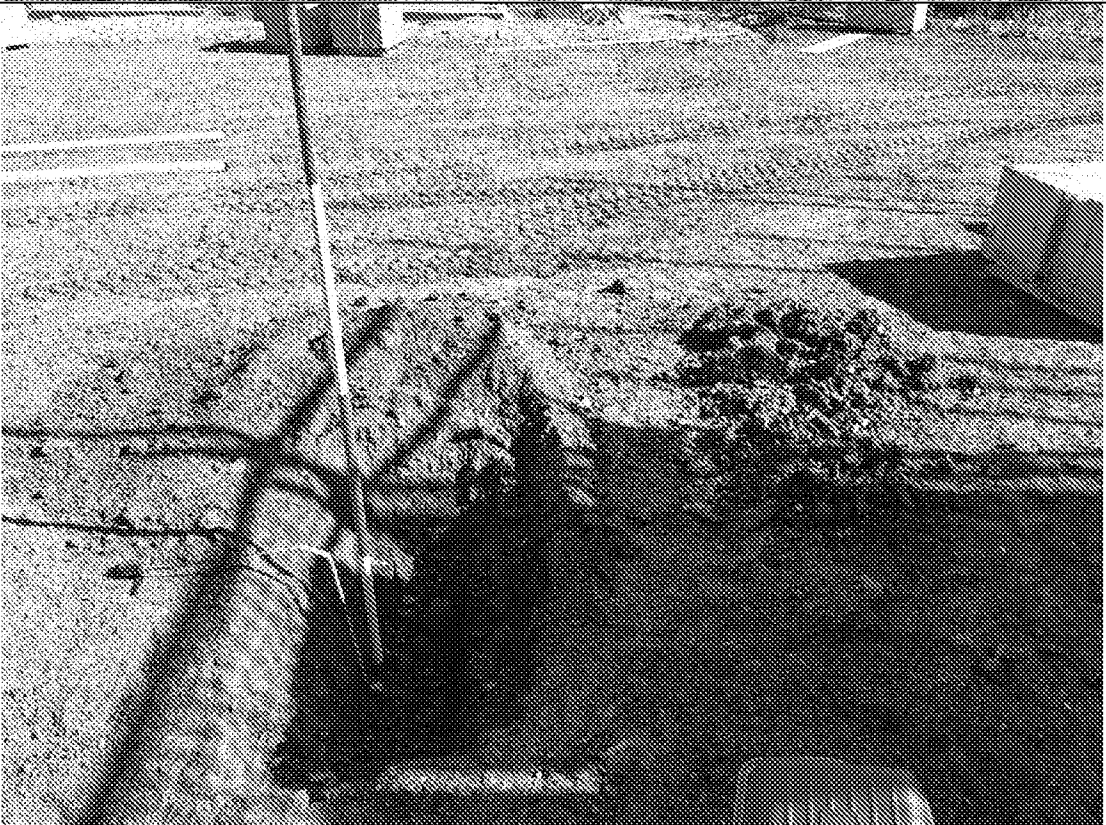
| <p>Photo No.<br/><b>34</b></p> <p>Date:<br/>21/07/2020</p> | |

| <p>Overview of Plot 228 rear garden</p> | |

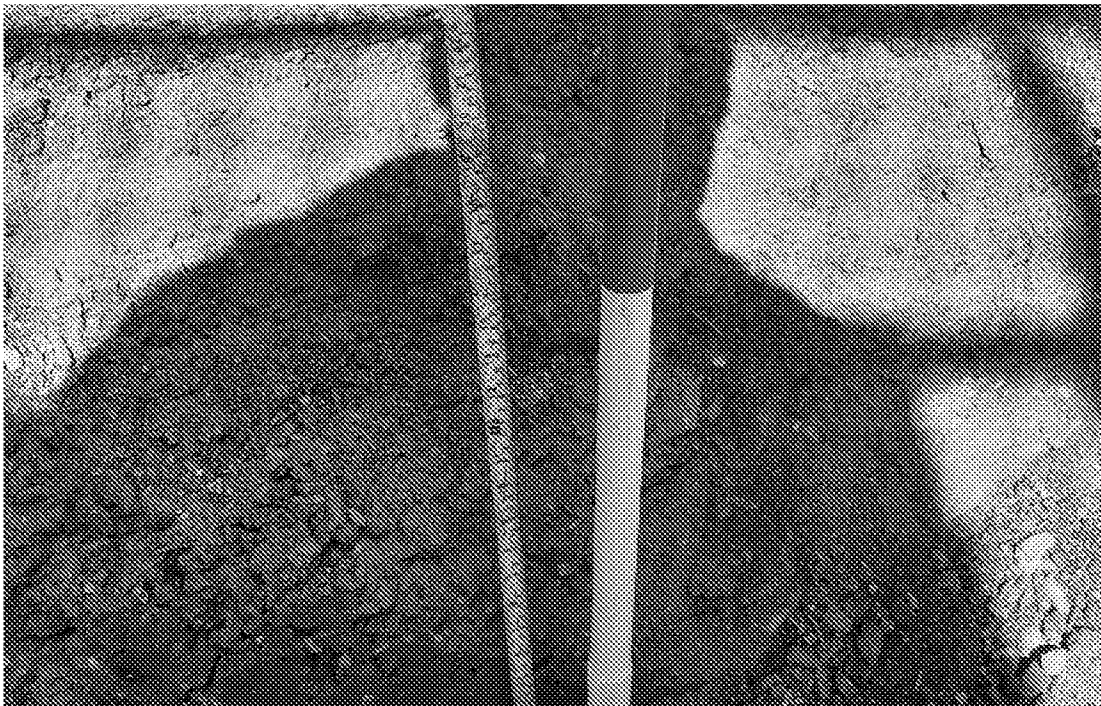
| <p><b>Photo No.</b></p> <p><b>35</b></p> <p><b>Date:</b></p> <p>21/07/2020</p> <p>View of the capping in Plot 228 rear garden – at least 450 mm thick.</p> | |

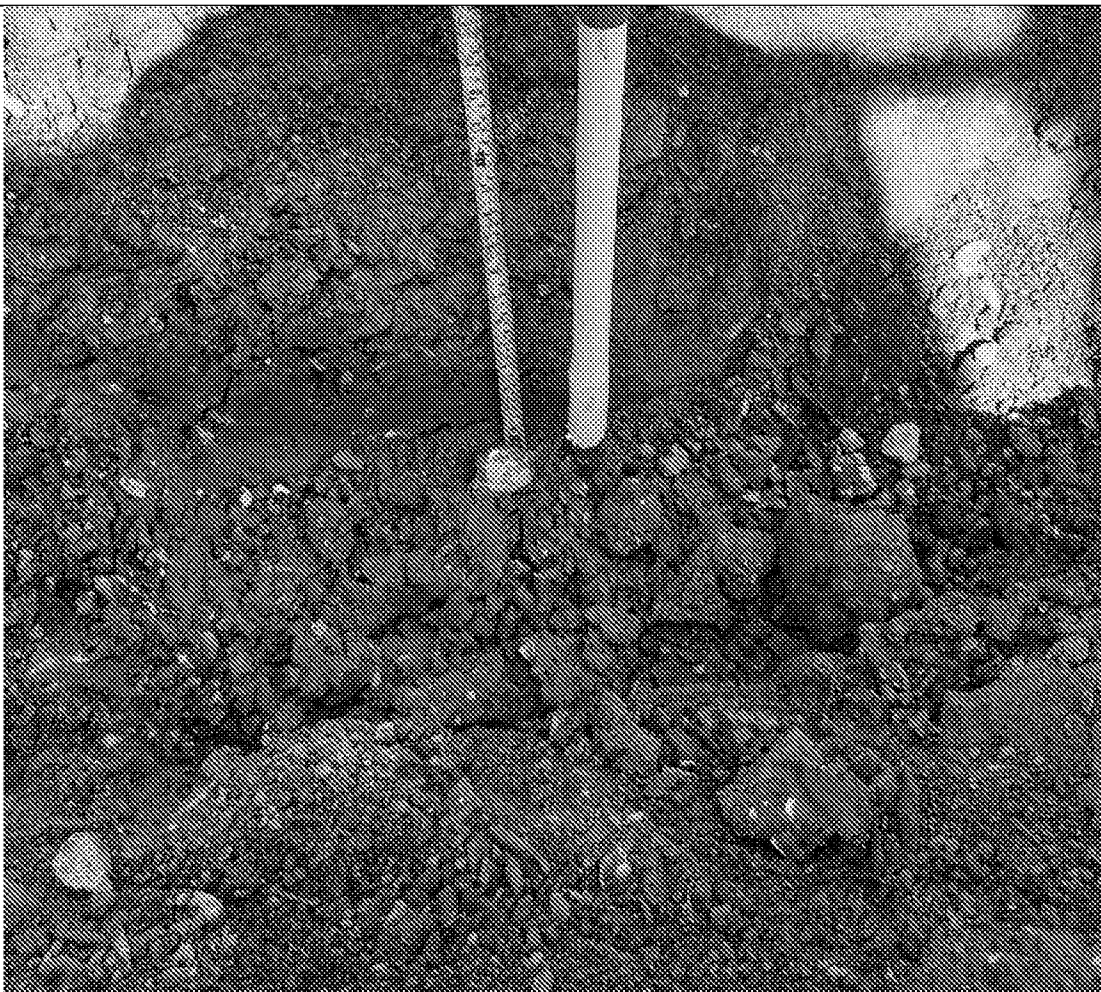
| <p><b>Photo No.</b></p> <p><b>36</b></p> <p><b>Date:</b></p> <p>21/07/2020</p> <p>View of hand dug pit in the rear garden of Plot 228</p> | |

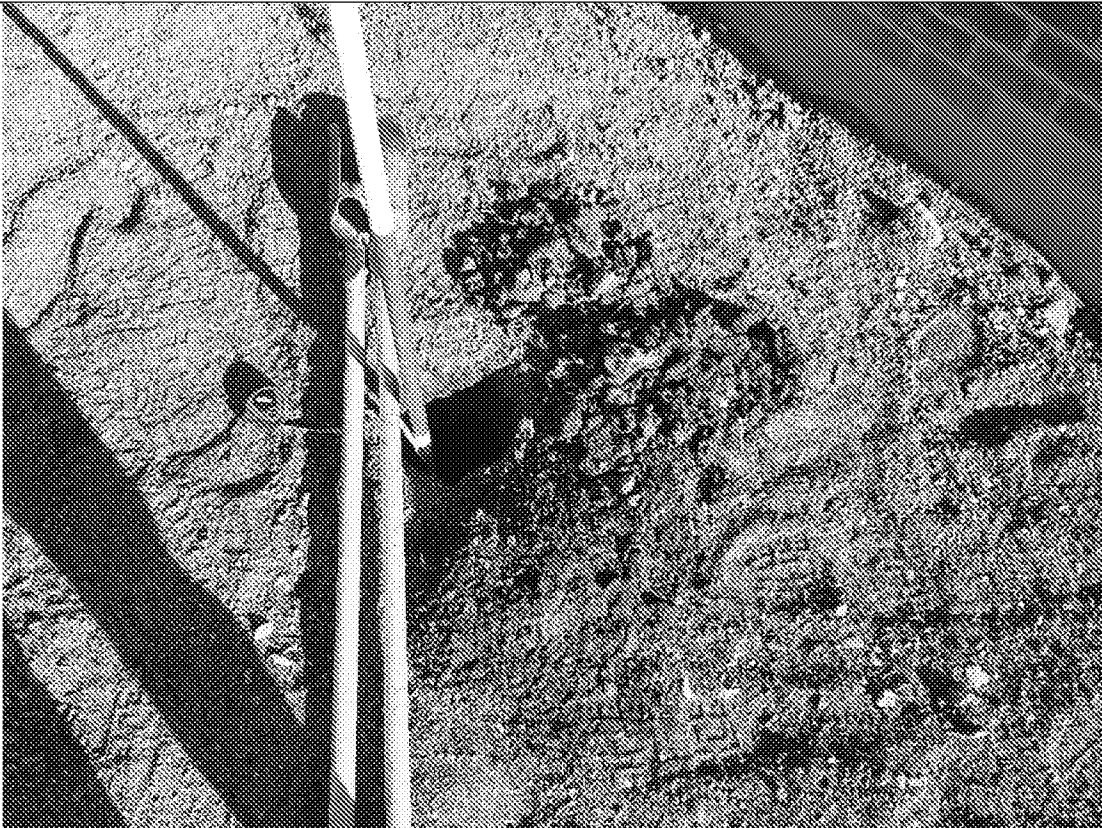
| <p>Photo No.<br/><b>37</b></p> <p>Date:<br/>21/07/2020</p> <p>Overview of Plot 229 front garden</p> | |

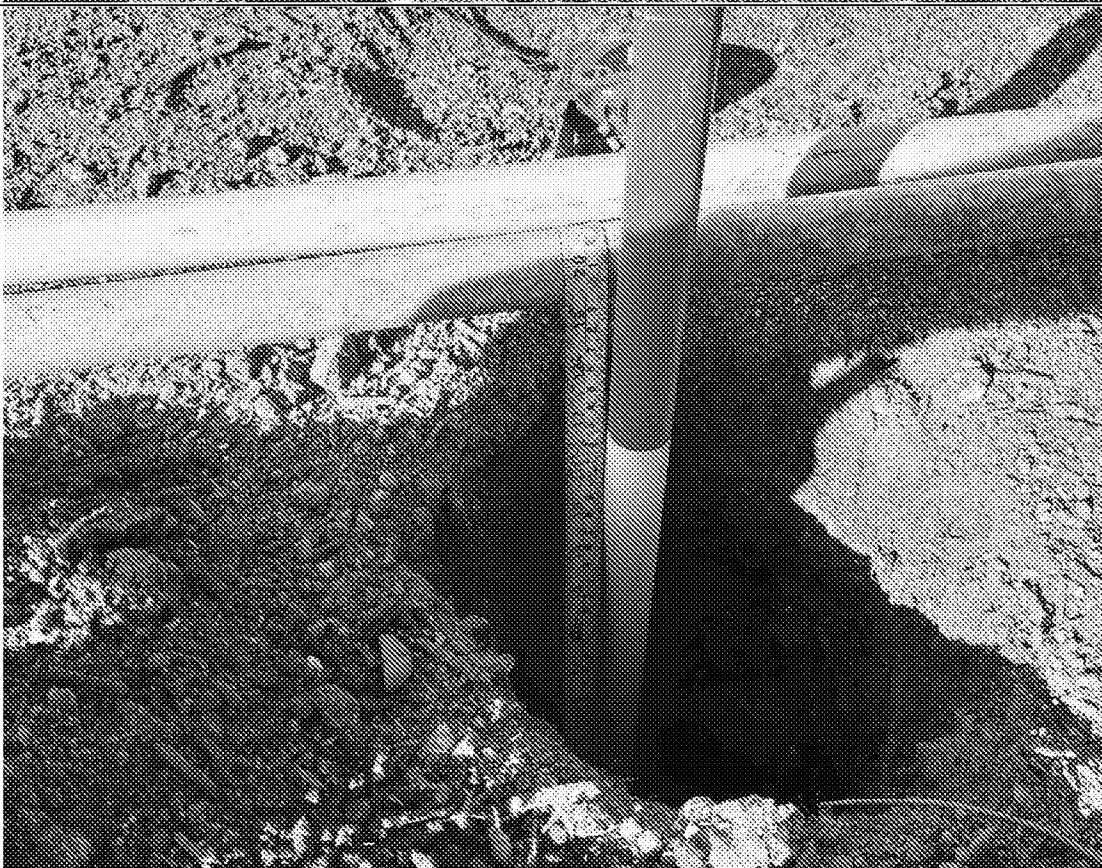
| <p>Photo No.<br/><b>38</b></p> <p>Date:<br/>21/07/2020</p> <p>View of the capping in Plot 229 front garden – at least 450 mm thick</p> | |

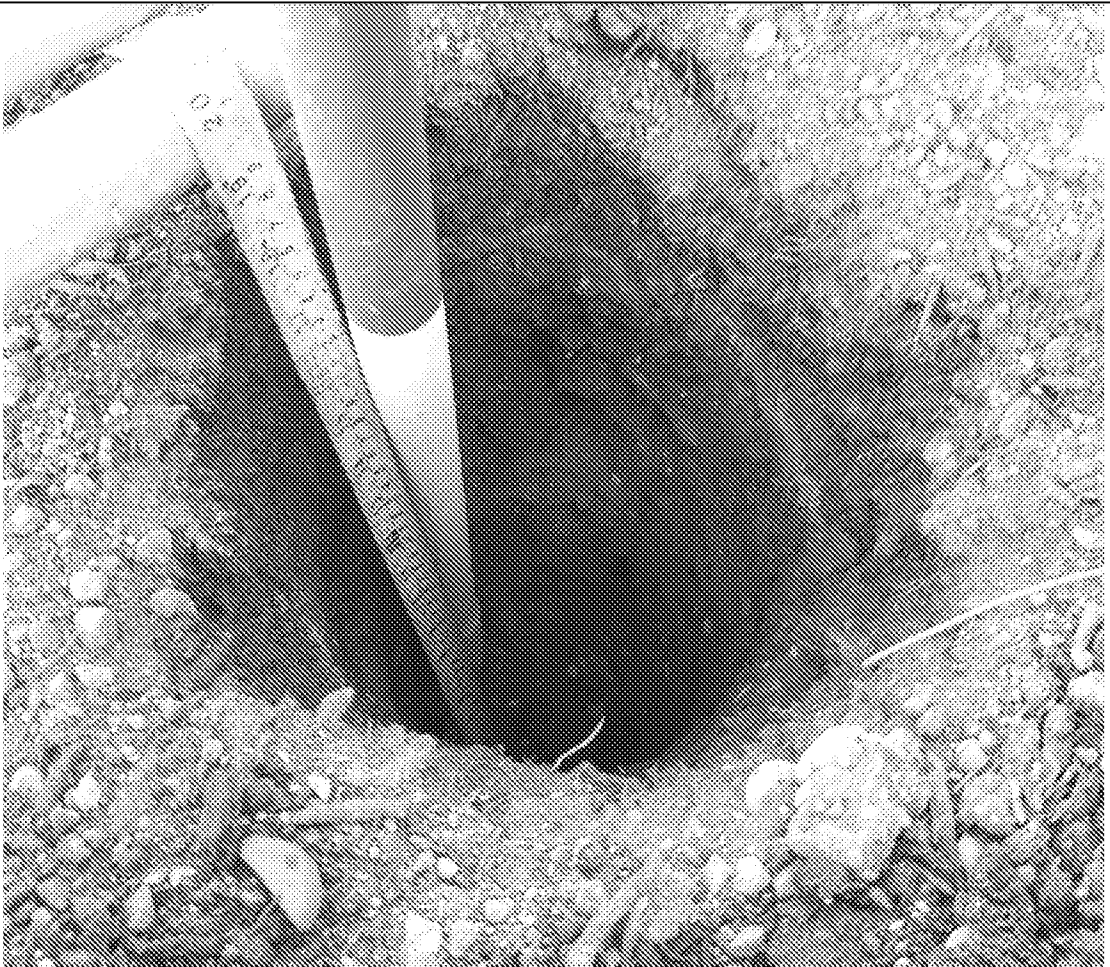
| <p>Photo No.<br/><b>39</b></p> | |

| <p>View of hand dug pit in the front garden of Plot 229</p> | |

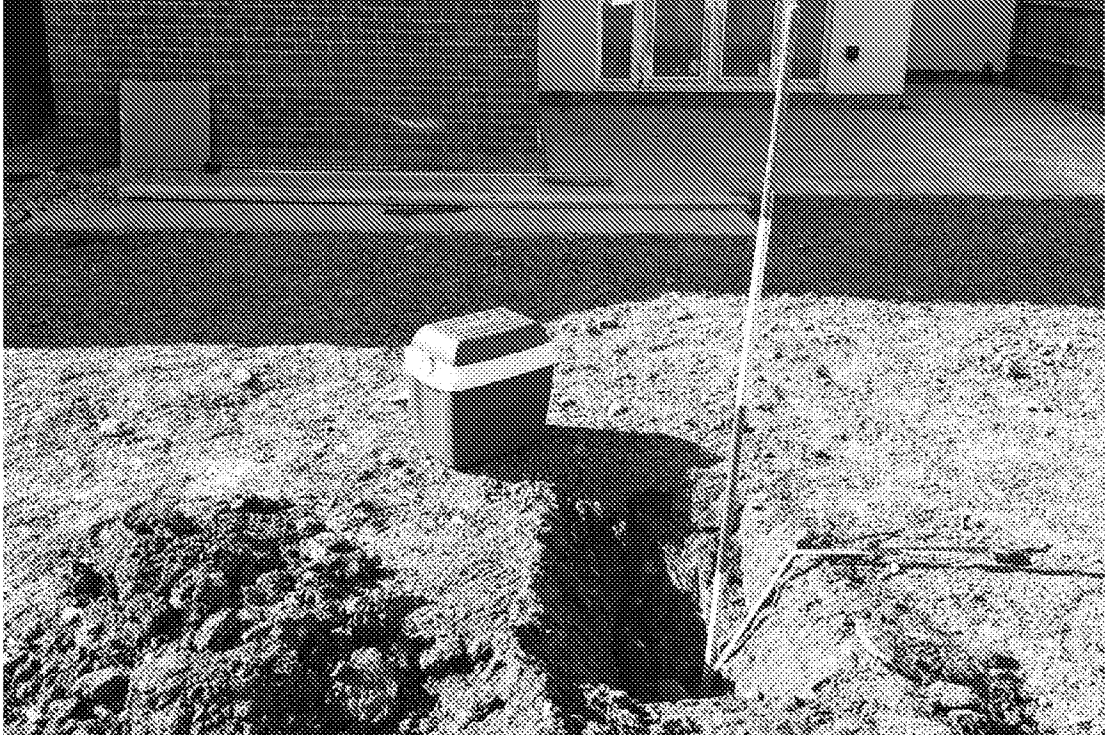
| <p>Photo No.<br/><b>40</b></p> | |

| <p>Overview of Plot 229 rear garden</p> | |

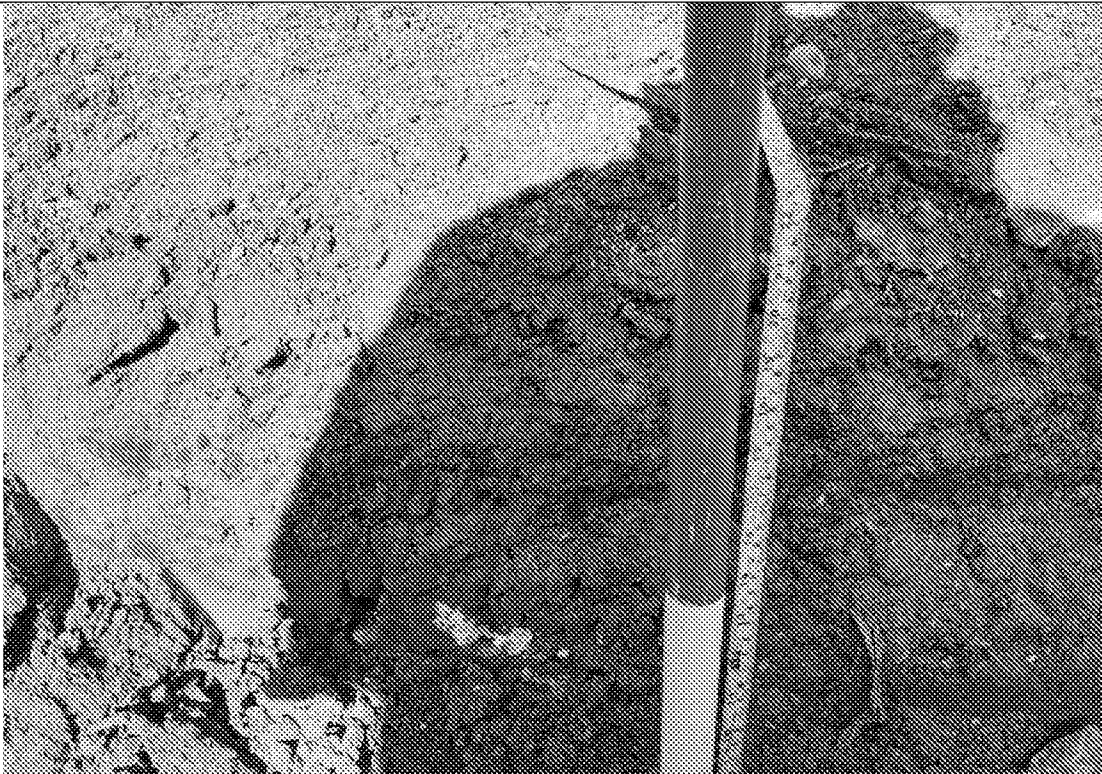
| <b>Photo No.</b><br><b>41</b> | |

| View of the capping in Plot 229 rear garden – at least 450 mm thick. | |
