| PHOTOGRAPHIC LOG | |
| Site Location: Land at West End Nursery, Angmering | |

## **APPENDIX C**

### **HAND PIT LOGS**

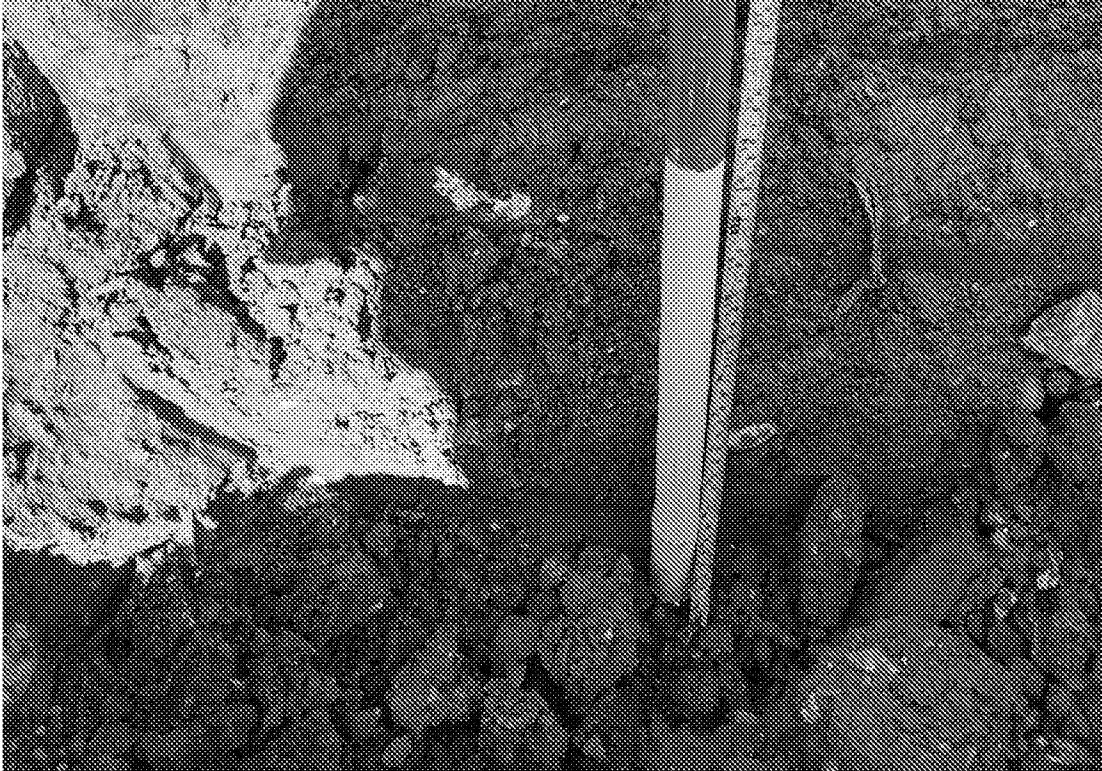
| <b>Photo No.</b><br><b>42</b> | |

| View of hand dug pit in the rear garden of Plot 229 | |
