Project Title  
FORMER WEST END NURSERY,  
ANGMERING

Drawing Title  
OUTSTANDING  
REMEDIAL/VALIDATION WORKS

**EXTENT OF MADE GROUND ENCOUNTERED IN PHASE 1B PLOTS 65 TO 121**

**RE: FORMER WEST END NURSERY, ANGMERING – PHASE 1B ASBESTOS DELINEATION WORKS (PLOTS 65 TO 121) AND HISTORIC BOILER HOUSE VALIDATION WORKS**

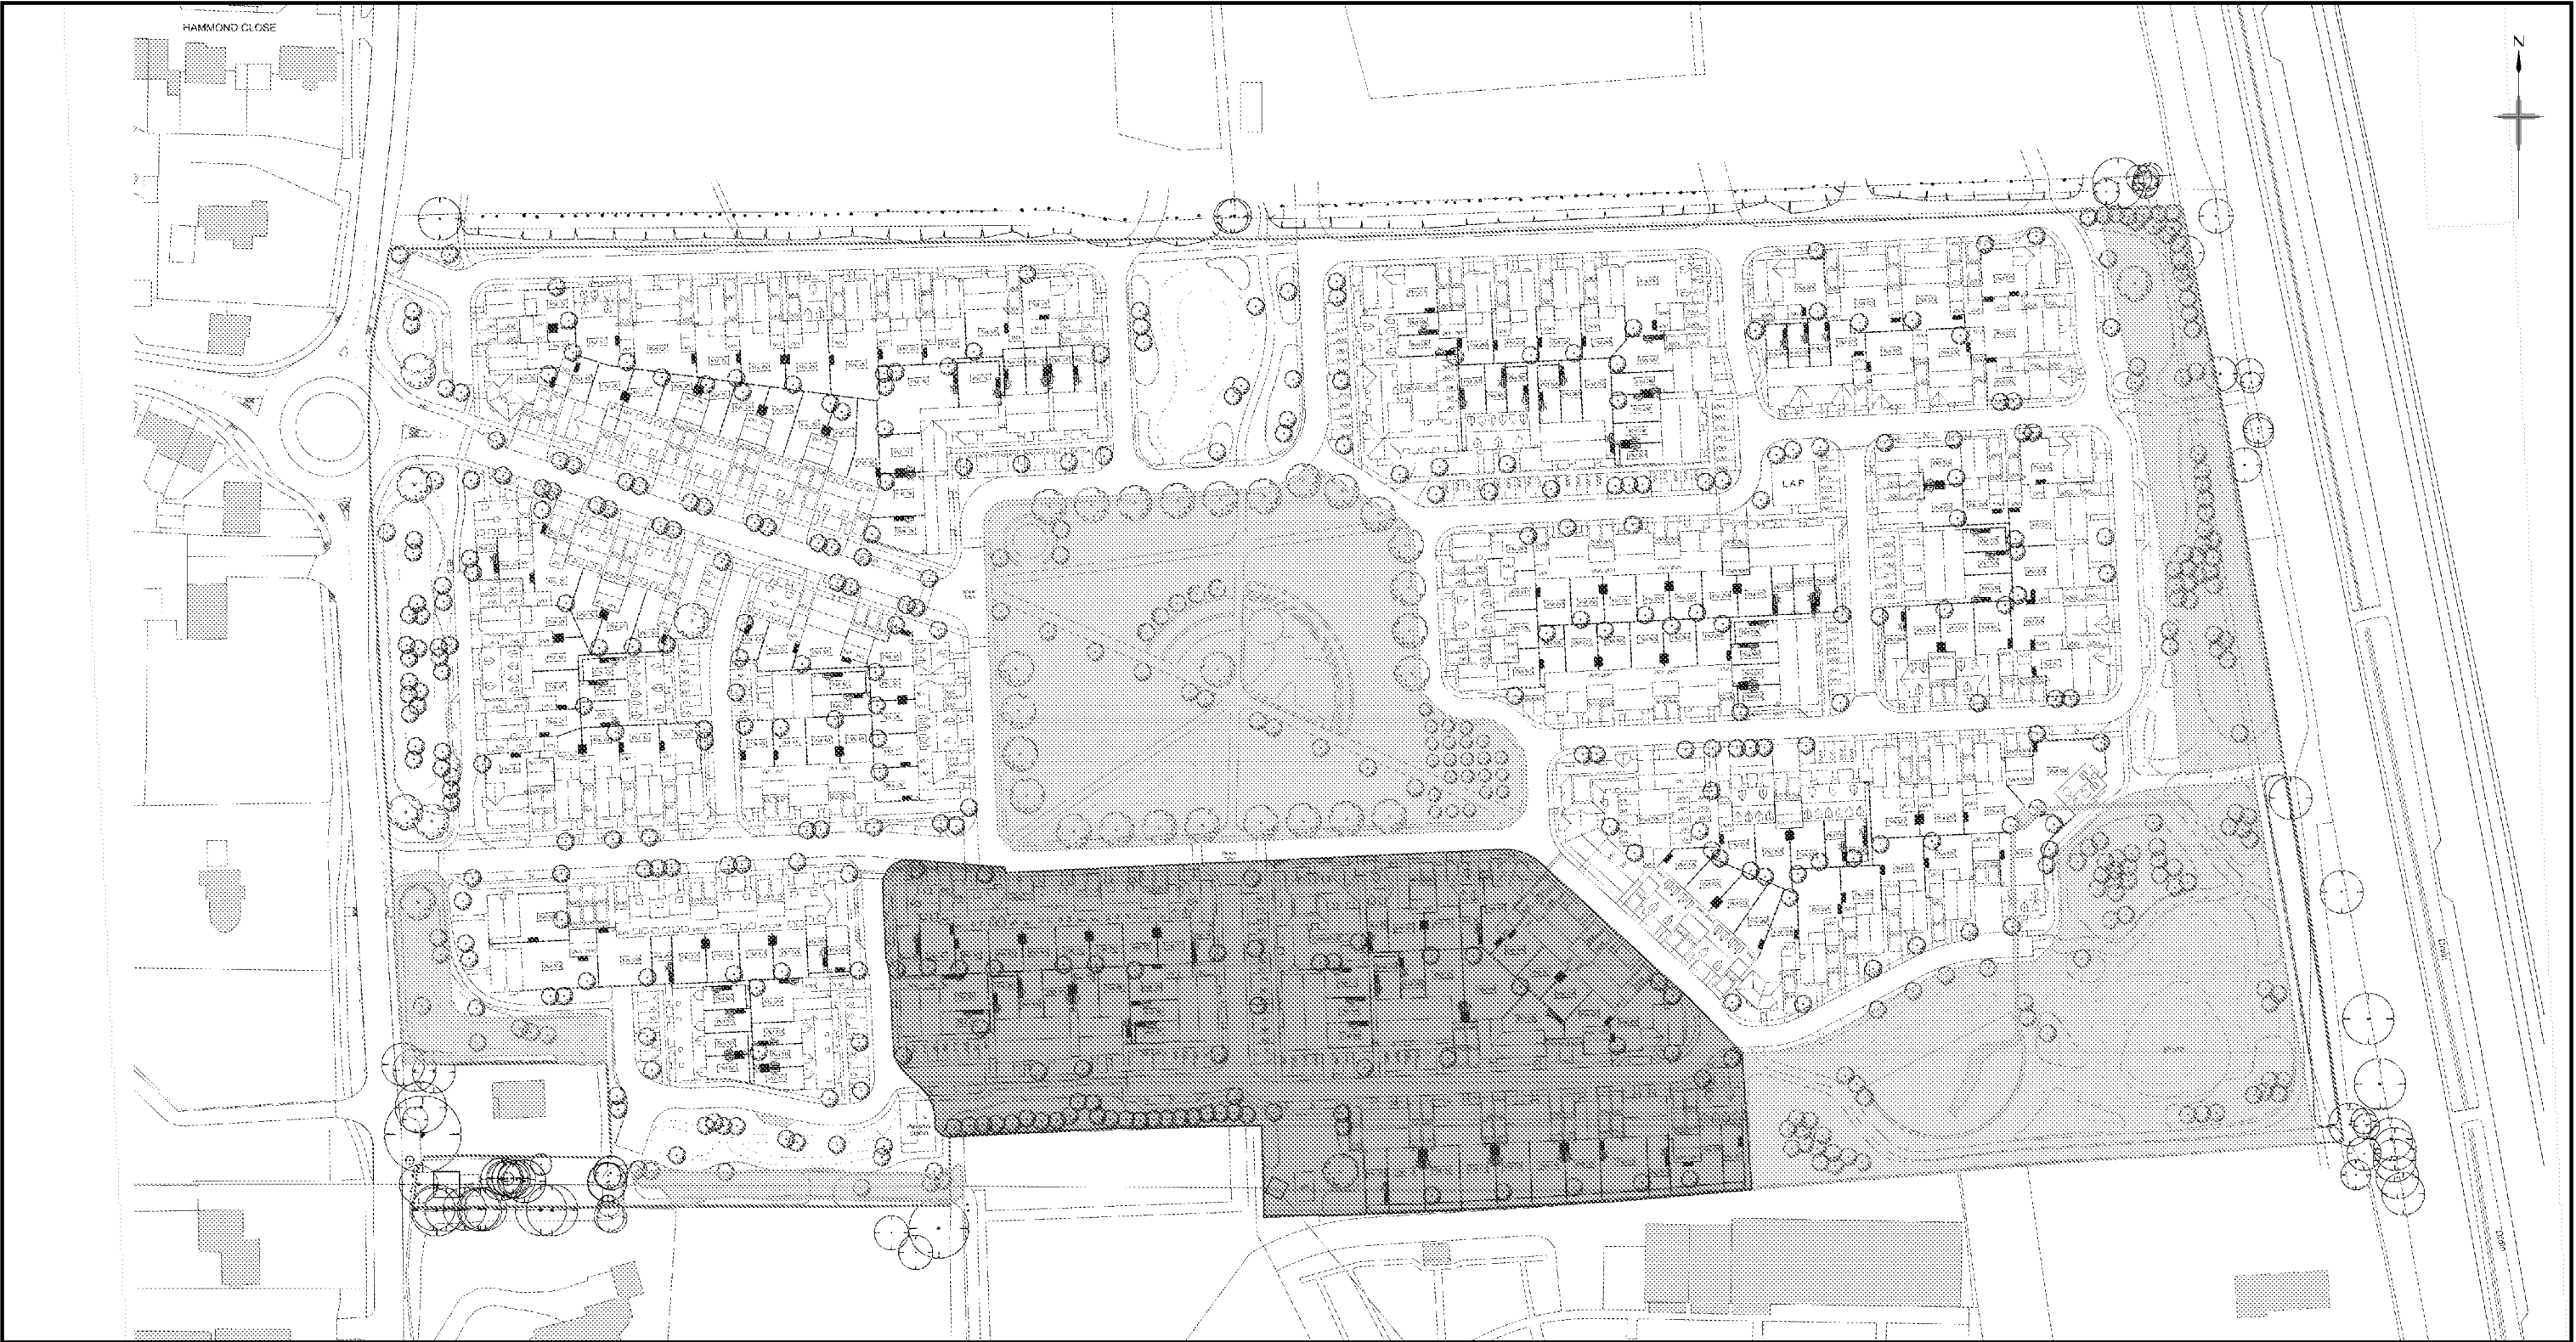
Drawing No.  
FIGURE 5

Approximate Areas with Associated with Outstanding Remedial and/or Validation Work within Areas other than Phase 1B.

Outstanding Validation Works within Phase 1B.

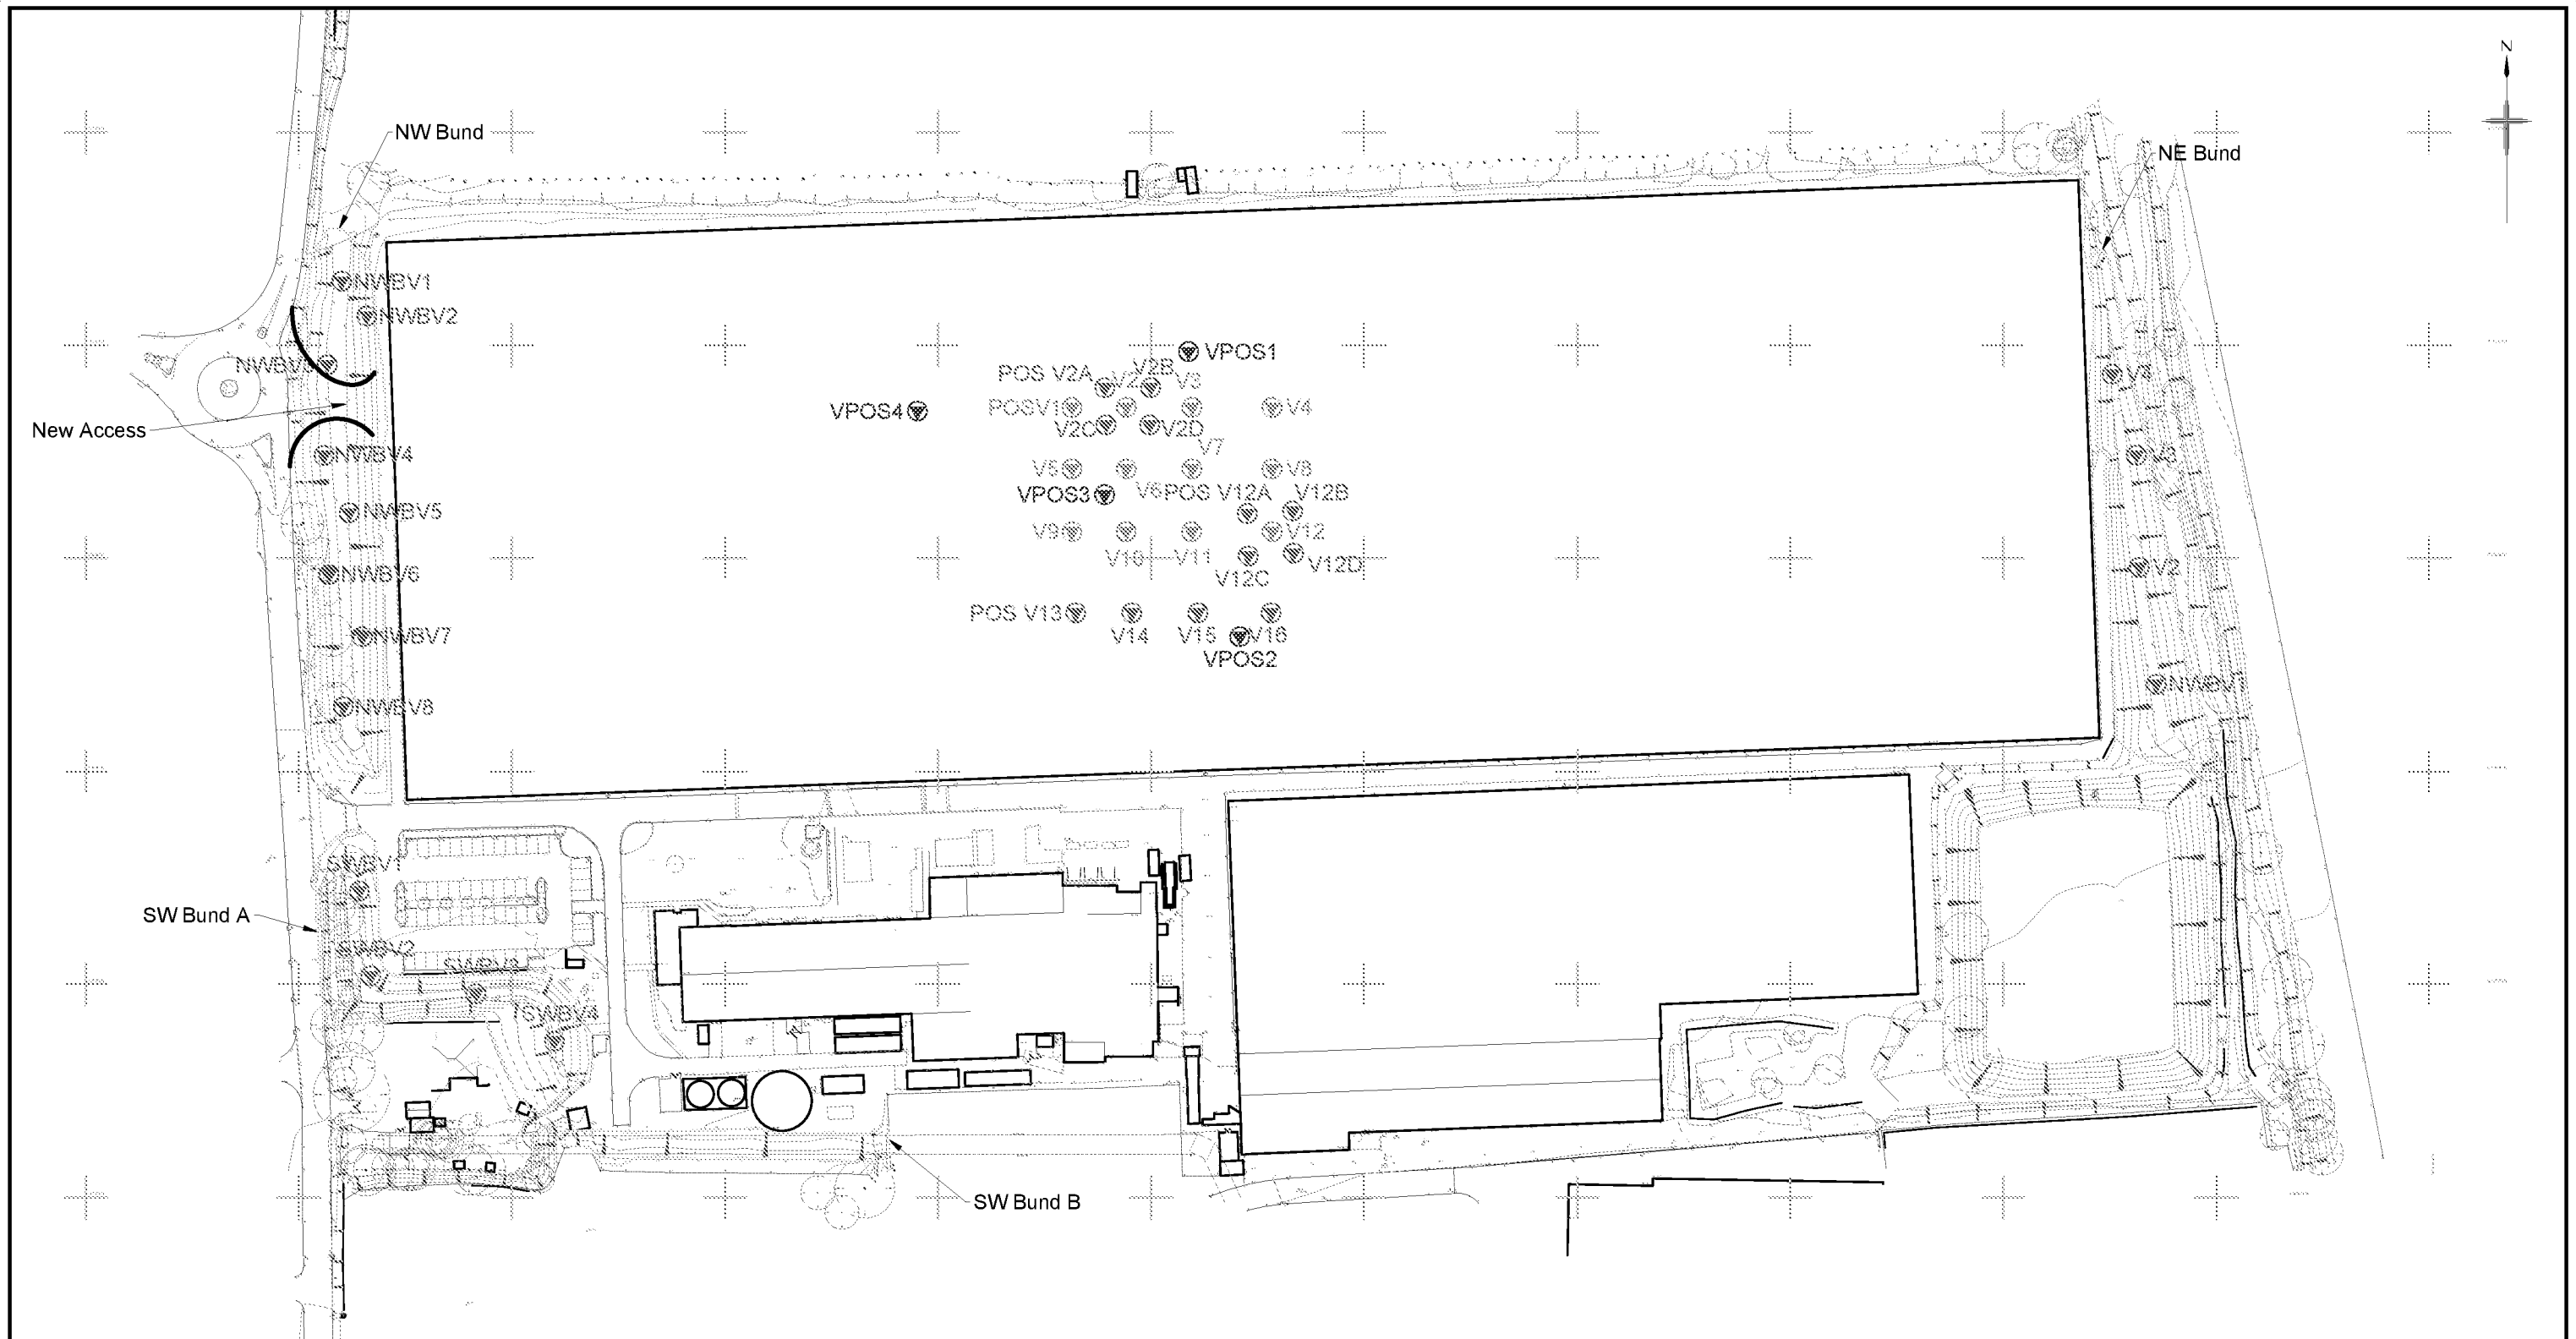
| | | | | | Drawing Title<br>RSK VALIDATION LOCATIONS<br>- POS AND BUNDS | |

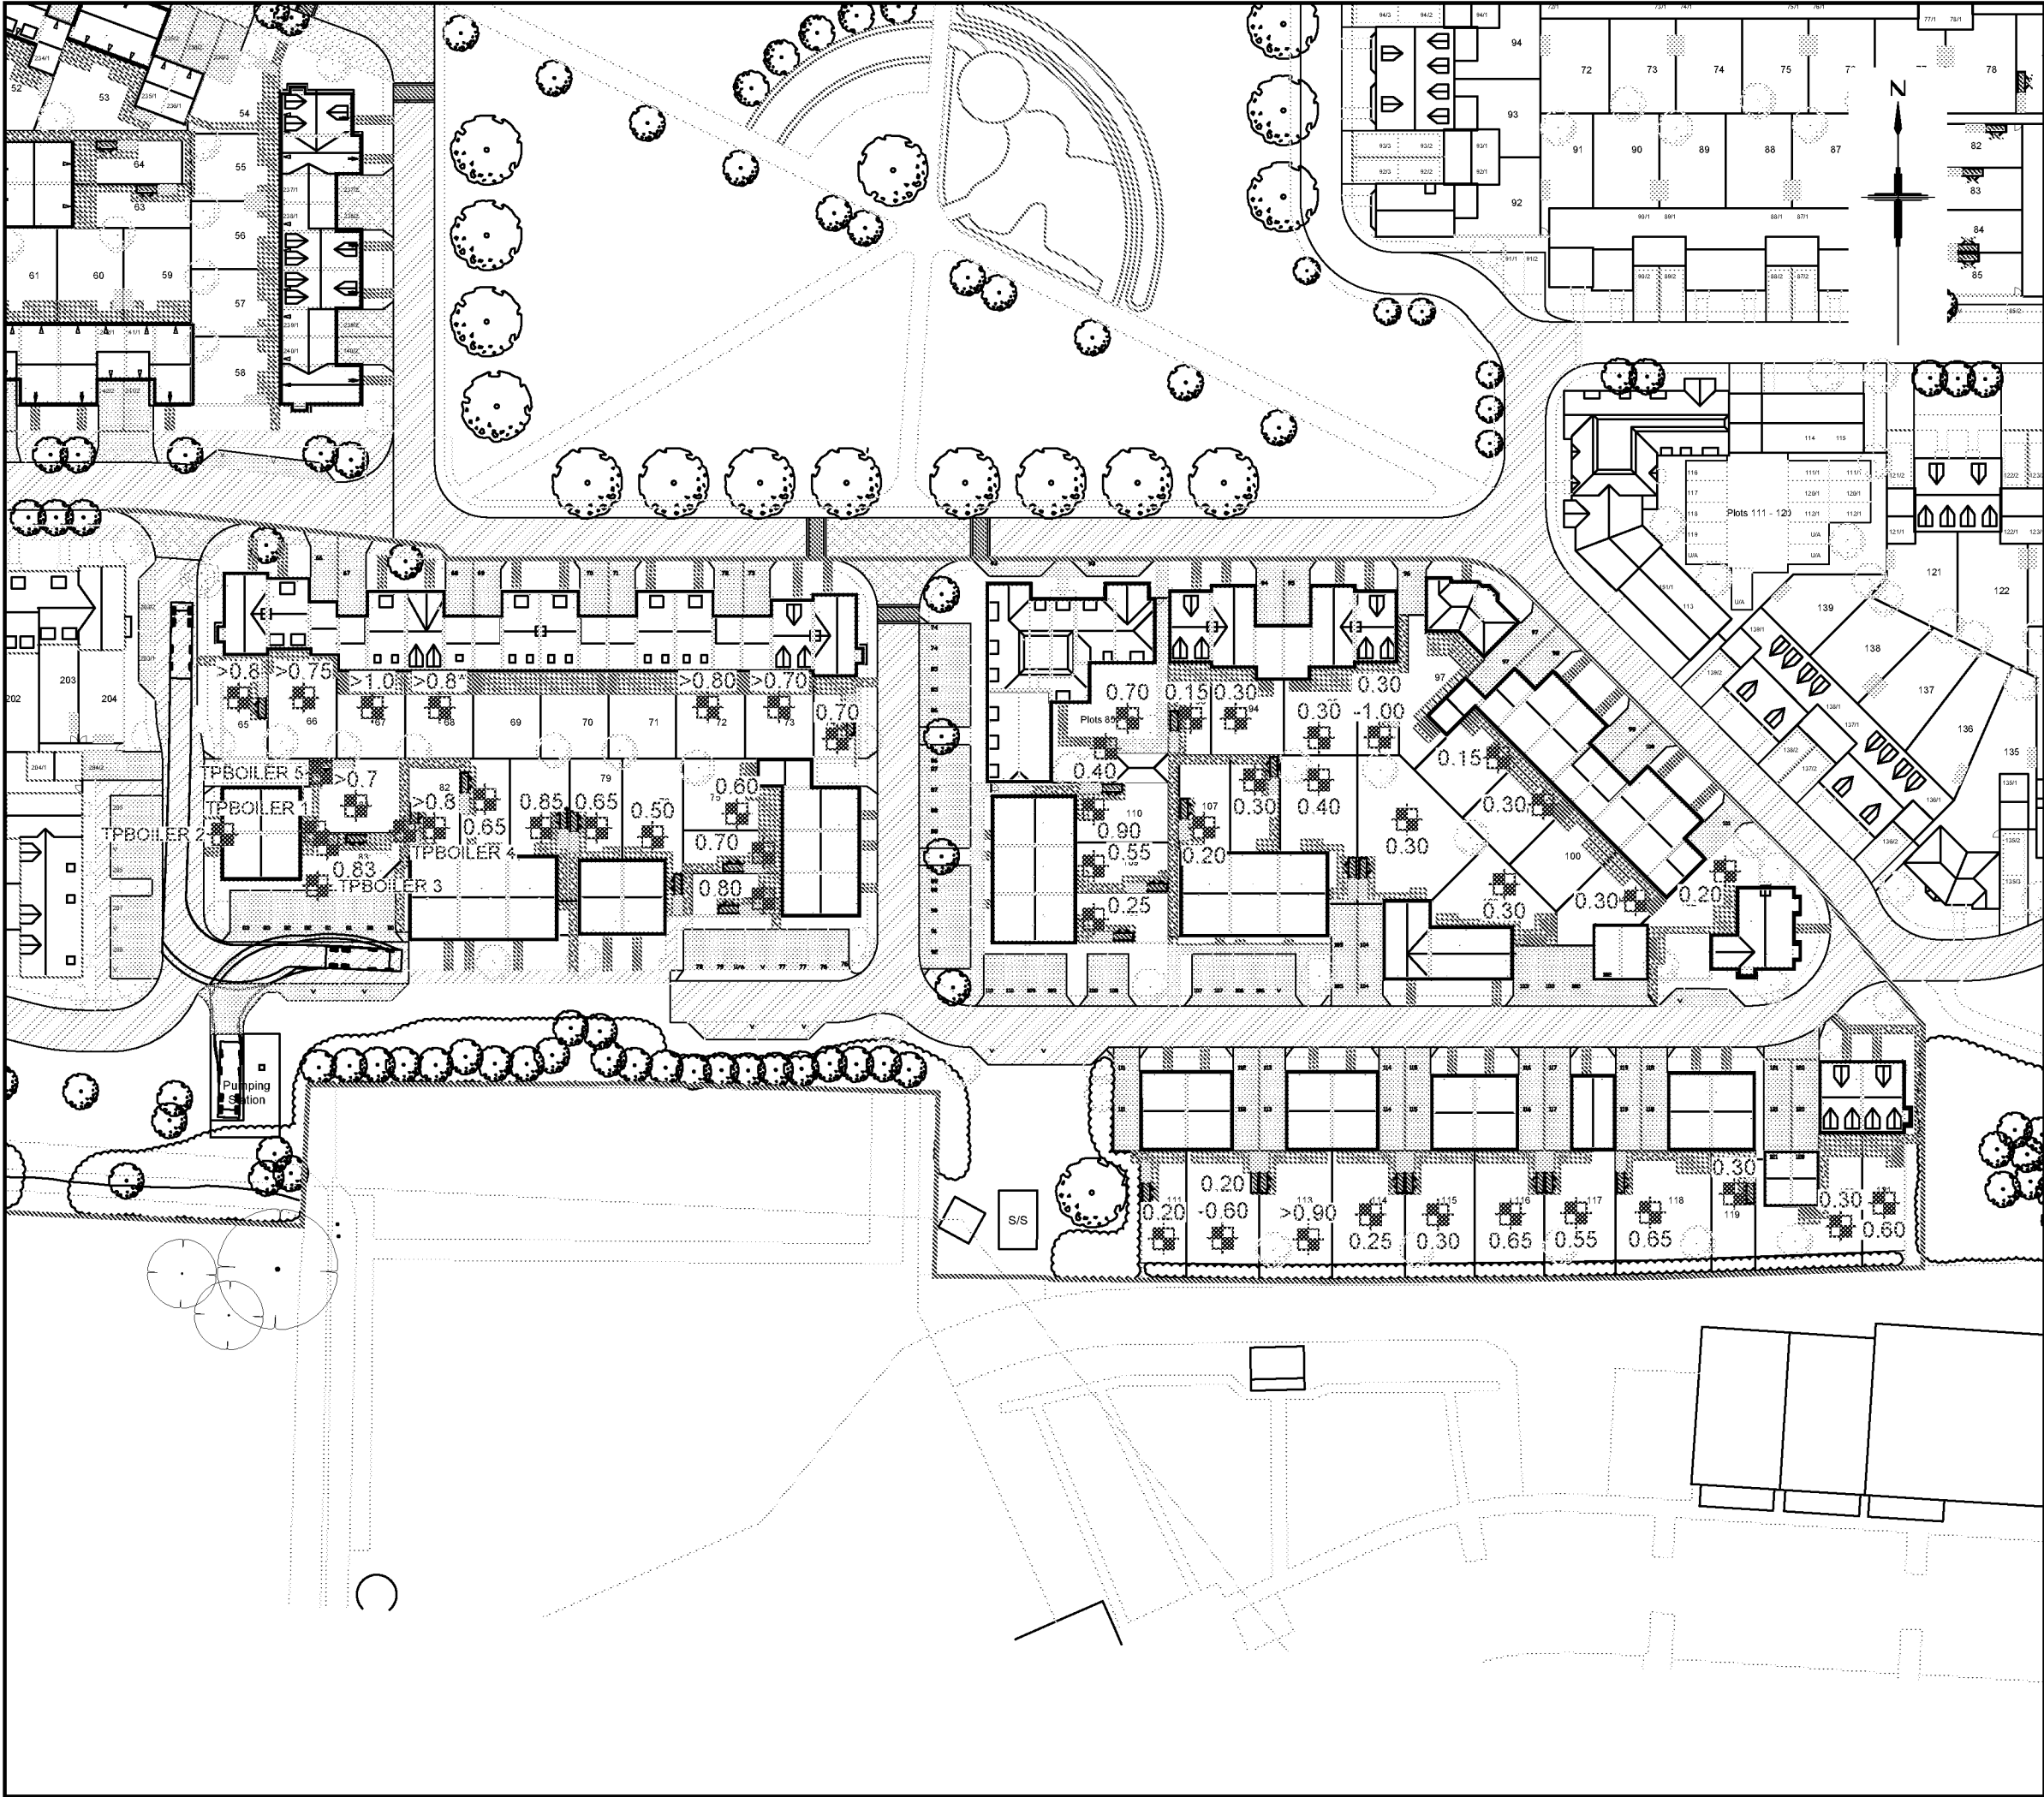
| FIGURE 2 | P1 |

The locations of the exploratory holes are shown on **Figure 2**. The exploratory holes were positioned via reference to physical on-site features, such as sides of buildings, edges of roads being constructed at the time, and site boundaries.

\* Brick wall encountered from 0.60mbgl as well as asphalt surfacing 0.50-0.60mbgl.

Drawing Title  
**EXTENT OF MADE GROUND ENCOUNTERED IN PHASE 1B PLOTS 65 TO 121**

During the excavation of Plot 83 and Plot 84 on the 25<sup>th</sup> April 2017, elevated levels of volatile organic compounds (VOC) up to 140 ppmV were identified by the hand-held photo-ionisation detector (PID), and weak to moderate hydrocarbon odours were noted. Weak to moderate hydrocarbon odours were also noted during the excavation of Plot 66, although PID readings in this location were low with a maximum reading of 2.5 ppmV recorded. Indicative photos of the trial pits are shown in the photographic log (**Appendix B**). These plots are located in close proximity to the historic boiler house. Therefore on 25<sup>th</sup> April 2017, RSK carried out further delineation of soils in this area to determine the extent of hydrocarbon impacts. Exploratory holes advanced as part of these works were annotated as TPBOILER, followed by a number, and are shown on **Figure 2** as green exploratory locations.

A total of 15 plots were found to contain suspected asbestos cement fragments or asbestos fibres in made ground beneath the surface, as shown on **Figure 2** and in photos 4 and 6 of the photographic log (**Appendix B**). Red shading denotes the plots in which fragments of suspected asbestos cement were observed below the ground surface on-site, or where asbestos fibres were identified by later laboratory analysis.
