# Former West End Nursery, Roundstone Lane, Angmering, BN16 4AX

Post Remediation Validation Report – Phase 1B

27621-R09 (00)

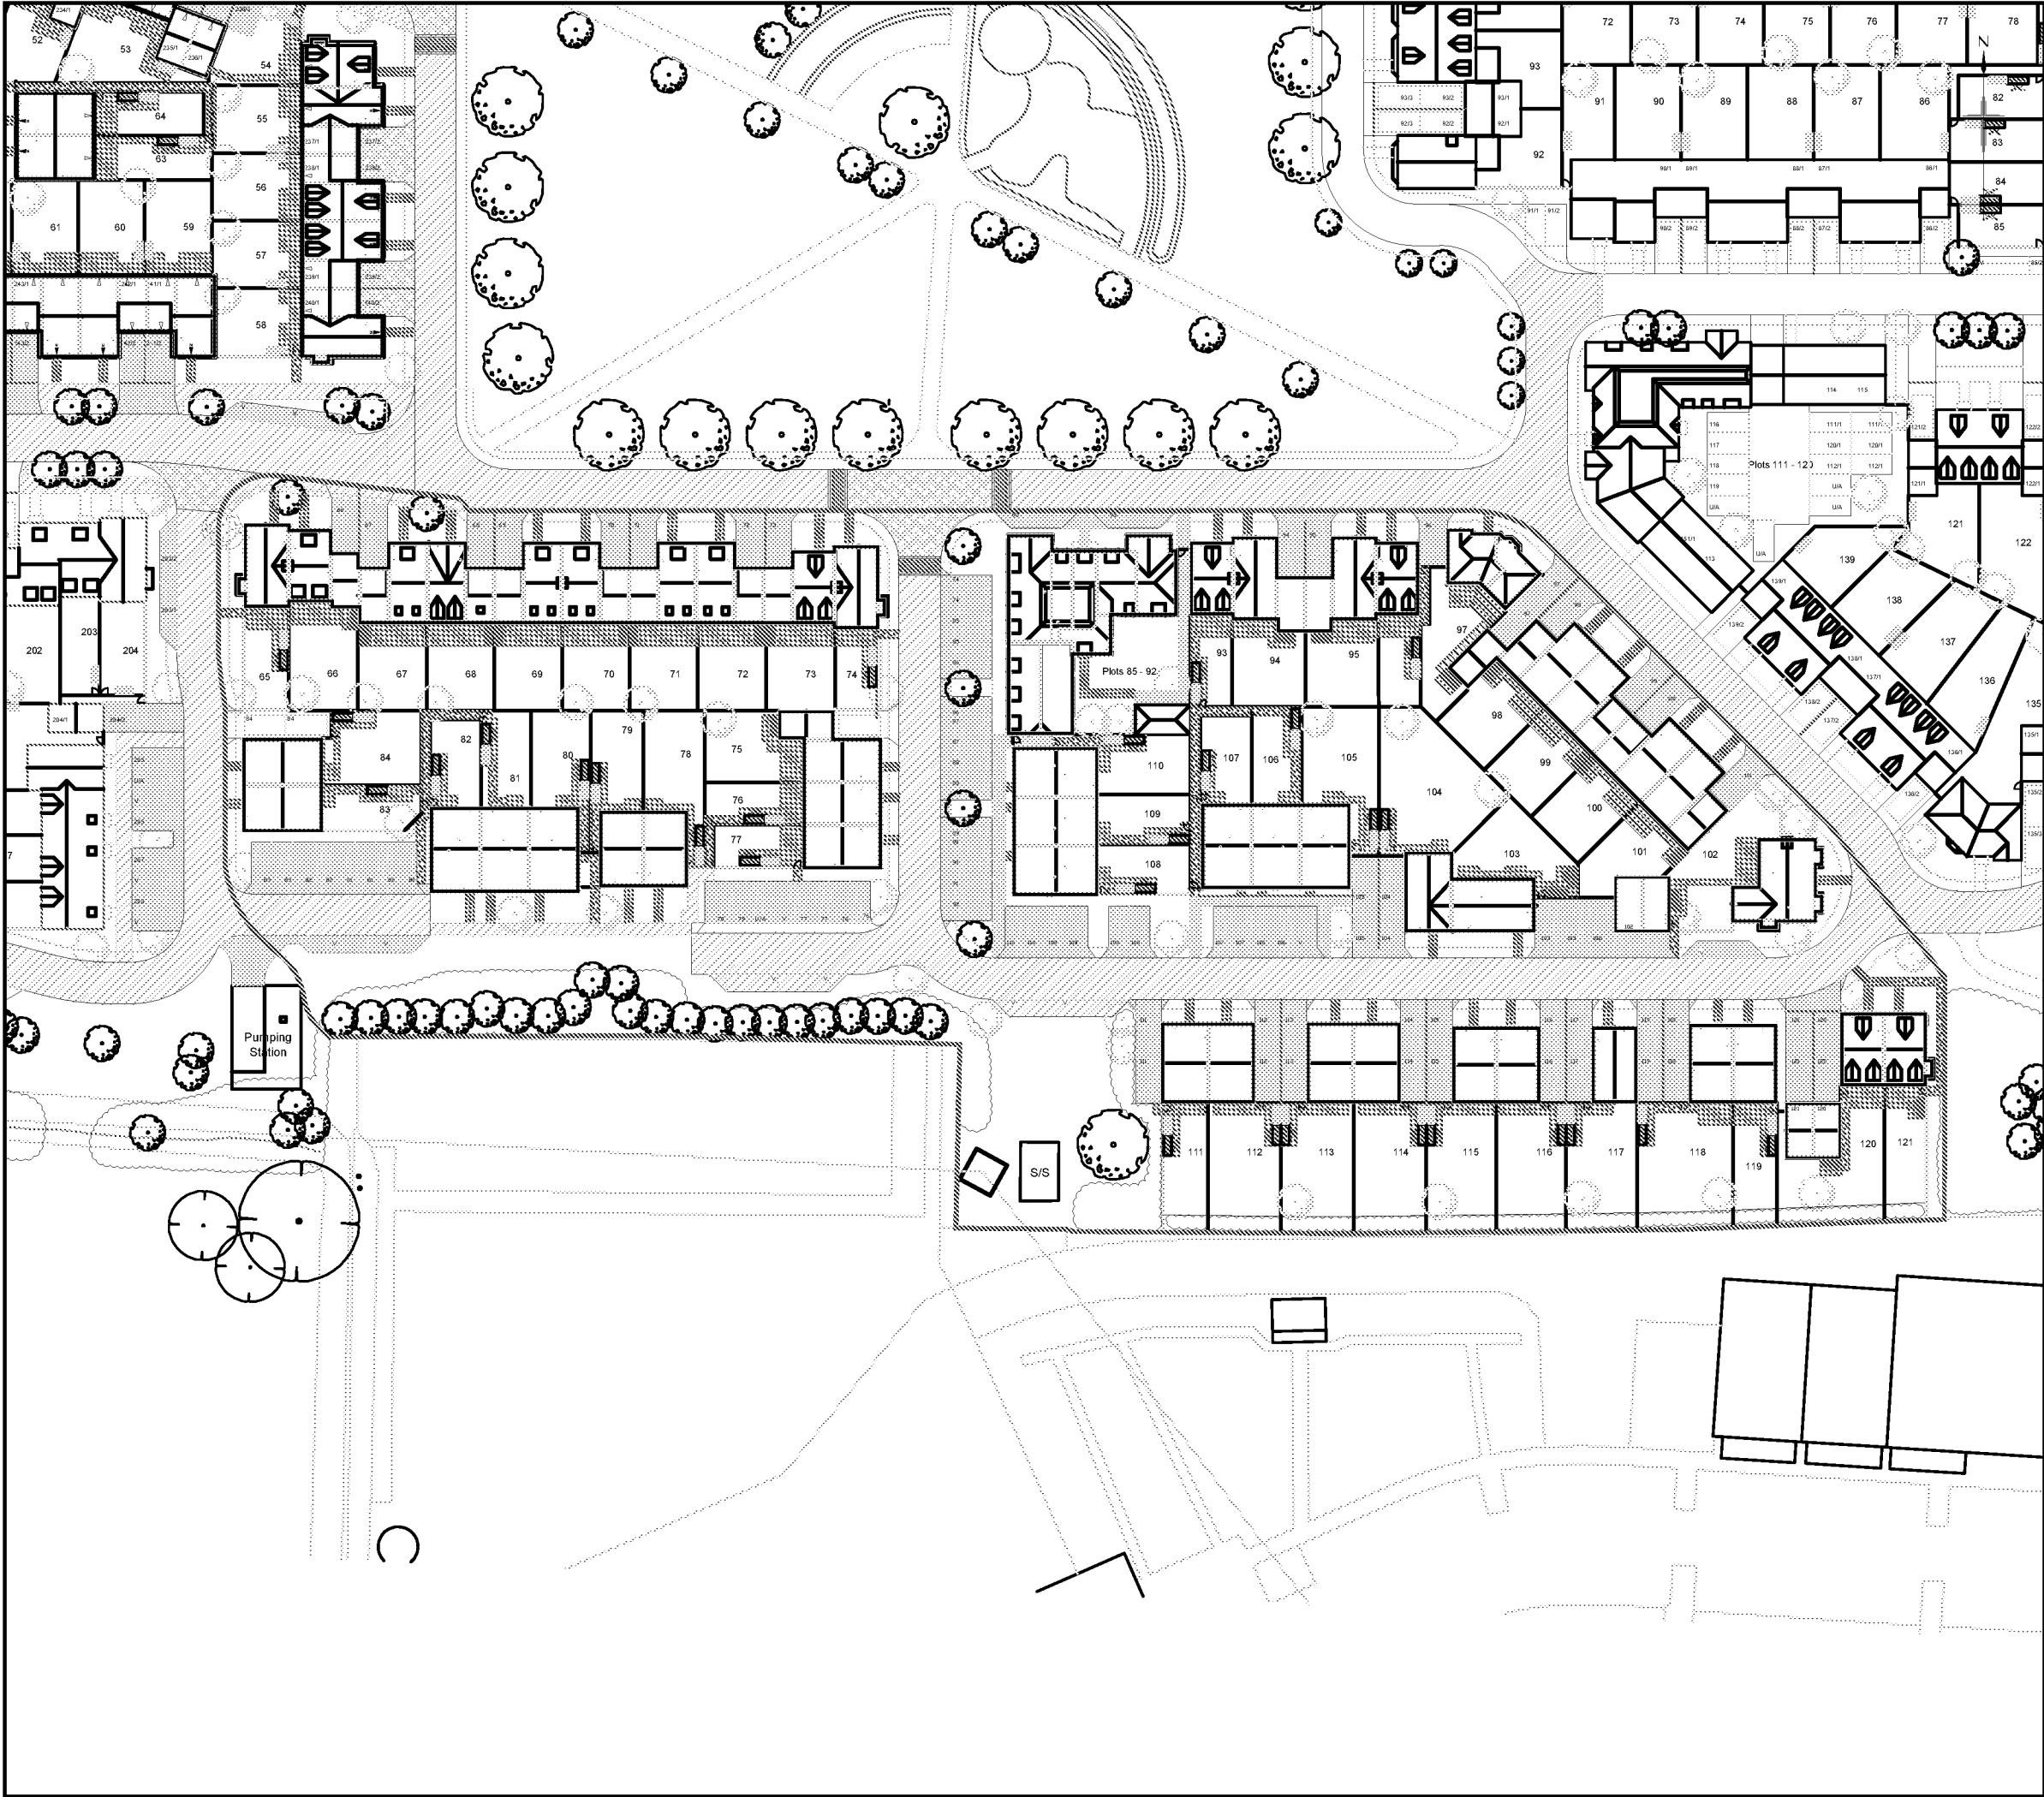
| FIGURE 3 | P1 |

Phase 1B Boundary

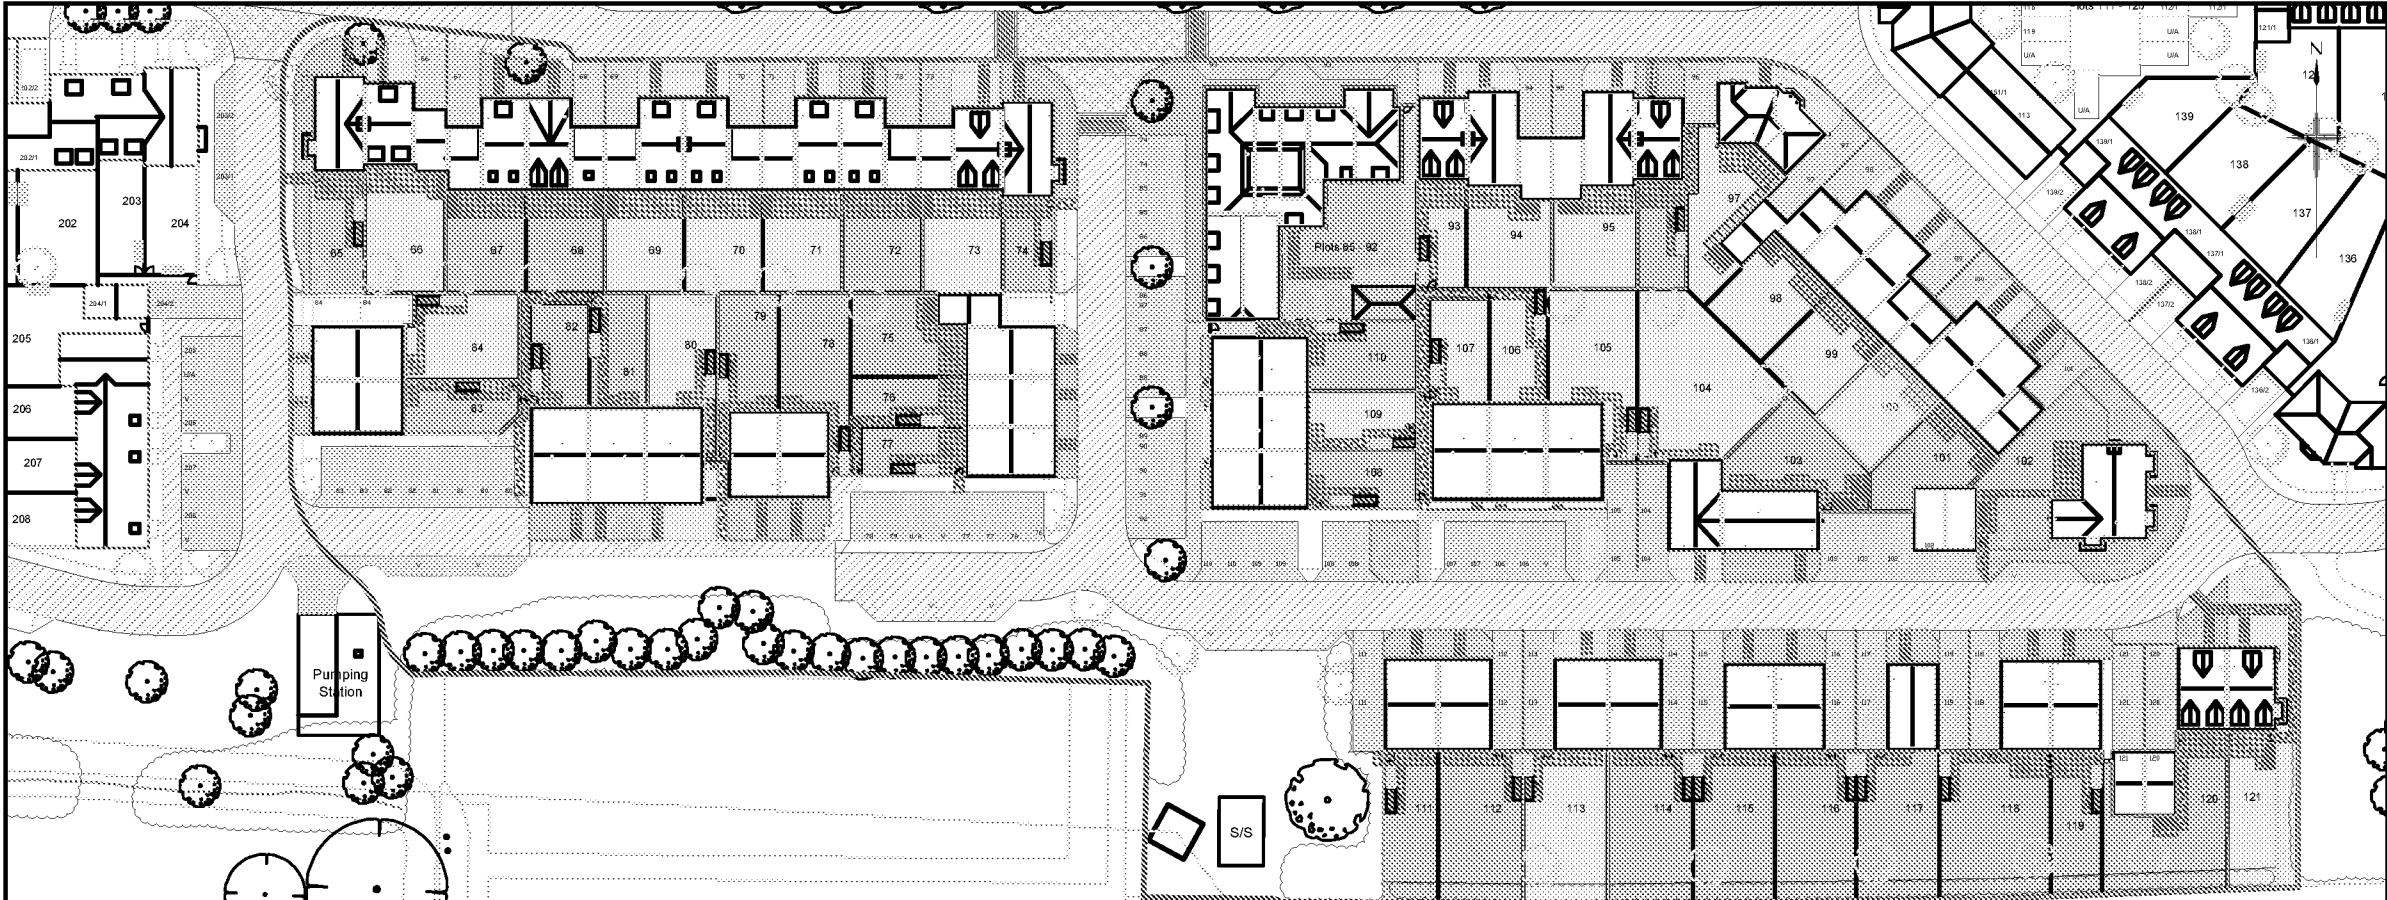
On the basis of the results discussed above, it was recommended that 600 mm of clean cover, underlain by a geo-marker membrane should be placed in the front and back gardens of Plots 66, 68, 73, 80, 84, 93 to 94, 98, 99, 104, 105, 107, 113 and 121, where suspected ACM or asbestos fibres have been found to be present. 600 mm of clean cover underlain by a geo-marker membrane should also be placed in the front and back gardens of Plots 69 to 71, 97 and 100, as these plots were inaccessible at the time of the delineation works. A 450 mm clean cover layer is required across the front and back gardens of all other plots in Phase 1B. The cover layer requirements for Plots 65 to 121 are presented on **Figure 4**.

On the basis of the results discussed above, it was recommended that 600 mm of clean cover, underlain by a geo-marker membrane should be placed in the front and back gardens of Plots 66, 68, 73, 80, 84, 93 to 94, 98, 99, 104, 105, 107, 113 and 121, where suspected ACM or asbestos fibres have been found to be present. 600 mm of clean cover underlain by a geo-marker membrane should also be placed in the front and back gardens of Plots 69 to 71, 97 and 100, as these plots were inaccessible at the time of the delineation works. A 450 mm clean cover layer is required across the front and back gardens of all other plots in Phase 1B. The cover layer requirements for Plots 65 to 121 are presented on **Figure 4**.
