## PHOTOGRAPHIC LOG

Site Location: Land at West End Nursery, Angmering

# **APPENDIX C**

## **EXPLORATORY HOLE RECORDS AND STOCKPILE SAMPLE DESCRIPTIONS**

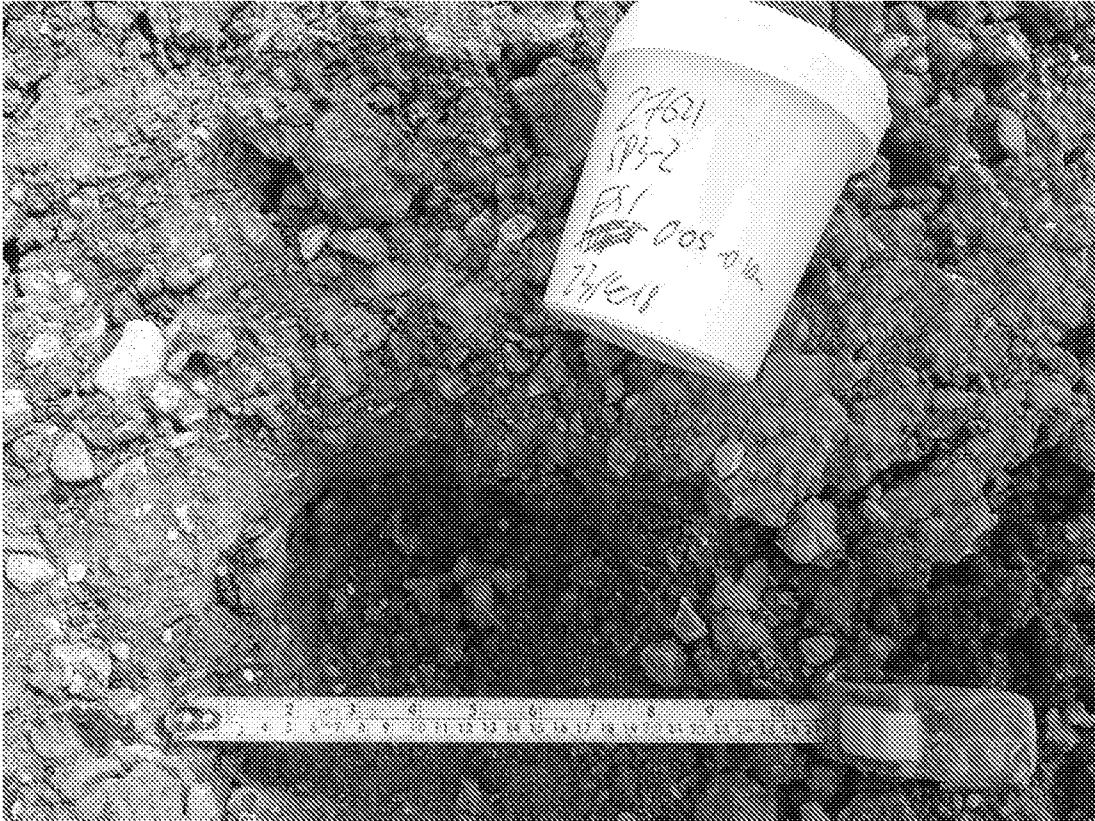
| Photo No.<br>27 | |

| SP3-2<br>stockpile<br>sampling<br>location. | |

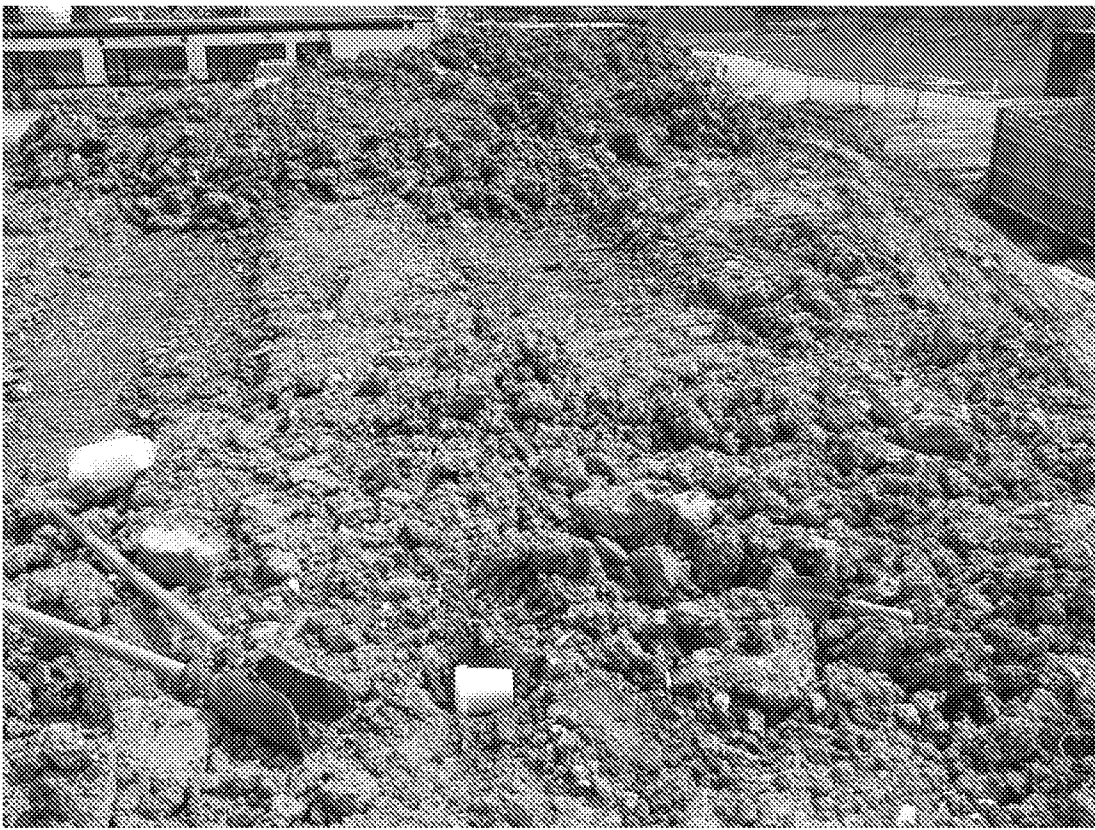
| Photo No.<br>28 | |

| View east of<br>stockpile<br>sampling<br>location SP3-<br>3. | |

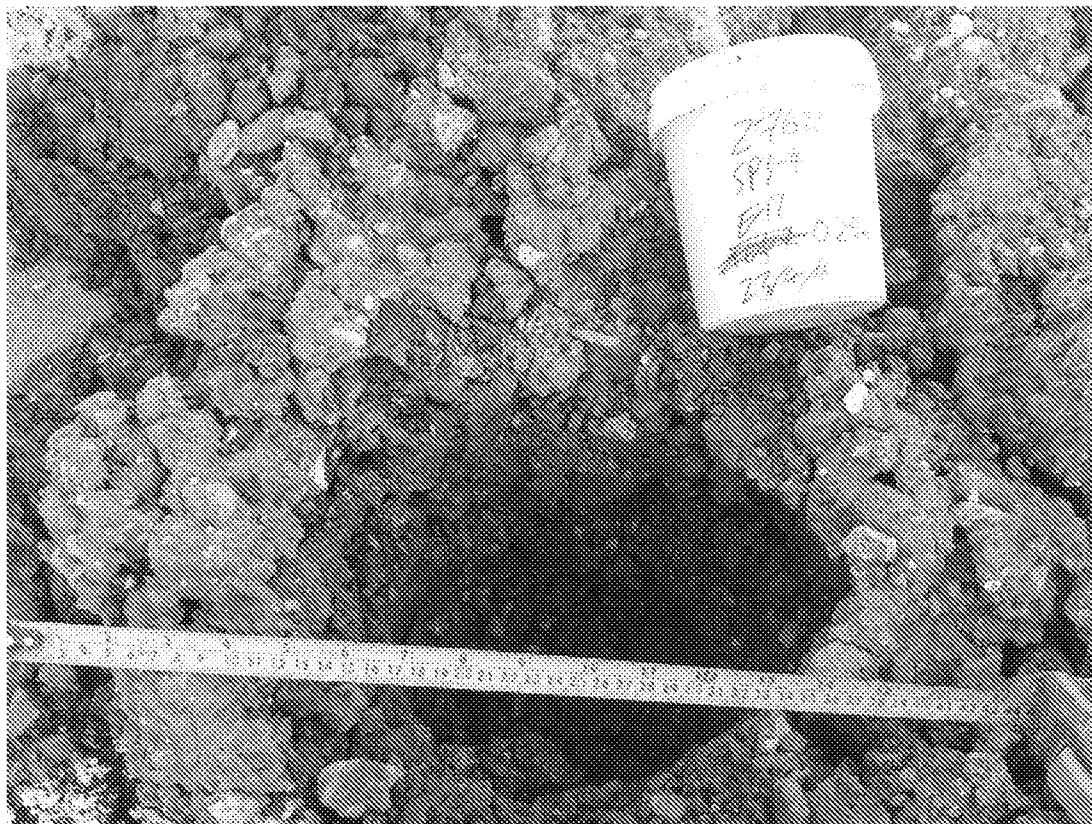
Photo No.  
29

SP3-4  
stockpile  
sampling  
location.

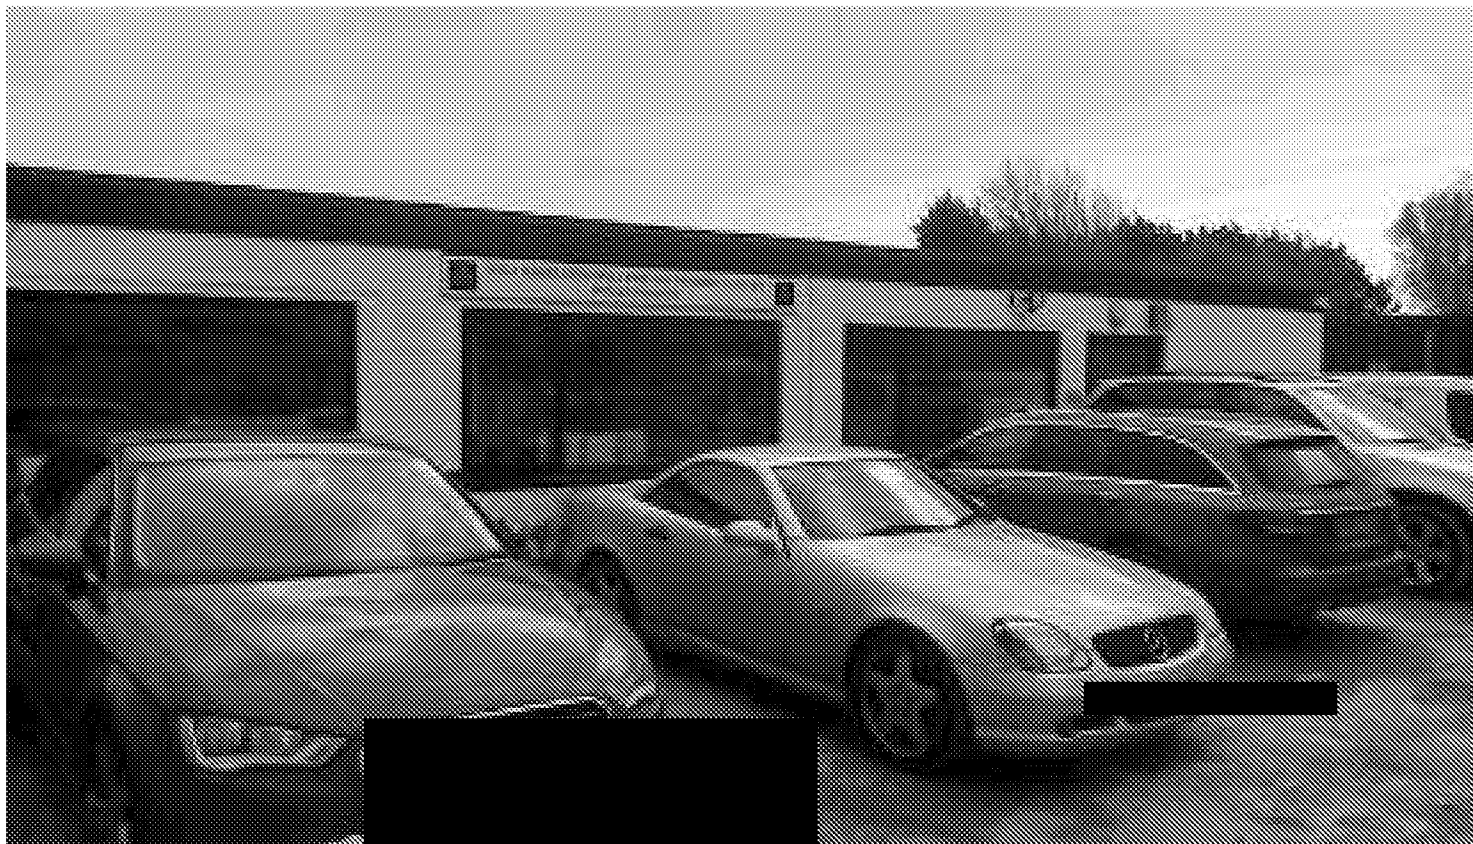
A demolition asbestos survey was carried out at West End Nursery, Roundstone Lane, Angmering, Littlehampton, BN16 4AX. Demolition Survey with limited access to specified areas only of a single story occupied projects office block

Externally the building is constructed of Brick walls, wood and UPVC soffit and fascia boards, wood window frames, modern bitumen felt to flat roof, plastic rain water goods. .

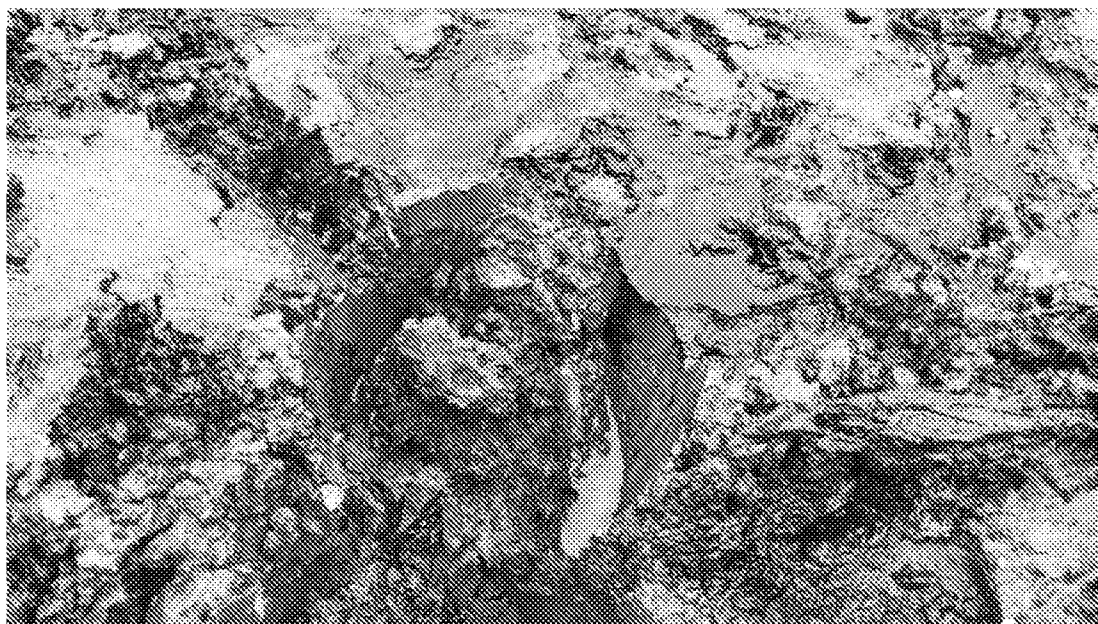
Hydrocarbon impacts observed at the ground surface following rainfall in the vicinity of plot 325. Two samples collected for laboratory analysis.

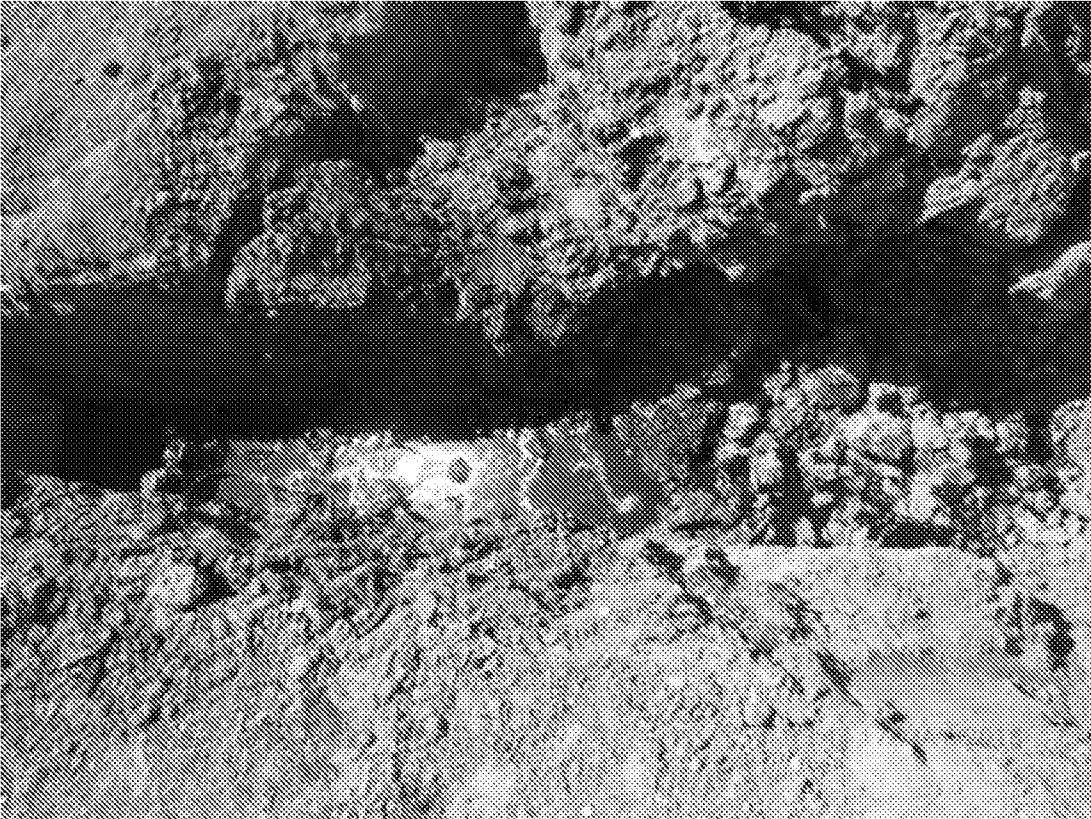
| PHOTOGRAPHIC LOG | |
|---|---|
| <b>Photo No.</b><br>5 | |

| PHOTOGRAPHIC LOG | |
|---|---|
| <p>Phase 2A: Facing south west: hydrocarbon product freely observed Plot 325 east-central foundation trench, prior to hotspot removal works.</p> | |

The works were conducted on the 17<sup>th</sup> May. As agreed the arisings were placed on and covered by polythene sheeting to prohibit hydrocarbon impacts leaching to ground. Fragments of rusted corroded metal were observed in the vicinity of the impacts which appear to be what remains of historic oil drums buried in this area.

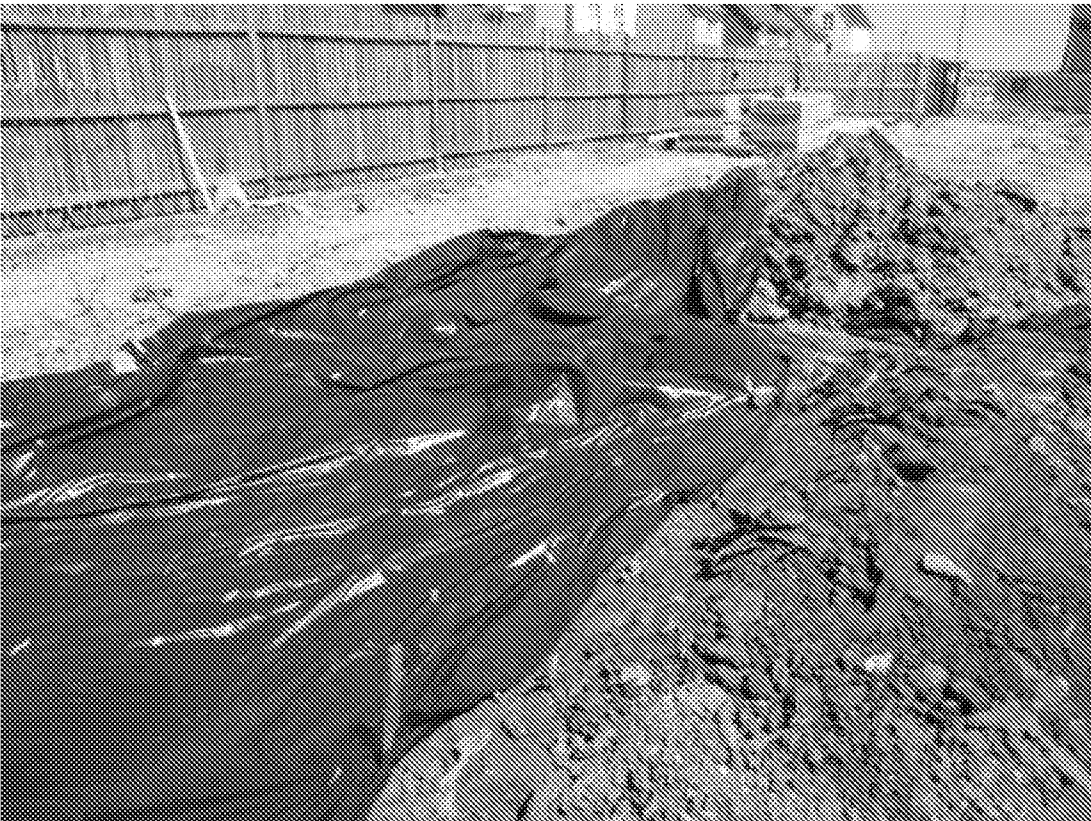
| PHOTOGRAPHIC LOG | |
|---|---|
| <b>Photo No.</b><br>6 | |

| PHOTOGRAPHIC LOG | |
|---|---|
| <p>Phase 2A: Facing north east: polythene sheeting laid down adjacent to/ and partially over pre-existing temporary stockpile of hydrocarbon impacted soils arising from original excavation of Plot 325 foundation trenches. Stockpile Named temporary stockpile TSP02-P3.</p> | |
