Site Location: Land at West End Nursery, Angmering

## **APPENDIX C**

### **TRIAL PIT LOGS**

**RE: FORMER WEST END NURSERY, ANGMERING – PHASE 3 SUPPLEMENTARY ASBESTOS DELINEATION WORKS**

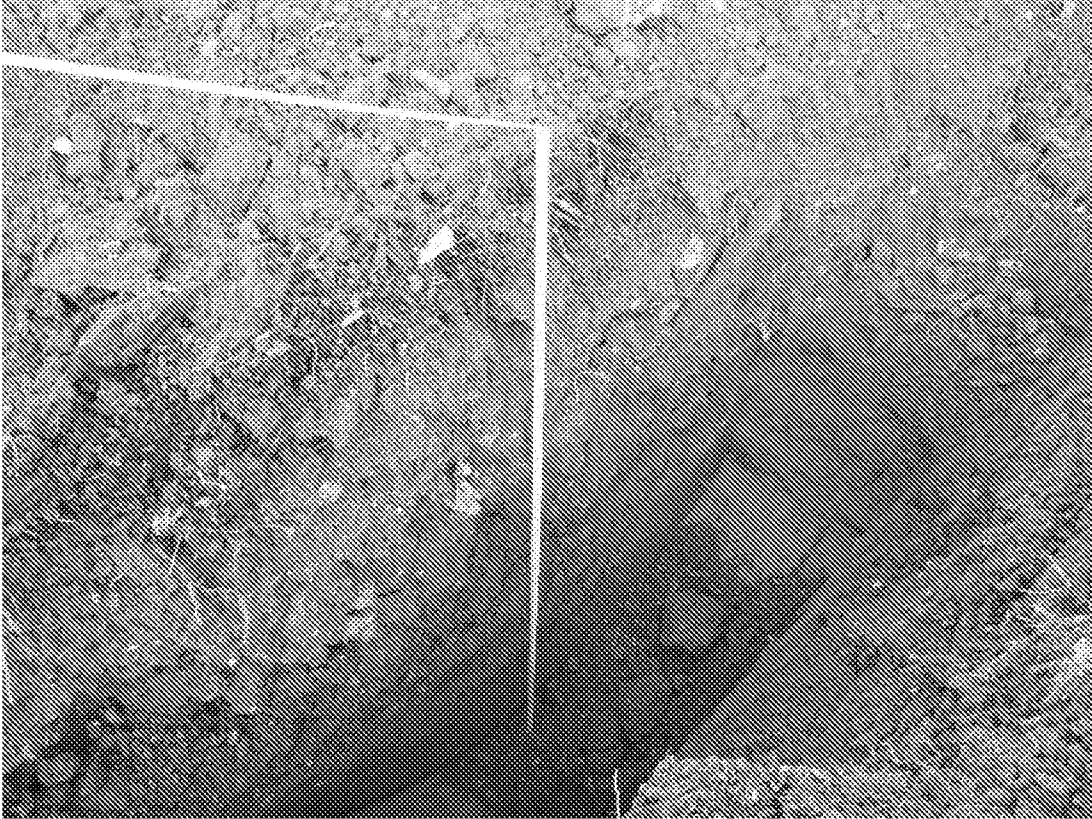
| Photo No.<br>27 | |

| Downhole<br>view of TP311 | |

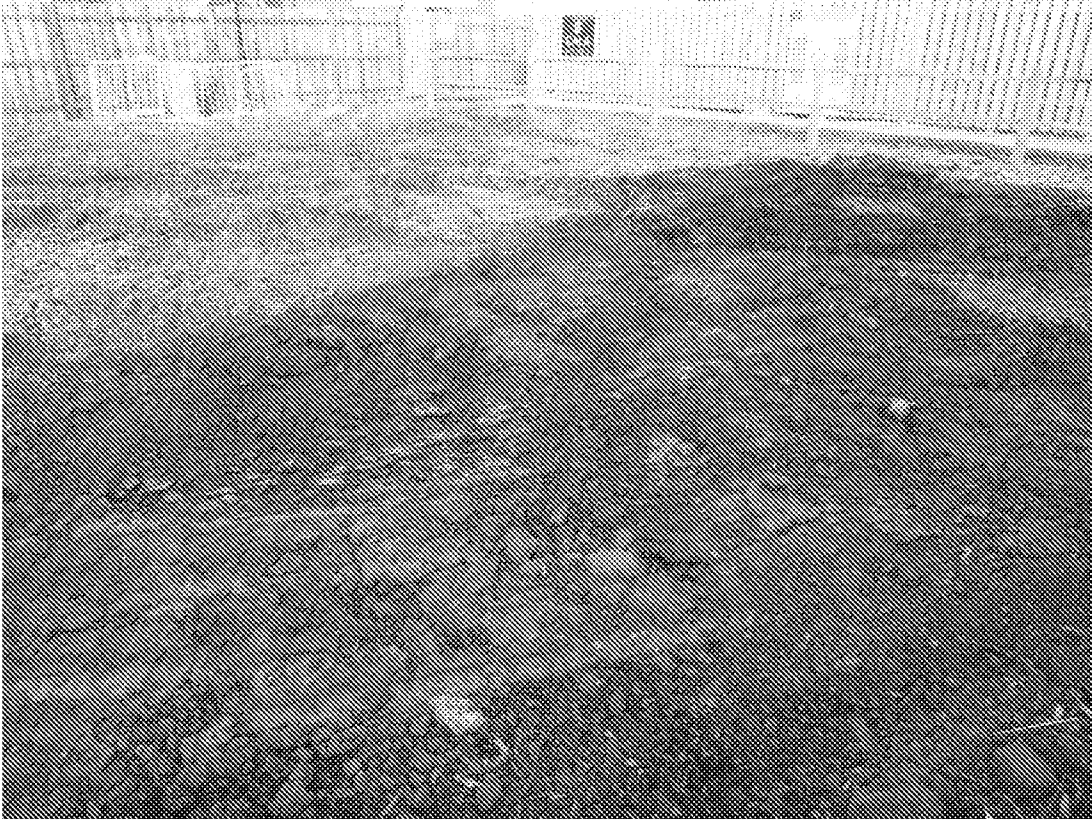
| Photo No.<br>28 | |

| View of<br>reinstated<br>hole TP311,<br>typical<br>reinstatement<br>of trial pits in<br>Phase 3 | |

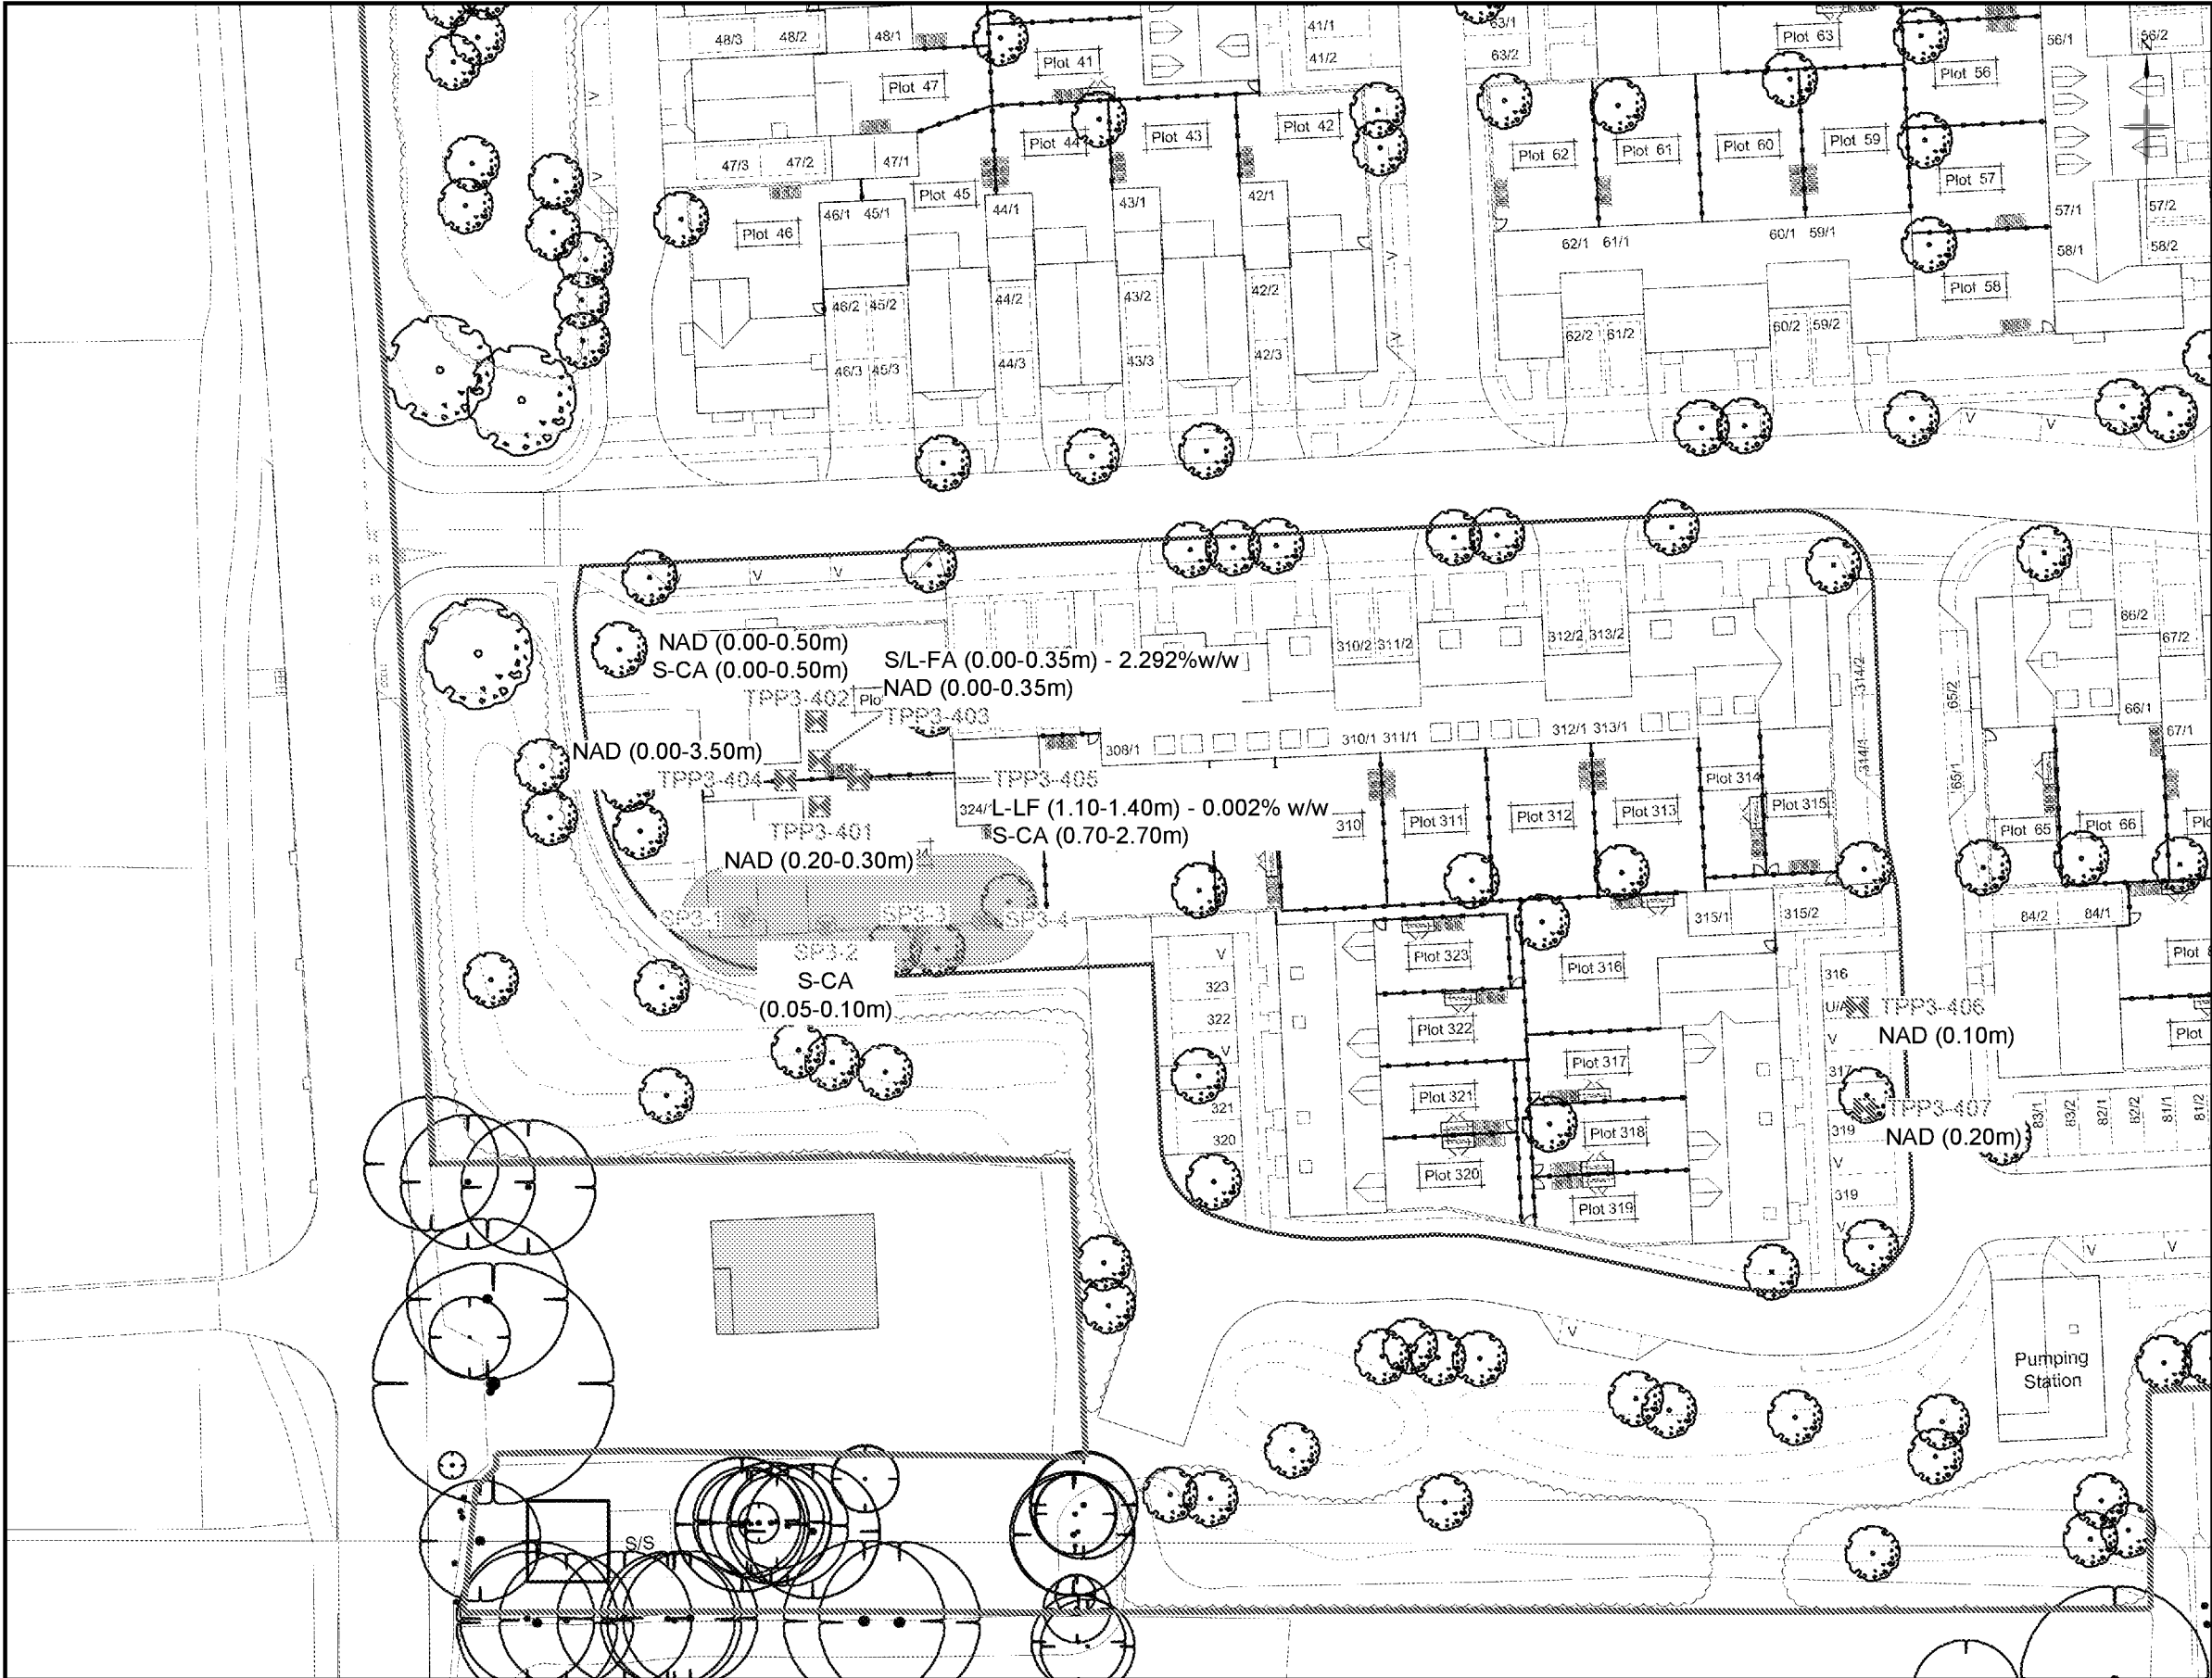
- S-CA Suspected ACM Cement Found During Site Works.
- S/L-FA Suspected Fibrous ACM Found During Site Works. Laboratory Analysis Confirmed Amosite Loose Insulation.

- L-LF Loose Asbestos Fibres in Soil Identified by Laboratory Analysis.
- NAD No Asbestos Detected in Soil Sample Collected for Laboratory Analysis.
- 1.0%w/w Asbestos Quantification Result

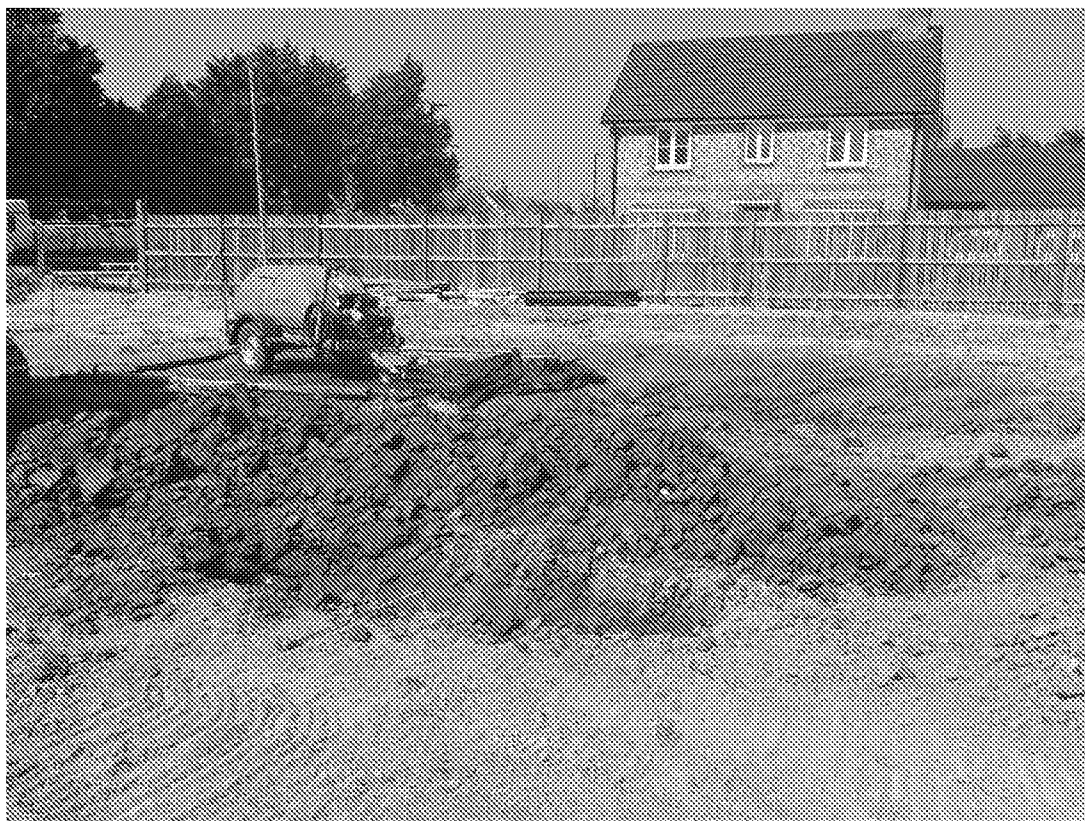
Overview of  
amosite  
delineation  
works area.  
Location  
TPP3-401 in  
foreground.

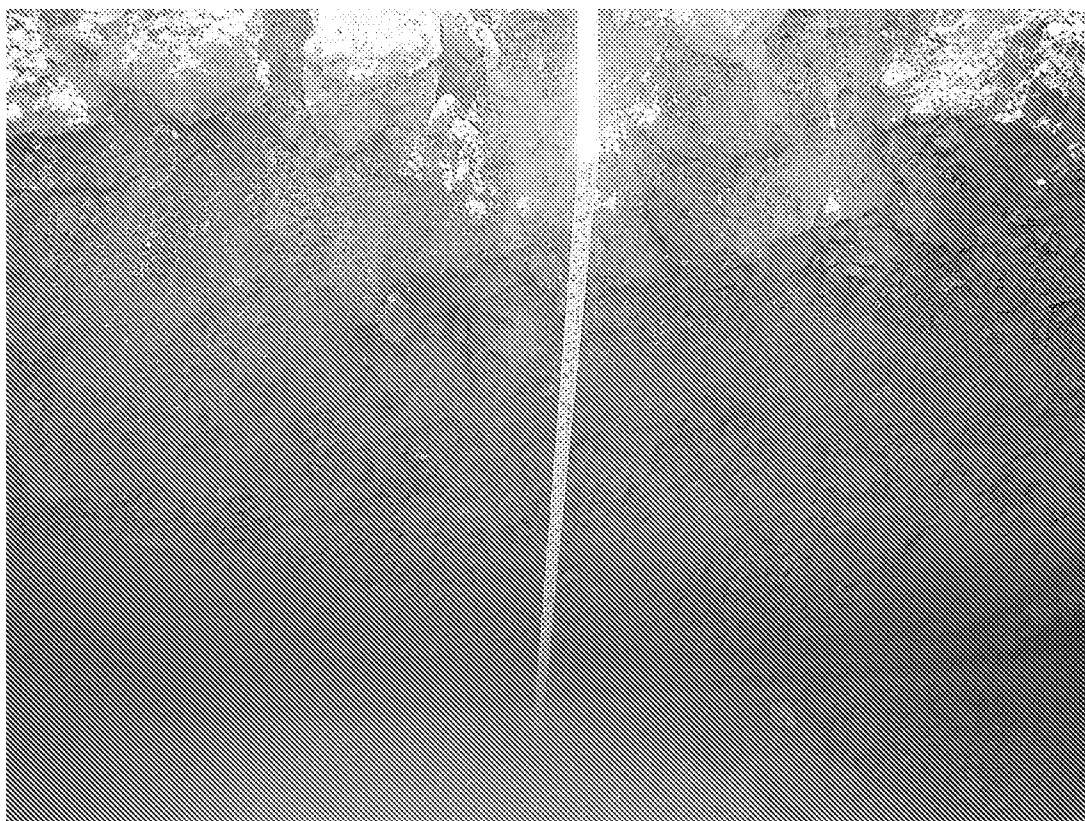
Photo No.  
2

View of  
TPP3-401  
south face  
indicating  
final depth of  
excavation,  
1.70 m.

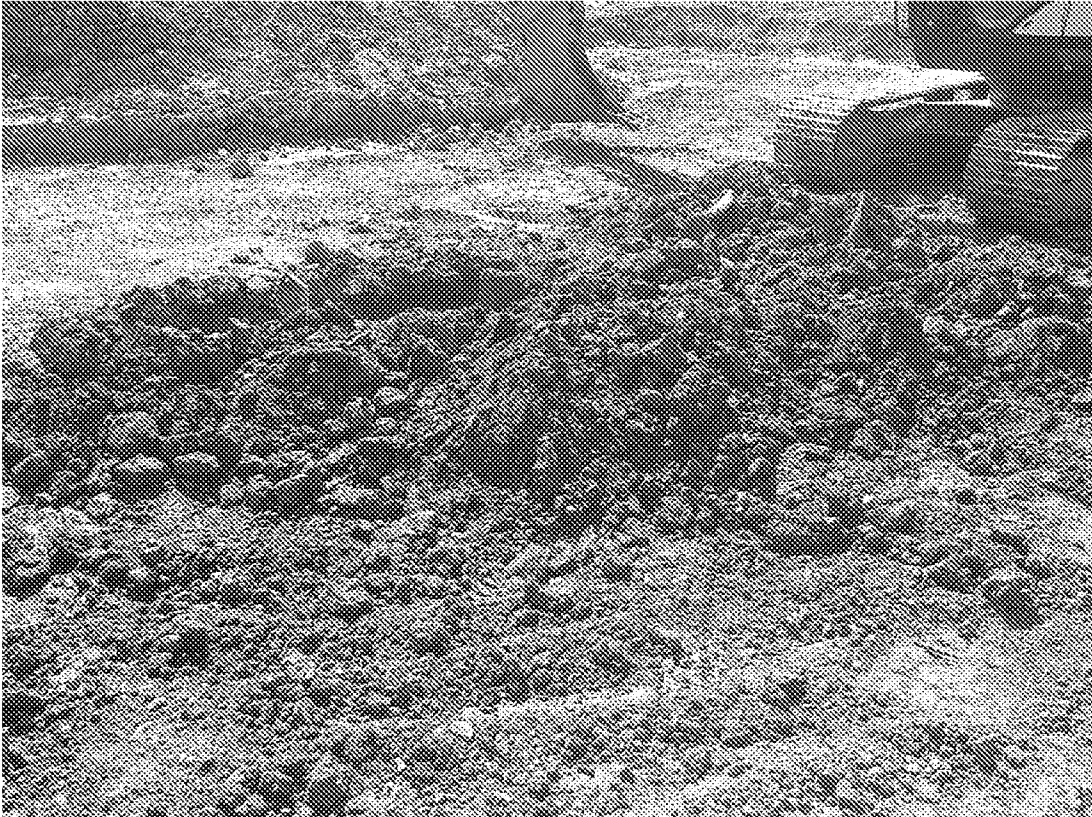
| Photo No.<br>3 | |

| Arisings from<br>TPP3-401. | |

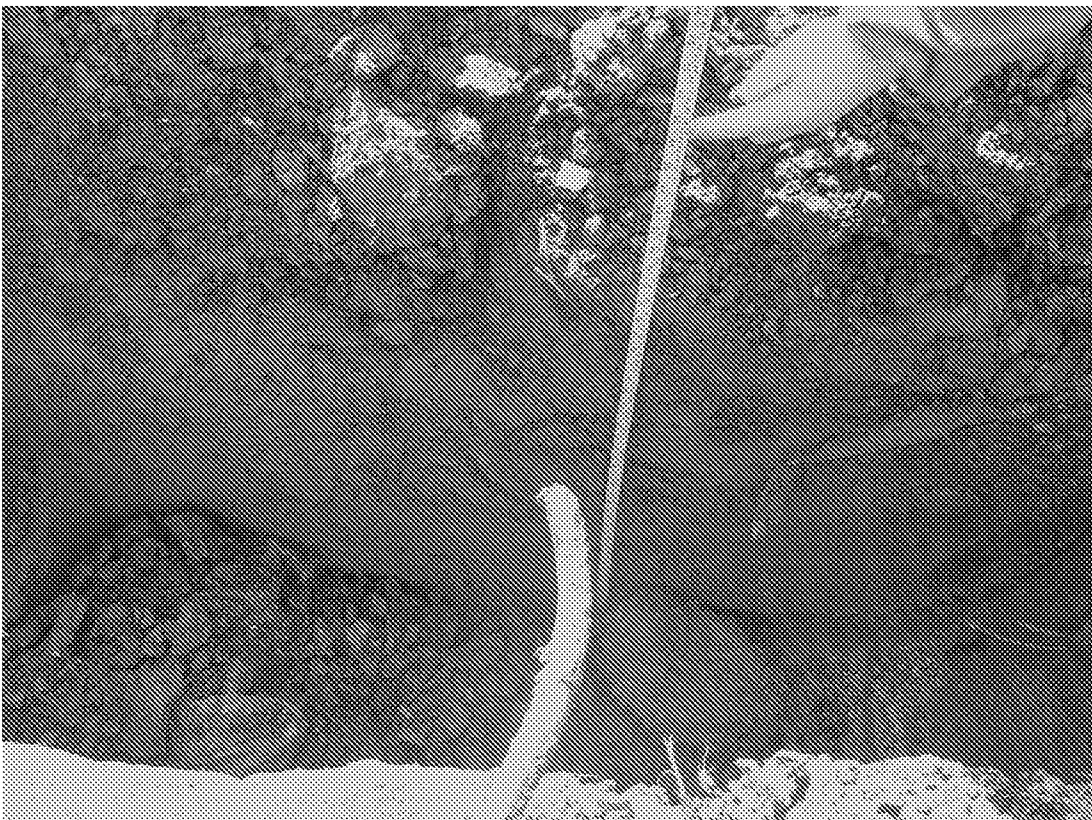
| Photo No.<br>4 | |

| View of<br>TPP3-402<br>south face. | |

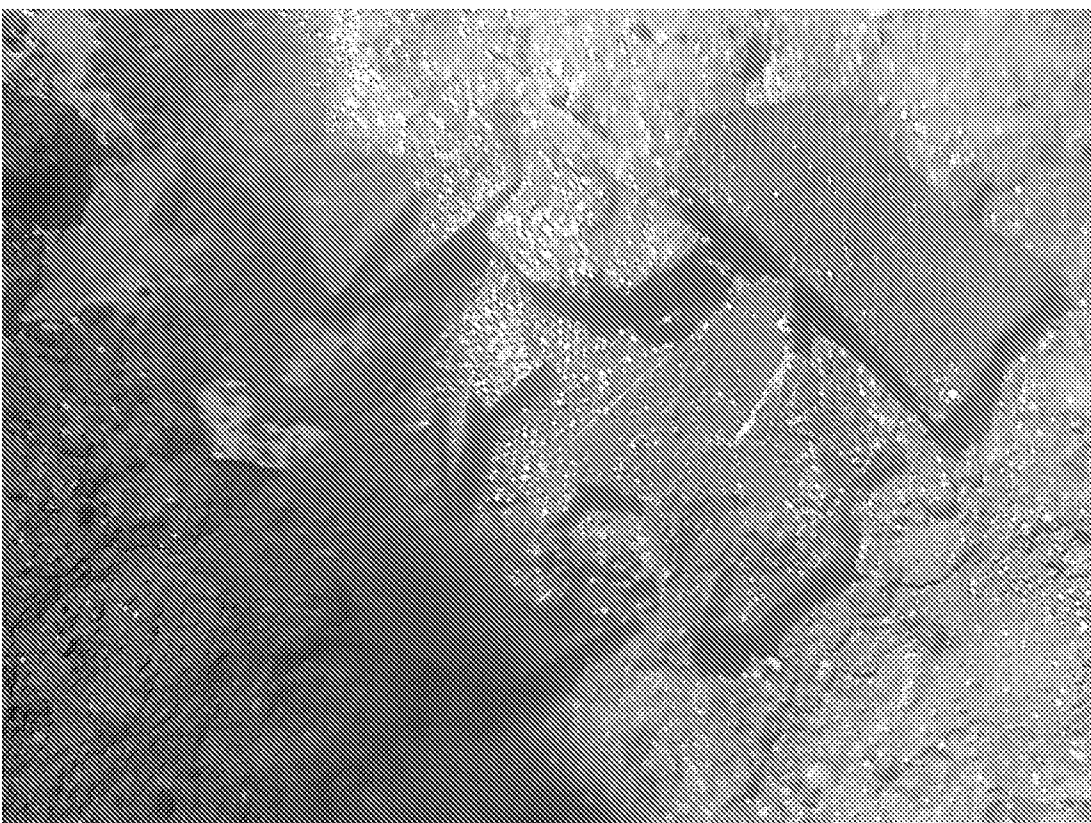
| Photo No.<br>6 | |

Fragments of suspected ACM cement were noted throughout made ground soils in TPP3-402 (0.0 m to 0.5 m), TPP3-405 (0.7 m to 2.7 m) and stockpile sampling location SP3-2 (0.05 m to 0.1 m). These fragments ranged between 30 mm and 150 mm in size.

| Suspected<br>ACM cement<br>fragments<br>found in soil<br>arising from<br>TPP3-402. | |

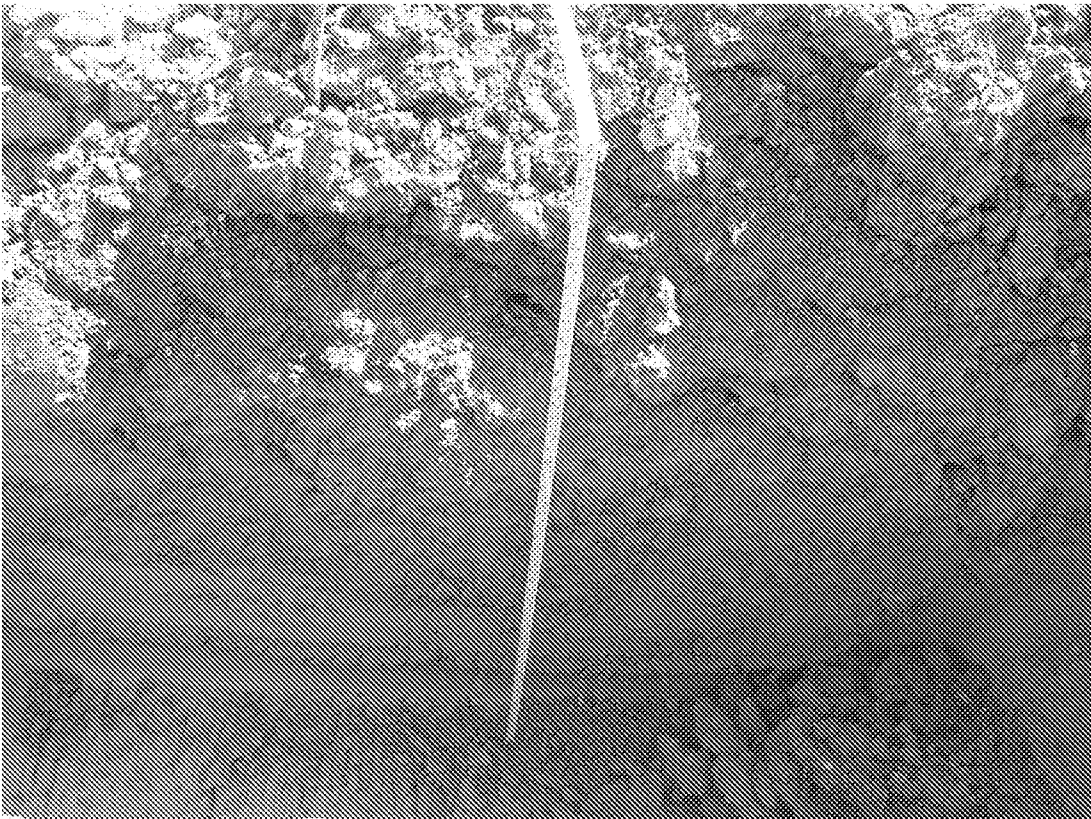
| PHOTOGRAPHIC LOG | |
|---|---|
| <b>Photo No.</b><br>8 | |

| PHOTOGRAPHIC LOG | |
|---|---|
| View of TPP3-403 east face. | |

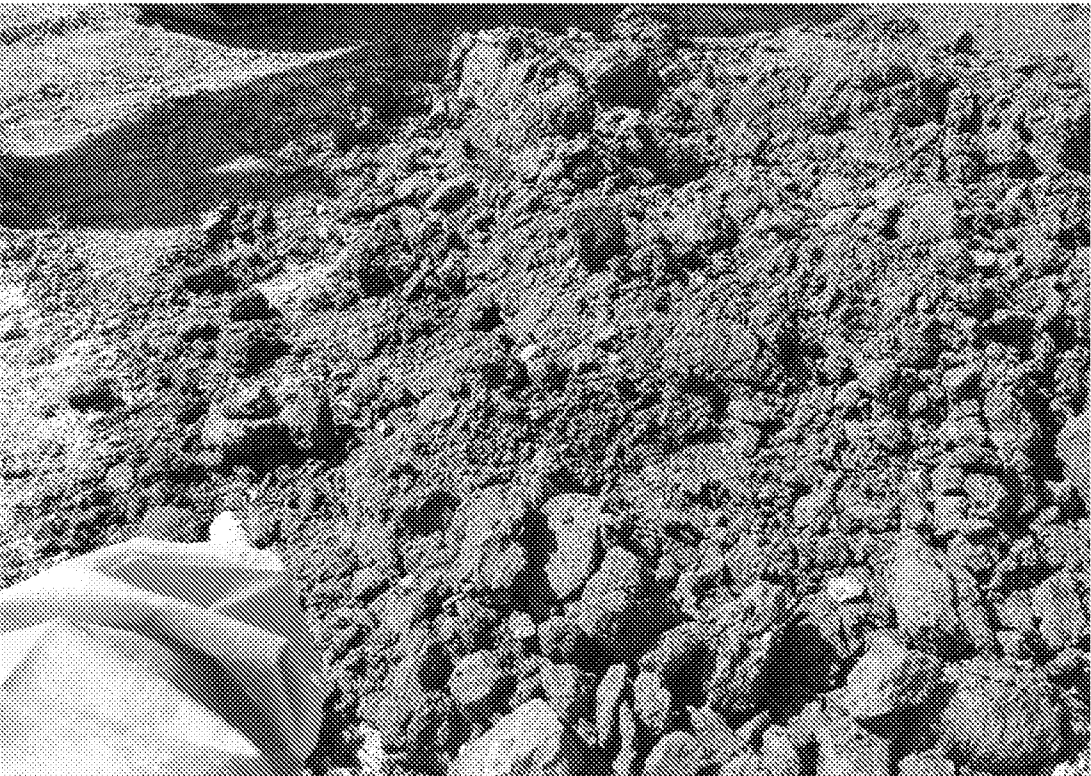
| PHOTOGRAPHIC LOG | |
|---|---|
| <p><b>Photo No.</b><br/>10</p> <p><b>Date:</b><br/>20/04/2018</p> <p>View of TPP3-403 arisings, with made ground in foreground, and natural soils in background. Location where amosite fibres shown in Photograph 9 were found and subsequently sampled from.</p> | |
