**First Interim Completion Report:**

**Former Texaco Service Station,  
Station Road  
Angmering**

**Client: JS Bloor (Newbury) Ltd.**

Report: MAS-BH-312-1  
Rev 01  
10/03/09

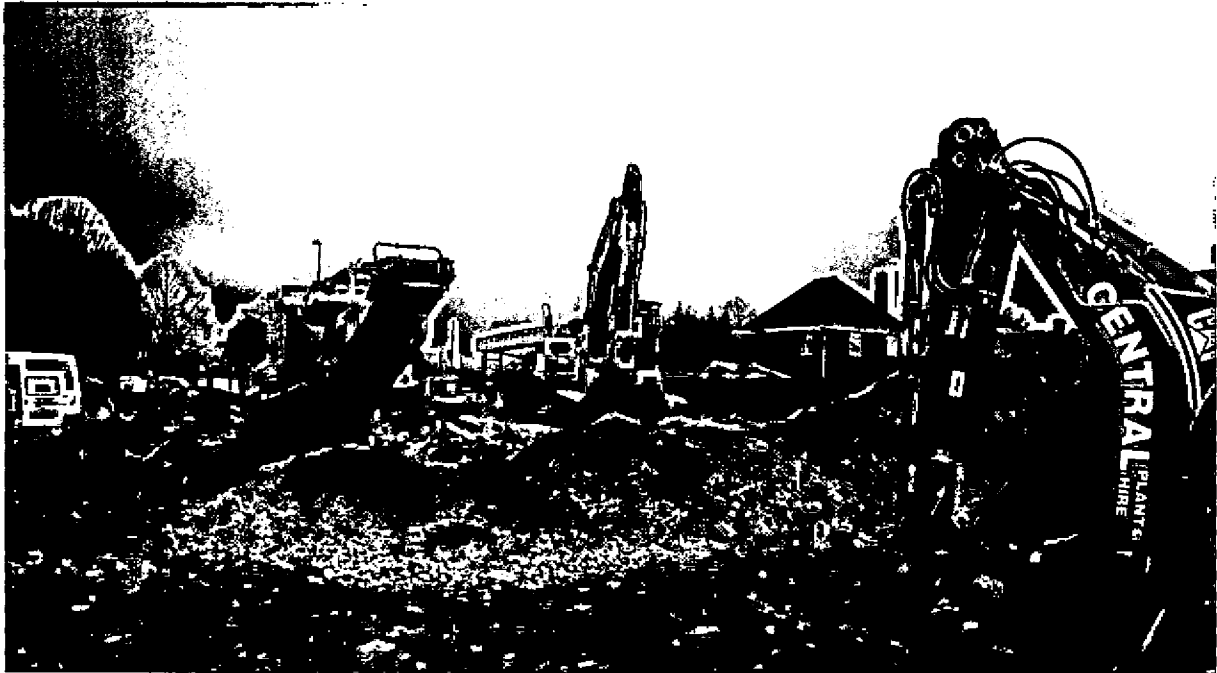
Figure 26: 7 February 2008 -General view towards north-east corner showing stockpiled crushed concrete.

The site-won crushed concrete used for infilling and to form the piling blanket was uncontaminated thereby meeting the requirements of Condition 11.

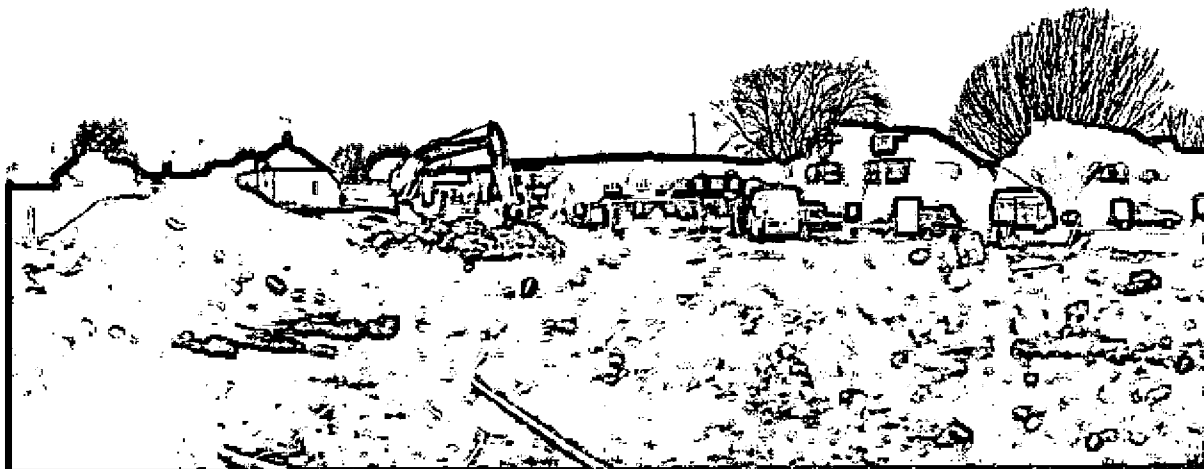
Figure 28: 7 February 2008 - View towards south-west corner (Station Road in the right background).  
The car wash excavation is in the right mid-ground

The car wash interceptor was found to be non-functional and so a large tank was brought to site to hold the arisings of potentially contaminated groundwater.

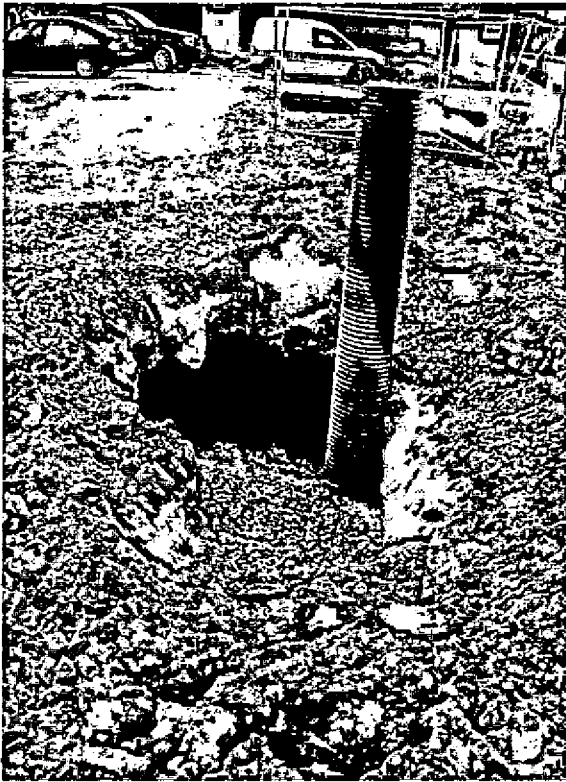
Figure 33: 26 March 2008 – extraction sump pipe

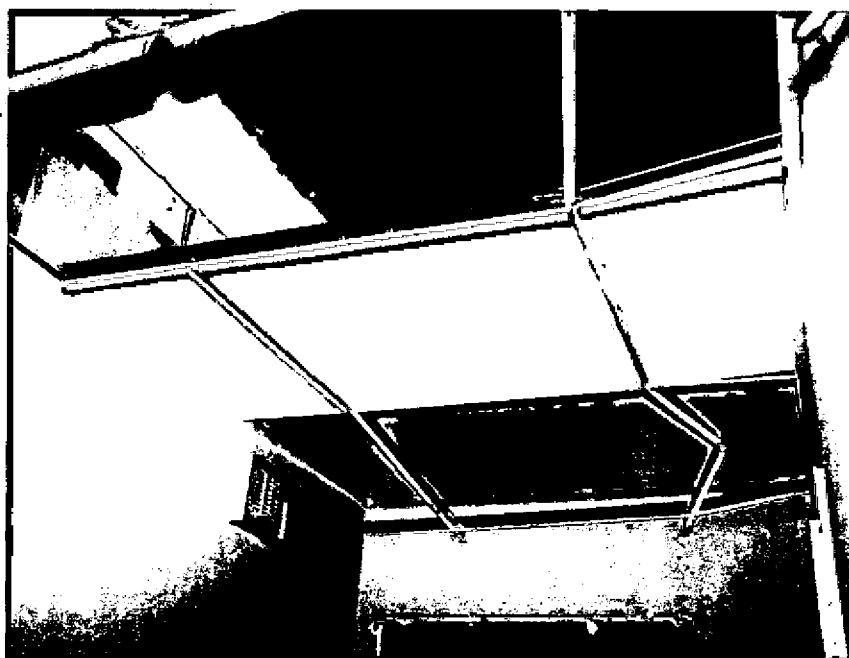
| | | Risk Band: | E | | |

The ceiling tiles (lying as debris) to the toilet area are NON asbestos

Recommended  
Action:

No further action required

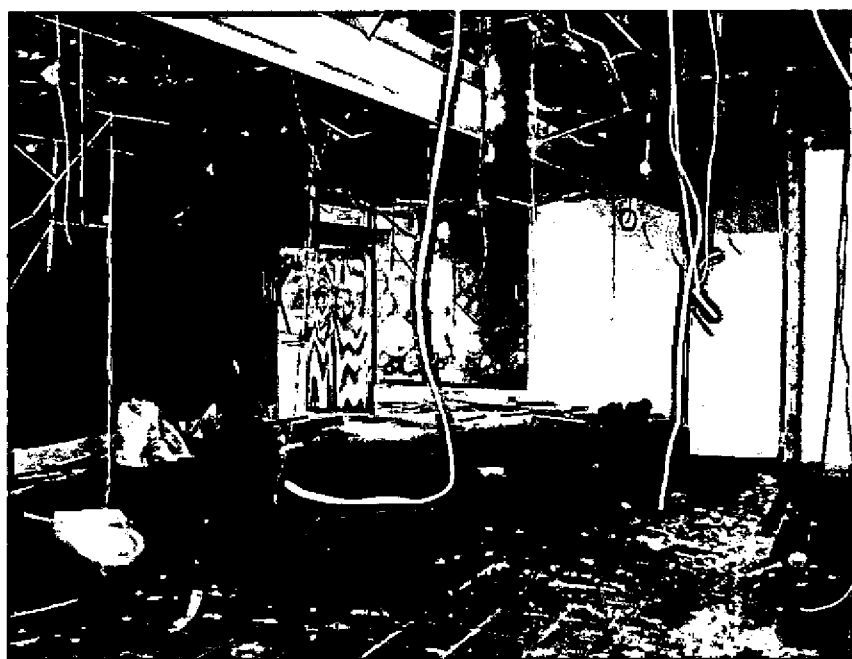
No materials to the the main building were suspected of containing asbestos fibres.

Recommended  
Action:

No further action required

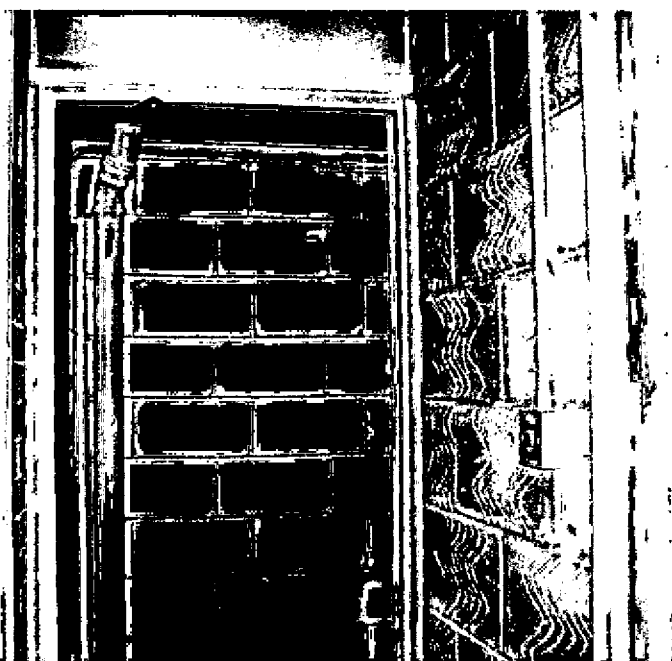
No materials to the the store were suspected of containing asbestos fibres.

| <b>Recommended Action:</b> | No further action required |
