**Pound Place  
Roundstone Lane  
Angmering  
West Sussex**

**Combined Geotechnical and  
Ground Contamination Risk Assessment**

**Report No. R18-12844**

**April 2018**

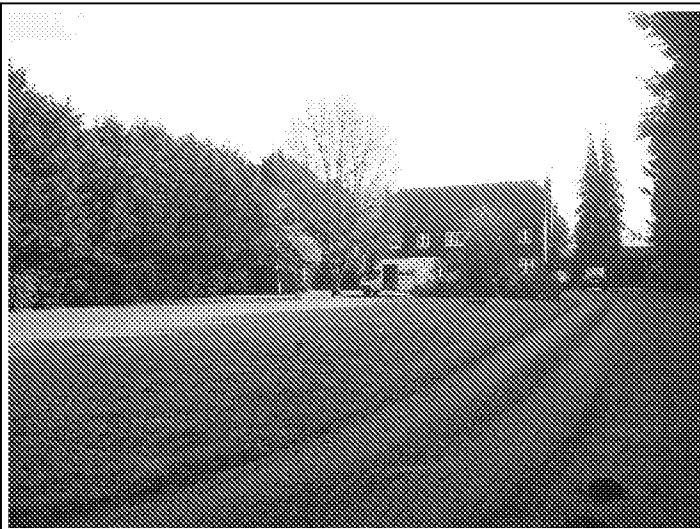
View east along driveway towards existing property.

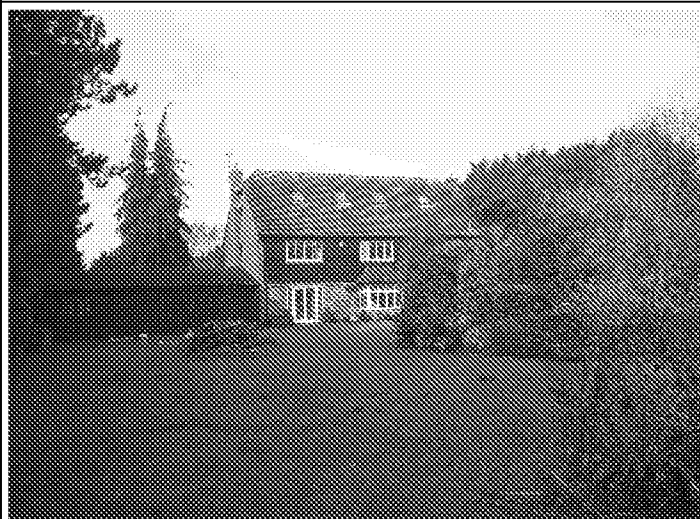
View west across rear garden area.
