**The Laurels  
Dappers Lane  
Angmering  
West Sussex**

**Ground Contamination  
Risk Assessment Report**

| Document Control | | | |
|---|---|---|---|
| R18-13291 | 14 <sup>th</sup> Nov 2018 | Final for issue | |

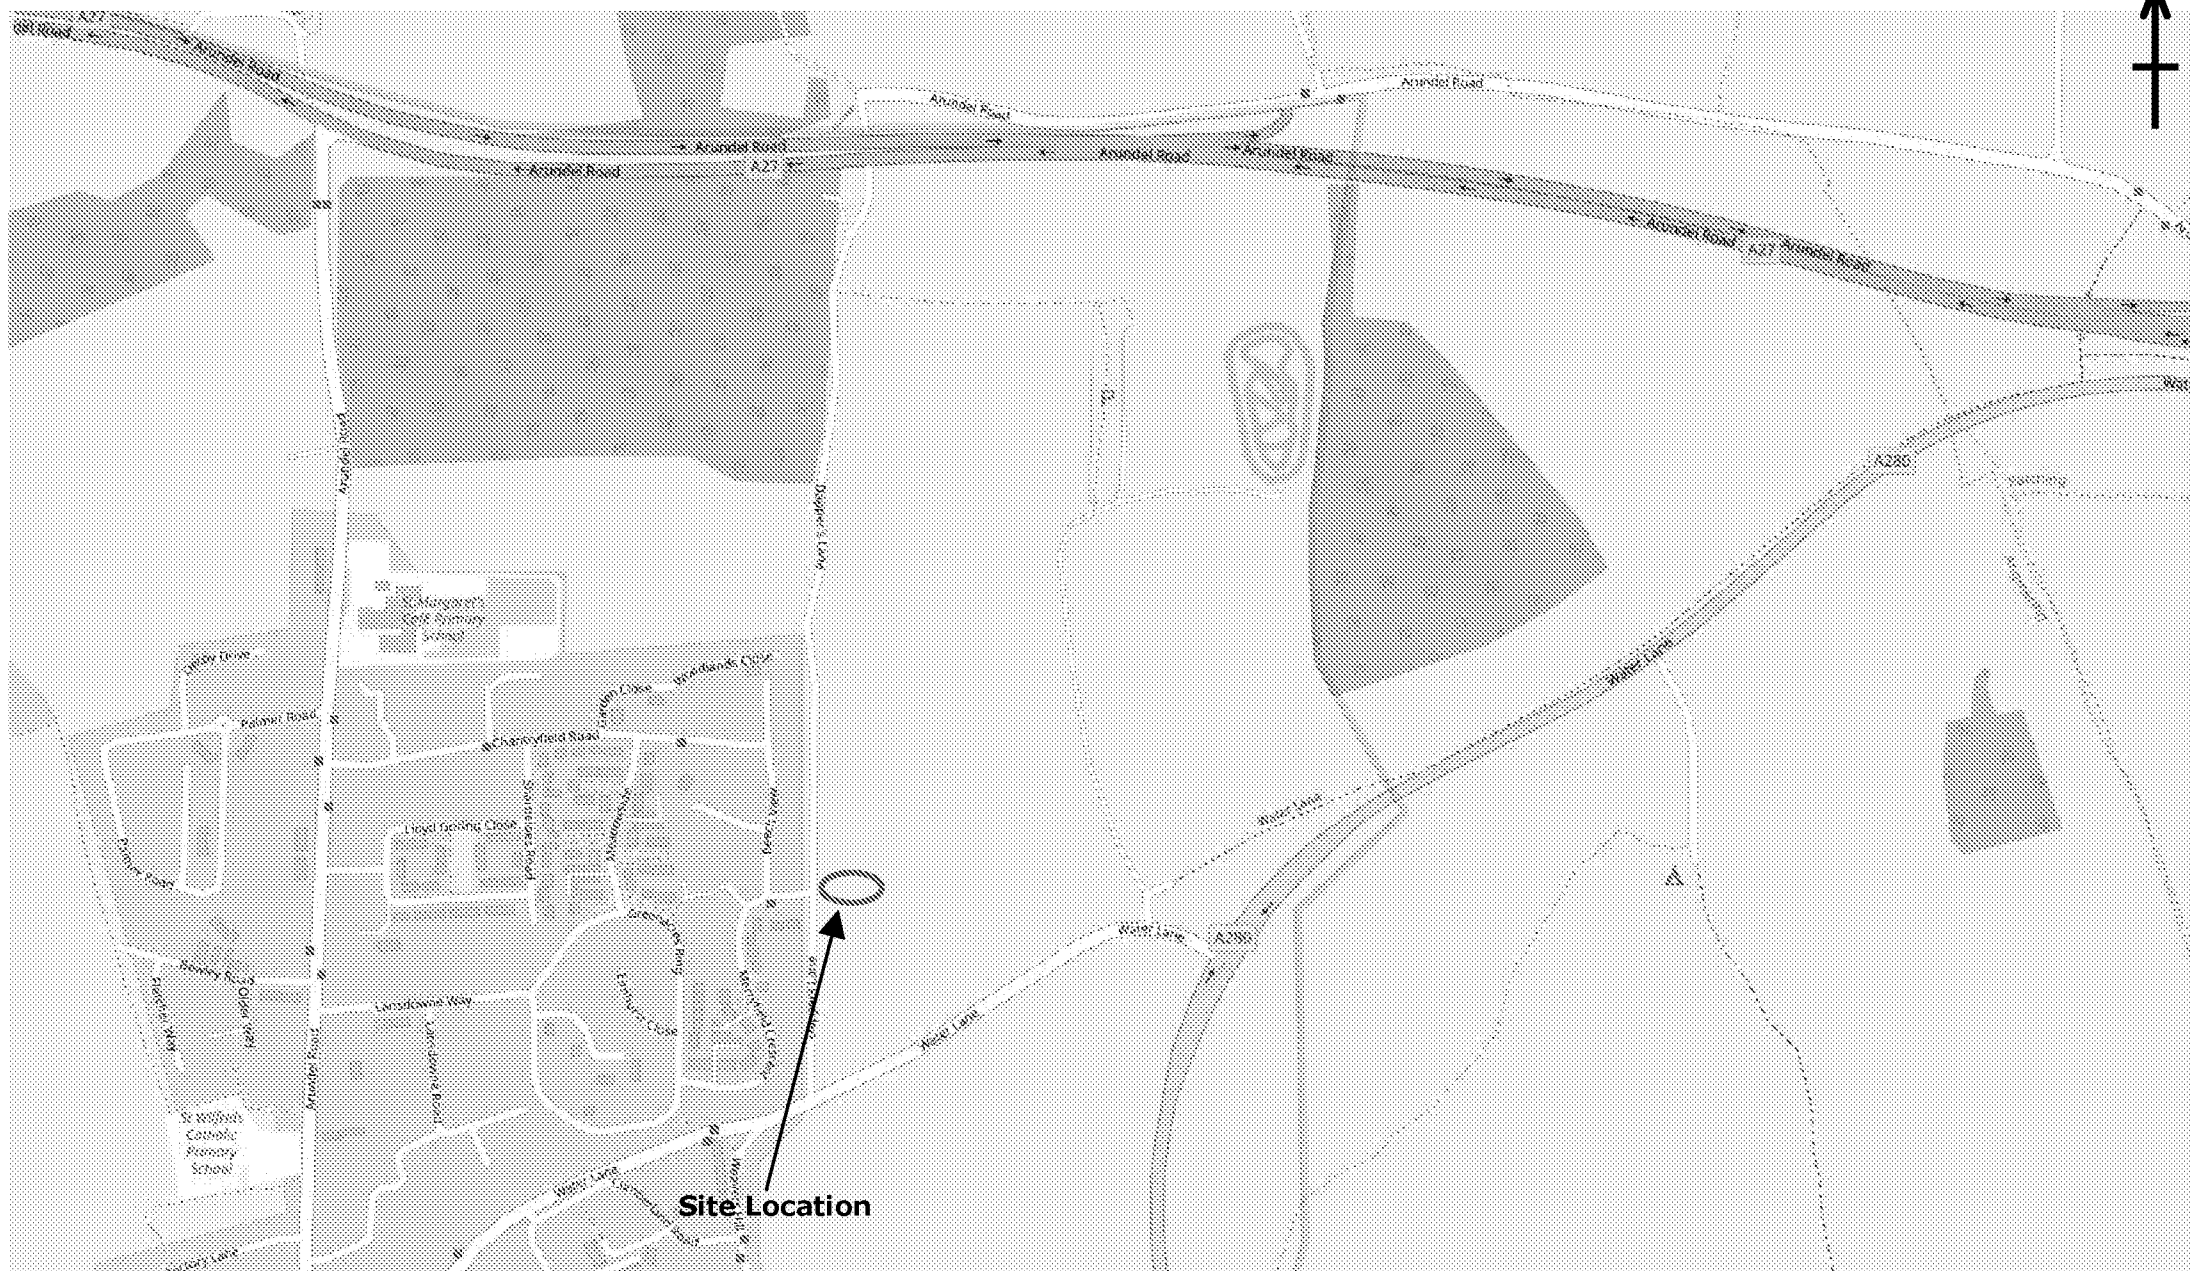
Figure 2 Site Plan

The ground investigation comprised the excavation of a series of dynamic sampler boreholes, together with hand dug pits and a hand augered borehole. A groundwater monitoring standpipe and datalogger were installed in one of the exploratory holes. The fieldwork was carried out on 17<sup>th</sup> October 2018. The exploratory hole locations are shown on Figure 2.

The site comprises an approximately 'L' shaped plot of land located at Dappers Lane, Angmering, West Sussex, and is centred on the approximate Ordnance Survey national grid reference TQ 07350 04860. A site location plan and site plan are presented as Figure 1 and Figure 2, respectively. Photographs taken during the walkover survey are included in Appendix B.

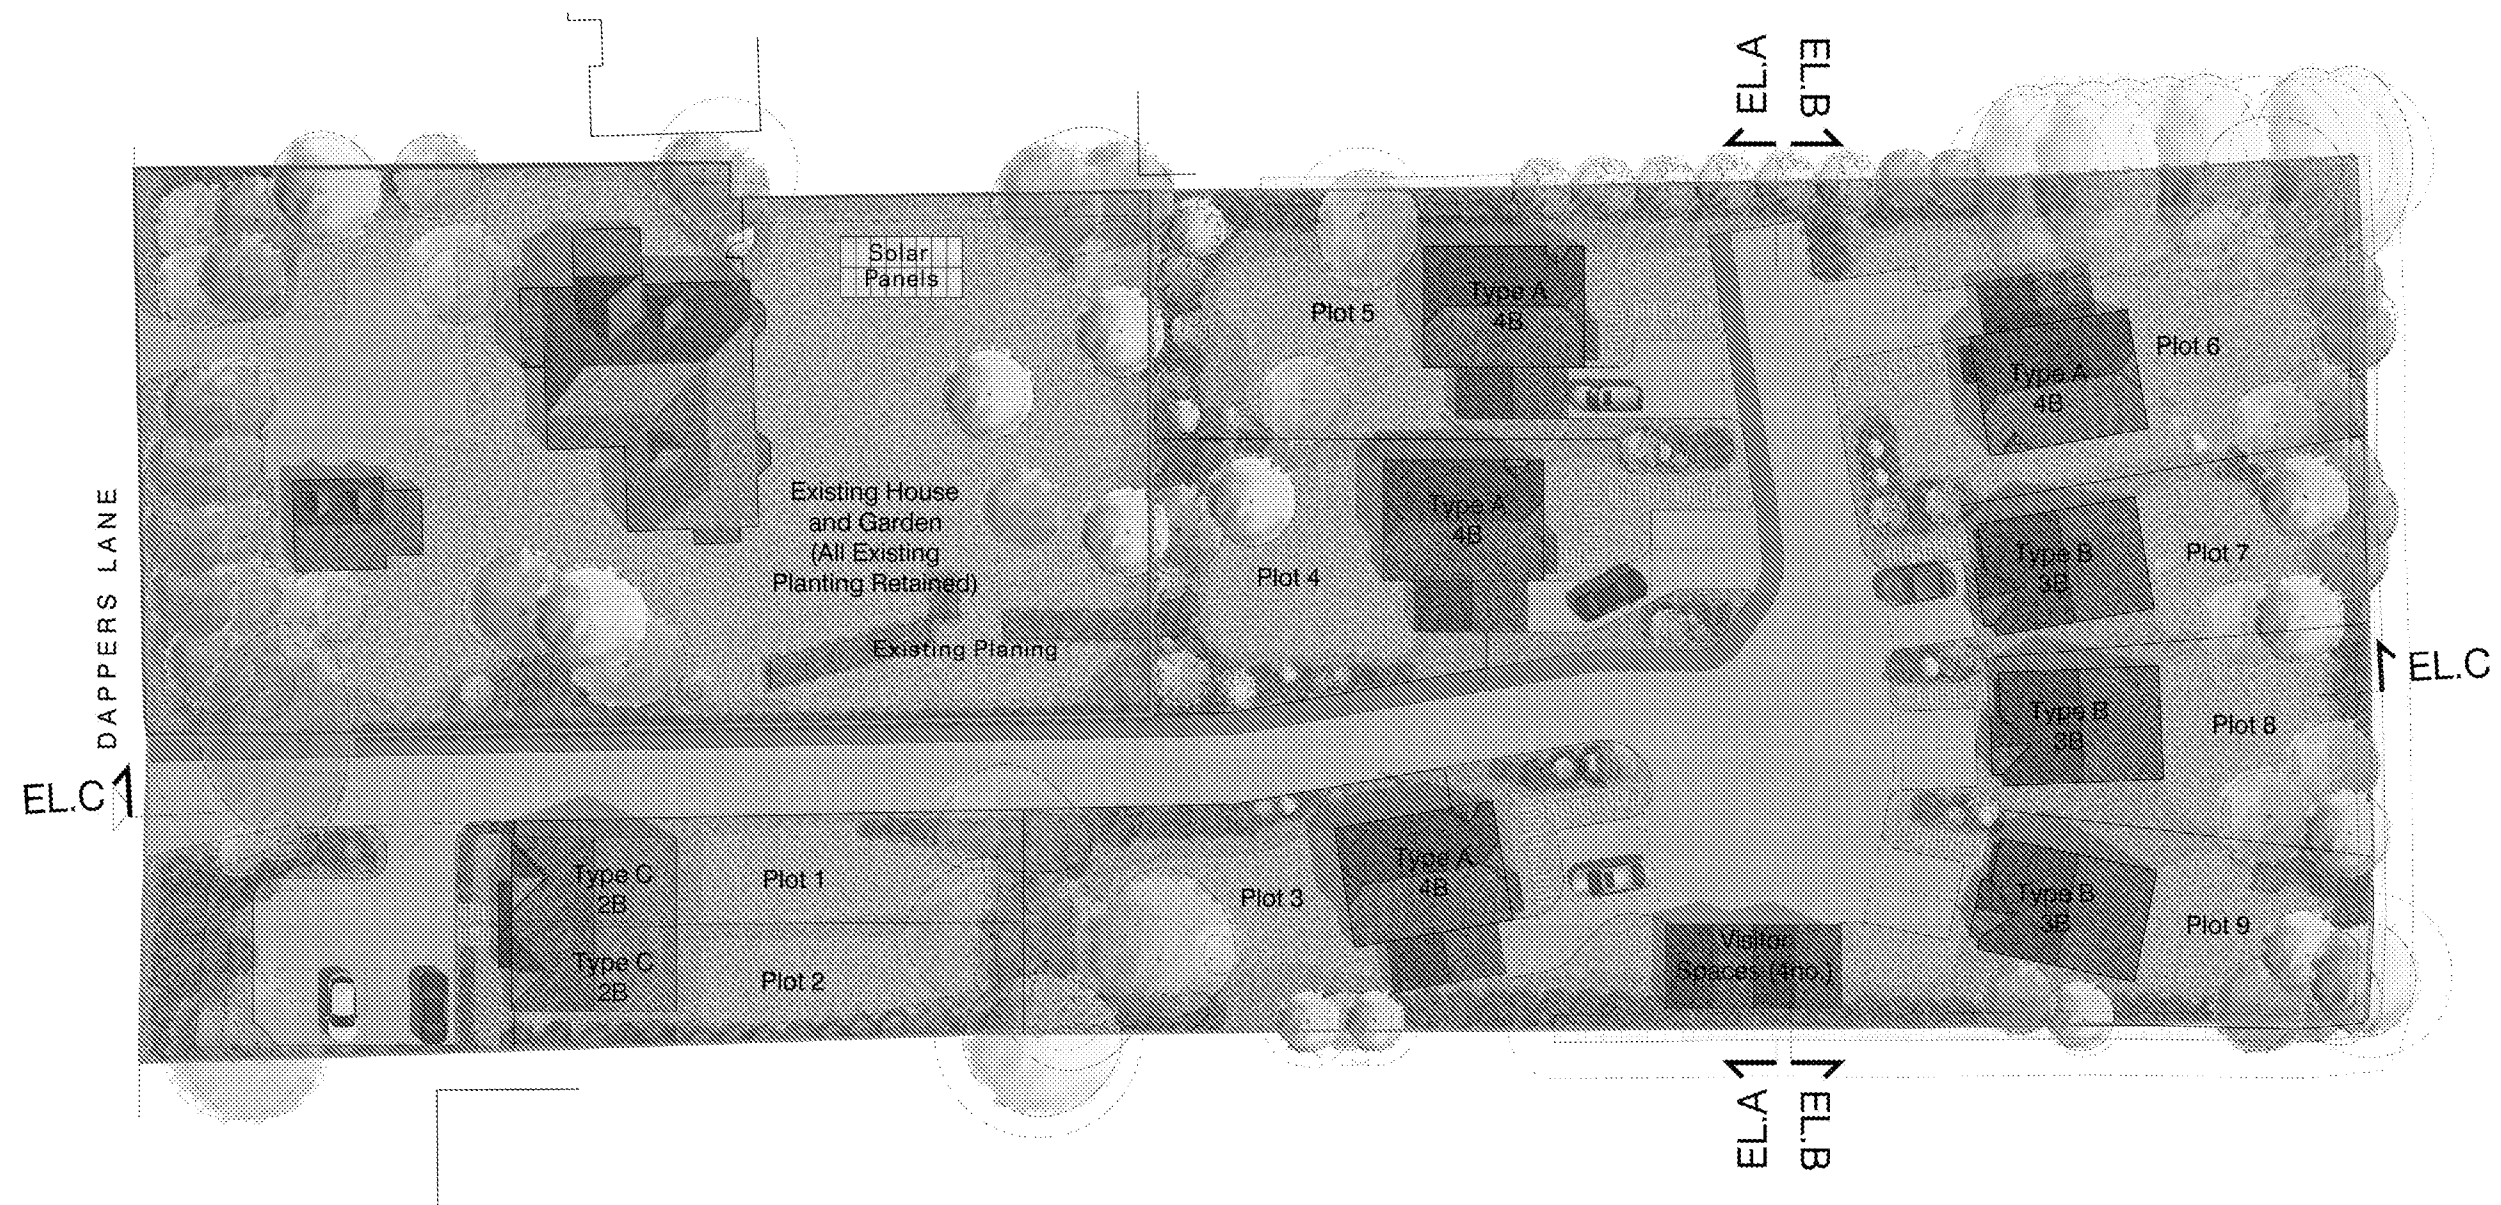
Drawing number:  
0242/P009

Drawing name:  
Master Plan For 9 Units

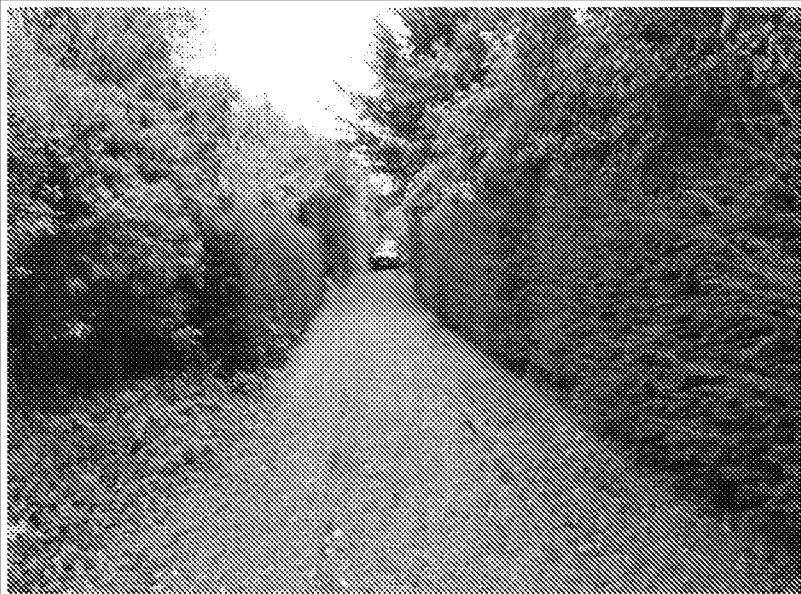
Site access off Dappers Lane

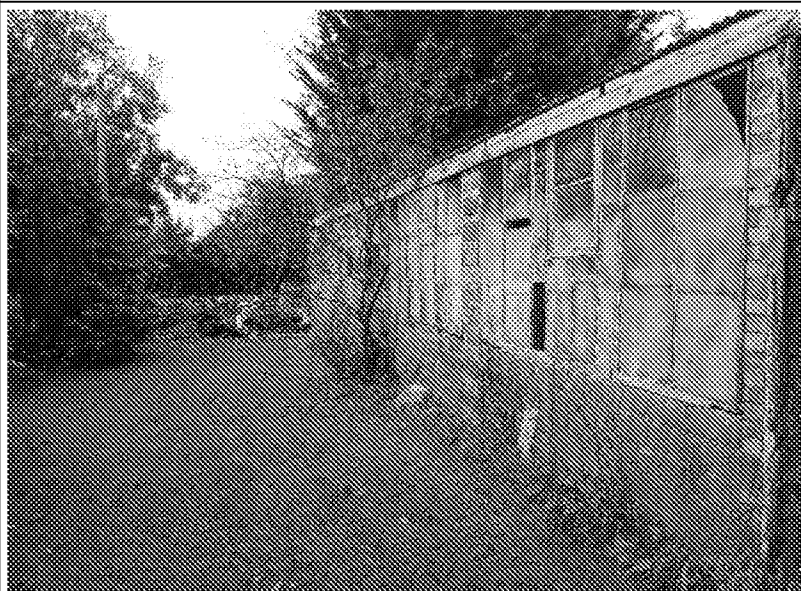
Former nursery building in western part of site

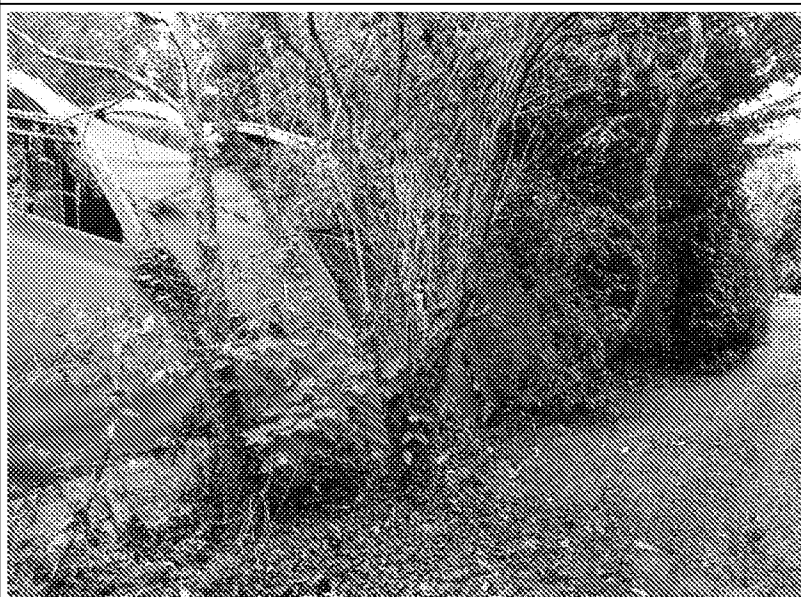
At the time of the walkover survey the site comprised a largely disused parcel of land, accessed via a gated entrance off Dappers Lane at the westernmost end of the site. Within the western 'neck' of the site several former plant nursery buildings were present, including a semi-derelict brick/glass shed with adjoining timber store and a former polytunnel type structure with partial textile covering and corrugated metal panelling to either end.

The roof of the former structure was noted in part to comprise corrugated suspected asbestos cement sheeting. The buildings appeared to be being used for ad hoc storage purposes, including timber, general building materials and other miscellaneous items. Some areas of relic concrete hardstanding were present around the buildings and a pile of waste wood and pallets was located close to the site entrance. A number of loose corrugated suspected asbestos cement panels were observed on the ground adjacent to the former nursery buildings.

Former polytunnel structure in western part of site

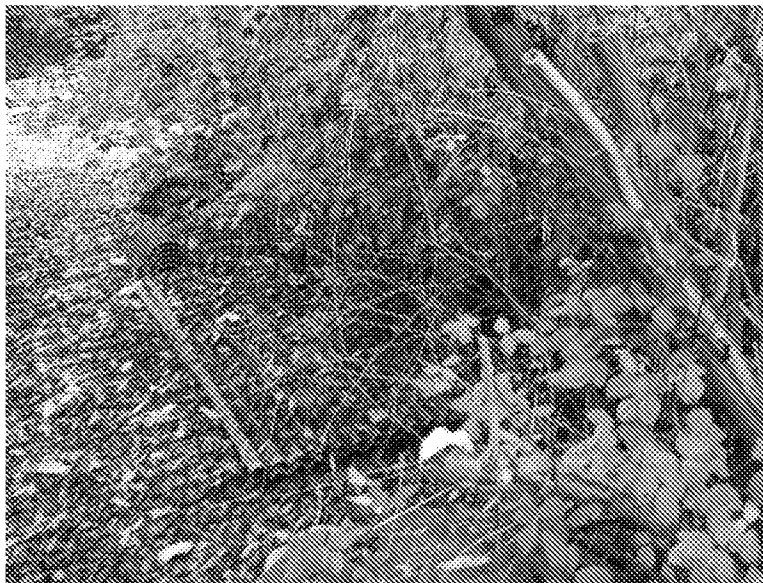
Whilst widespread asbestos contamination of the shallow soils at the site does not appear to be present, as suspected asbestos materials were observed on the ground surface at a number of locations, there remains the potential for localised asbestos contamination within the shallow soils which is considered to pose an unacceptable risk to the proposed end users of the development.

Suspected asbestos cement panels on ground observed adjacent to former polytunnel structure.

It is noted that an asbestos survey of existing structures and infrastructure<sup>5</sup> was beyond the brief of this report. The risk assessment has been undertaken on the basis that should asbestos be identified within buildings or infrastructure, with particular attention to the possible suspected asbestos cement roof panels, these materials will be removed appropriately by licensed contractors and asbestos materials disposed of in accordance with legal requirements prior to demolition or other works in order to avoid contaminating soils at the site.

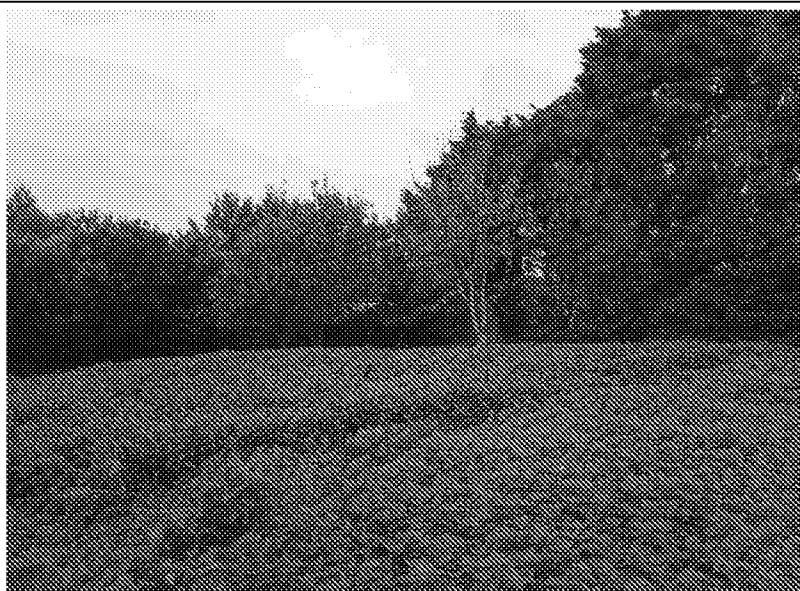
The larger, eastern portion of the site was found to be overgrown with vegetation and some small trees. No existing structures were evident in this part of the site. An above ground storage tank was observed approximately 2-3m beyond the boundary of the northeast corner of the site.

Looking north-eastwards across eastern portion of site.

Due to the presence of numerous mature trees within areas of proposed soft landscaping it is recommended that the local Tree Protection Officer should be consulted at an early stage to ascertain whether any of these trees are subject to tree protection orders, as remedial measures

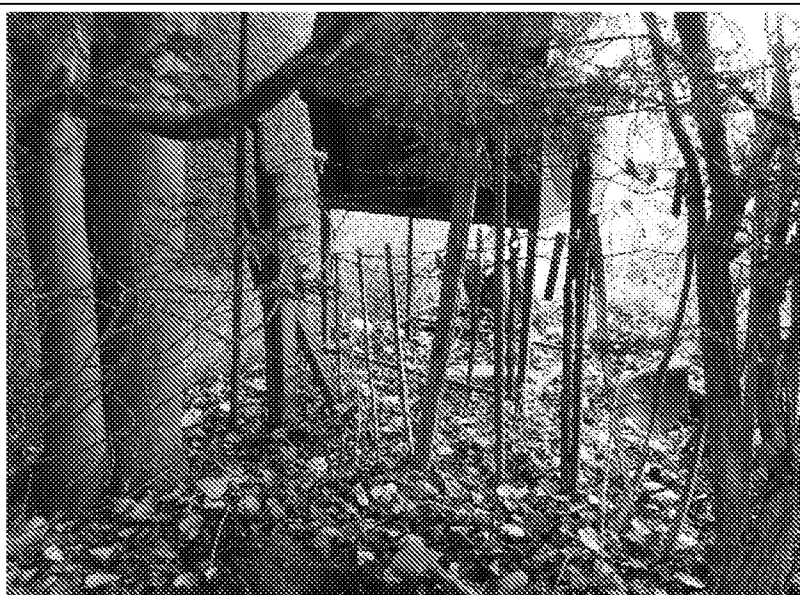
It is noted that the made ground sample from trial pit TP02 at 0.50m depth recorded a total hydrocarbon concentration in excess of 1000mg/kg, although no suspected fuel odours and/or visual indications of hydrocarbon contamination were observed at this location. In addition, no suspected fuel odours and/or visual indications of hydrocarbon contamination were noted at exploratory hole HA1, which was positioned close to an above ground storage tank located off-site to the northeast.

Above ground storage tank observed adjacent to northeast of site.
