# **Frontier Estates Limited**

## **Supplementary Geoenvironmental Investigation and Remediation Strategy**

**Dappers Lane  
Angmering  
West Sussex  
BN16 4DA**

**Report No: 21.05.026  
July 2021**

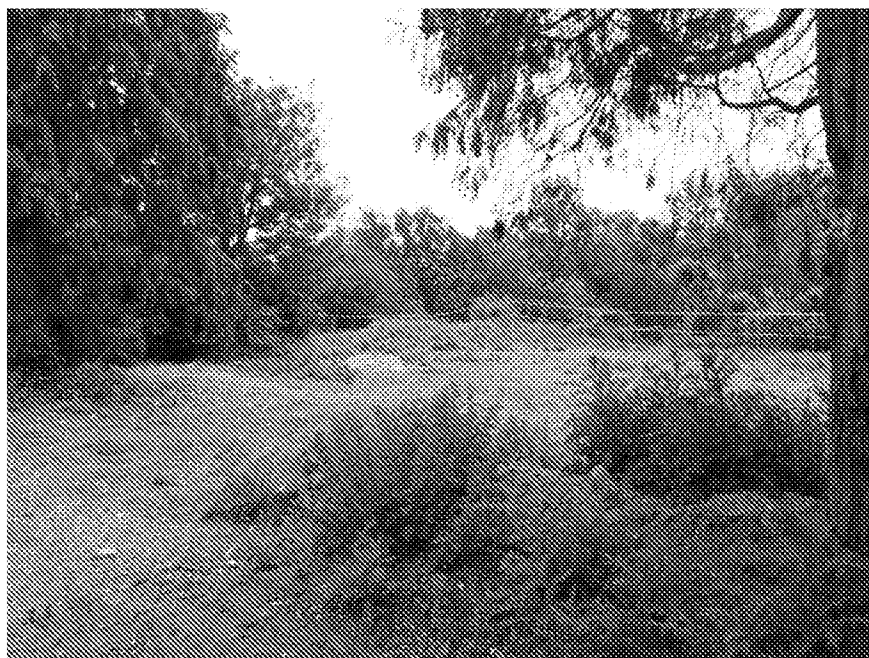
**Photo 1**

Looking Southeast from the northern site boundary across the area of the former residential property.

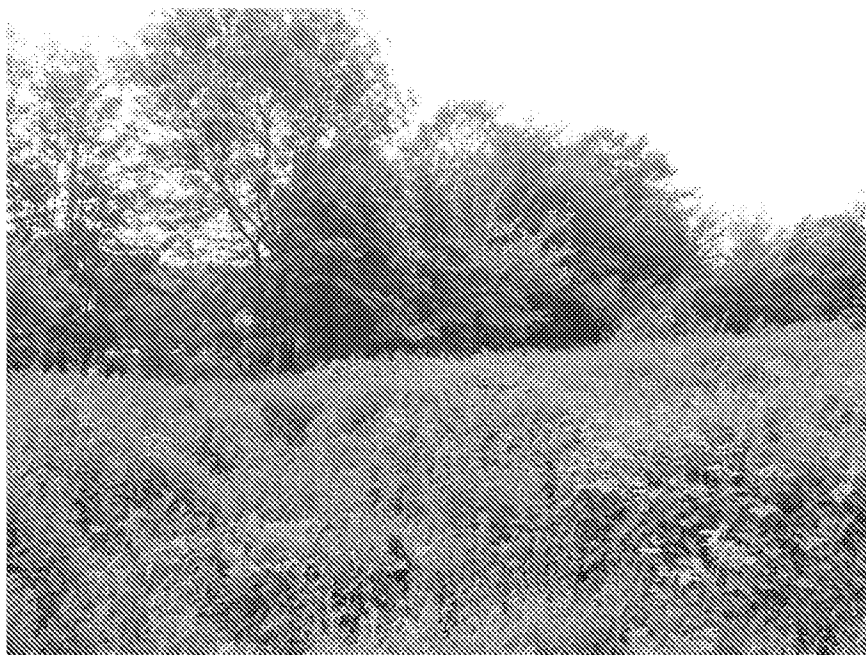
**Photo 3**

Looking southwest across the overgrown southern section of the site towards Water Lane.

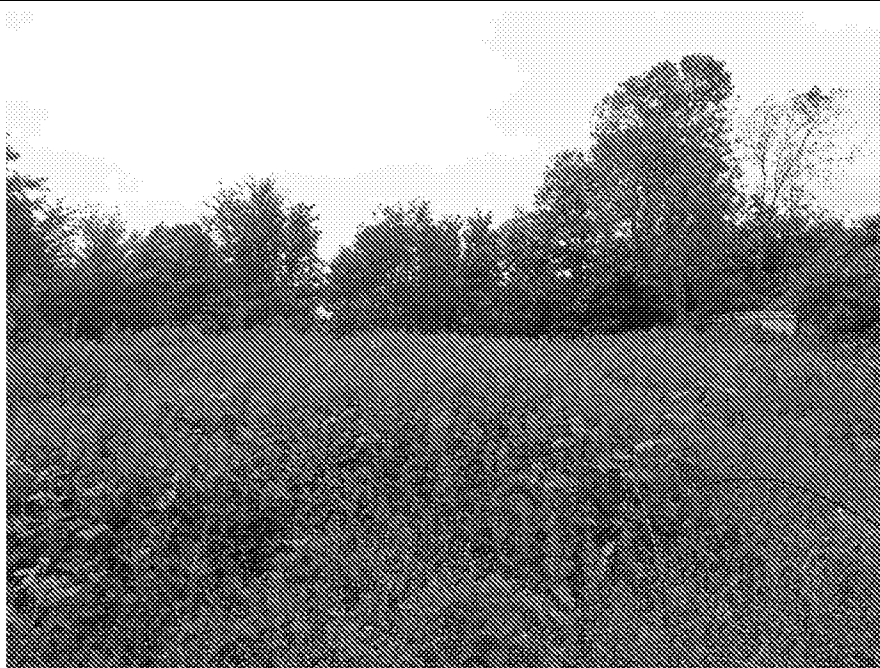
**Photo 4**

Looking west towards Dappers Lane showing the overgrown nature of the site.
