**Temporary Car Parking**  
**Caffyns Audi, Worthing**  
**Flood Risk & Drainage Statement**

The proposal is to construct a temporary car storage area adjacent to a recently completed car dealership site. The layout is shown on the appended proposed site plan, SRA Architects Drg. No. 3480-SK01A.

## **Audi Worthing – Report on Infiltration Tests**

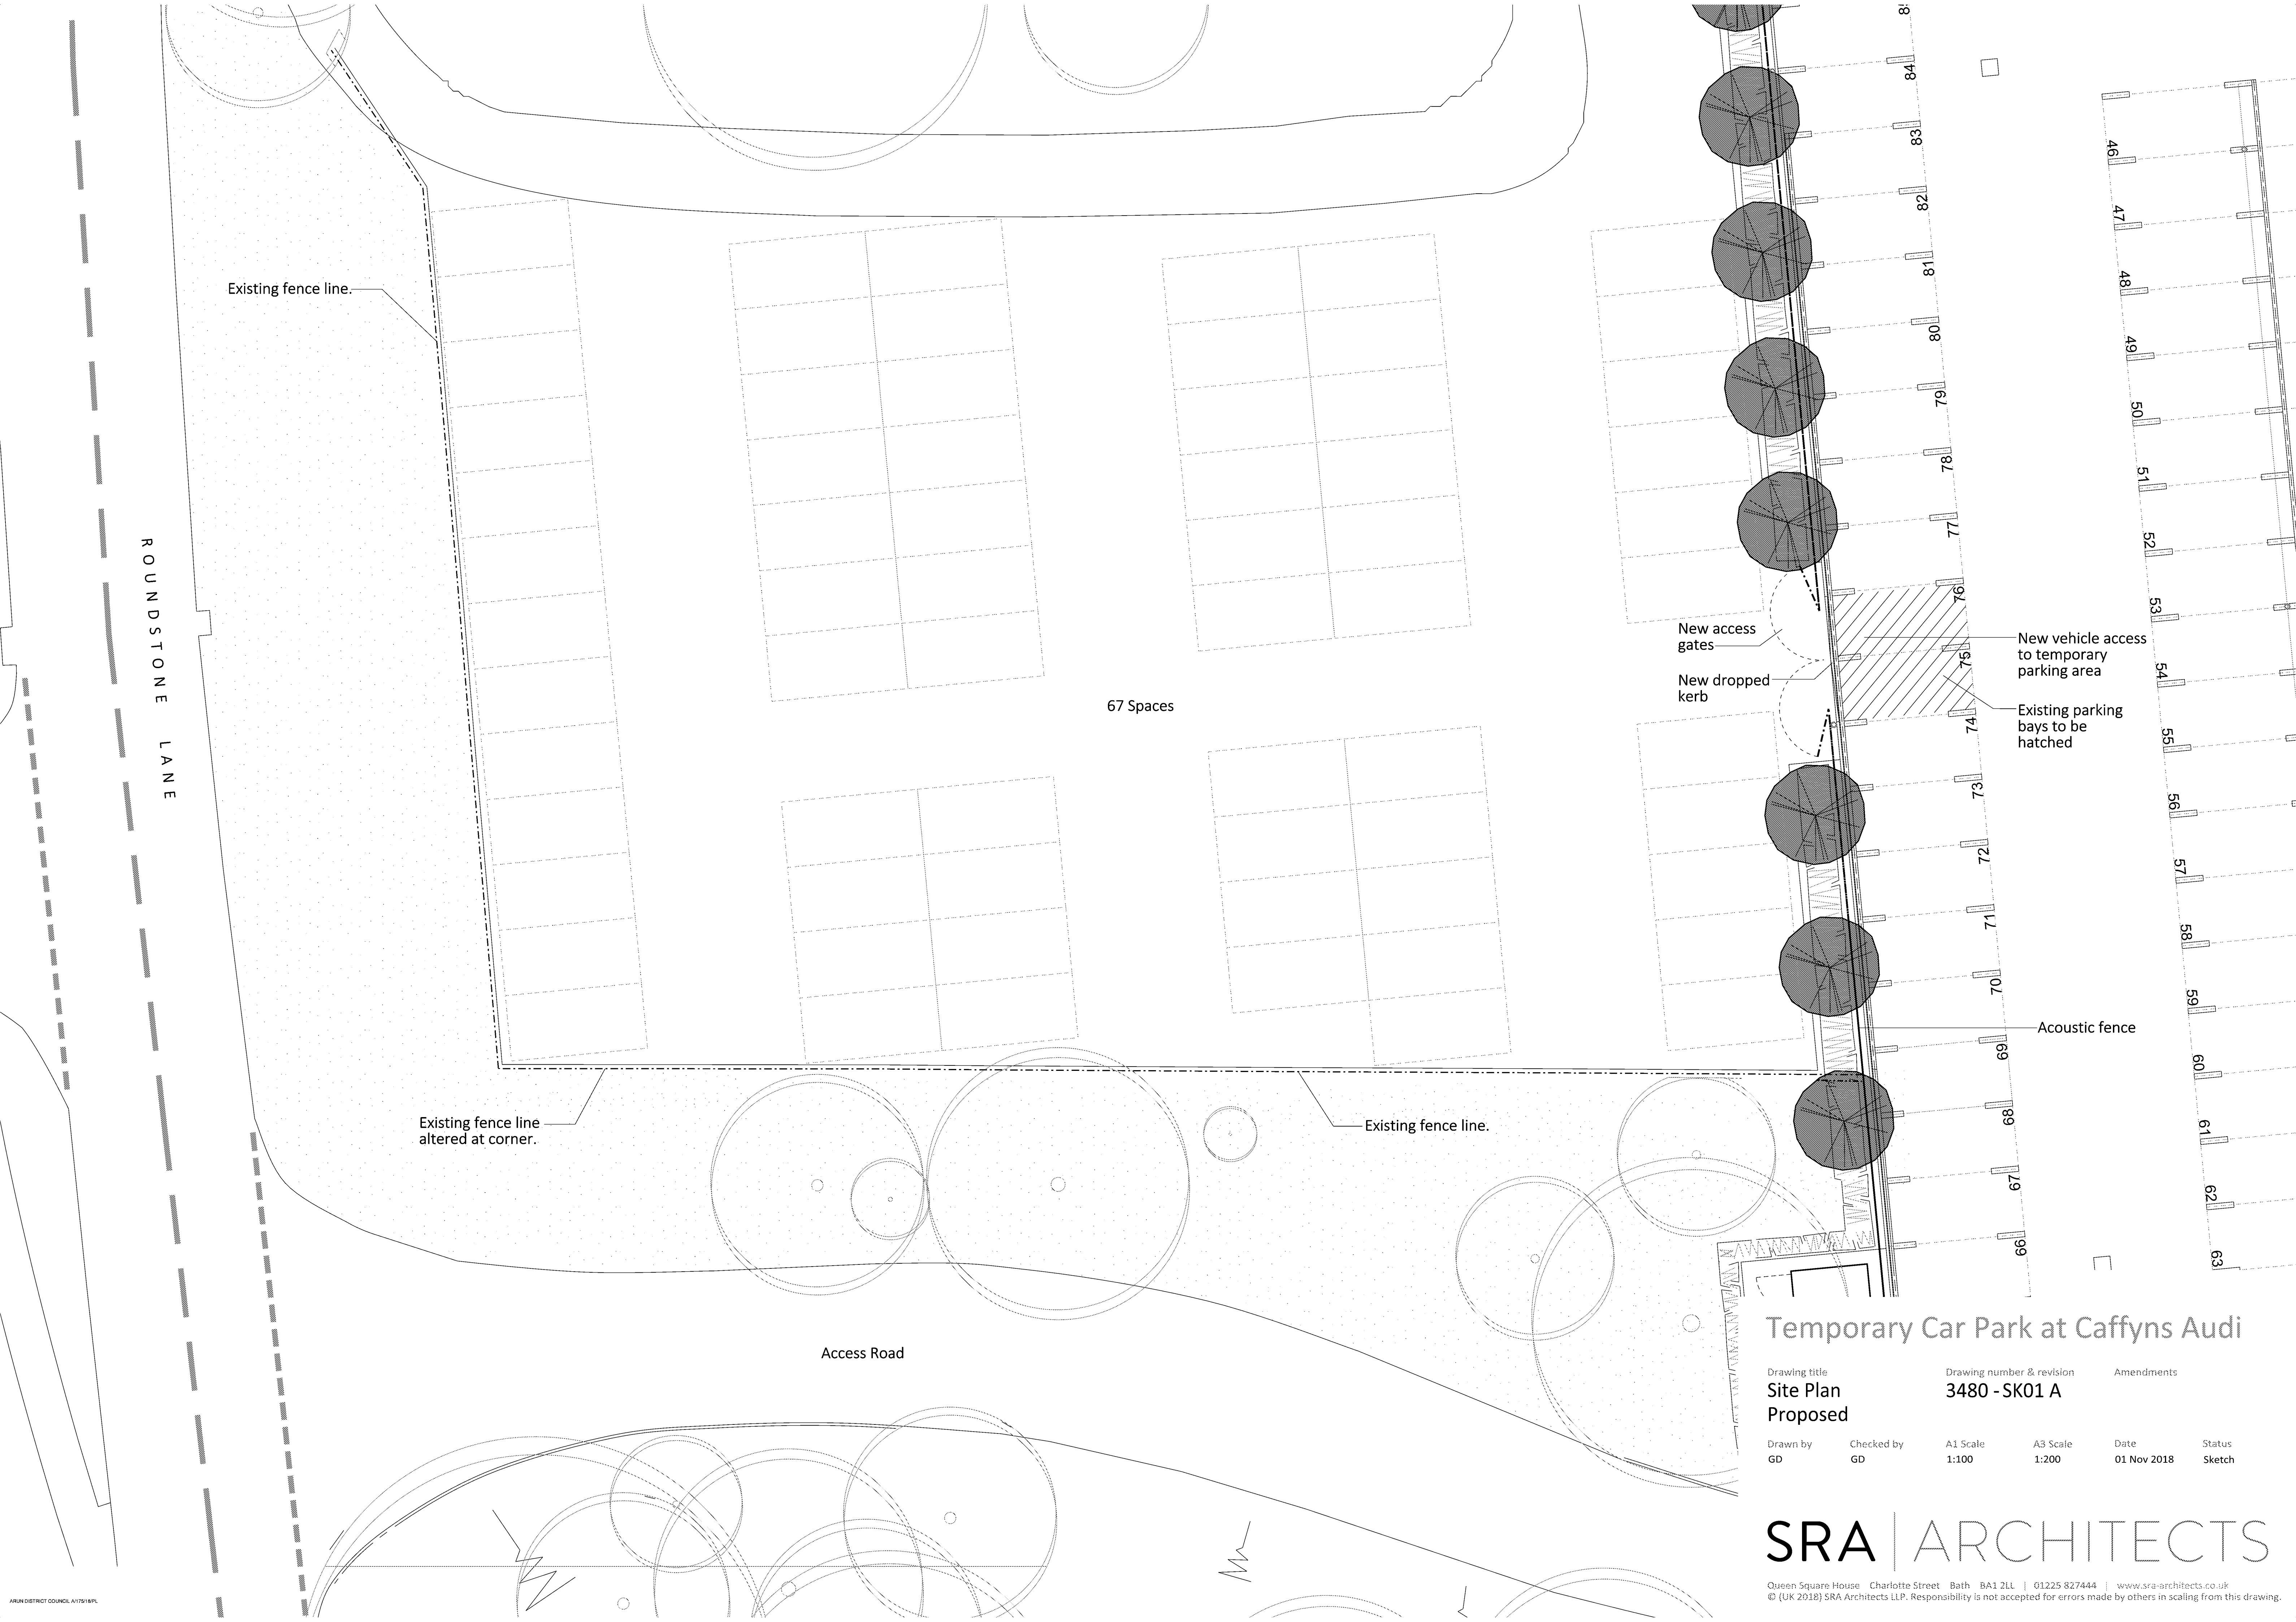
| Site Plan Proposed | | 3480 - SK01 A | | | |

67 Spaces

New access gates  
New dropped kerb

New vehicle access to temporary parking area  
Existing parking bays to be hatched

Acoustic fence

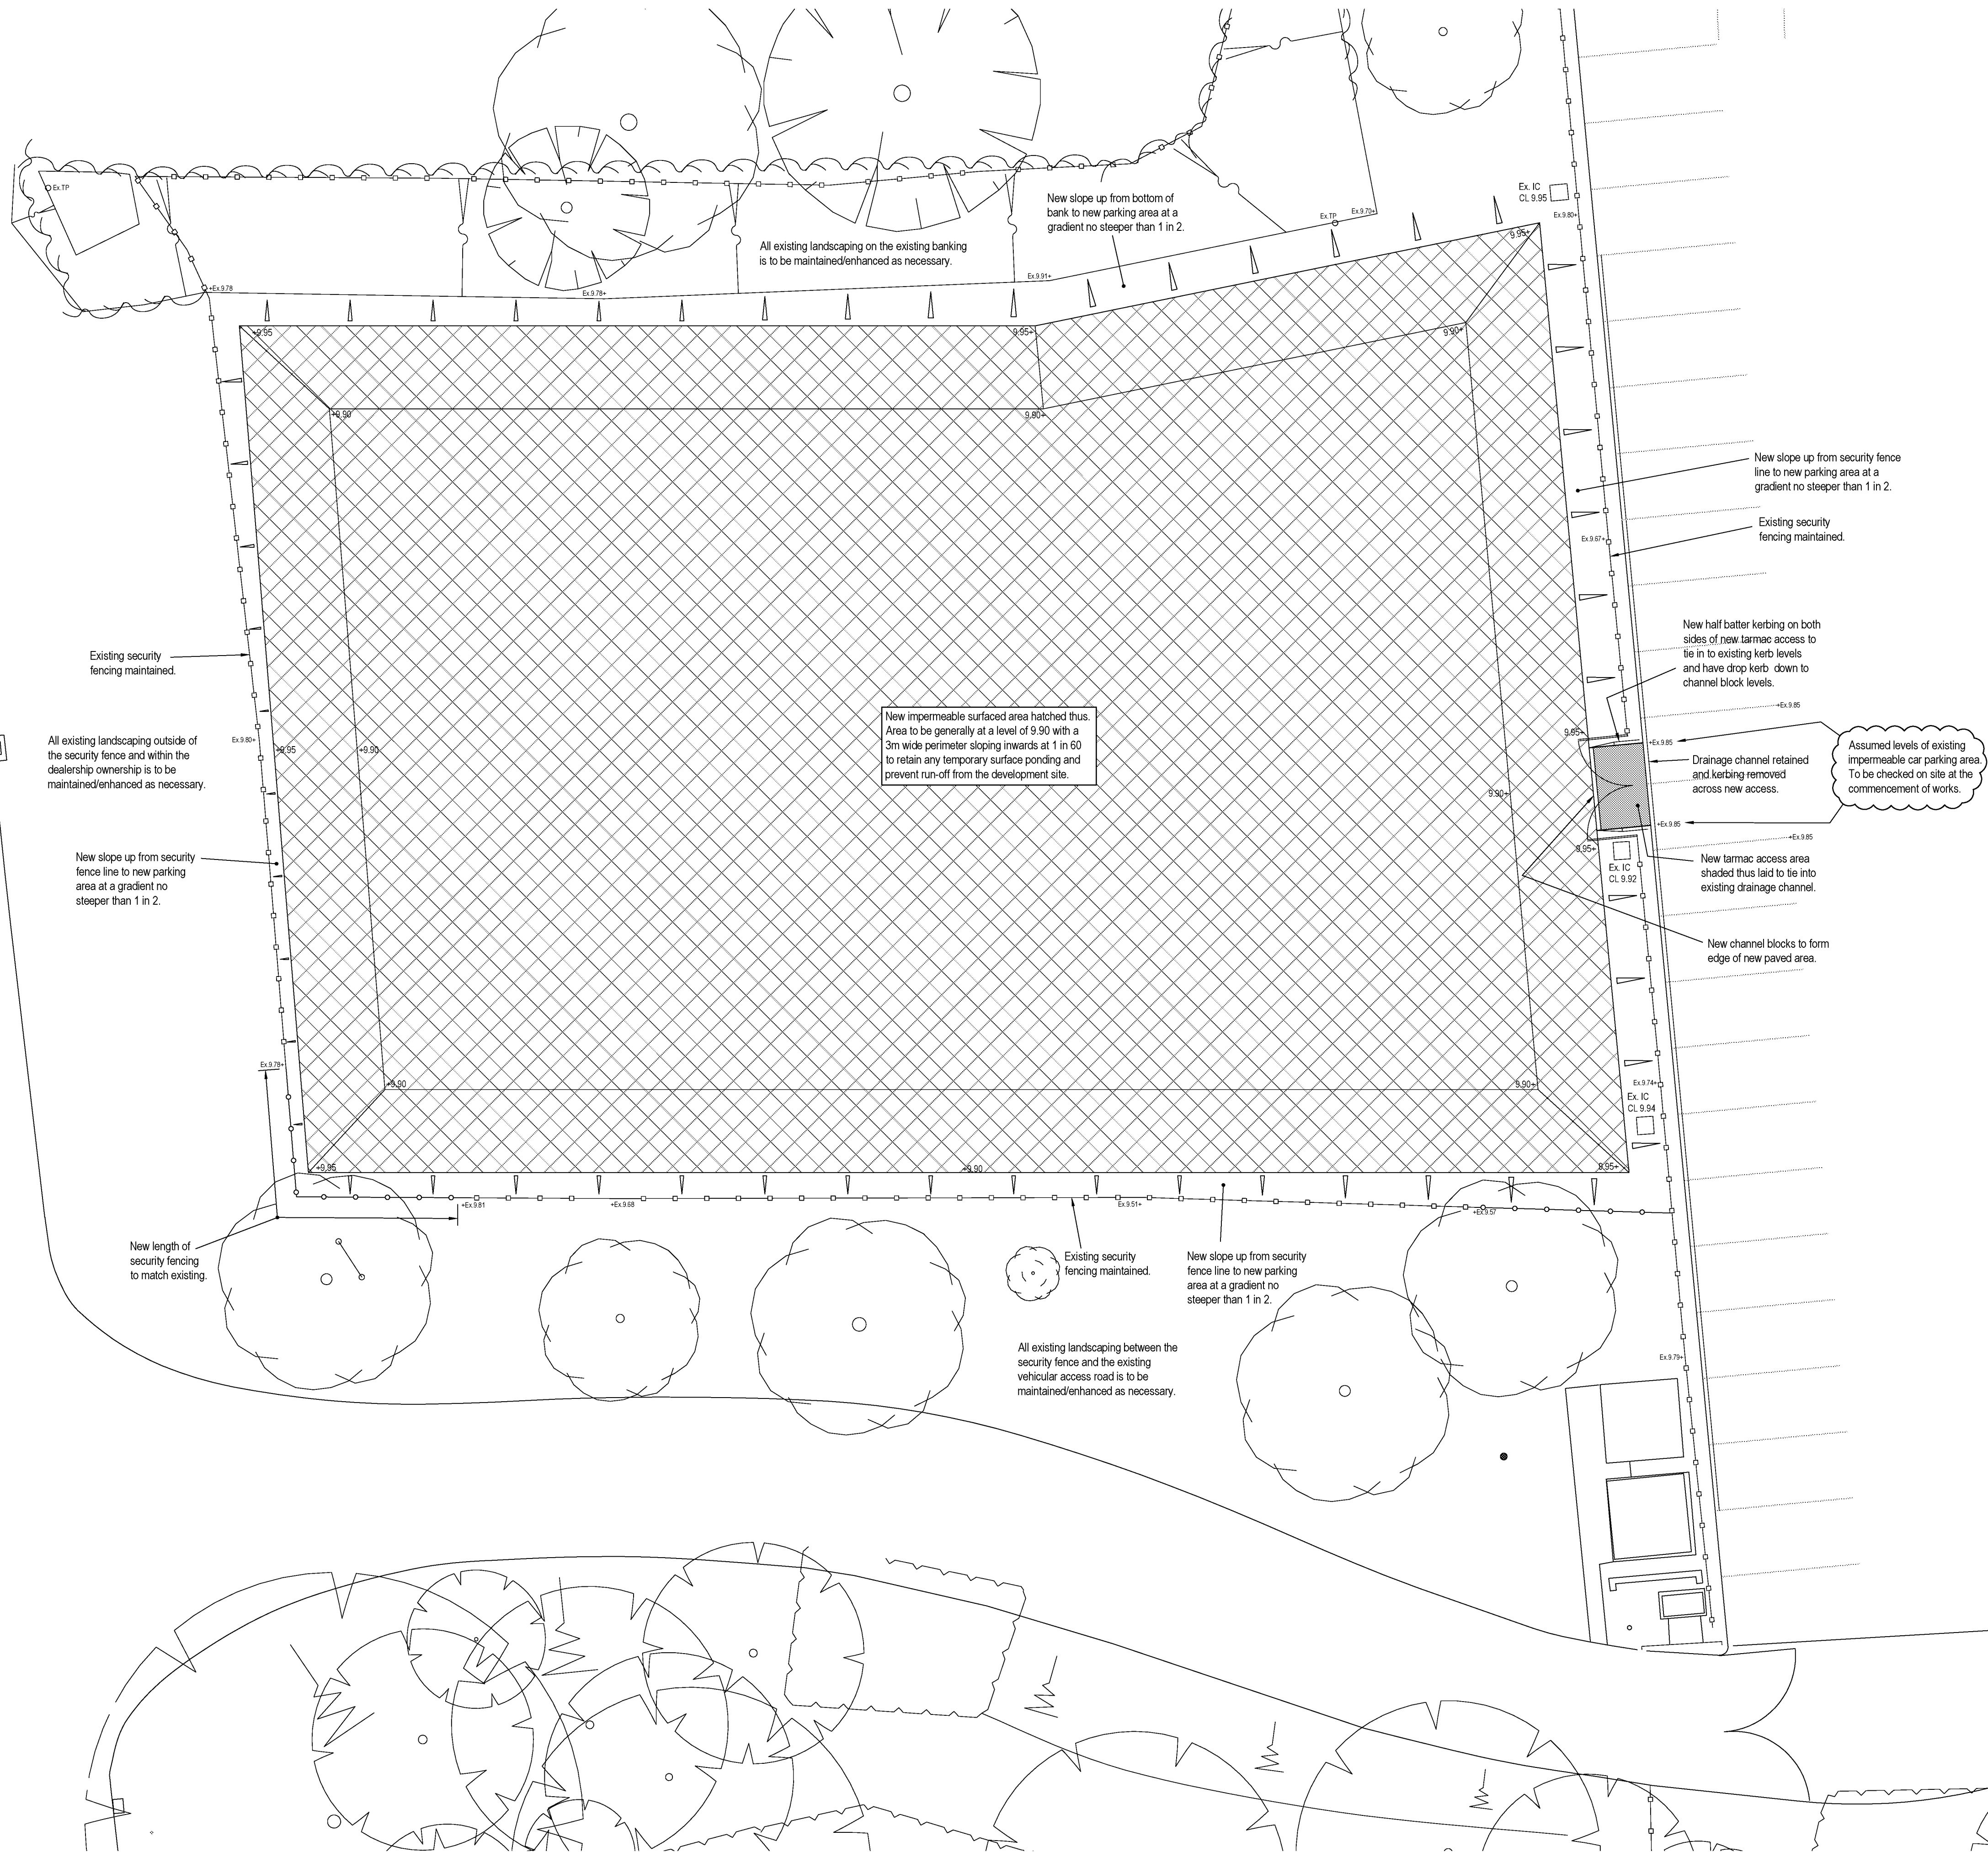
| MW | SJE | 13-04-17 | 43413/001 | A |

Permeable storage area  
150mm thickness of Type 3 stone.  
Permeable geotextile.  
150mm thickness 6F2 granular material.

Tarmac access  
30mm thickness of 10mm size close graded surface course.  
55mm thickness of 20mm size dense base course.  
250mm thickness of DTp Type 1 granular material.

The new construction build-up is to consist of a 150 thickness of granular 6F2 material, overlaid with a permeable geotextile and surfaced with a 150 thickness of Type 3 stone (40mm size with reduced fines content). As well as creating a significant amount of water storage this will also provide a level of treatment to the run-off should any oils be deposited. It should be borne in mind that it is highly unlikely that any significant deposition of oils will occur, as the vast majority of vehicles stored will be new or nearly new, and are consequently well maintained.

The appended Drg. No. 43413/001A shows the proposed parking area levels and construction build-up.
