# Discharge of Drainage Condition 11

| Project | Land north of Mayflower Way, Angmering |
| Project Number | 23685 - North Development |

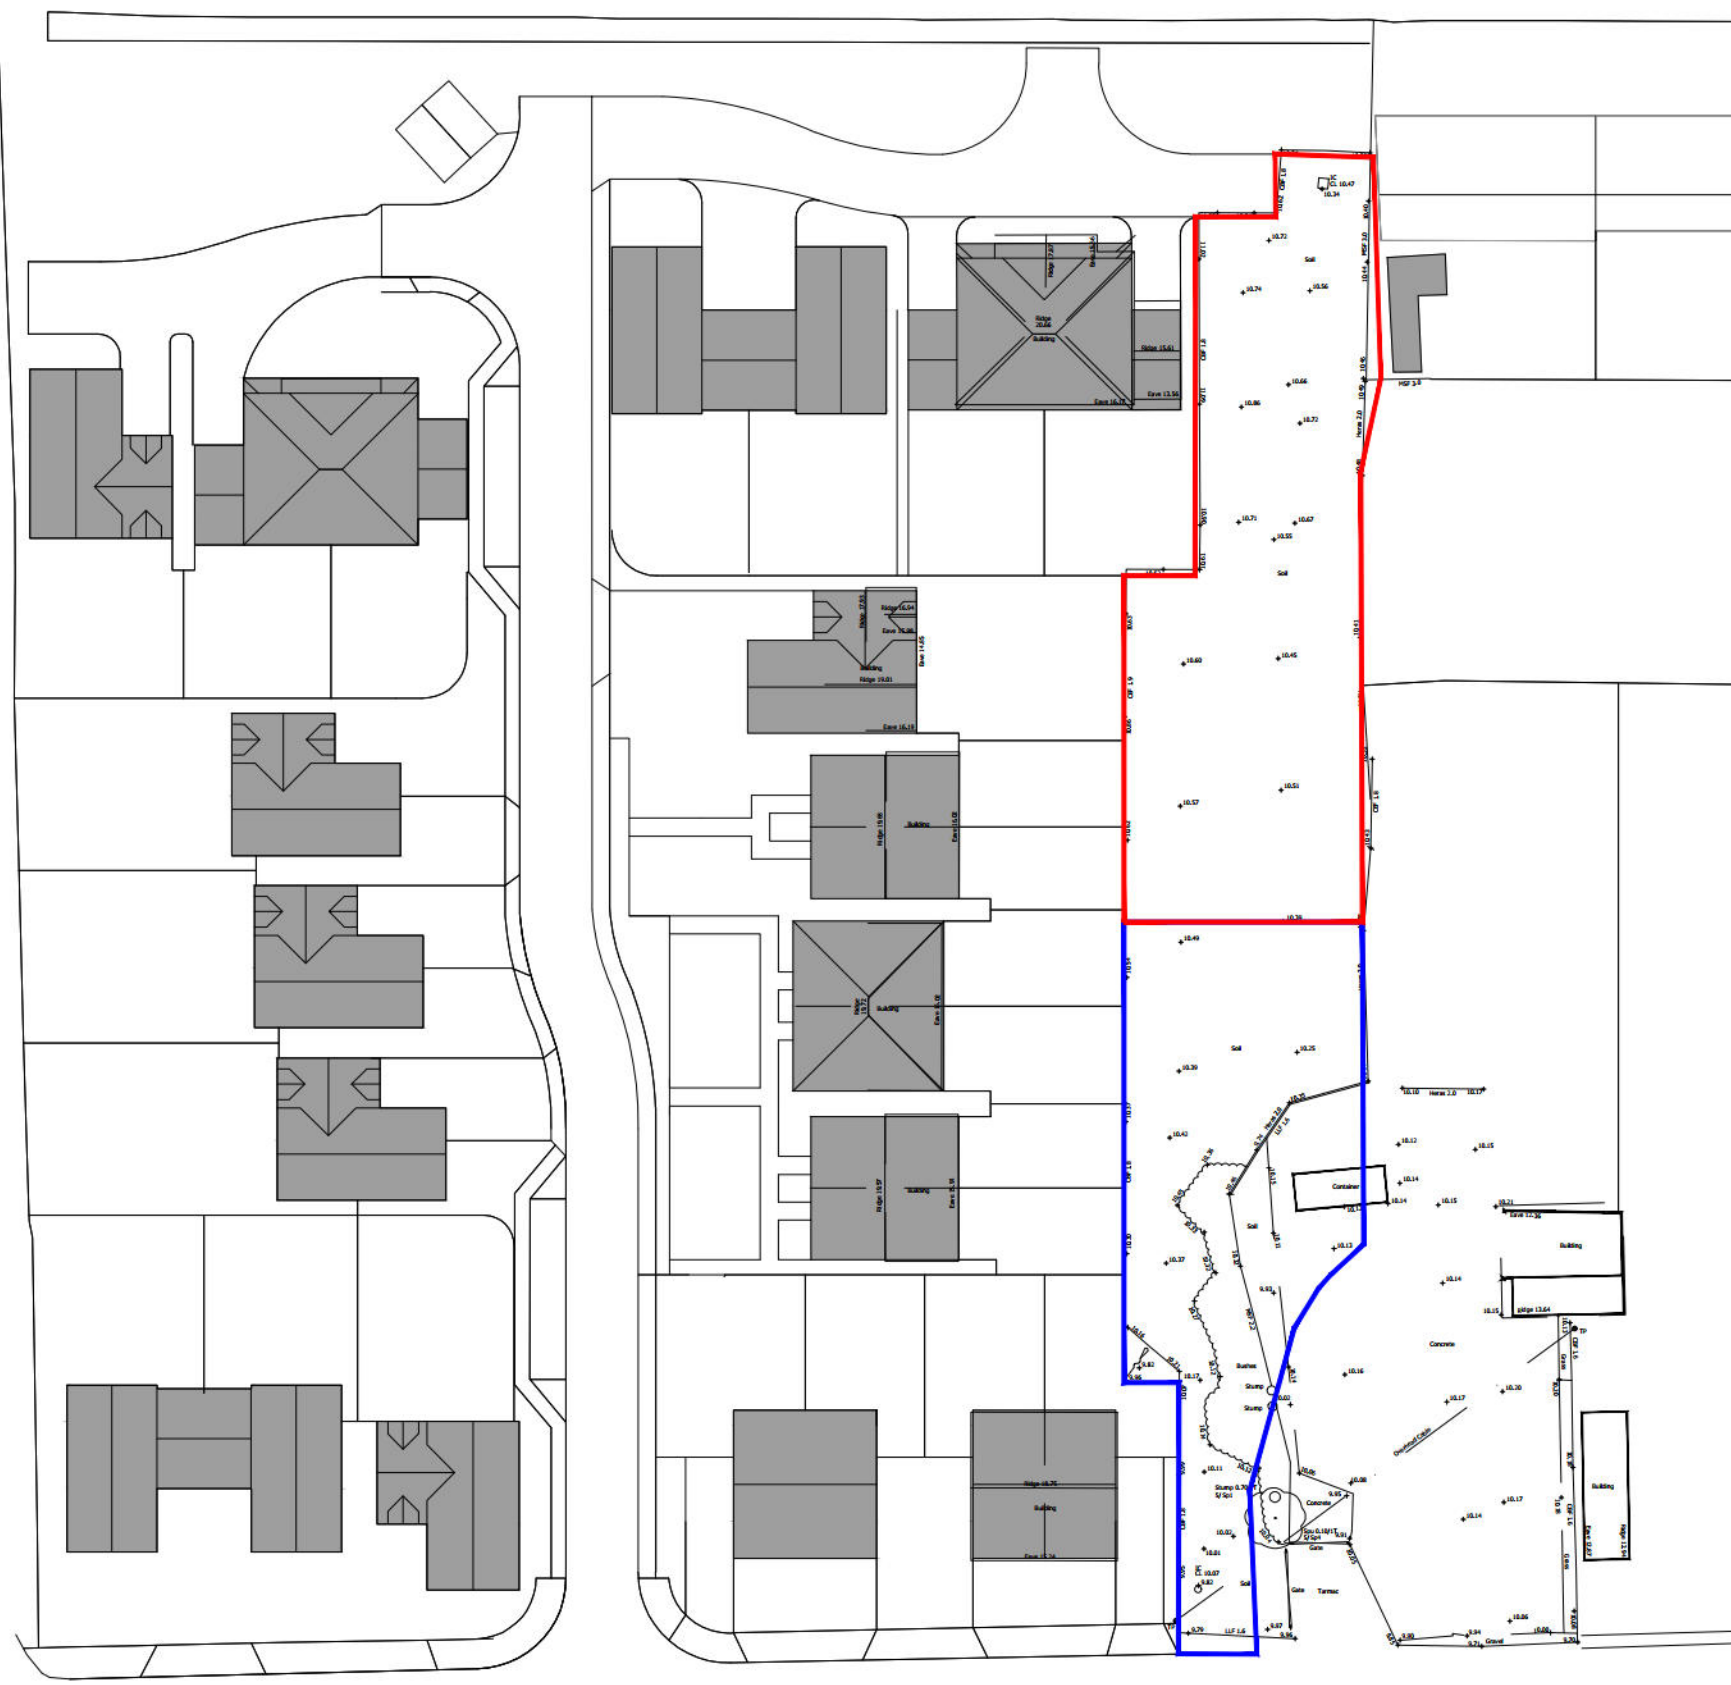
| TITLE<br>Existing Site Layout Plan | | | |

**Appendix 2**  
**Existing Site Layout Plan**

3.2.2 Existing ground levels are highest at the north of the site at approximately 10.75m AOD and falls towards its southern boundary at approximately 10.40m AOD.

3.2.3 A copy of the existing site layout plan is located in Appendix 2 at the rear of this report.

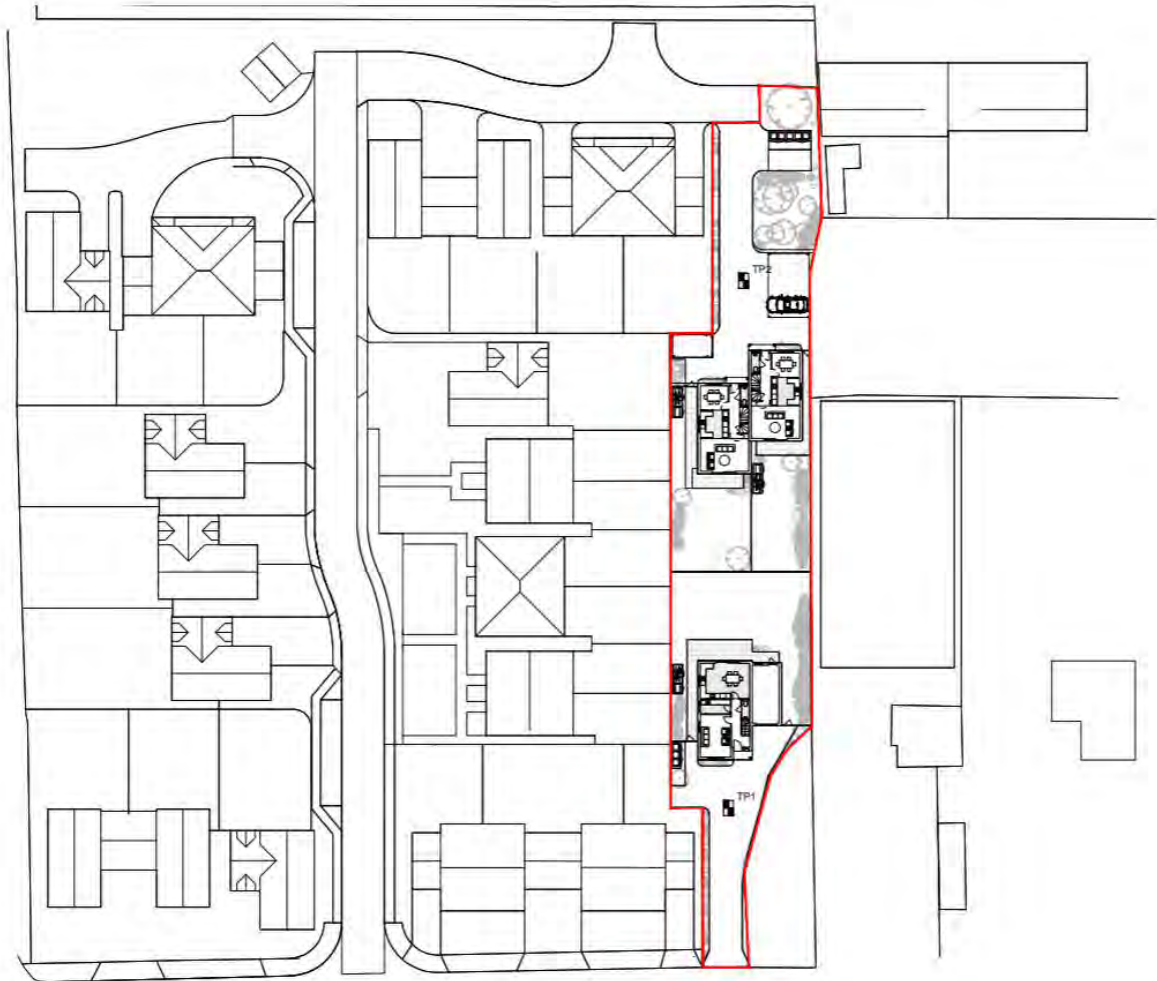
**Figure 2. Trial Hole Location Plan**

The site investigation was undertaken on the 9<sup>th</sup> and 10<sup>th</sup> of March 2023 and comprised 2No. machine excavated trial pits identified as TP1 and TP2 to a depth of 0.80 and 0.89m bgl respectively. All trial hole locations were selected by the Client's Engineer. The trial pits were excavated beyond the Client's target depth of 0.65m bgl due to the presence of Made Ground. Prior to excavation, both locations were scanned for services using a CAT and signal generator (Genny). Following the construction of the trial pit, infiltration testing in accordance with the principles of BRE DG 365:2016 were carried out.

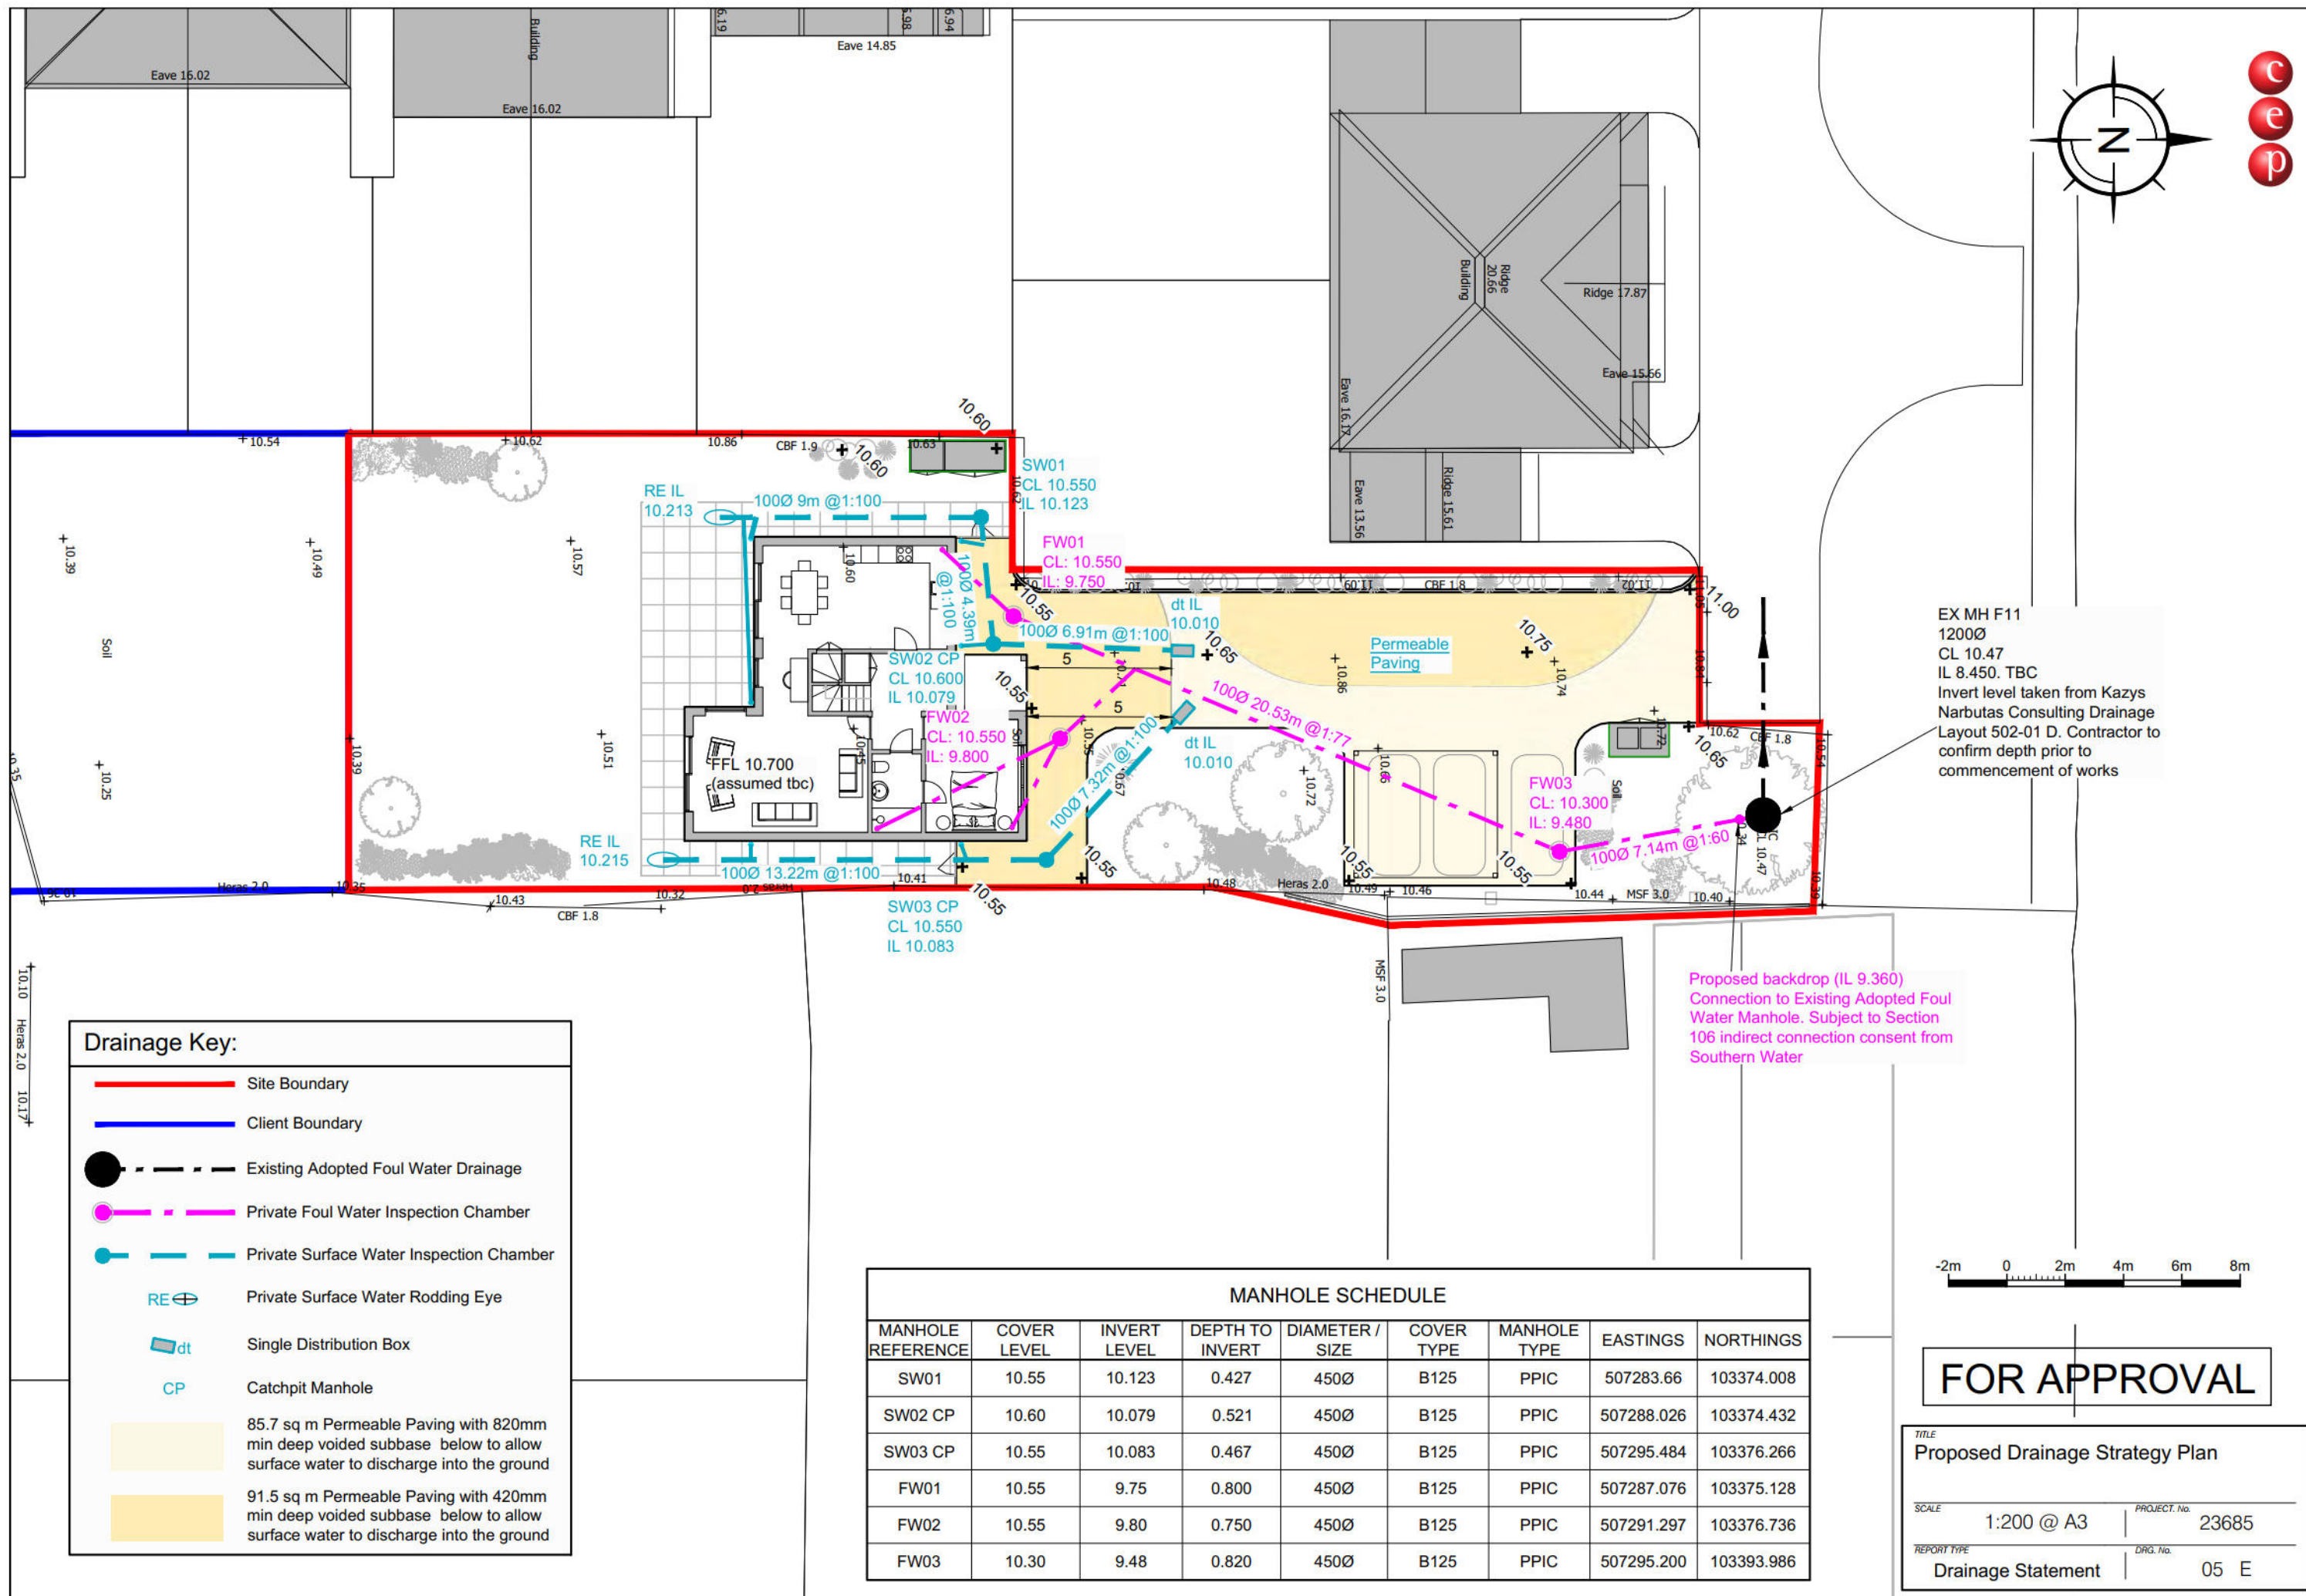
**Drainage Plan, Construction Details  
and Calculations**

- 5.2.8 The proposed drainage system utilises permeable paving infiltrating to ground to serve the dwelling and its associated car park / driveway area.

- 5.2.9 The permeable paving system incorporates a 30% voided subbase with a minimum storage volume of 25m<sup>3</sup> to accommodate the 1:100 year storm event including an additional 45% to account for the predicted effects of future climate change.

- 5.2.10 In accordance with West Sussex LLFA Policy for the Management of Surface Water guidance, the distribution tanks that allow connection of the roof drainage to the voided stone subbase will be set above the water level of the 1:10 year plus climate change volume at 10.009m AOD.

- 5.2.11 The subbase within 5m of any building is reduced to 400mm and further than 5m increased to 820mm so that surface water storage is provided for the roof areas for all rainfall events up to and including the 1:10 plus climate change within the deeper voided stone infiltration blanket area.

- 5.2.14 A copy of the drainage plan, construction details and calculations is located in Appendix 5 at the rear of this report.

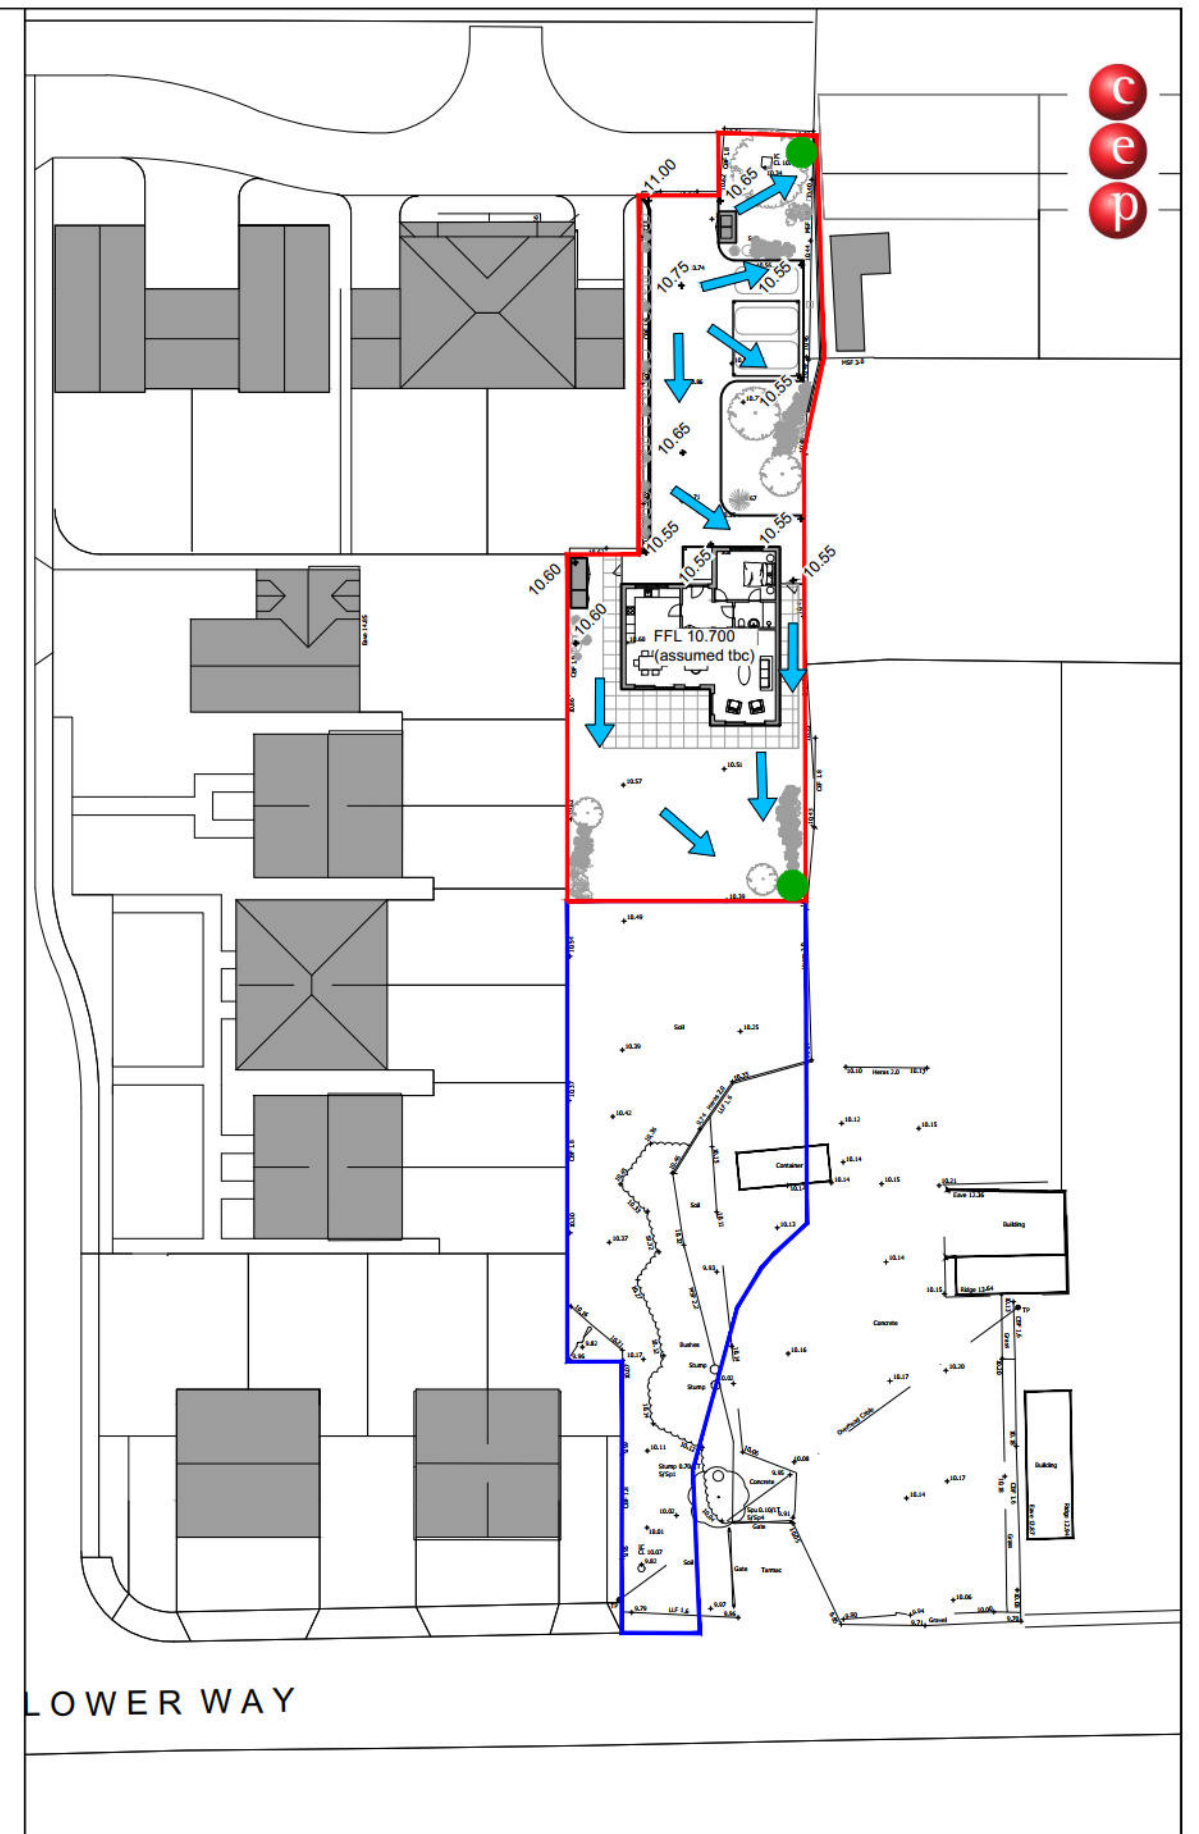
| TITLE<br>Exceedance Flow Route Plan | |

**Appendix 7**  
**Exceedance Flow Route Plan**

5.5.1 In the event that part of the onsite surface water drainage network was to become blocked, suffer a failure due to lack of maintenance or be inundated with a storm beyond the 1:100 year +45% design storm surface water would migrate overland towards the location of the onsite voided stone subbase and garden area would in all likelihood be retained on site.

5.5.2 Any water leaving the site would mimic the existing flow route to the south and east.

5.5.4 An exceedance flow route plan is located in Appendix 7 at the rear of this report.
