Angmering Pavilion
Angmering Sports Hub
Decoy Drive
Angmering
Litthehampton
BN16 4DN
West Sussex

Interim Bat Survey
Preliminary Roost Assessment & Emergence Survey
Report ref.: R2769_BS_a

November 2024

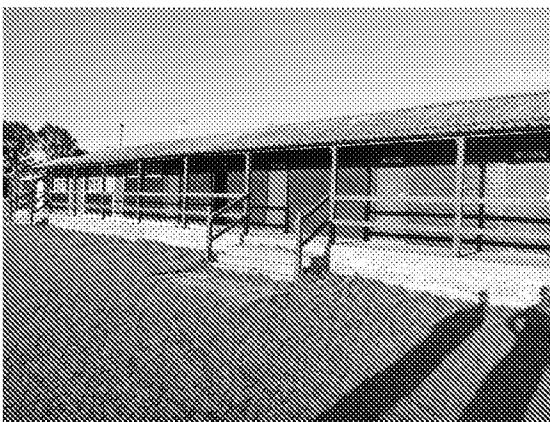
5.2.2 The pavilion is a simple, detached, single-storey building with a pitched roof (**Photographs 1 & 2**).

Photograph 1. Front elevation viewed from the southwest.

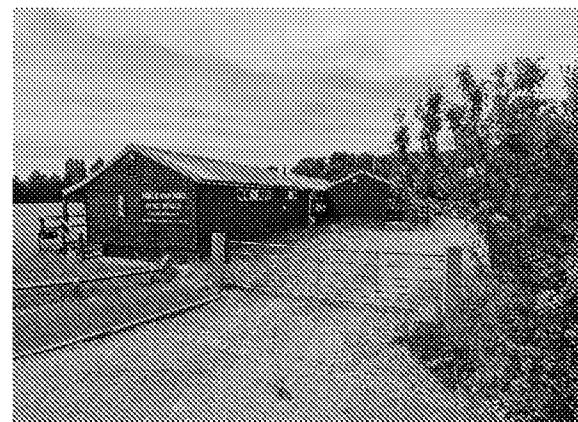
Photograph 2. Rear elevation viewed from the southeast.

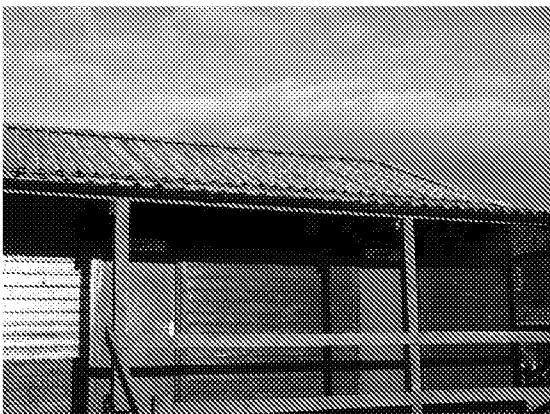
5.2.3 The roof was formed of corrugated metal sheets that had frequent gaps beneath the metal ridge cap, leading directly within the voids of the building (**Photograph 3; Target note 1**). In addition, slight gaps were situated behind the end cap along the

Photograph 3. Gaps between corrugated sheets and ridge (front elevation).

- Gaps between the corrugated metal sheets and metal ridge (**Photograph 3; Target note 1**);
- Gaps behind the end cap along the northwest timber gable (**Photograph 4; Target note 2**);
- Gaps between the grooves of the timber cladding and bargeboard on the northeast gable (**Photograph 8; Target note 3**);
- A large vent within the south gable (**Photograph 10; Target note 4**);
- Gaps at the ends of the corrugated metal sheet roof (**Photograph 14; Target note 6**); and
- Gaps along the edges of the timber sarking gables (**Photograph 15; Target note 7**).

6.1.2 Whilst the features associated with the corrugated metal roof, ridge and timber gables directly lead inside the roof void, which had sufficient space for internal flight and suitable conditions for supporting void-dwelling bats such as the locally recorded brown long-eared bat (*Plecotus auritus*), no bat droppings were observed and so the presence of void-dwelling bats is considered unlikely.

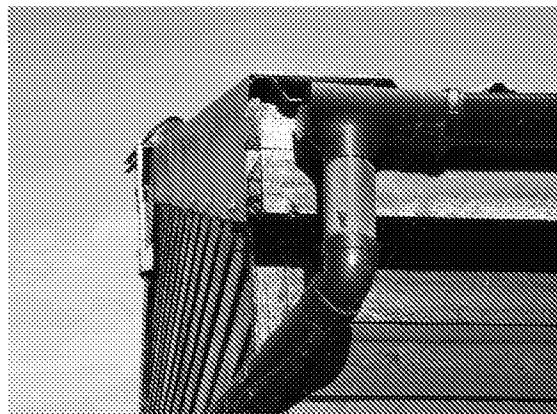
northwestern timber gable (**Photograph 4; Target note 2**).

Photograph 4. Gaps behind the metallic end caps (north elevation).

6.1.3 With that said, the features associated with the gable and end caps offer potential crevice roost sites for small numbers of crevice-dwelling bats such as the locally recorded common pipistrelle (*Pipistrellus pipistrellus*) and soprano pipistrelle (*Pipistrellus pygmaeus*). Evidence of crevice roosting species is typically hidden from view in areas such as gaps between tiles and internal linings/insulation.

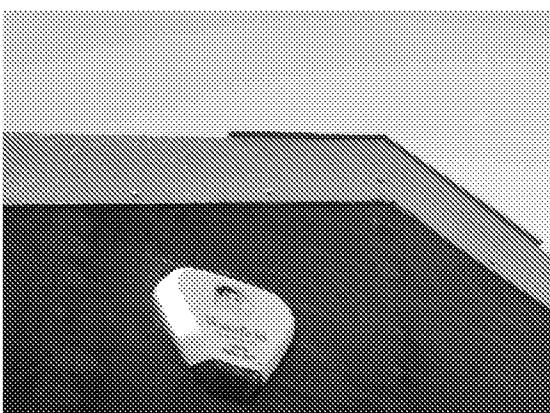
5.2.4 The timber soffit along the front elevation, in addition to the painted timber soffit along the rear, was sealed to the walls of the pavilion (**Photographs 5 & 6**). Whilst the timber bargeboard under the metal cap was sealed to the eastern timber clad gable, slight gaps were situated between the grooves of the timber cladding and bargeboard on the northeastern gable, however, the gaps were heavily cobwebbed with no signs of recent use by bats (**Photographs 7 & 8; Target note 3**).

Photograph 7. Timber bargeboard under metal cap sealed to the gable (south elevation).

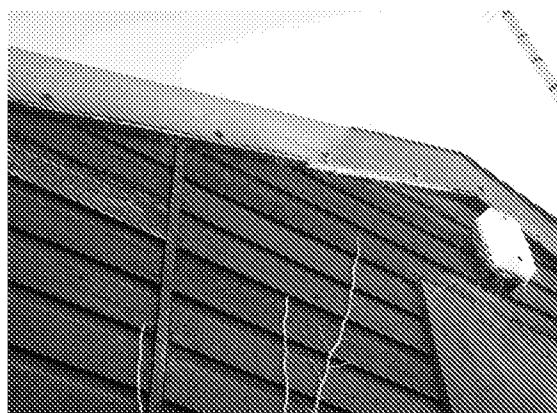
Photograph 8. Cobwebbed gaps between grooves of timber cladding and bargeboard (north elevation).

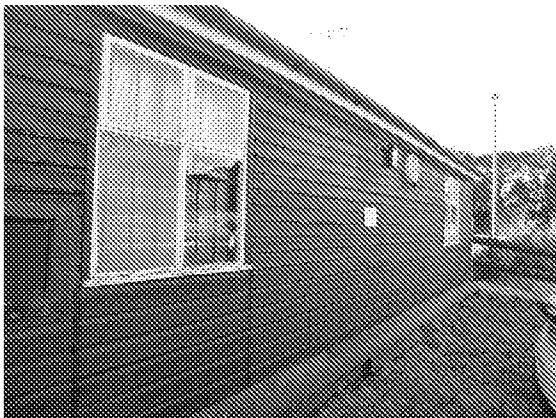
5.2.5 The timber clad walls were sealed on all elevations of the pavilion and a large vent with directly internal access to the void was situated on the southern gable (**Photographs 9 & 10; Target note 4**).

Photograph 9. Timber cladding walls fully sealed (rear elevation).

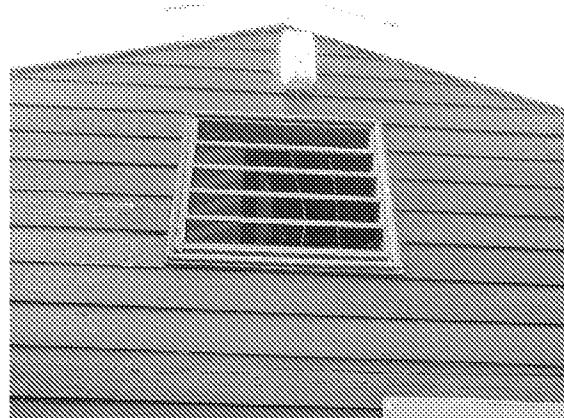
Photograph 10. Large vent within southern gable (south elevation).

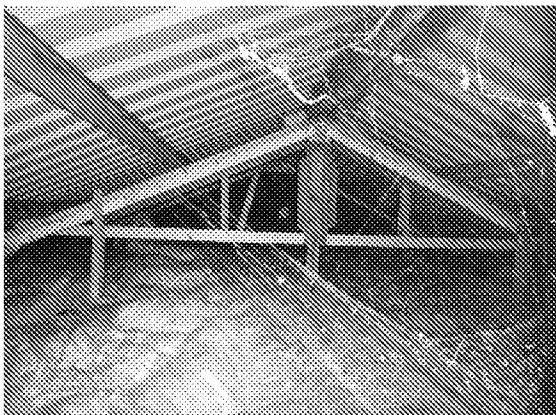
5.2.6 The pavilion had two roof voids that covered its footprint. Both voids were of simple construction, accessible via loft hatches, had approximate floor-to-ridge heights of 0.5 metres and were heavily cobwebbed throughout (**Photographs 11 & 12**).

Photograph 11. Roof void 1 heavily cobwebbed throughout.

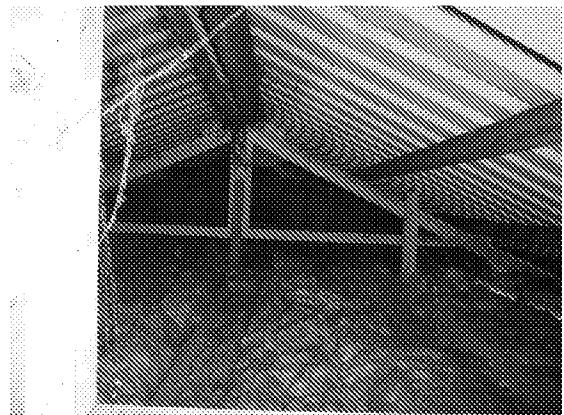
Photograph 12. Roof Void 2 heavily cobwebbed throughout.

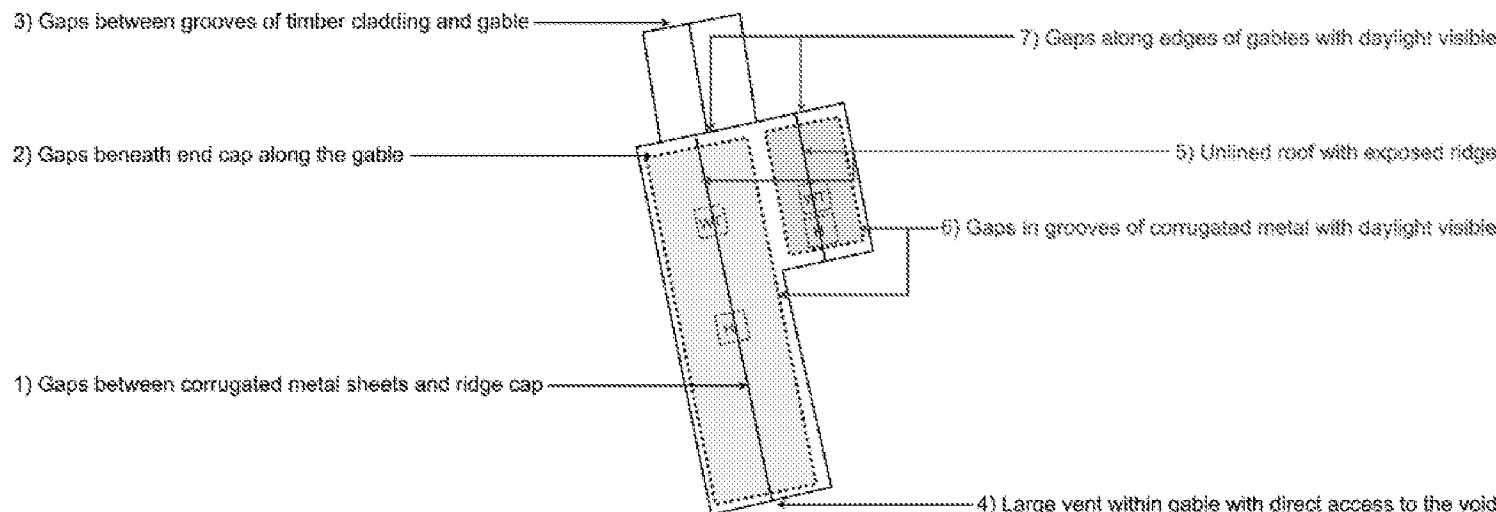
Figure 1. Preliminary Roost Assessment findings plan.

5.2.1 The survey findings from the external and internal inspections carried out for the building are described with photographs and are annotated in a plan, as follows:

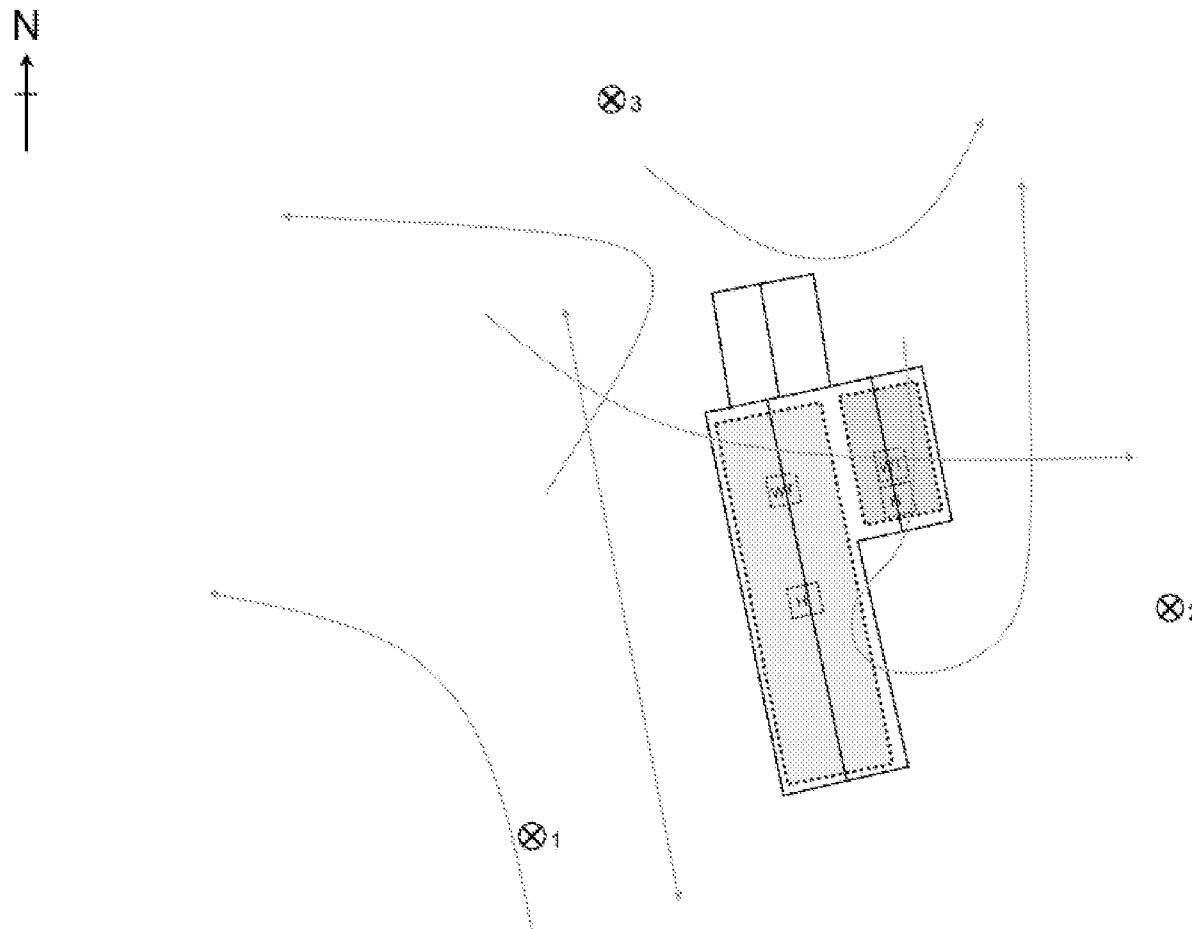
Figure 2. Emergence Survey Findings.

5.3.1 The bat emergence survey findings are described, summarised in **Tables 2-3** and illustrated in **Figure 2** below; the raw detector data is supplied in **Appendix 2**.

5.3.4 Activity was low throughout the survey period and primarily comprised *P. pipistrellus* foraging passes over the pavilion, along its northern, western and eastern elevations

and over the nearby sports ground. Artificial lighting illuminated all elevations of the pavilion.
