Our Ref: YE7990

**Ref: Arundel Road, Angmering**

We thank you for your request to undertake permeability testing at the above mentioned site and take pleasure in enclosing the results of this work. The investigation was undertaken on the 15<sup>th</sup> January 2020 in accordance with your instruction to proceed. This letter describes the work undertaken, presents the data obtained and discusses the results of the tests.

#### Soakaway Tests

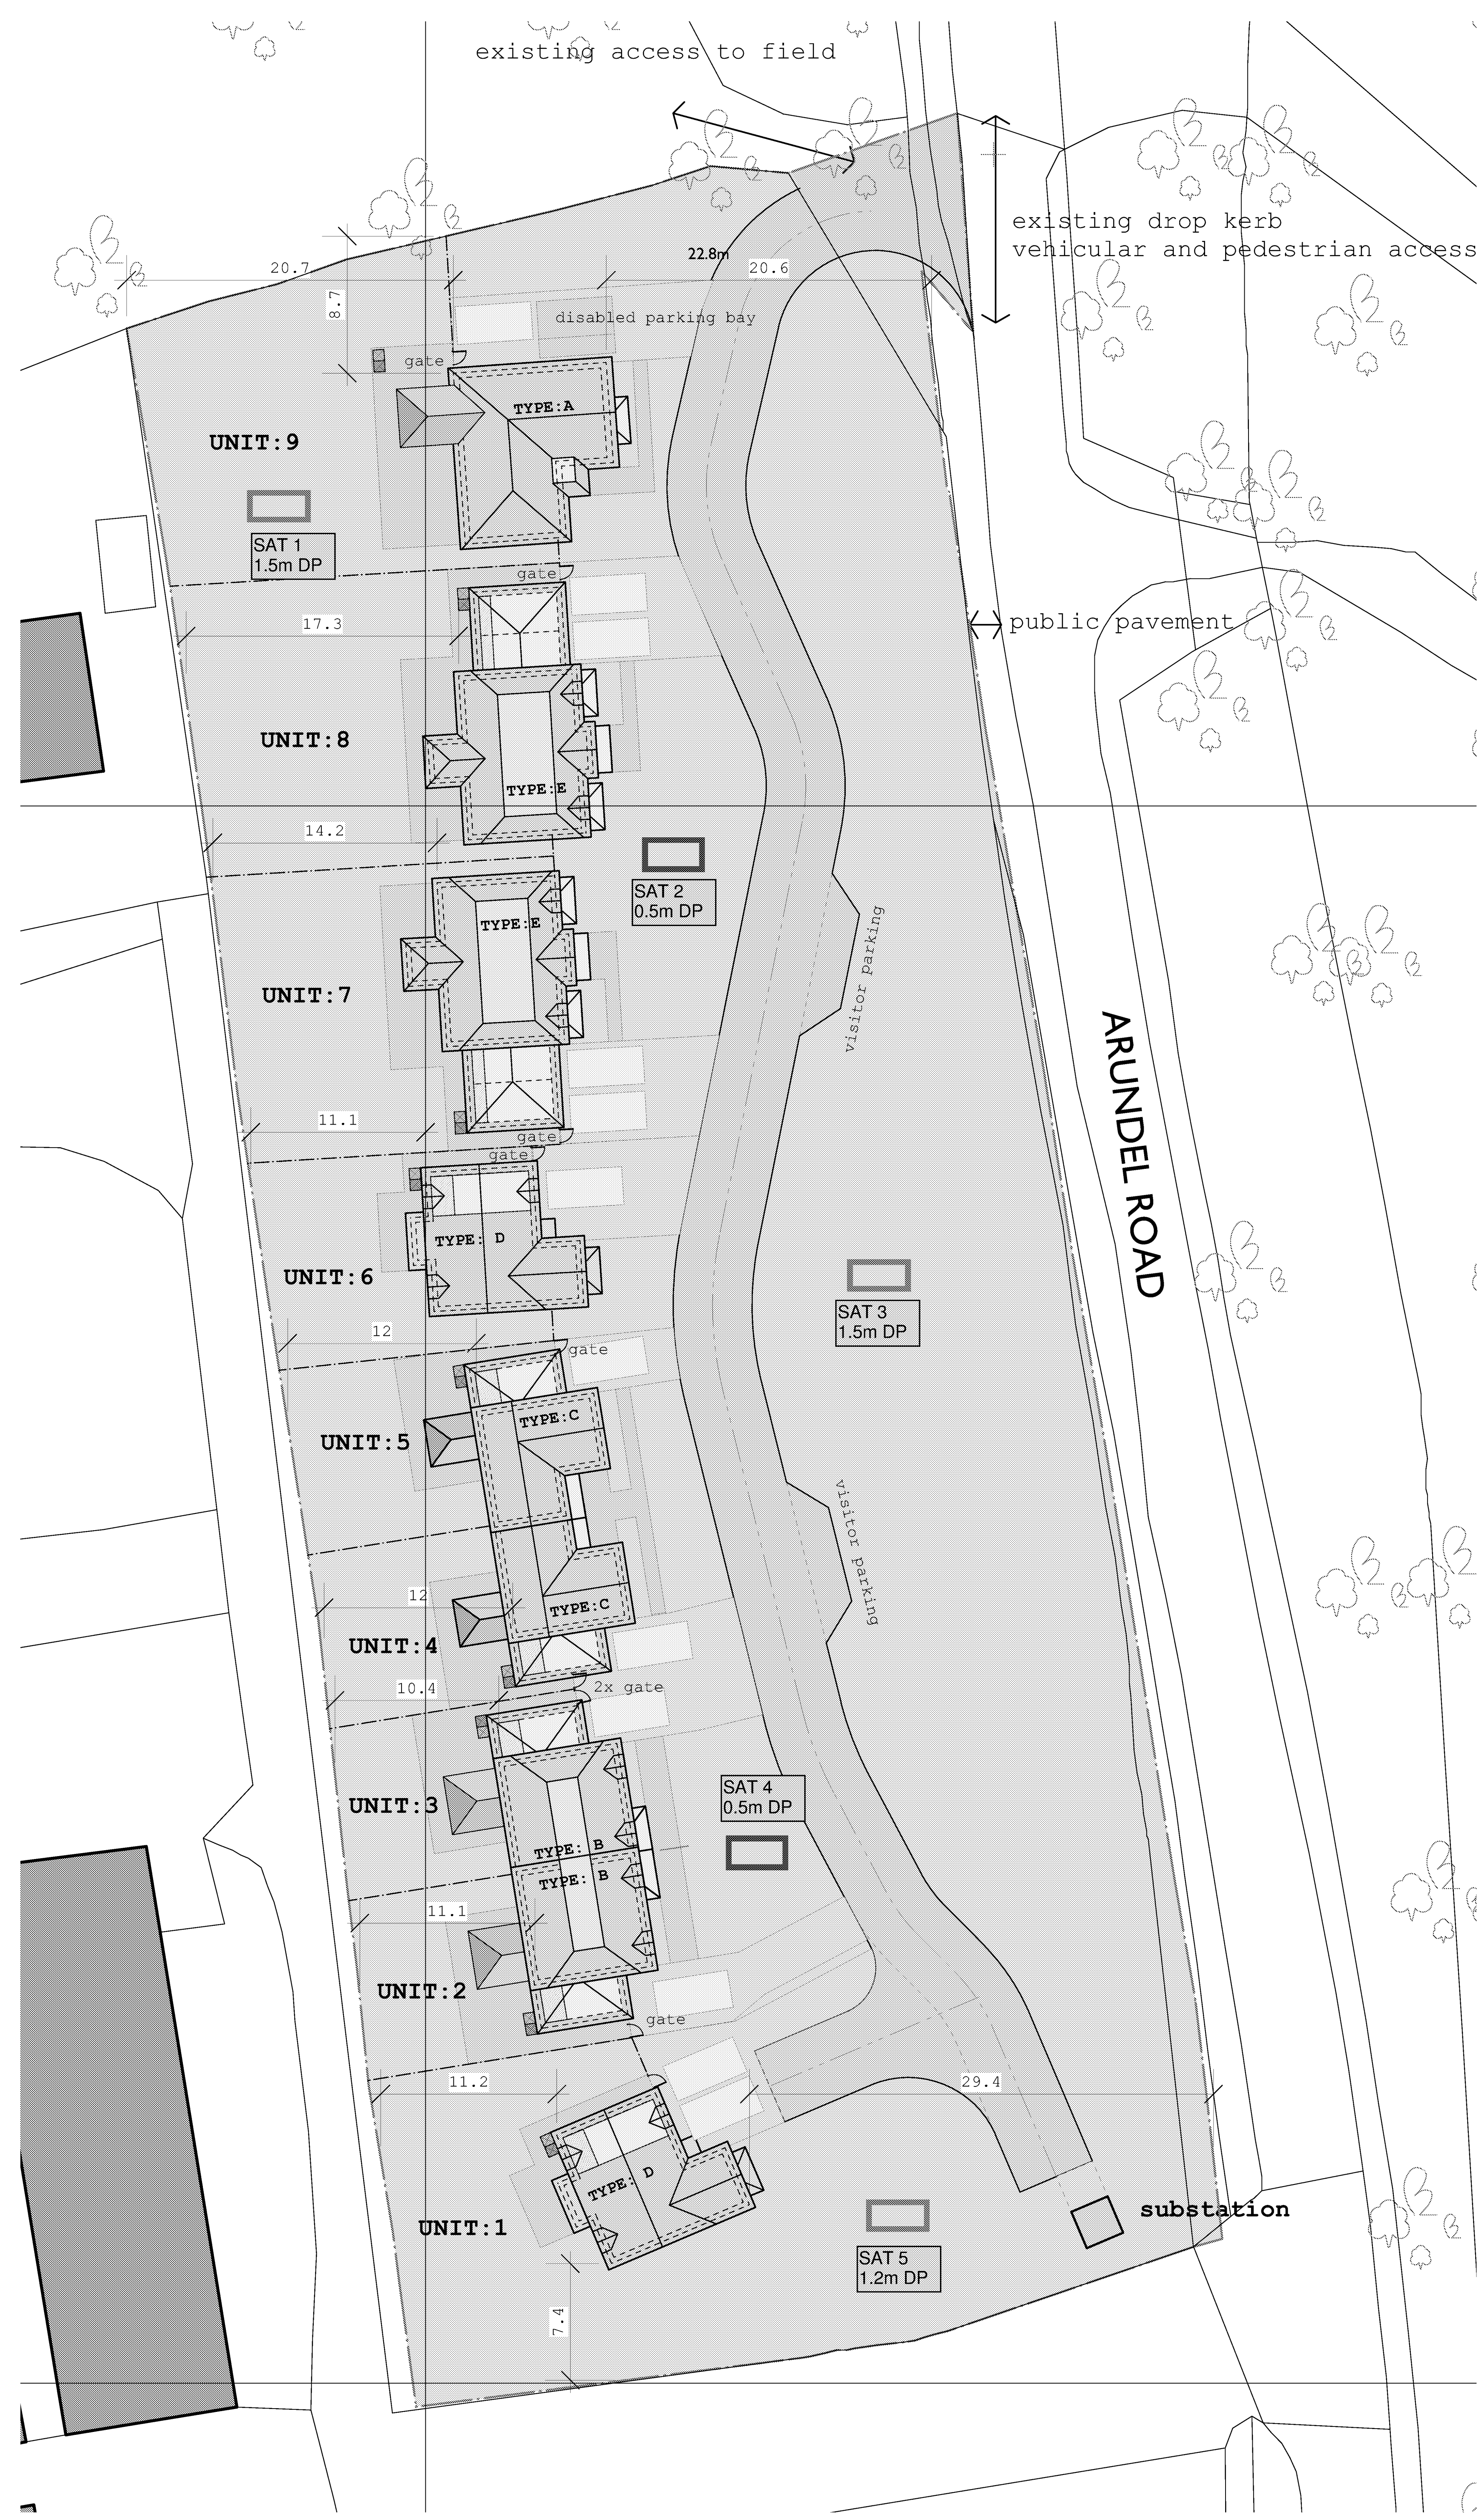
## APPENDIX A: Site Investigation Plan

The programme of this investigation included the excavation of five trial pits. The locations of the soakaway tests were selected and excavated by the client.
