**PHASE 1 ENVIRONMENTAL SITE  
ASSESSMENT REPORT**

**WHITE LODGE,  
HANGLETON,  
FERRING,  
WEST SUSSEX,  
BN12 6PP**

ENVIROSOLUTION LTD

**Date: 10<sup>th</sup> February 2020**

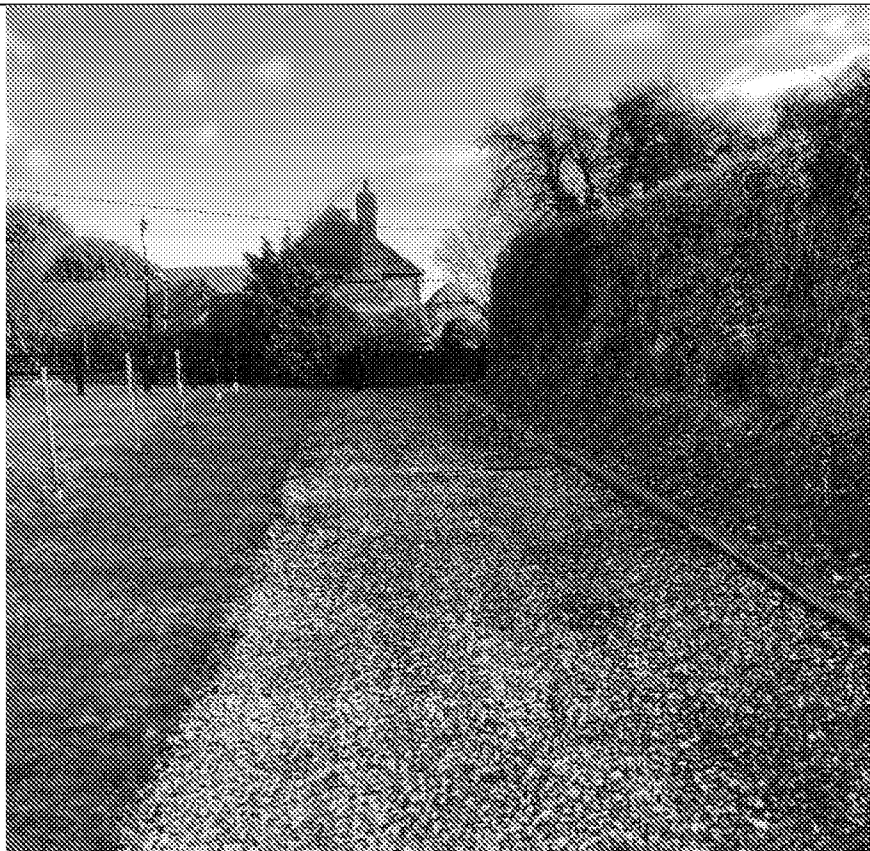
**View looking east along the southern site boundary**

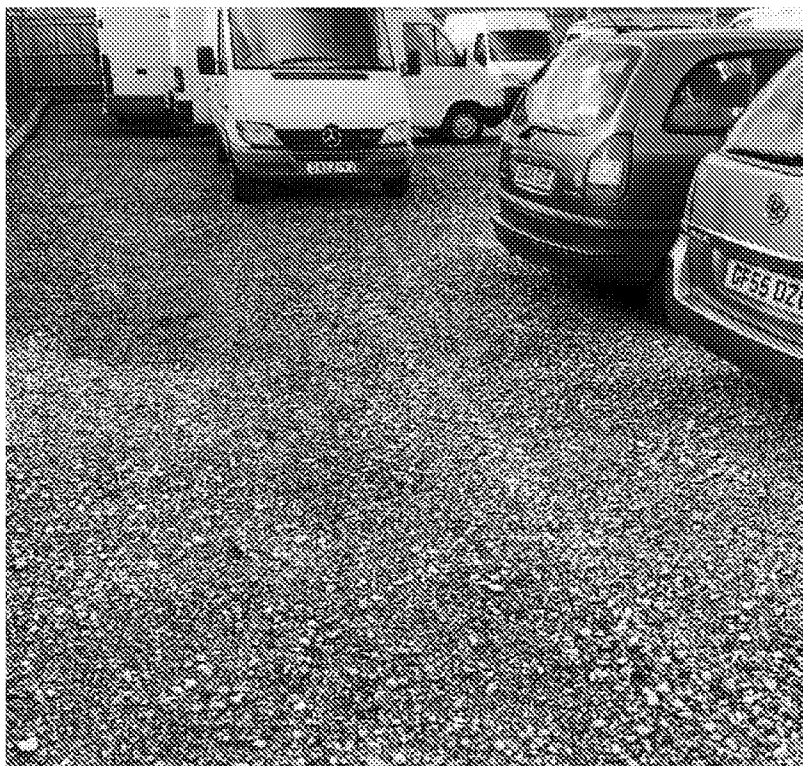
The area of vehicle storage is covered in pea gravel.

Pea gravel ground covering in western half of the site in areas for van storage

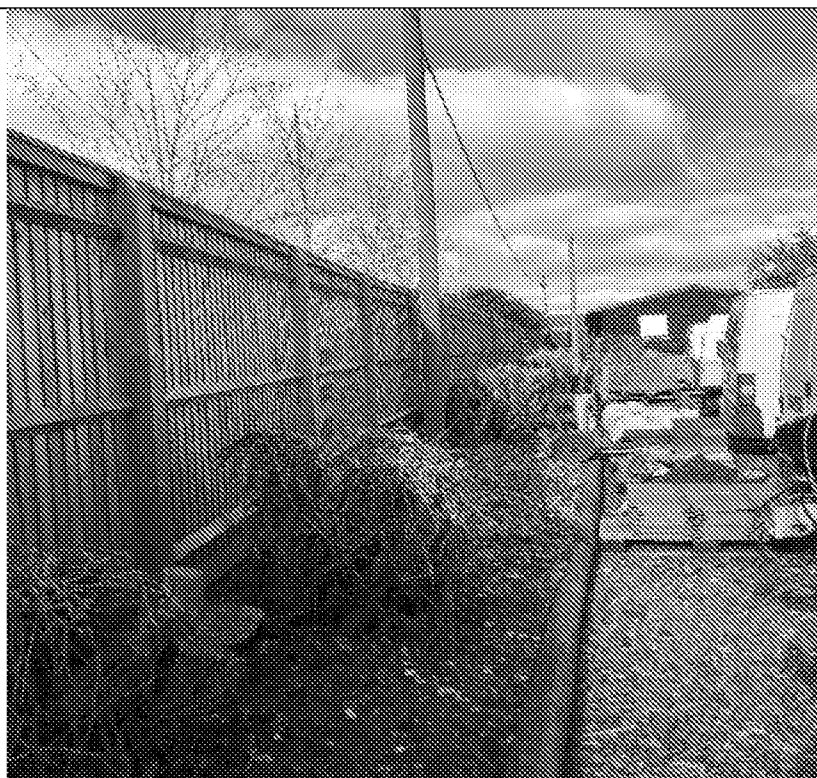
The site boundaries consist of 2.5m tall hedgerows along the southern and eastern boundaries and wooden panel fencing on all other sides. The site is bounded by residential properties to the south and west, an equestrian centre to the east and open agricultural fields to the north.

Western site boundary
