Farr House

***Bat survey results and mitigation plan for the farmhouse on Brook Lane, Rustington, West Sussex.***

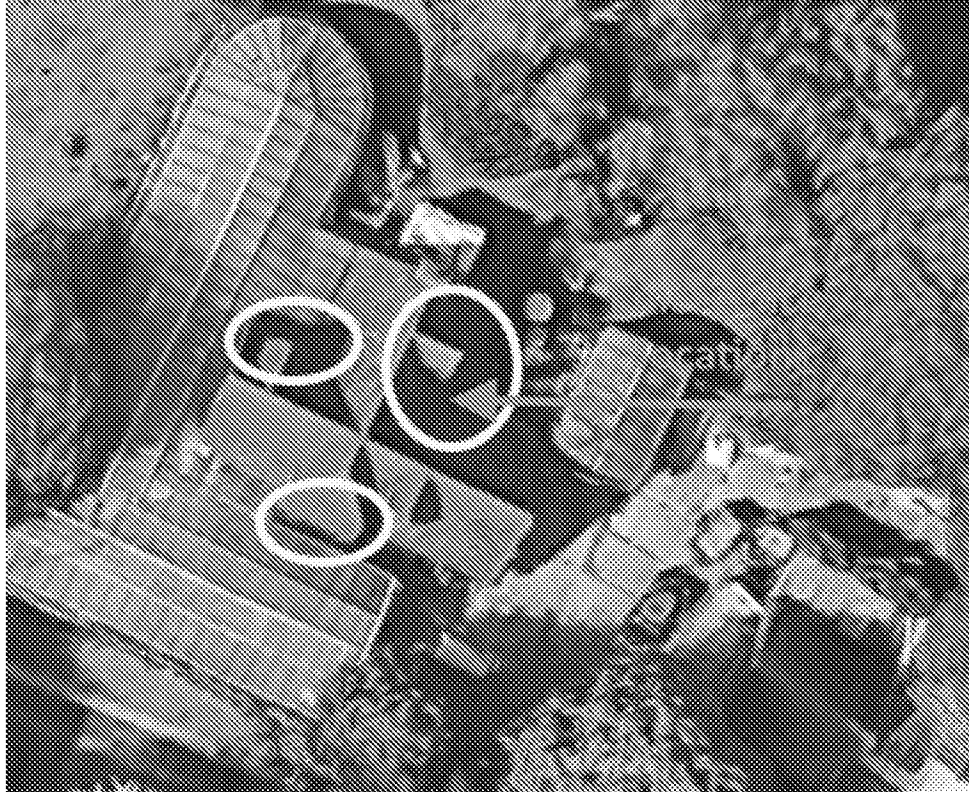
*Figure 2: Yellow circles indicate areas of lifted weatherboarding.  
Red arrow indicates where the bat was seen to emerge from on the 2nd May 2017*

A single bat was seen to emerge from the weatherboarding around the eastern dormer window from surveyor position 2 at 20.20. The bat did not echolocate but is considered likely to be a pipistrelle species.

It is recommended that another two bat surveys be carried out this season (May-September 2017). One dusk and one dawn survey are recommended. This will assist in determining the exact location of the roost, the number of bats using the roosting feature and confirmation of the species and if there are any additional bats using crevice features on other aspects of the house.

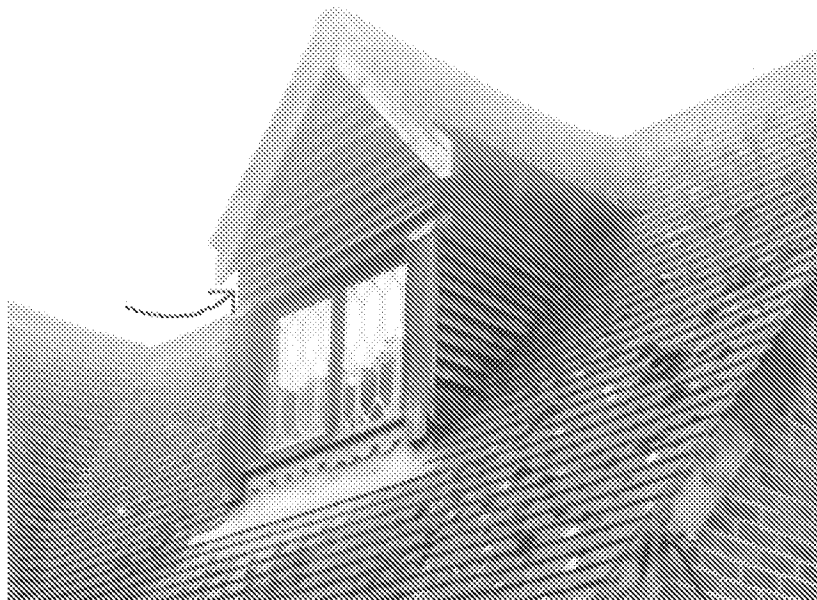
Surveyor two heard predominantly pipistrelle calls from common and sopranos, with a serotine pass at 21.23. Pipistrelles were seen to be foraging within the driveway for a continuous 10 minutes between 21.25 and 21.34. A bat was seen by surveyor 2 to emerge from the corner of the eastern dormer window, from underneath the weatherboarding, three boards up. The bat did not echolocate, however the next call heard was from a soprano pipistrelle. It is considered likely that the bat was a pipistrelle species.

*Figure 3: Photograph of the area where the bat was seen to emerge from on the 2nd May 2017*
