## Land at Brook Lane, Rustington

### Water Vole Mitigation and Method Statement

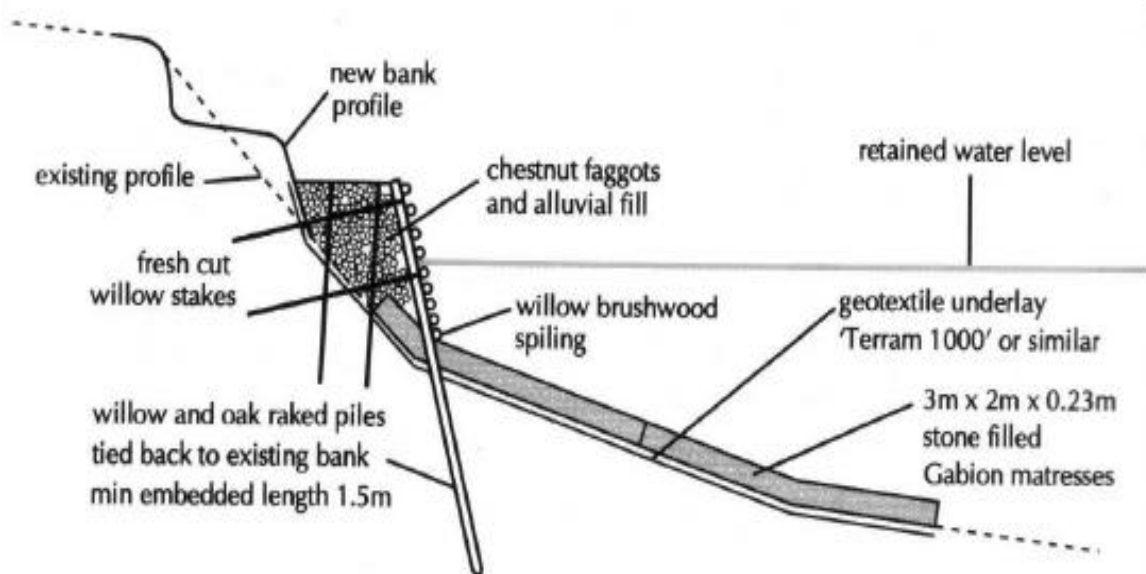
- 3.2 The new balancing pond to the south east corner of the site will be planted and designed for water voles. The banks should be stable and stepped with good vegetation cover and should use substrate that voles can easily dig into (Figure 1). There should be some depth to the water immediately in front of the bank to allow the voles to escape quickly. The watercourse should contain water at all times of the year.

*Figure 1: Example of water vole bank design (Strachan 1998)*
